Filler Joist Wall Investigation The Ambassadors Theatre, London

Project Code P00706

Issue No. 001

Issue Date 07 August 2024

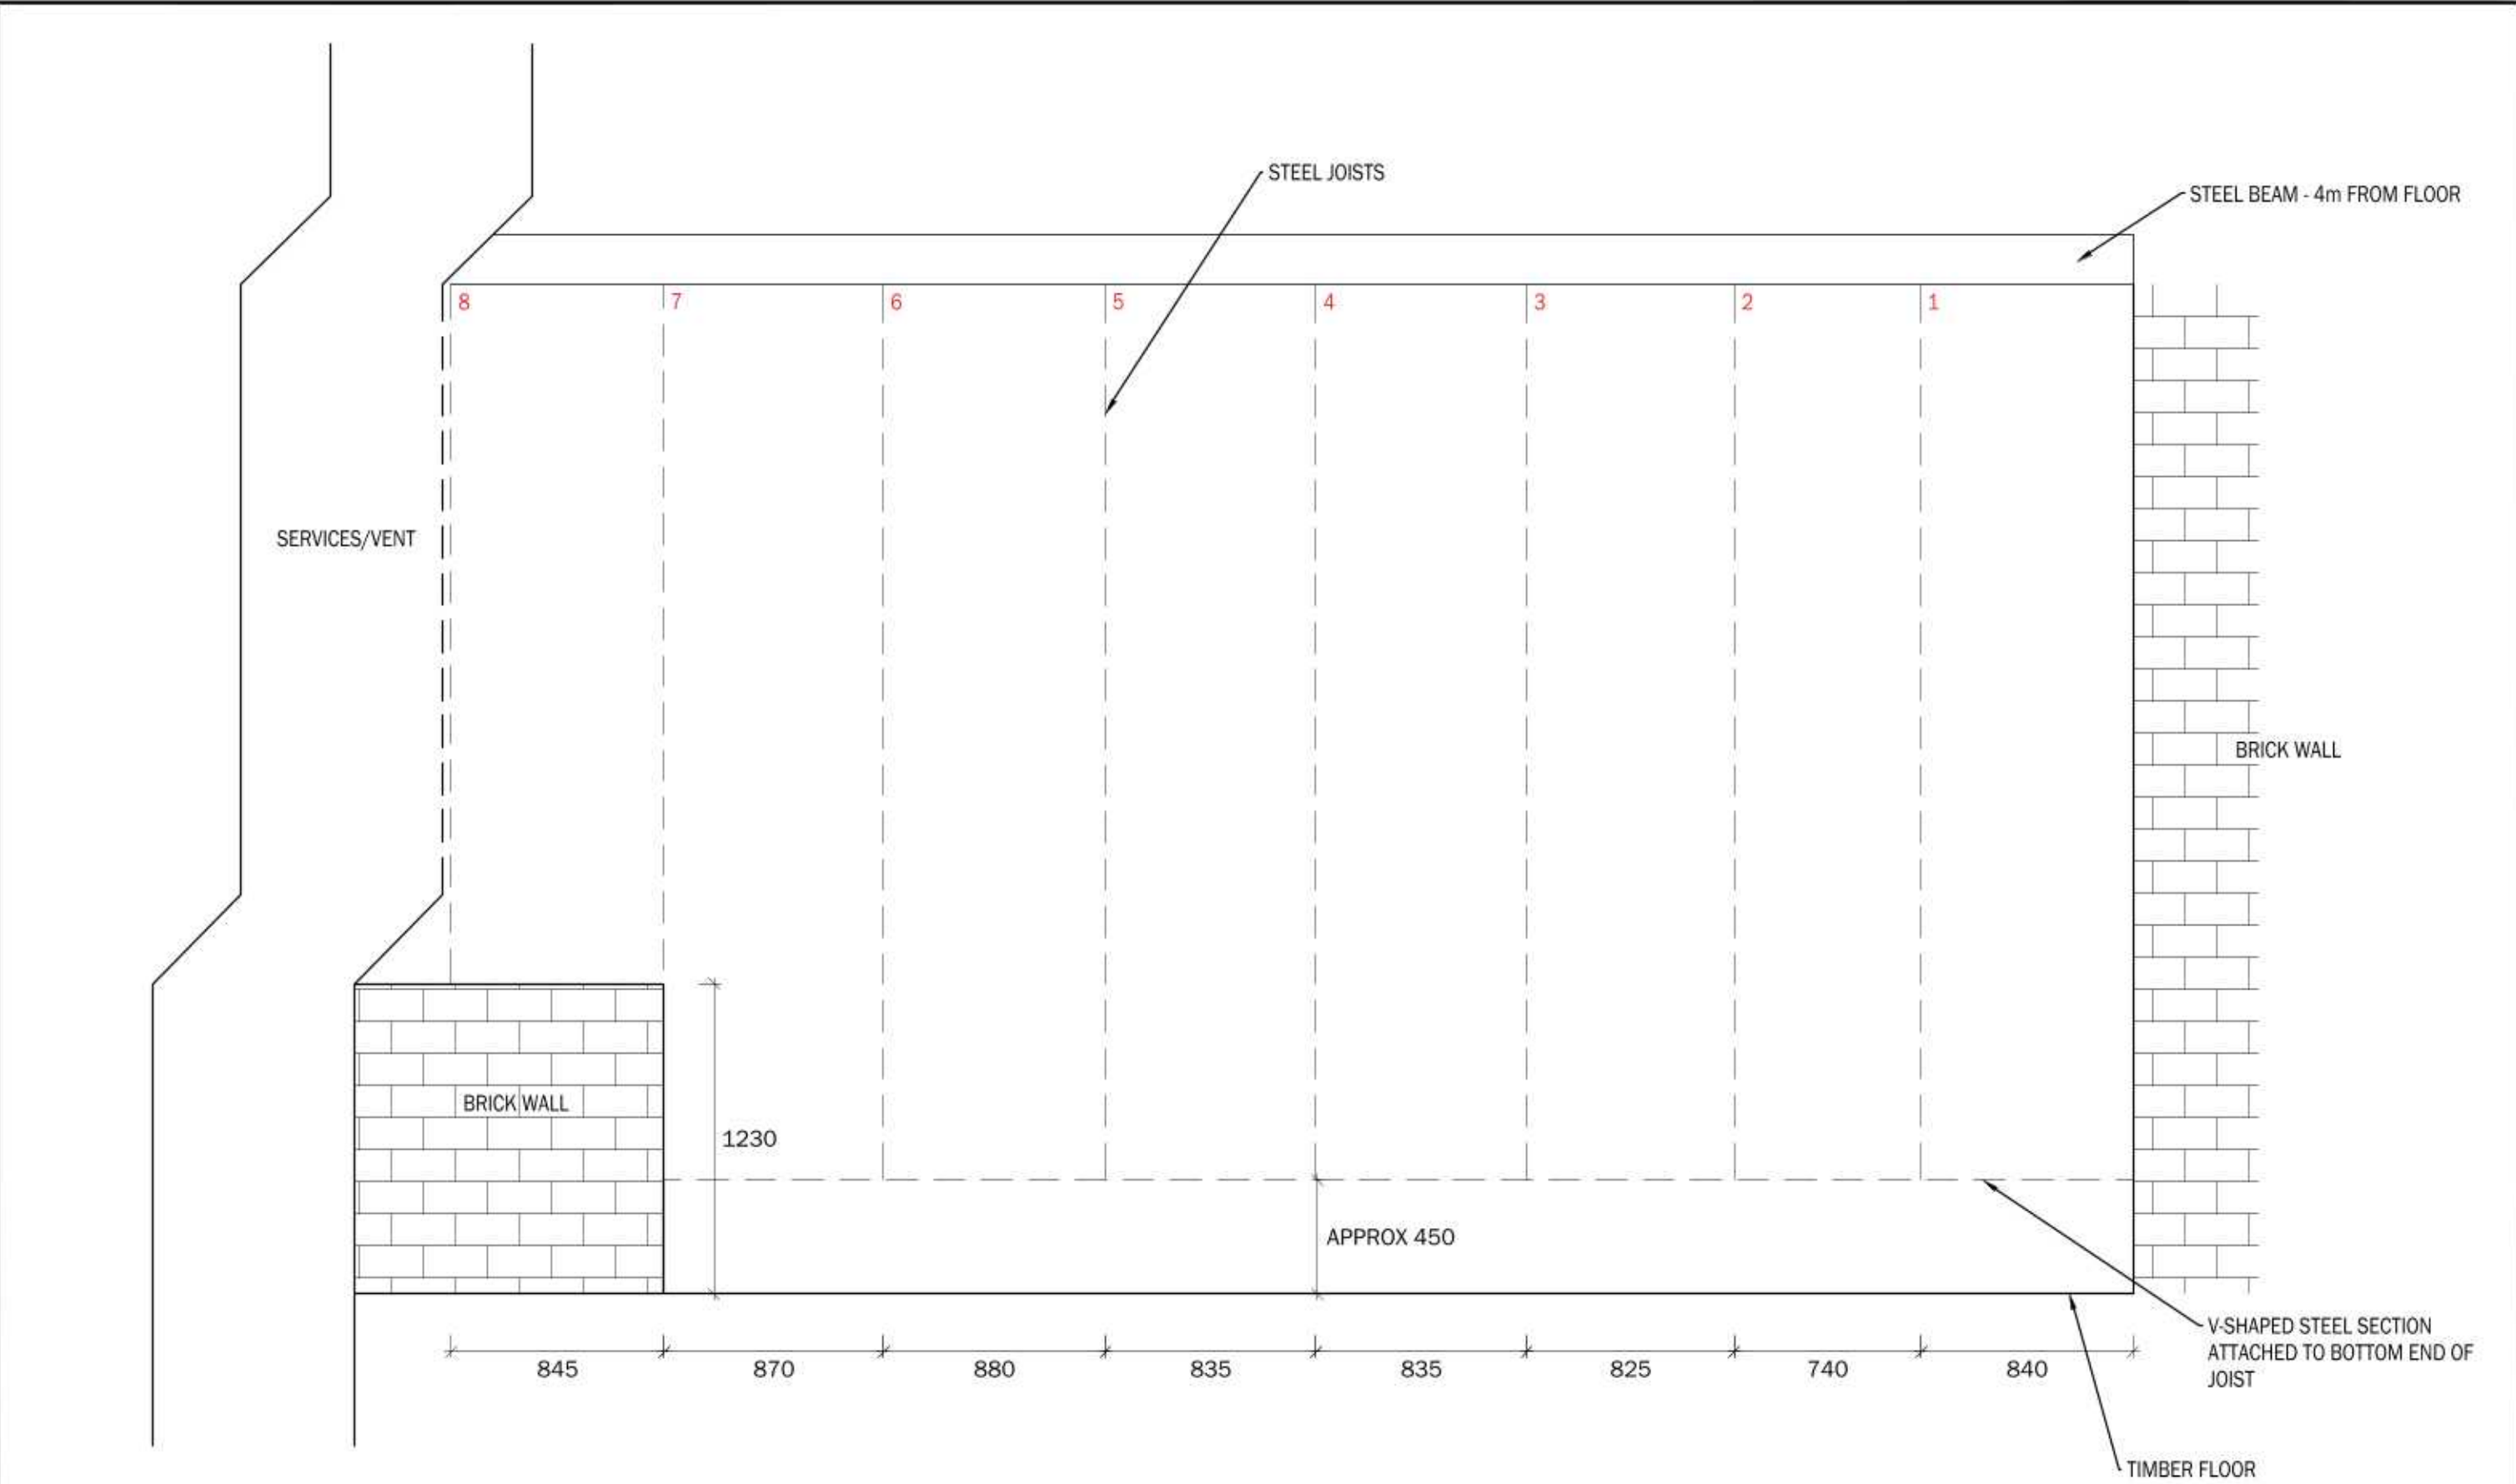
The investigation area was undertaken internally to the first-floor slanting wall adjacent to the fly tower. A schematic drawing shows the wall elevation and is presented in **Figure A1 in Appendix A**.

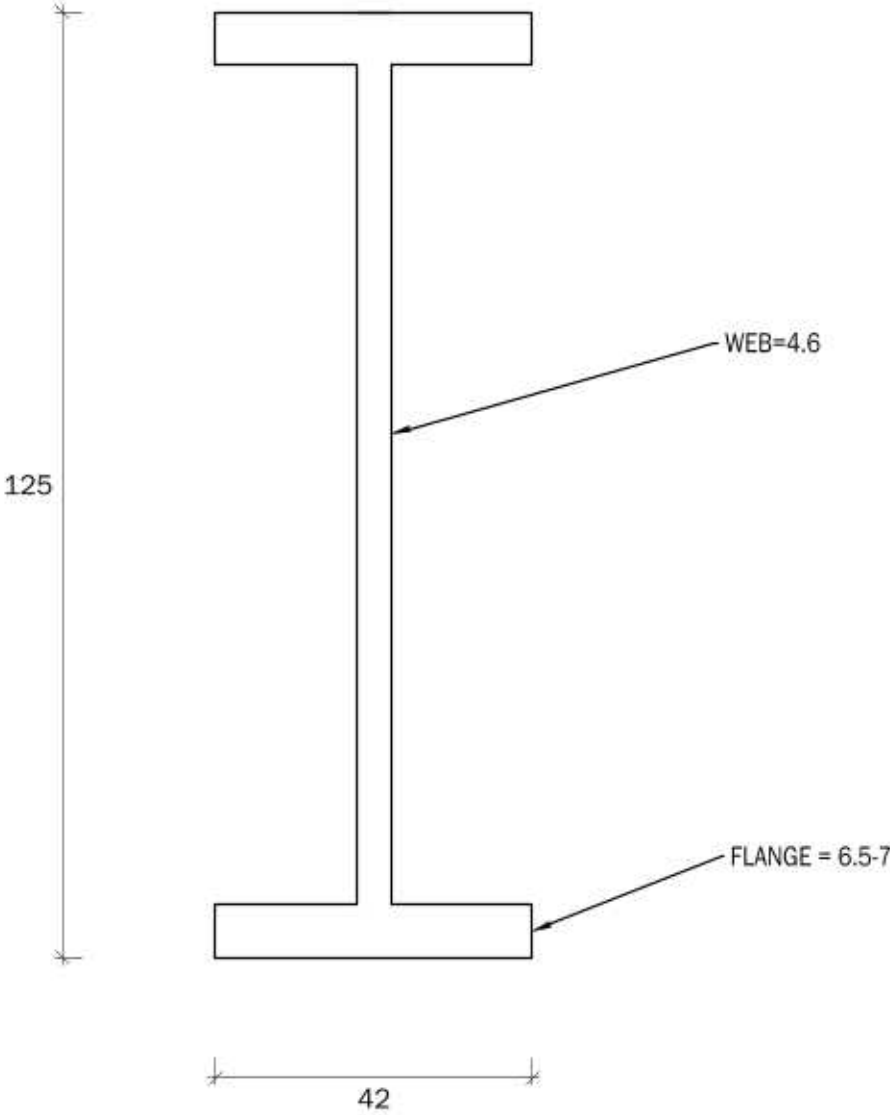
The cover to the internal flanges of the steel joists is typically 15 to 25mm of clinker concrete and render.

- * FILER JOIST MEASUREMENTS IN mm
- * ALL 6 No, JOISTS EXPOSED - MEASURED TO BE SAME DIMENSIONS

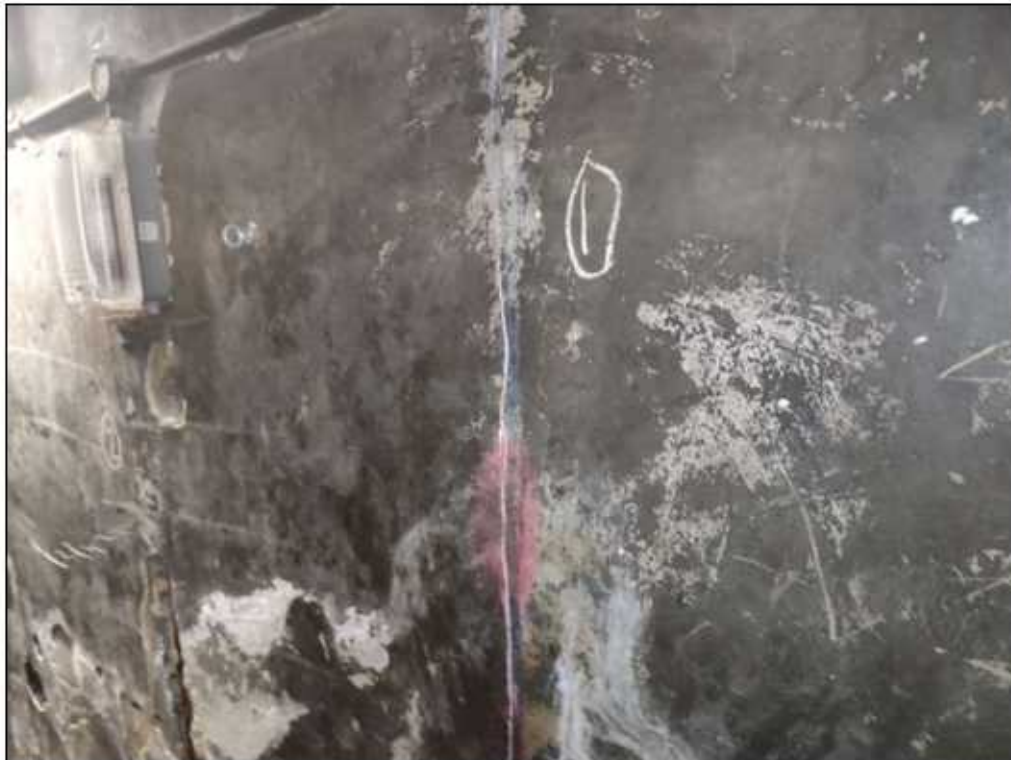
Photo 1: Joist 1, general view before opening-up work. Crayon line indicates position of joist.

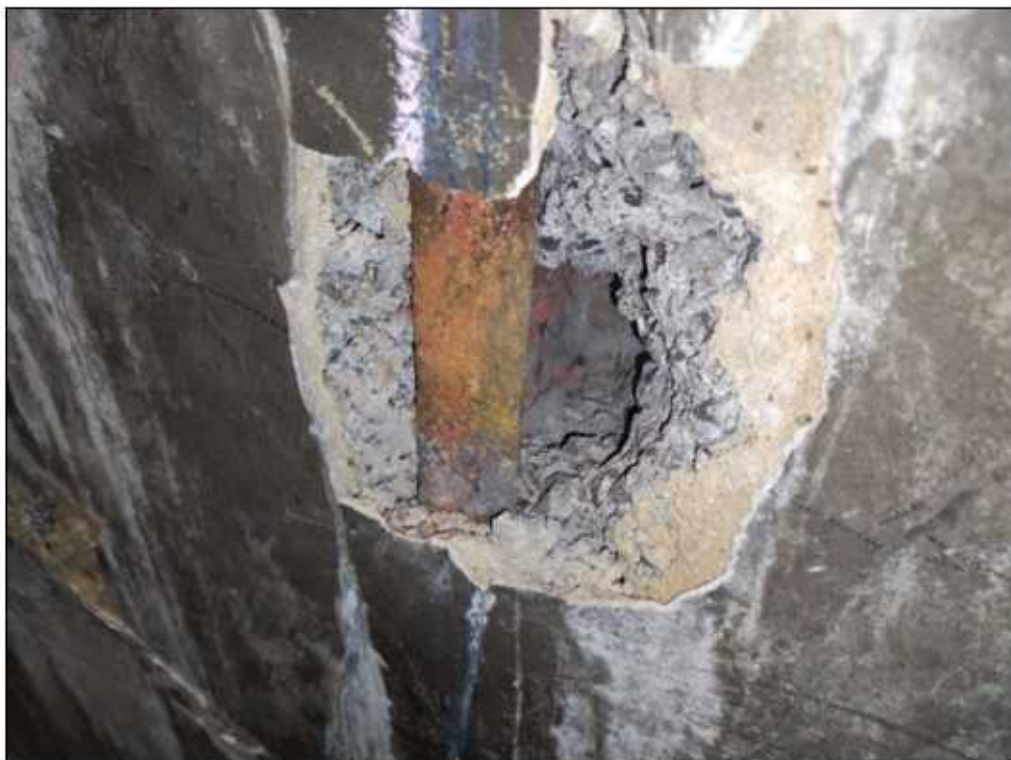
Joist Ref.	Internal face joint flange	Web	External face flange
1	Light surface corrosion	Light surface corrosion	Heavy corrosion
2	Heavy corrosion	Heavy corrosion	Severe corrosion (flange completely corroded through)
3	Heavy corrosion	General surface corrosion	Heavy corrosion
4	General surface corrosion	General surface corrosion	Heavy corrosion
5	Light surface corrosion	General surface corrosion	Heavy corrosion
6	Heavy corrosion	Heavy corrosion	Severe corrosion (flange completely corroded through)

Photo 2: View of the web and front flange of joist 1.

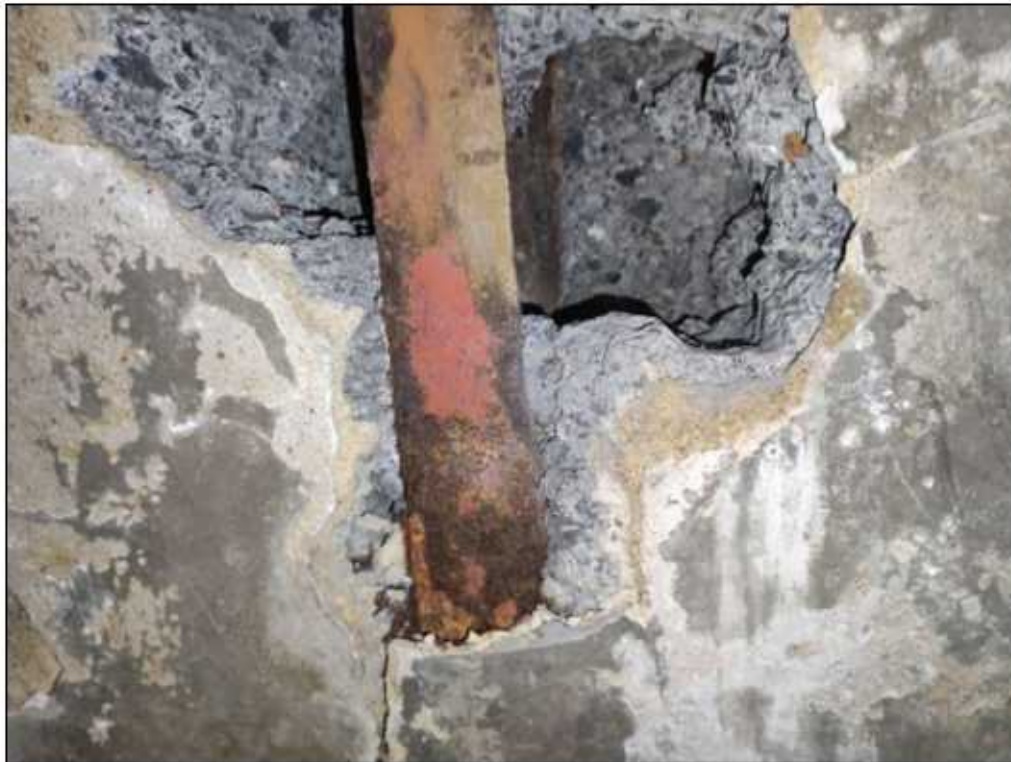
Photo 3: View of the web and front flange of joist 2.

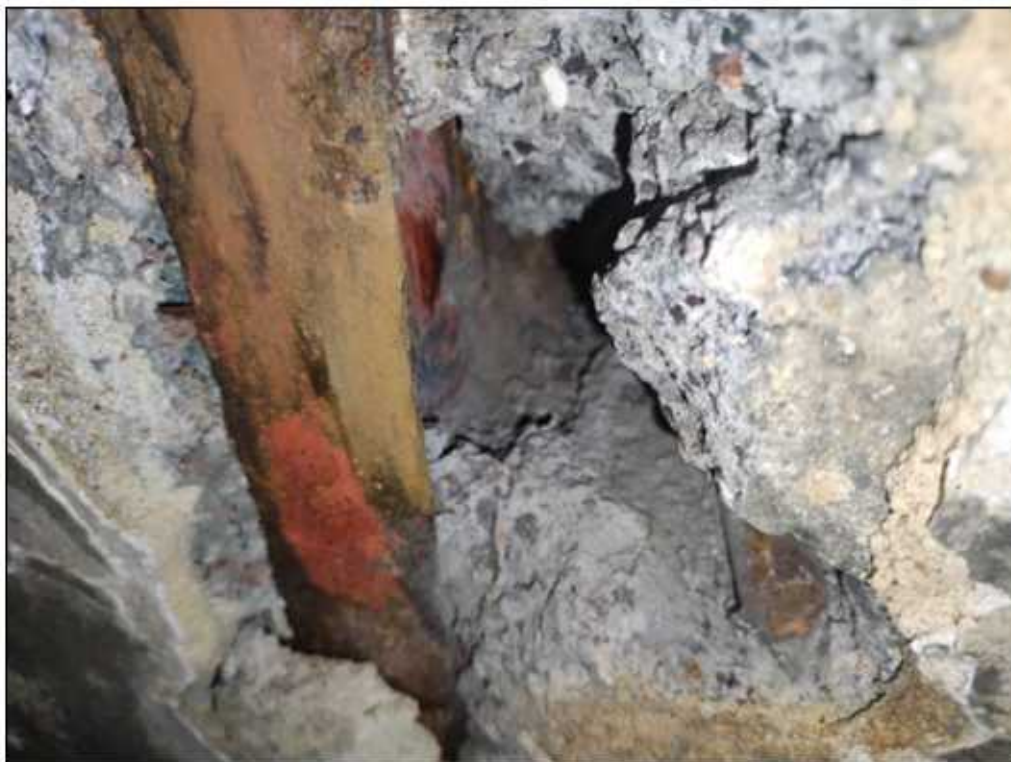
Photo 4: Close-up view of the web and front flange of joist 2.

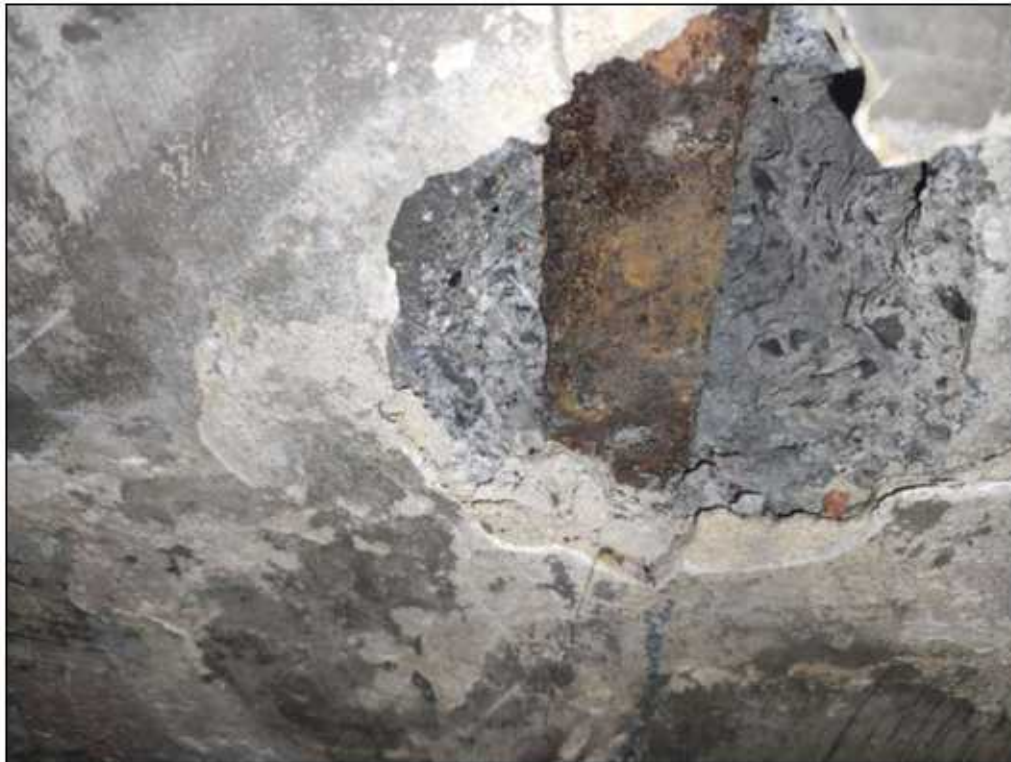
Photo 5: Front flange of joist 3.

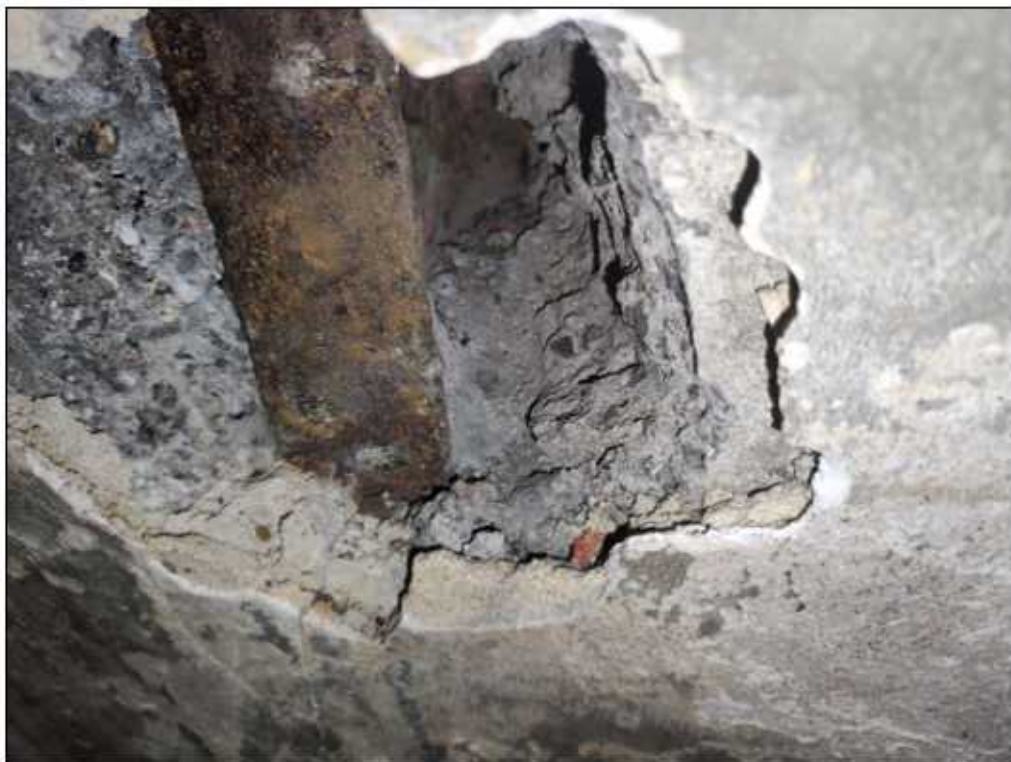
Photo 6: View of the rear flange, web and front flange of joist 3.

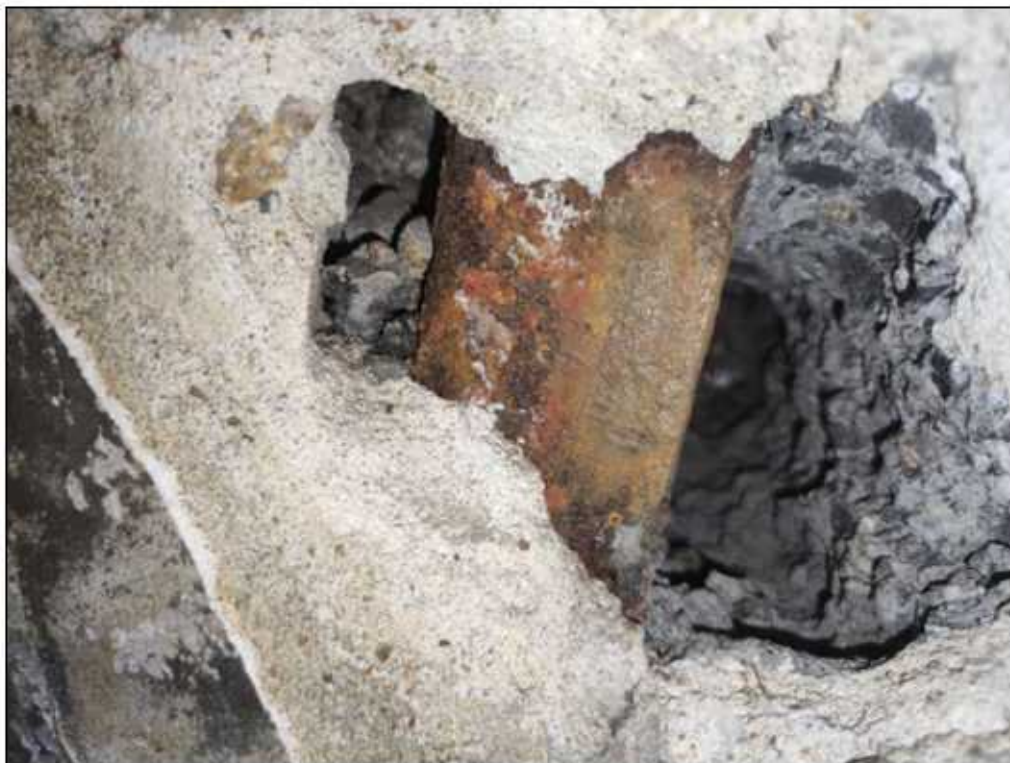
Photo 7: Front flange of joist 4.

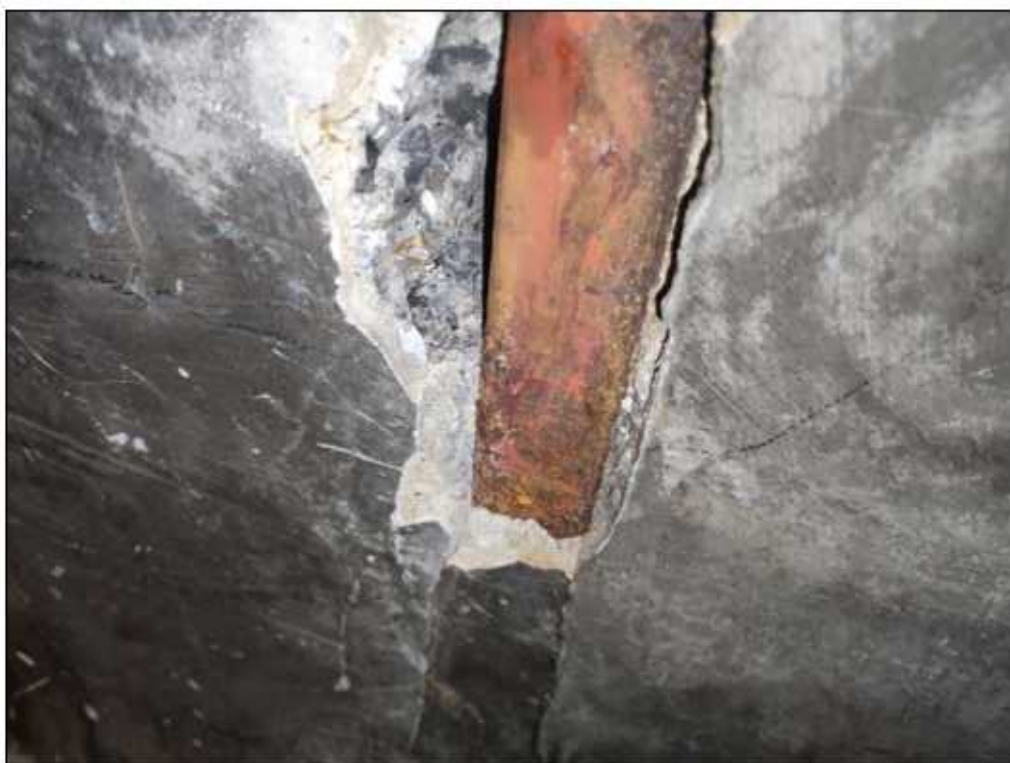
Photo 8: Front flange of joist 5.

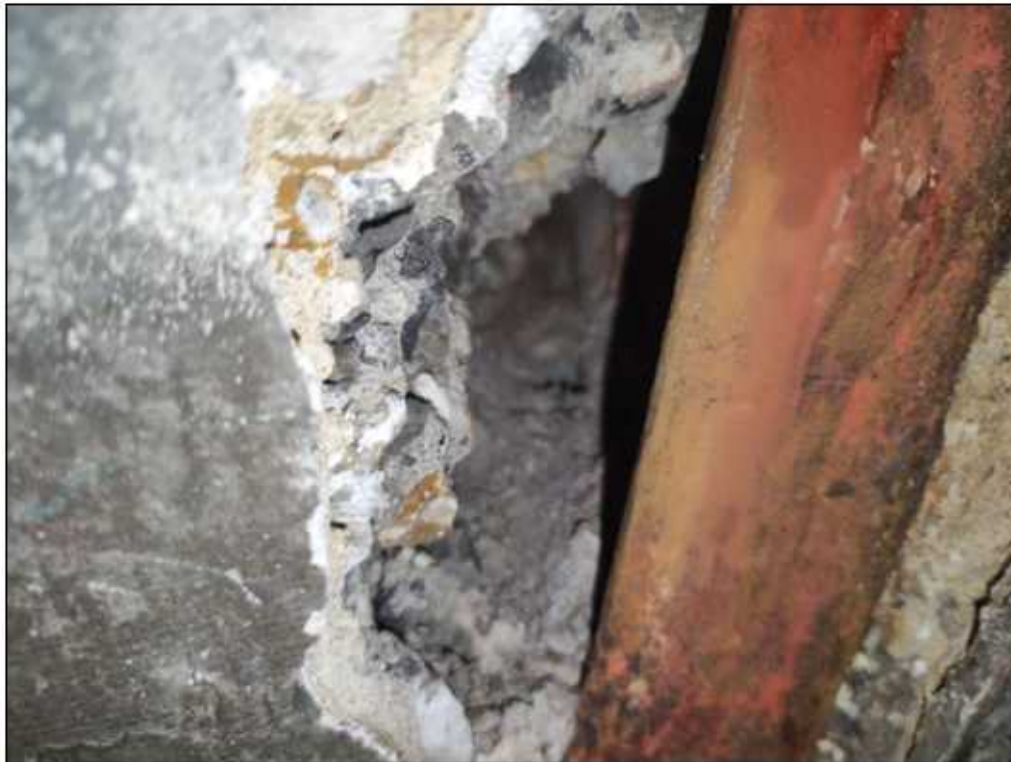
Photo 9: View of the front flange of joist 5 with the rear flange in the background.

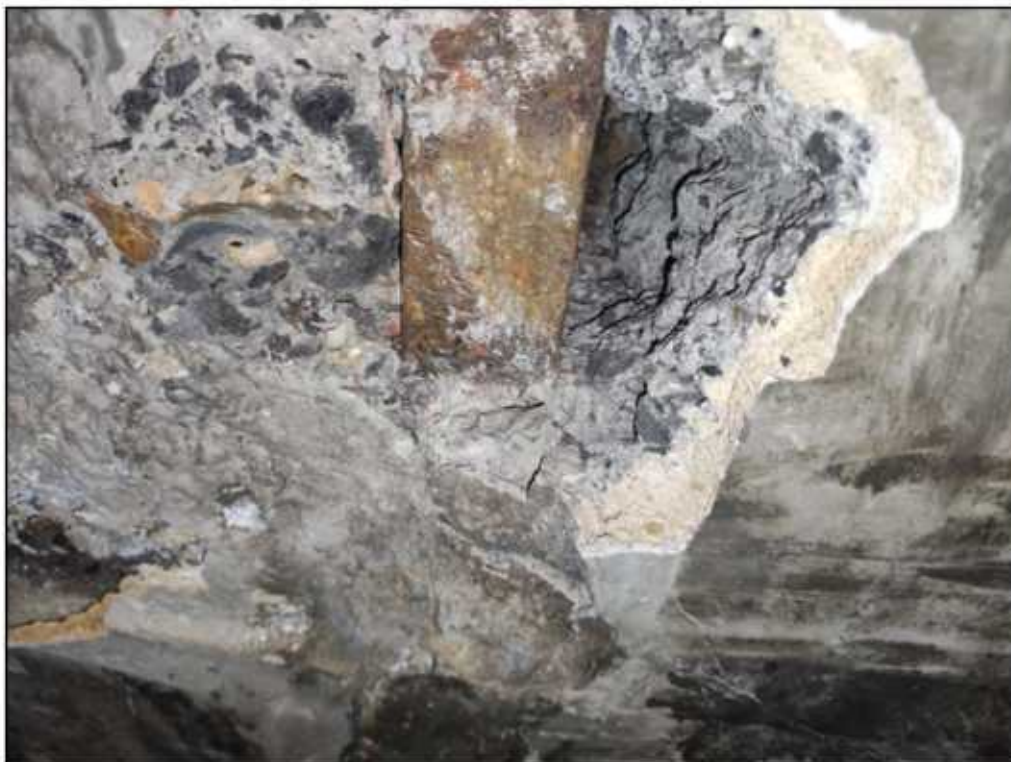
Photo 10: Front flange of joist 6.

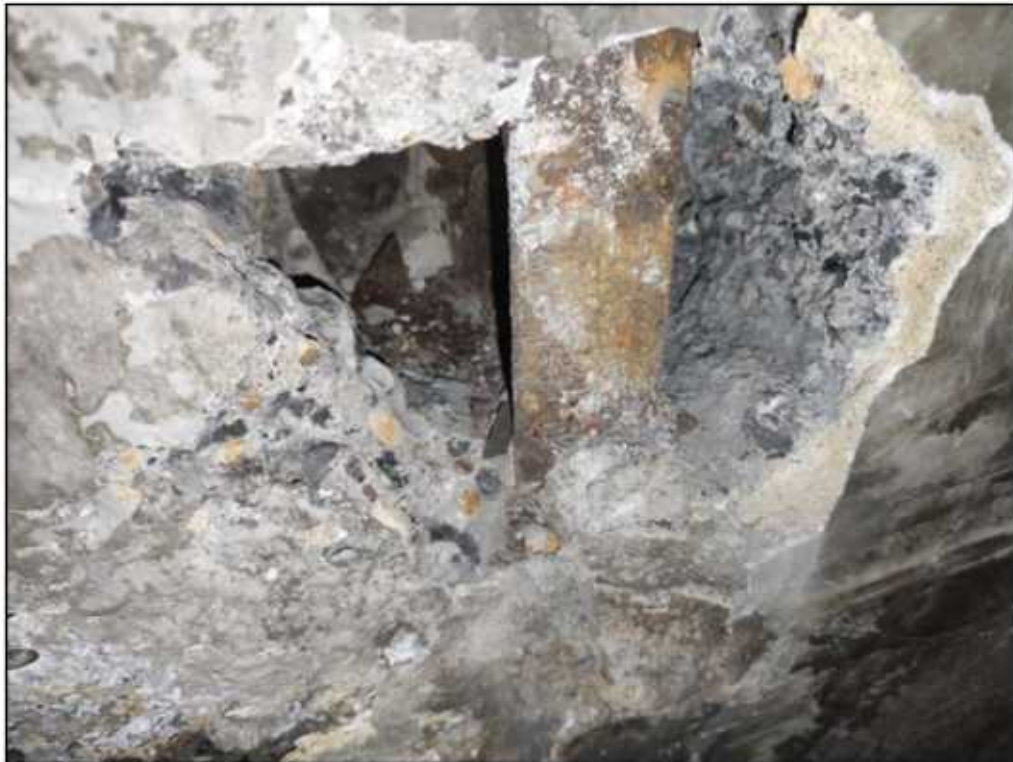
The investigation found varying degrees of corrosion were present on the joists. The worst areas were the external flanges of the joists. It is understood that a gutter is present to the rear of the wall and that this has, on some occasions, become clogged and resulted in water running down the wall.

This is likely to be a contributing factor to the corrosion of the steel joists.

Photo 11: The rear flange at joist 6 exhibits severe corrosion with much of it missing.

A structural engineer will need to check the structural performance of the wall, based on the corrosion discovered, and some remedial work will be necessary.

For future durability, it is essential that any guttering on the building is maintained to prevent water overflowing onto structural elements.

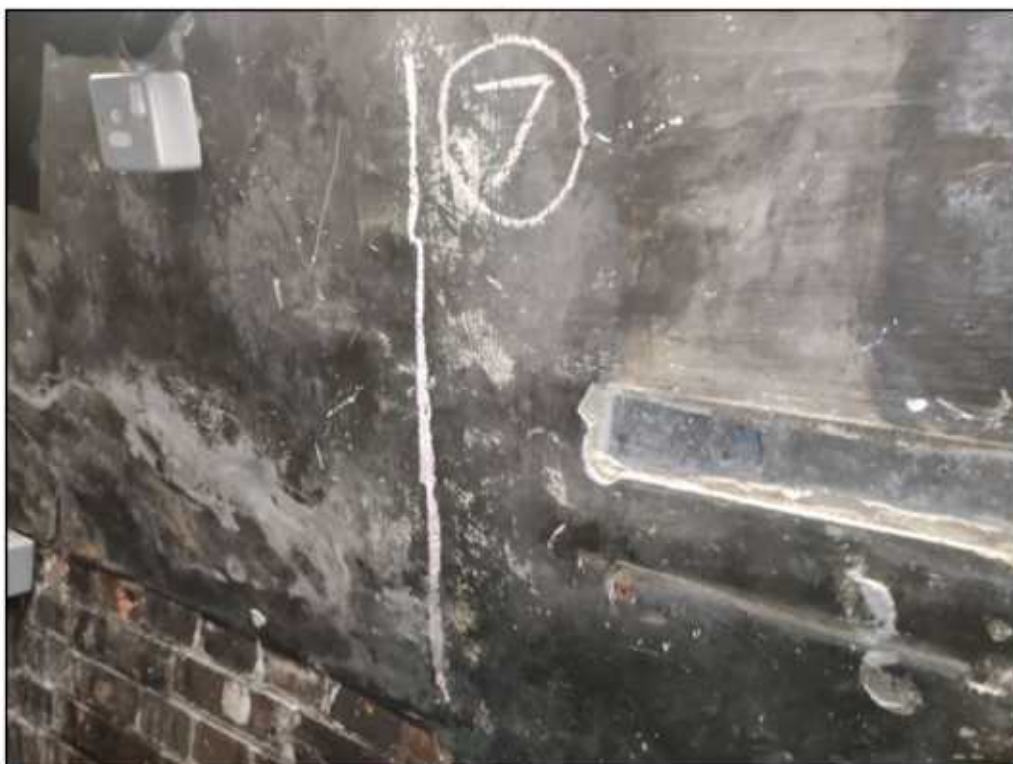
Photo 12: Joist 7, not exposed.

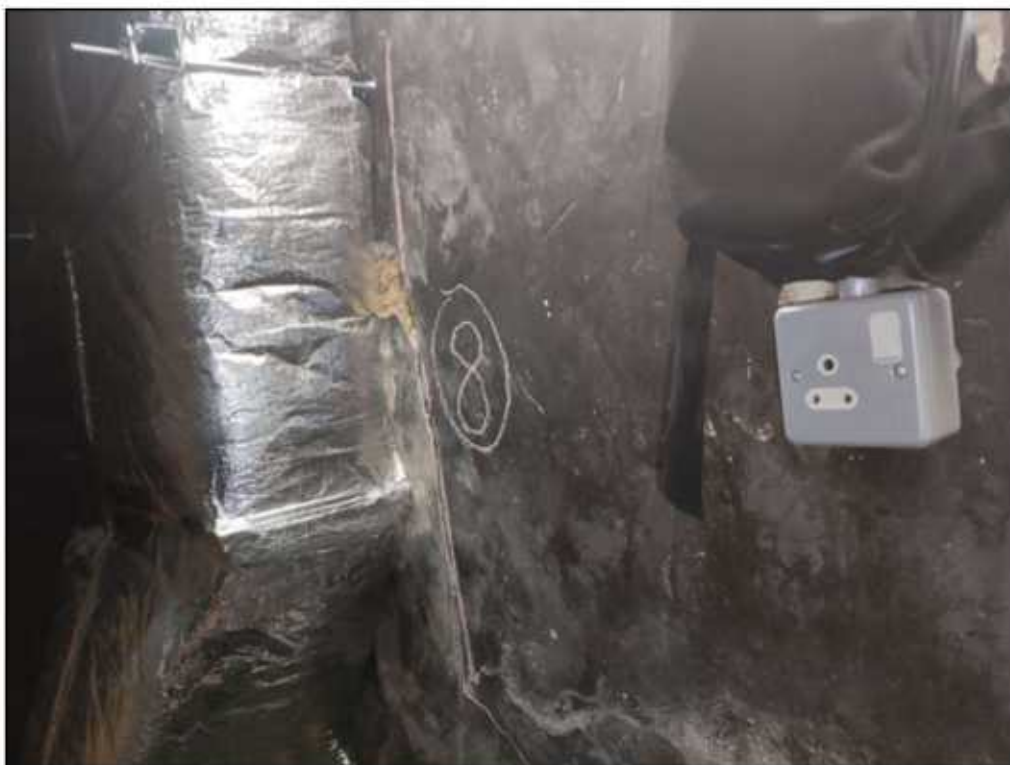
Photo 13: Joist 8, not exposed.

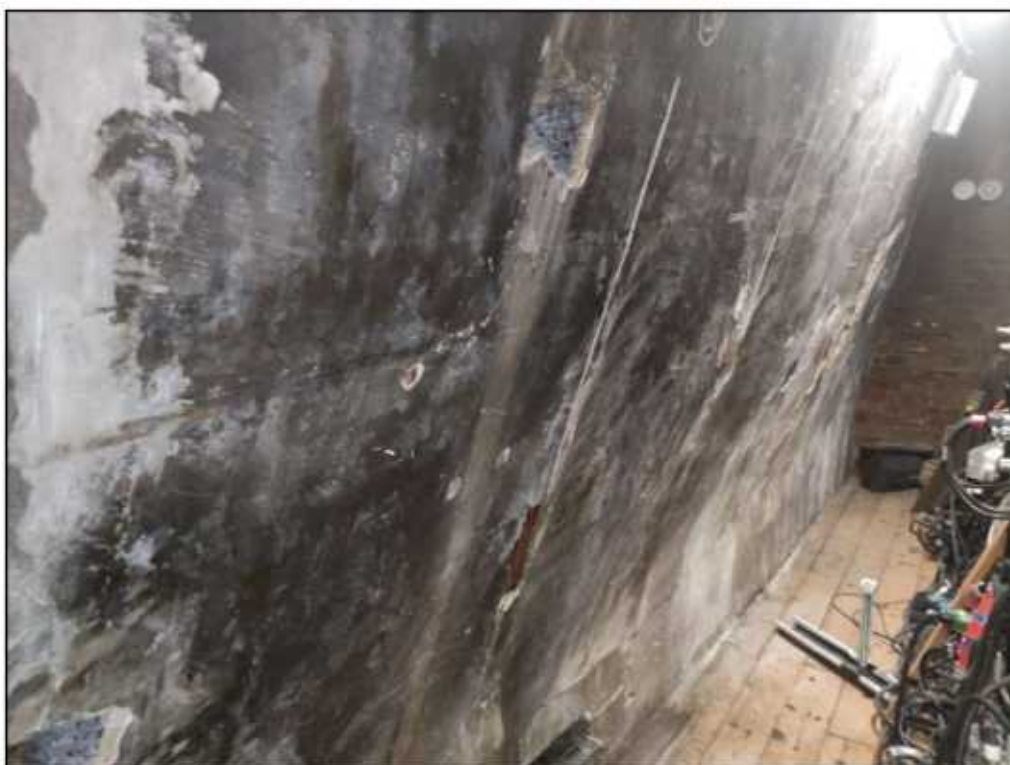
Photo 14: General view of the wall.

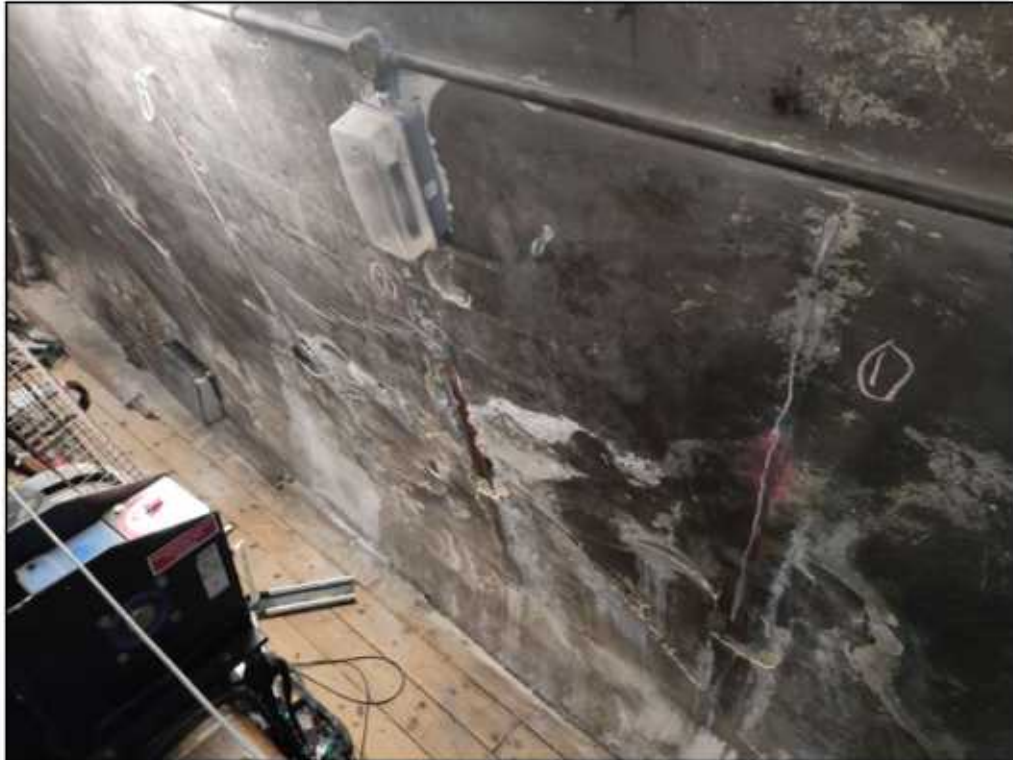
Photo 15: General view of the wall.

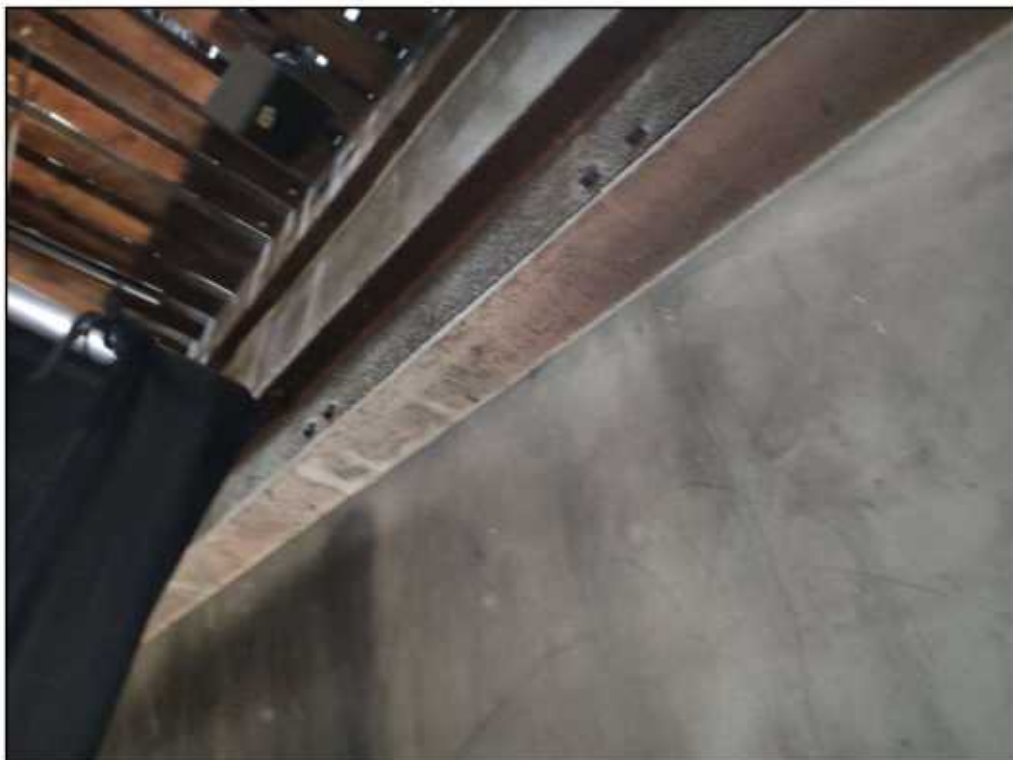
Photo 16: The steel beam towards the top of the sloping section of the wall.

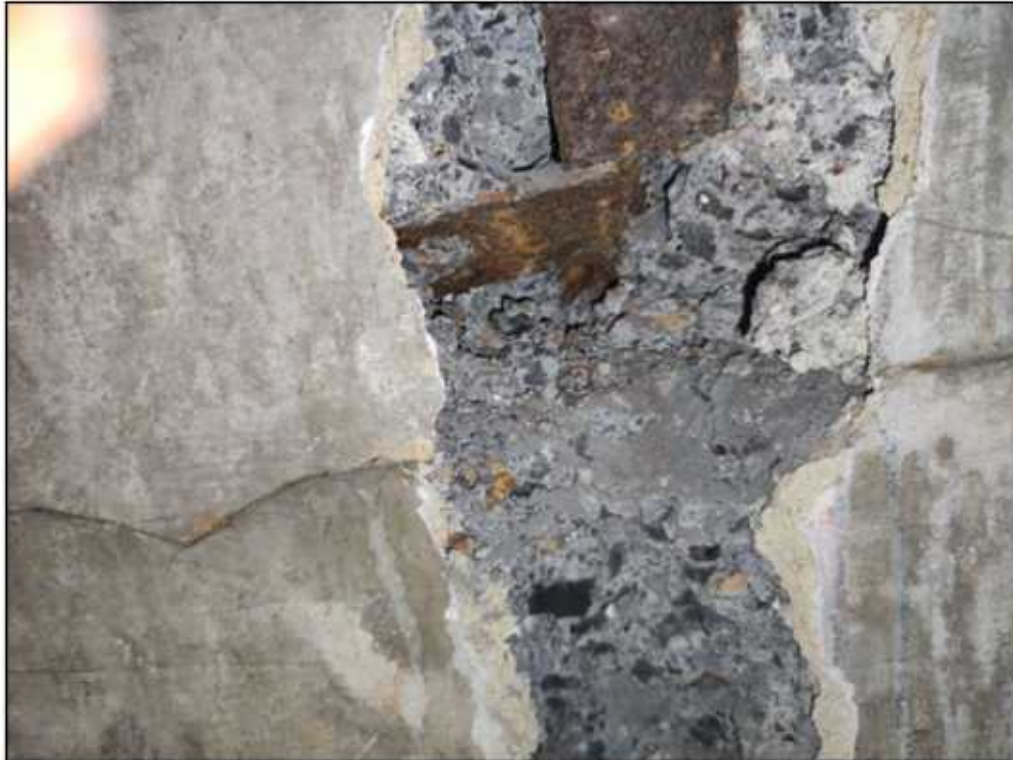
Photo 17: The horizontal steel section attached to joist 2. No brick wall encountered.
