MORI

5 Hampstead High Street
London
NW3 1PR

Existing conditions survey plan, elevations/shopfront elevation

Drawing number
MORI005.06-01

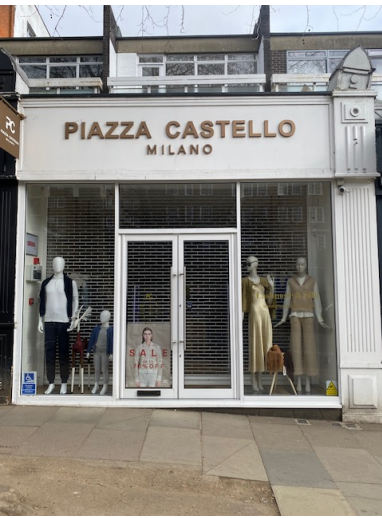
Existing shopfront elevation

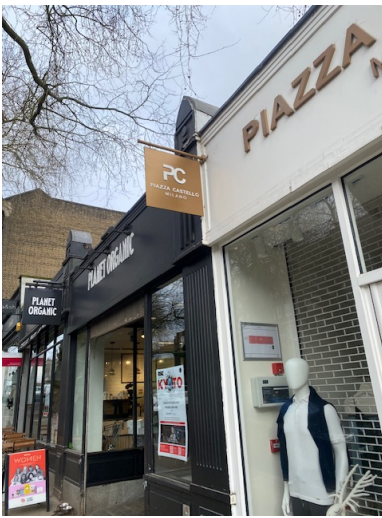
Existing shopfront Blade sign

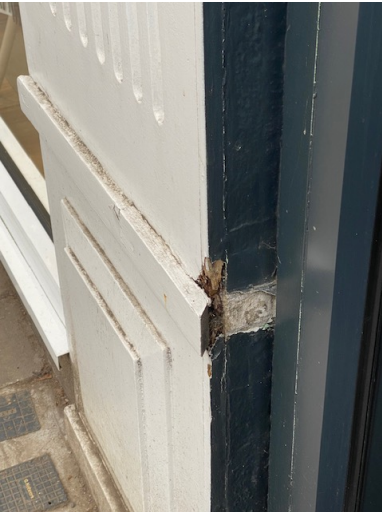
Storefront Frame is white UVPC.
Storefront Timber pillar to right hand side has wet rot to the lower part and shopfront. Fascia has wet rot to the right hand side. These will need to be made good when the storefront is re decorated.
Note existing step into store.
Existing internal shopfront shutter in working order.
New timber laminate floor in store in good condition.
Walls and ceilings in good condition.
Led track lights and track in good condition.
Speakers and smoke detectors in good condition.
AC controls and Burglar alarm controls will have to be re located.
Fire alarm panel and break glass points in good condition.
Air conditioning units x 2 in good condition.
Fuse board in the small office to the rear.
Existing WC and sink in good order.
Existing kitchenette in good order.

Existing right pillar rot

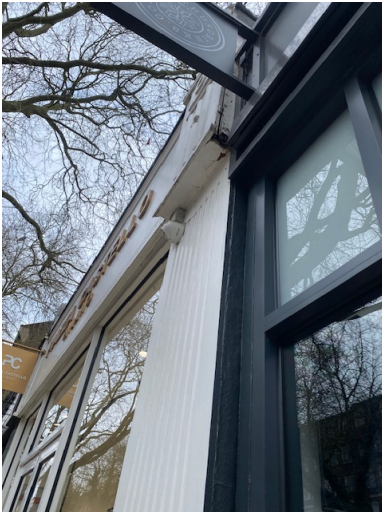
Existing right pillar high level rot
