# Site Investigation Report

Auger were commissioned by Crawford & Co to undertake a site investigation and CCTV inspection of the underground drainage within the area of concern (AOC) at the property.

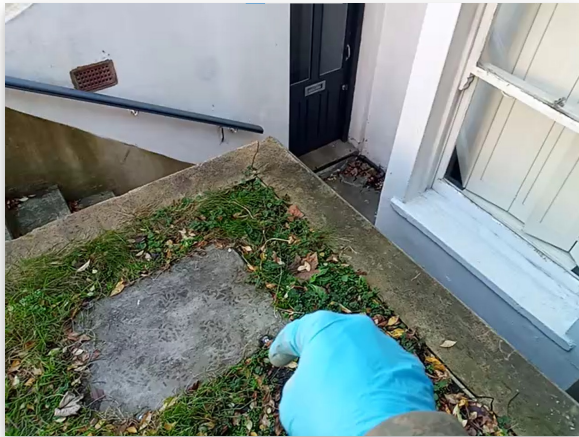
Fig 1.1: MH Location (Above TH1 Location)

Upon arrival our engineer found that the location of TH1 was 1.5m below ground level. The landlord did not wish for us to carry out a trial hole in the proposed location as he would require more notice to inform the tenants. As well as this, the hole would be through concrete and so access to power would be required to break through the concrete. Please note in this location is also a 2 storey bay, this bay will have a different footing to the main house meaning the trial hole will need to be done either side of the bay, however there are drainage pipes that are located either side of the bay on the main house meaning they would most likely be broken and need to be replaced at a further cost if trial holes are to be done there. Alternatively a trial hole can be done against the bay, however this may feature a different footing to the main house.

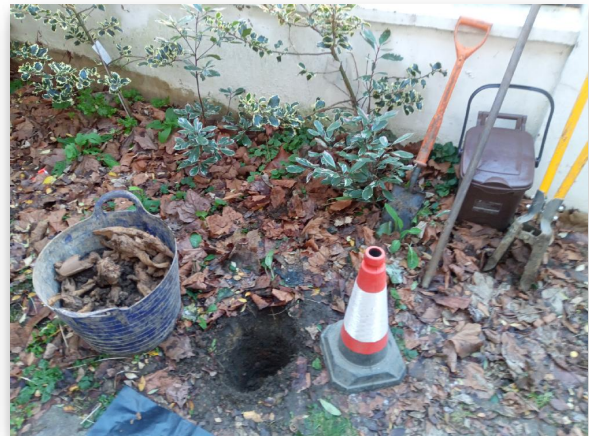
Fig 1.4: TH1 Borehole

Soil and root samples were taken from a remote borehole in the front garden, this reached 3m depth.

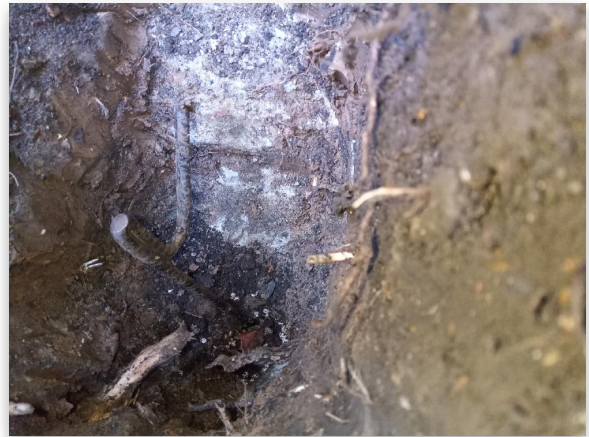
Fig 2.2: TH2 Footing

TH2 was attempted in the proposed location. Our engineer determined the footing to consist of brick steps onto concrete however our engineer hit some sort of concrete layer at 1.1m depth. Despite this our engineer was able to probe the footing down to at least 1.6m depth however the base of the footing cannot be confirmed. Our engineer therefore stepped back 1m to attempt a borehole, this borehole hit refusal at a depth of 1.1m also due to a solid obstruction which our engineer believes to be the same concrete as in TH1.

Another remote borehole was conducted in the garden which collected soil and roots down to 3m, however for the footing to be confirmed in the proposed location 2 men must return for a full day at a further cost. A quote for a deep trial hole has been included however please be aware this cost may change due to factors on site such as samples and thick concrete to be broken through.
