# Site Investigation Report

Auger were commissioned by Crawford & Co to undertake a site investigation and CCTV inspection of the underground drainage within the area of concern (AOC) at the property.

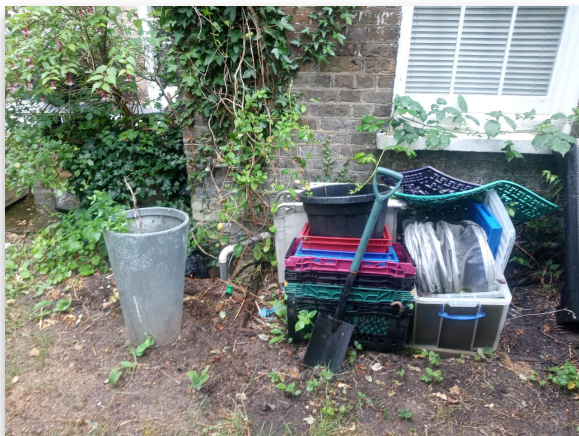
Fig 1.1: Trial Hole 2 Location

Trial hole 2 was conducted as a deep trial hole to the rear of the property - our engineers were able to excavate the trial hole down to a depth of 2.7 and then augered to a depth of 3.0m. The footing was found to start at approximately 0.25m and extended beyond the 2.7m reached by our engineers. Due to the depths encountered our engineers were unable to determine the exact underside, save that it is deeper than 2.7m.

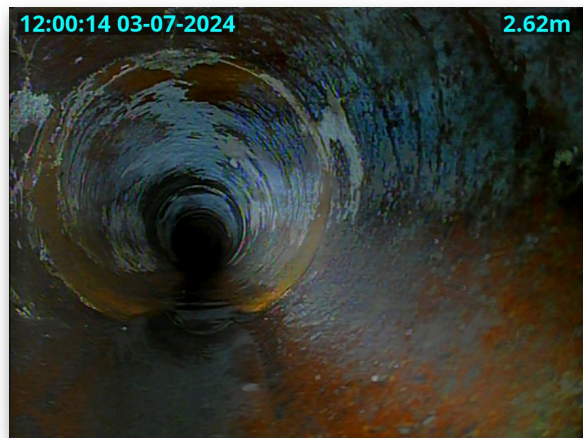
Fig 2.1: Line 4

Our survey of line 4 revealed joint displacements and cracking throughout the line.

<b>Refer Back to Client</b>	<p>It is recommended that the following repairs are carried out to prevent an escape of water from the system:</p> <p><b>Line 4</b></p> <p>Install 4m of 150mm liner directly downstream of MH1 to just before the branch connection.</p> <p>Install 4m of 150mm liner directly upstream of MH2 to just before the branch connection.</p> <p>Deep manhole entry and an additional man will be required to install the liner.</p> <p>CCTV survey upstream from MH2 to check for further defects on the WG2 and SWG2 lines.</p> <p>We will now refer the claim back to the client in order to progress the claim.</p>
<b>Repair Caveats</b>	<p><i>Once repairs have been undertaken the customer should ensure the drainage system is periodically inspected in the future for any deterioration and kept free flowing / free of blockages. Any damage noted during future inspections should be repaired immediately in accordance with current Building Regulations.</i></p> <p><i>With any repair process, complications and unforeseen circumstances can arise. These scenarios will be reported whilst on-site and could potentially cause an increase in repair costs and inconvenience.</i></p> <p><i>If any of the above lining recommendations fail then excavation and replacement of the pipework would be required. This would severely increase the cost of repairs and would provide greater inconvenience to the residents. The relining of a severe joint displacement is normally unadvised due to the potential for complications in the future. If any issues arise in the future regarding this pipework, then excavation within the property would be required to replace the defective area of pipework. This in turn would result in major inconvenience to the occupier and a potentially large repair bill.</i></p> <p><i>Recommendations have been made to reline or patch reline sections of the drainage system at the property. This process combines a number of chemicals in a resin, which then harden in a fibreglass matting to create a new section of drain within the original. The reaction creates <b>a strong smell which can linger for up to 72 hours</b> once works are completed - this is not harmful. It is recommended that any areas where smells are experienced are kept well ventilated until the odour subsides.</i></p>

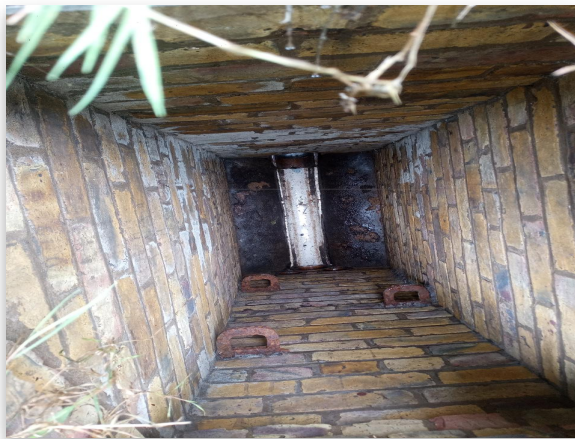
Fig 3.1: MH2

Due to the depth of MH2 our engineer was unable to survey the lines to WG2 and SWG2.

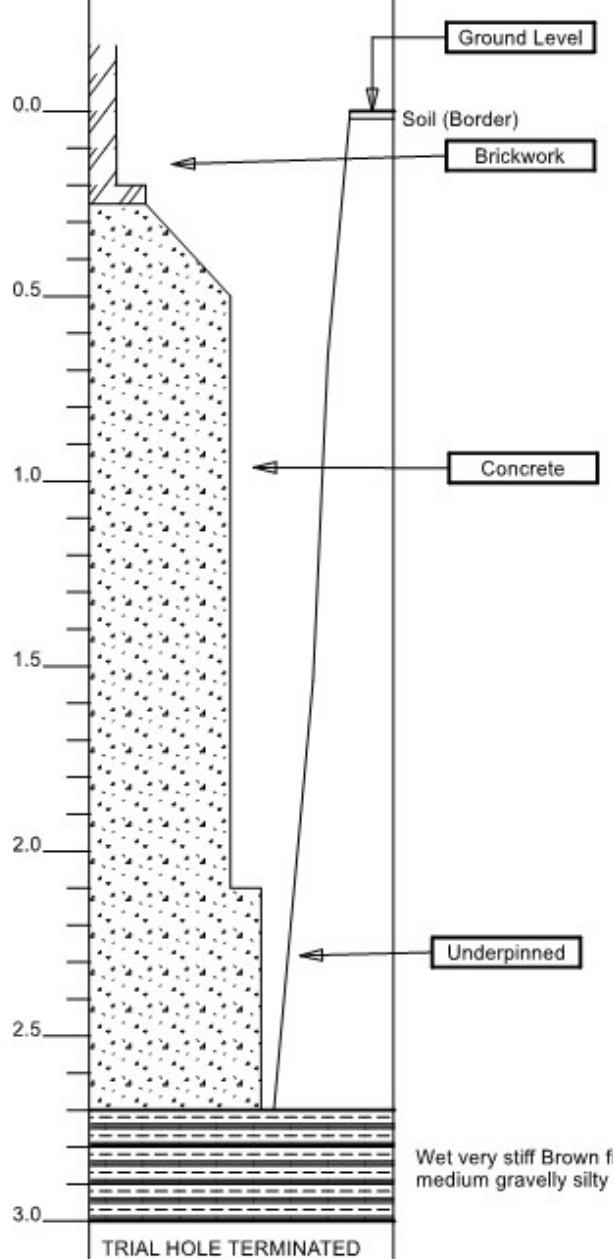
## Trial Hole Log No.2

Ground Level Soil (Border) Brickwork Concrete Underpinned Wet very stiff Brown fine to medium gravelly silty CLAY TRIAL HOLE TERMINATED				
0.5						
1.0						
1.5						
2.0						
2.5			120kpa			
2.7			128kpa		Soil @ 2.7m	Root @ 2.7m
3.0			132kpa

TH2, 2.7m		
6 no.	Examined root: HEDERA (Ivy) - or the related FATSIA (a robust shrub with fig-like leaves).	Dead*.
5 no.	Examined root: the family POLYGONACEAE (includes the invasive Russian Vine and Japanese Knotweed).	Alive, recently*.
	Unfortunately all with insufficient cells for identification.
