Crack and Level Monitoring

Job Reference: QG1S1287571

Address: 222 Finchley Road, London, NW3 6DH

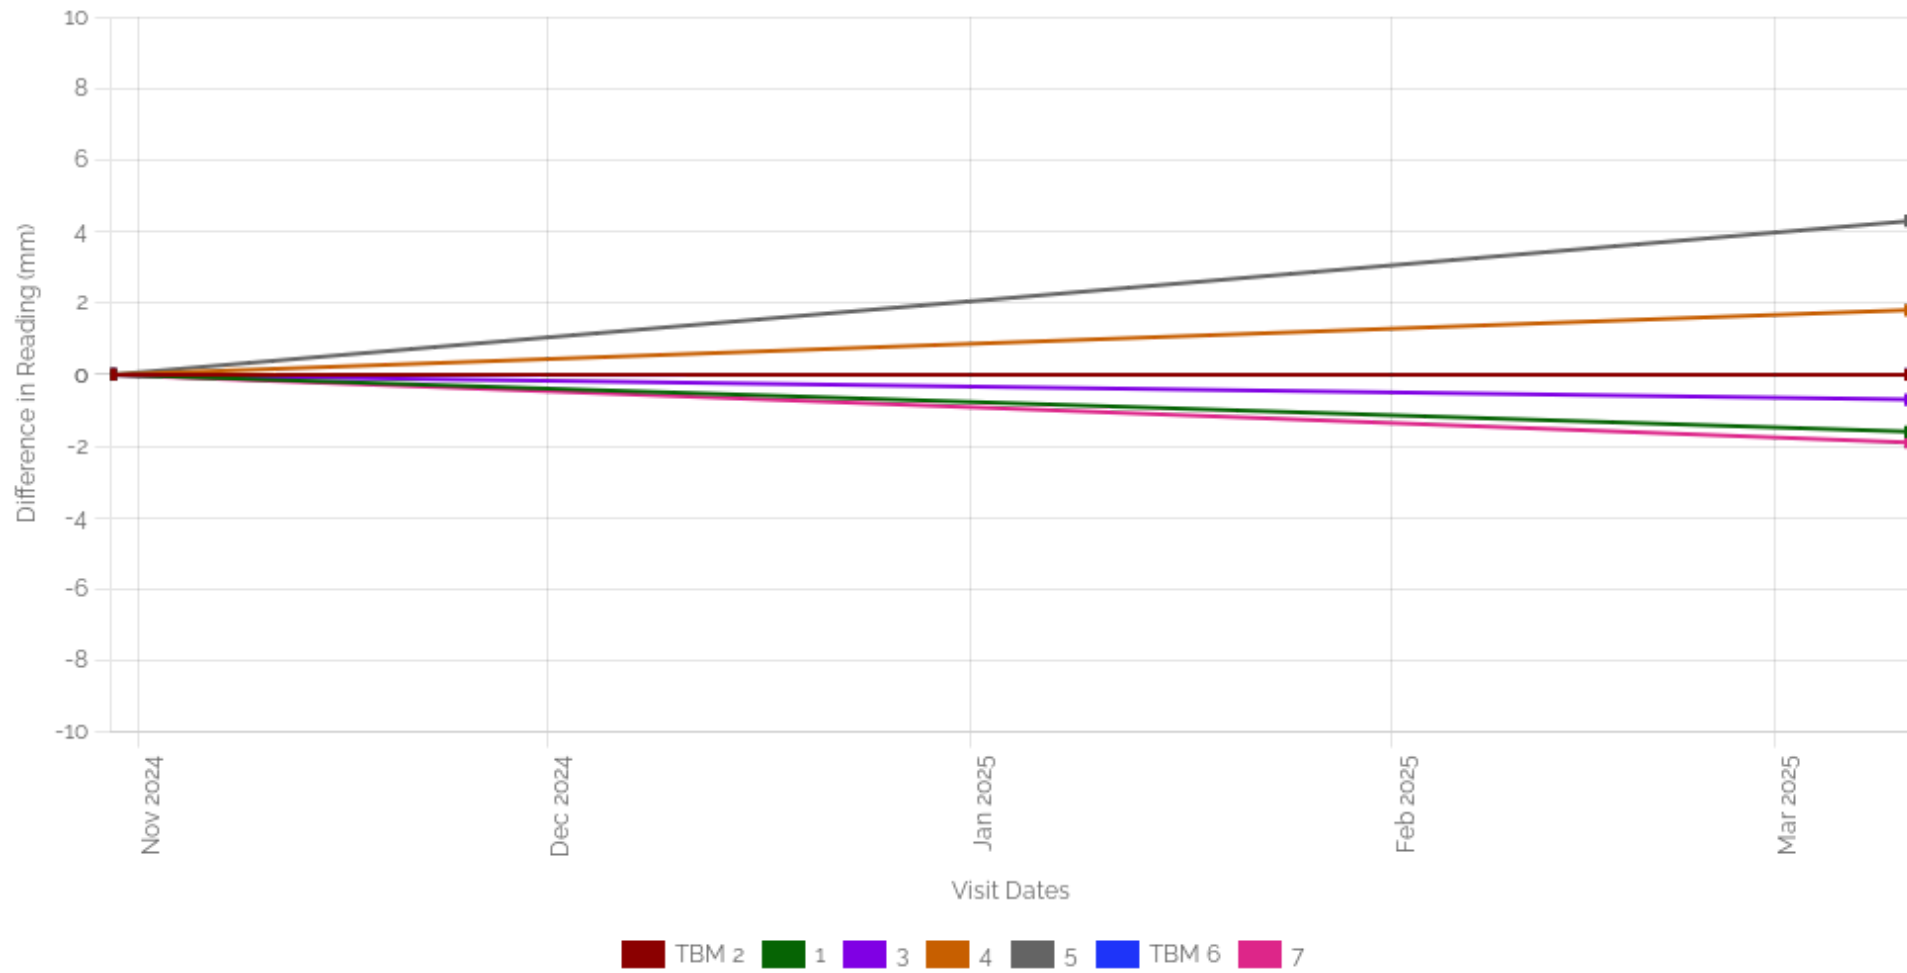
Level Readings Chart (Points TBM 2 - 7)

Visit 1	Visit 2	Visit 3	Visit 4	Visit 5	Visit 6	Visit 7	Visit 8
	29/10/24	10/03/25						
TBM 2	0	0						
1	0	-1.6						
3	0	-0.7						
4	0	+1.8						
5	0	+4.3						
TBM 6	0	0						
7	0	-1.9

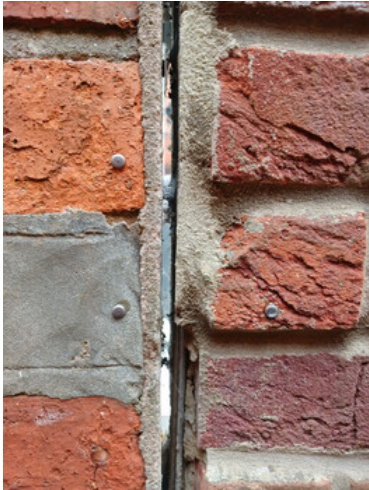
Right of wall after gate before stairs - Visit #1

Visit 1	Visit 2	Visit 3	Visit 4	Visit 5	Visit 6	Visit 7	Visit 8
	29/10/24	10/03/25						
H	0	0.41						
D	0	0.44						
C	0	-0.02
