**WINDOW SURVEY REPORT**

**180 Tottenham Court Road, London**

**Document Reference:** 5977-CTA-ZZ-ZZ-RP-0001  
**Revision:** 01  
**Inspection Date:** 24 January 2025  
**Report Prepared by:** Jacob Parkinson  
**Report Checked by:** Lawrence Gray  
**CTA Reference:** 5977

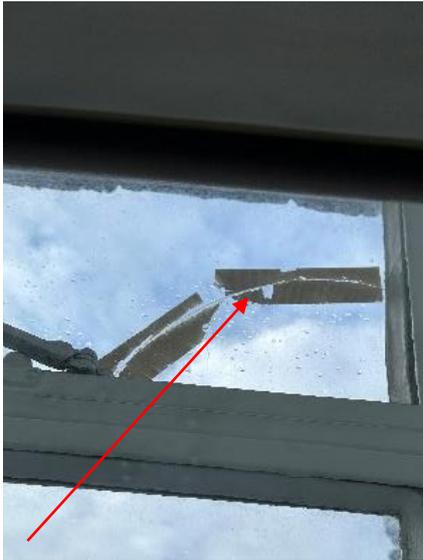
- 4.4.1. **Cracked glass:** Glass panes were found to be broken in several locations, and multiple were on the elevation overlooking Tottenham Court Road. This monolithic float glass poses an increased risk to pedestrians below should it shatter and fall from the building as it will fall as shards.

Photo 17 – Broken glazing

It is highly recommended that this glazing be replaced as soon as possible. If subjected to harsh weather conditions or impact during cleaning and maintenance, the cracked glass could fracture further, resulting in fragments becoming dislodged and falling from the building. In the meantime, it is recommended that cracks be taped over with a suitable film and that any windows exhibiting cracked glass be set in a secure, closed position and not used.

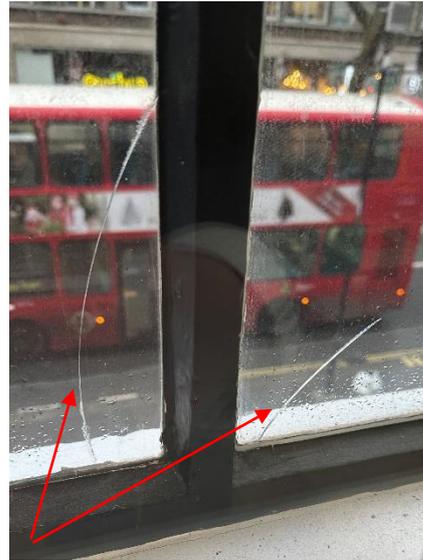
Photo 18 – Broken glazing

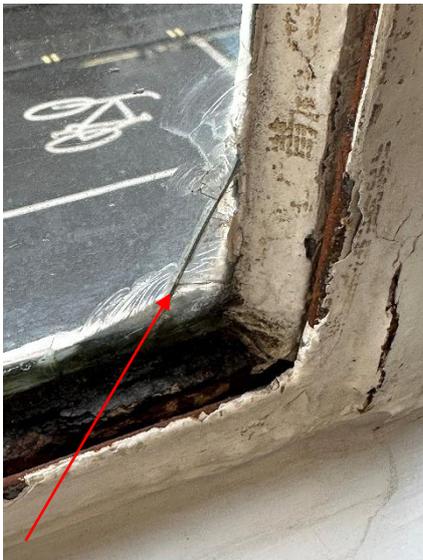
Photo 19 – Broken glazing

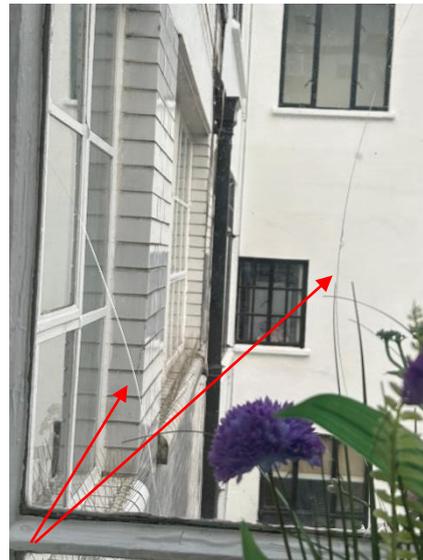
Photo 20 – Broken glazing

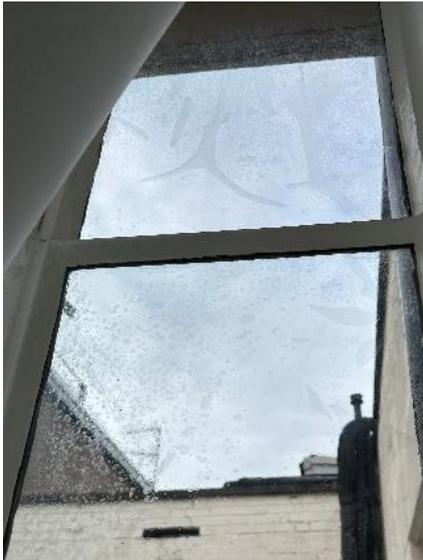
4.4.9. **Glazing films:** On the 4<sup>th</sup> floor, some windows have an internal glazing film applied that is no longer fully adhered to the glass. The reason for the film installation is unknown, as no product manufacturer markings were observed. The films could have been installed to improve the acoustic performance, reduce solar heat gains, or improve safety. The films have been poorly installed and do not extend into the putty line of the window, meaning they will not retain the glass should it fully fracture.

Photo 21 – Delaminated glazing film

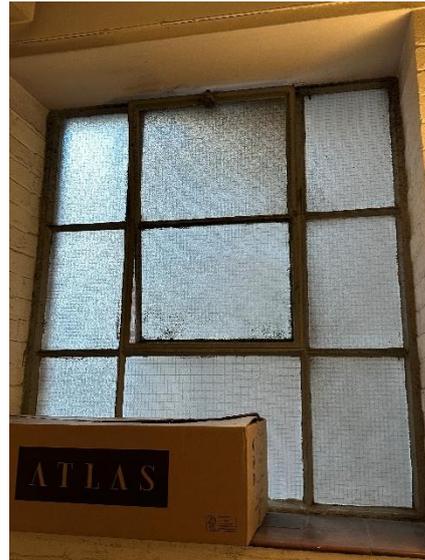
Photo 22 – Wired glass in the stair core

- 5.1.4.7. The location and rating for any fire-rated windows should be considered. This will likely require input from the fire engineer responsible for the building's fire strategy. As the windows in the rear stair core of the building currently include wired glass, they may require some level of fire resistance when replaced.

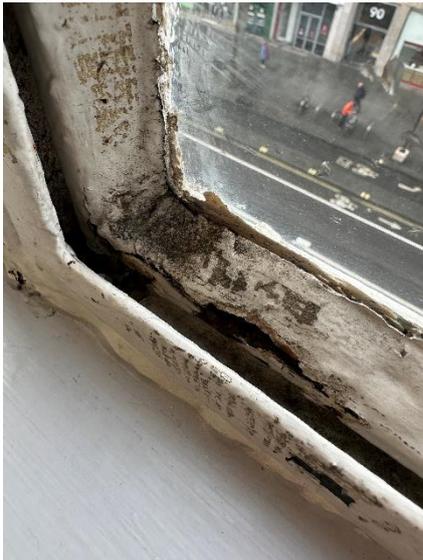
- 4.4.2. **Degraded putty sealant:** The putty sealants used to retain and seal the glazing were noted to be in poor condition on most windows where visible. Where windows had been repainted, the condition of the putty could not be viewed. It is believed that in these locations, the putty has simply been painted over and not repaired prior; as such, the putty sealants are thought to be in poor condition in all windows. Since the glazing rebates are not drained, any water entering the cracks can easily leak into the building interior and expedite the continued degradation of the seal.

In multiple areas, large chunks of the glazing putty had fallen away from the window, exposing the edge of the glass. Where large areas of the putty are missing, there is an increased risk of the glass dislodging from the frame. Caution should be used when operating such windows in the lead up to them being replaced.

Photo 23 – Degradation of the putty sealant

The only reliable method of repair is to rake out the seal completely and reapply a new seal. This is often problematic because the original seals/putty may remain firmly adhered to the glass or frame.

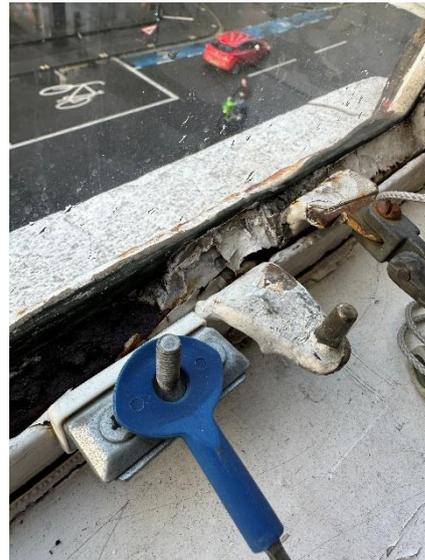
- 4.4.4. **Corrosion of framing and hardware:** Where the paint has worn or is damaged, the galvanised steel has been exposed. Over time, the galvanic coating has corroded, exposing the steel substrate, which has also begun to corrode. This weakens the frames and hardware locally, compromising their structural integrity. In locations of severe corrosion, the weather tightness of the window has also been compromised, as small pathways are formed that permit the passage of air and water.

Photo 24 – Extreme degradation of the putty sealant and corrosion of the steel substrate

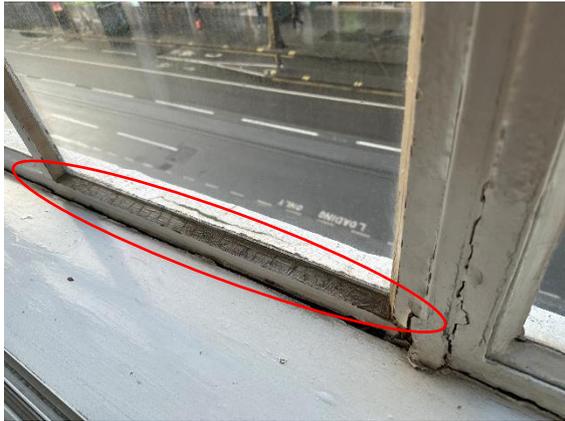
Photo 25 – Degradation of the putty sealant

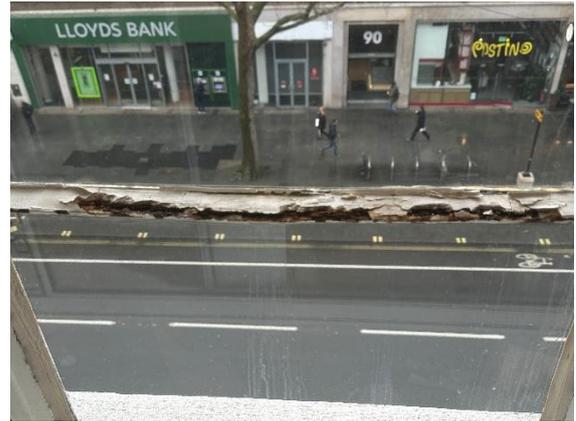
Photo 26 – Extreme degradation of the putty sealant and corrosion of the steel substrate

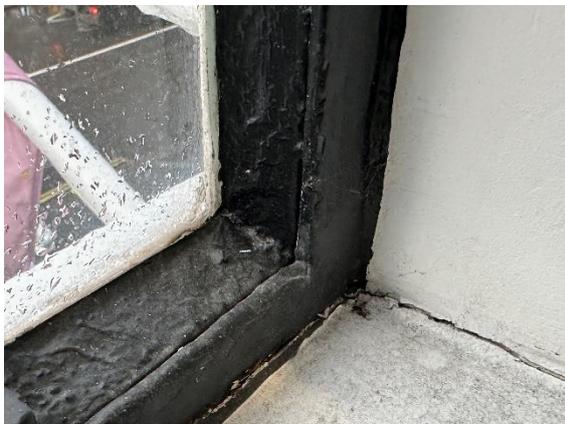
4.4.7. **Excessive overpainting:** The windows have been overpainted multiple times, and in some locations, this has resulted in the windows becoming sealed shut. Where the windows have been painted and closed before the paint was allowed to dry completely, the paint has split and flaked away from the steel framing when reopened. This has exposed the galvanised surface to the elements, which increases the risk of corrosion and rate of degradation.

Photo 27 – Overpainted degraded putty sealant

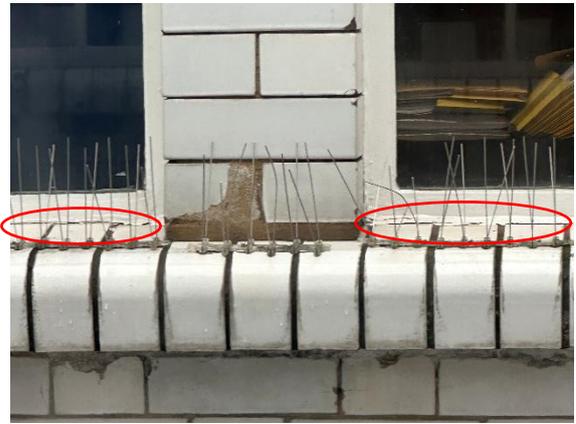
- 4.4.3. **Degraded external sealant:** Cohesive and adhesive failure of the external sealant to the perimeter of the windows was observed. Degradation of the sealant will form weak points for weather tightness, allowing the permeation of water and air through the facade.

Photo 28 – External sealant degradation

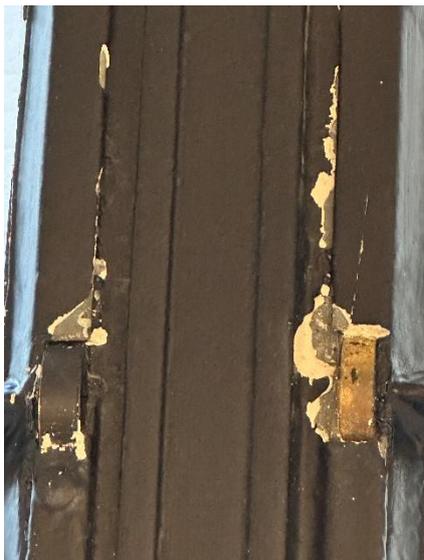
Photo 29 – Internal finishes flaked away, exposing the steel substrate

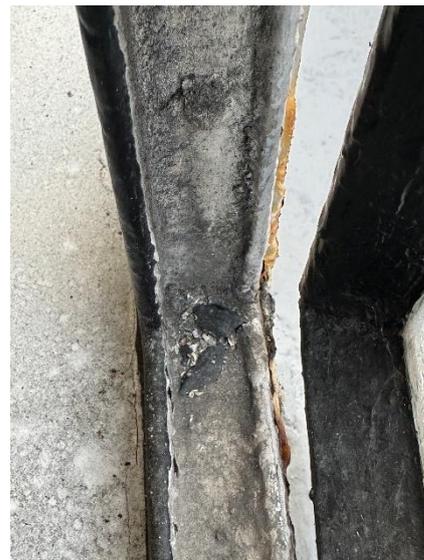
Photo 30 – Profile finish deterioration and corrosion of the steel substrate

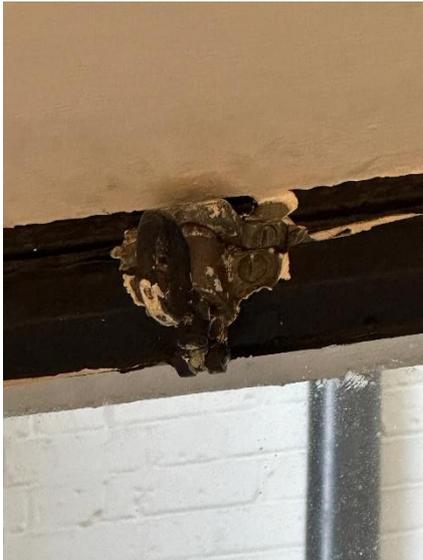
Photo 31 – Internal finishes flaked away, exposing the steel substrate

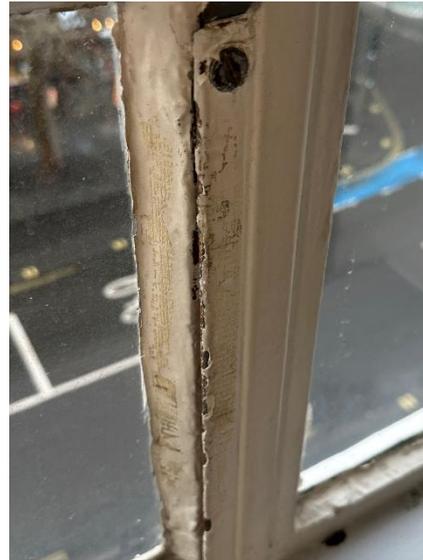
Photo 32 – Profile finish deterioration and corrosion of the steel substrate

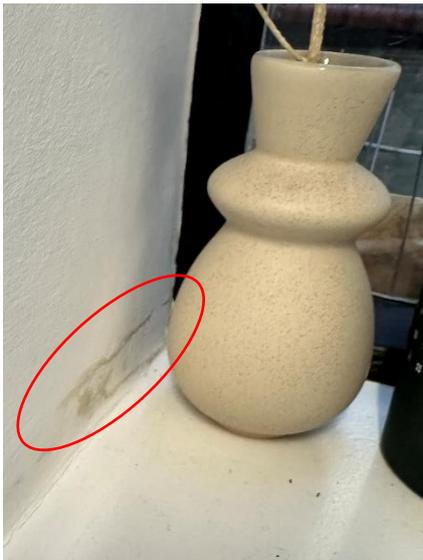
4.4.6. **Degradation of internal finishes:** Due to the above-mentioned failing in the windows, the cavity between the rear of the non-thermally broken window and the secondary glazing will be taking on the external temperature. The air leakage is, however, not sufficient to fully ventilate the cavity. This has increased the risk of interstitial condensation within the cavity between the glazing systems, resulting in trapped moisture condensing on the glass, frames and internal finishes, leading to water staining, deterioration and likely mould growth. The writer was also informed by the tenants on the 4<sup>th</sup> floor that the window reveals require relatively regular replastering and painting.

Photo 33 – Water staining to internal finishes

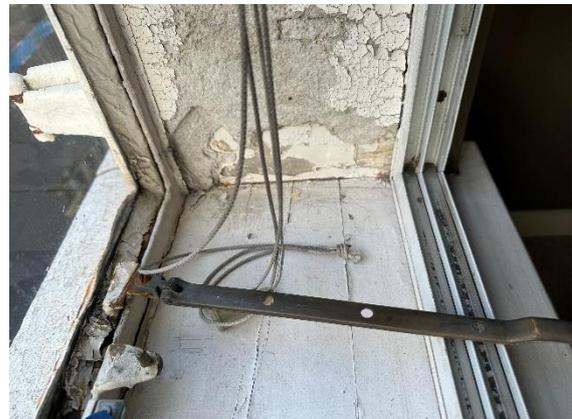
Photo 34 – Deterioration of the internal finishes due to water ingress and condensation

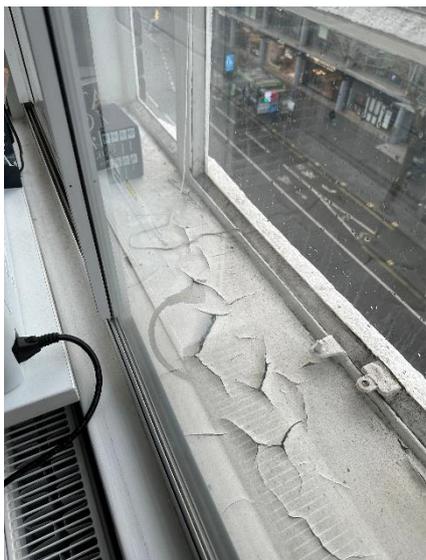
Photo 35 – Deterioration of the internal finishes due to water ingress and condensation

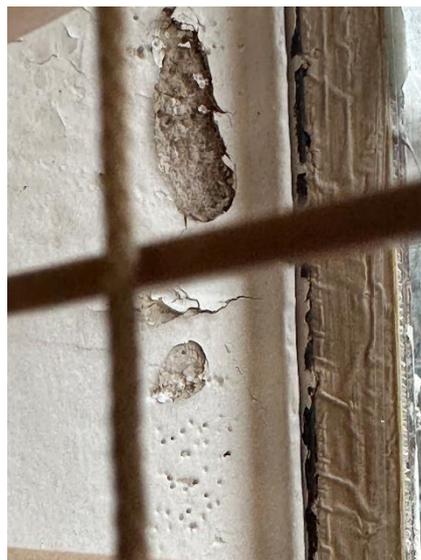
Photo 36 – Deterioration of the internal finishes due to water ingress and condensation
