Site Investigation Report

176136.1.2.BSI

Client	Structural Surveys Ltd
Client ref	QG1S1287571
Visit date	07/11/2024
Report date	29/11/2024

Auger were commissioned by Structural Surveys Ltd to undertake a site investigation and CCTV inspection of the underground drainage within the area of concern (AOC) at the property.

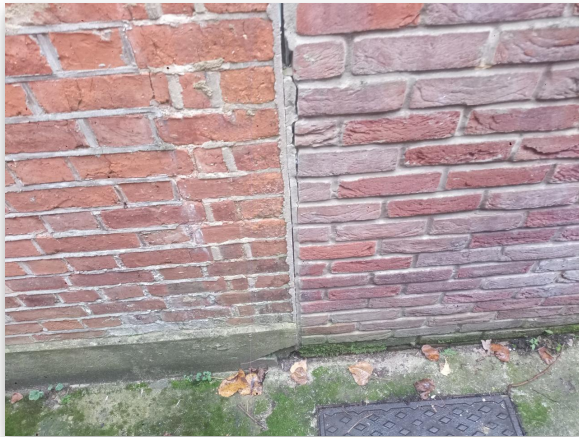
Fig 1.1: Trial Hole 1 Location

Within TH1 we revealed the footing but we were unable to reach the required depth in TH1 because we encountered rocky ground which our engineer could not auger through at 1.4m. The Trial Hole was excavated in the proposed location. We took soil and root samples. These measurements are shown in Trial Hole Log 1 below.

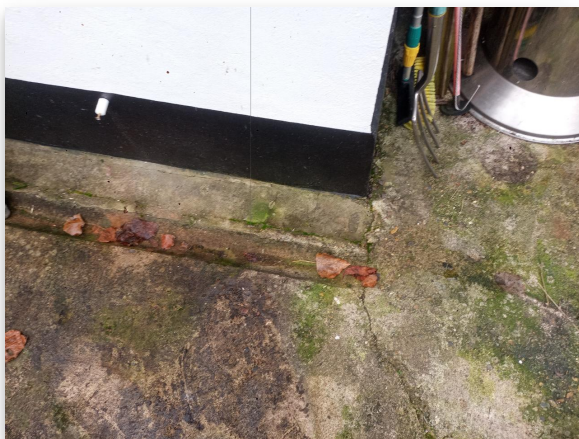
Fig 2.1: Trial Hole 2 Location

Within TH2 we revealed the footing but we were unable to reach the required depth in TH2 because we encountered rocky ground which our engineer could not auger through at 1.4m. The Trial Hole was excavated in the proposed location. We took soil and root samples. These measurements are shown in Trial Hole Log 2 below.

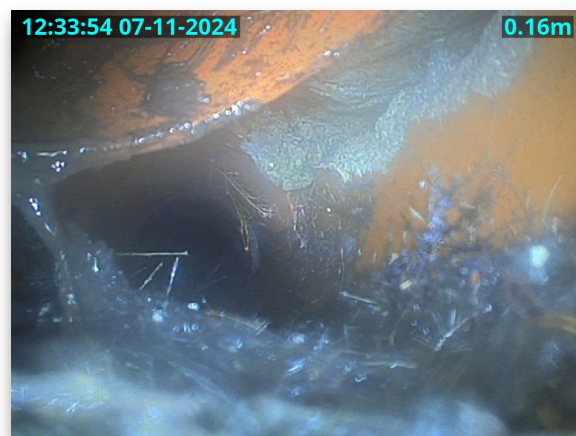
Our survey of line 1 revealed root ingress and the WG connection bossed into the main line restricting flow and allowing an escape of water, we have therefore been unable to survey upstream on the main line.

Fig 3.1: Root ingress and bossed in connection

<p>Refer Back to Client</p>	<p>It is recommended that the following repairs are carried out to prevent an escape of water from the system:</p> <p>Line 1 Excavate and replace WG1 and 1m of 100mm pipework including a branch connection at a depth no greater than 1.0m through concrete.</p> <p>Install a 100mm patch directly upstream of MH1 to the branch.</p> <p>We will then need to conduct a further CCTV investigation upstream on this line.</p> <p>Line 2 Excavate and replace RWG1 and 3m of 100mm pipework at a depth no greater than 1.0m through concrete.</p> <p>Install a 100mm patch liner directly upstream of MH1 to seal the pipework into the cast iron.</p> <p>MH2 Deep MH entry required to survey the connection.</p> <p>Please note that the further CCTV investigation may reveal additional defects to the drainage system. This will be reported whilst on-site and could potentially cause an increase in repair costs and provide further inconvenience to the customer/occupants.</p> <p>Auger have not allowed or will not be held responsible for any alteration or modification to the above ground drainage following the removal of the existing gully and reinstatement of a new gully. The customer must ensure that the above ground drainage correctly expels into the gully pot and avoids overcrowding the gully with numerous downpipes which could lead to the gully overflowing.</p> <p>During the clean-up/reinstatement process we will endeavour to leave the area we are working in clean and tidy and as close to how we found it as possible. There will always be an element of general debris/mud/waste that will build up in the area which cannot be prevented. There may however be elements of this process that are outside our remit i.e., Repainting or cleaning. If this is the case, then we will need to speak to the customer's insurers to help in this regard.</p> <p>We will now refer the claim back to the client in order to progress the claim.</p>

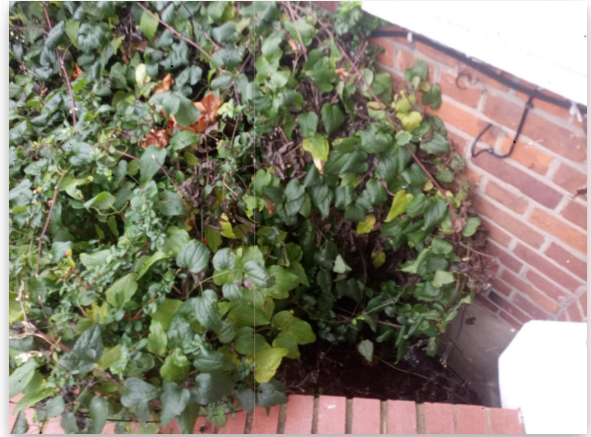
The proposed trial hole at the front of the property was to gain the footing of the main house and the bay window, however upon attending site we found a large amount of vegetation preventing access, we also found there is a cellar in the area.

Fig 4.2: Vegetation in the proposed area of trial hole

If the loss adjuster wishes for the trial hole in this location a specialist should remove large amounts of vegetation and 2 men can return to excavate a deep trial hole in the area,

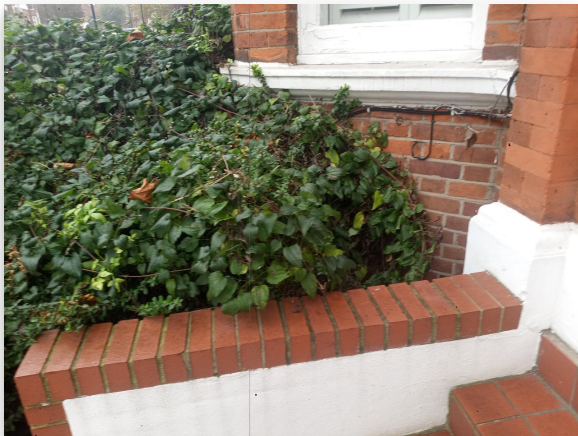
Fig 4.3: Vegetation to be removed

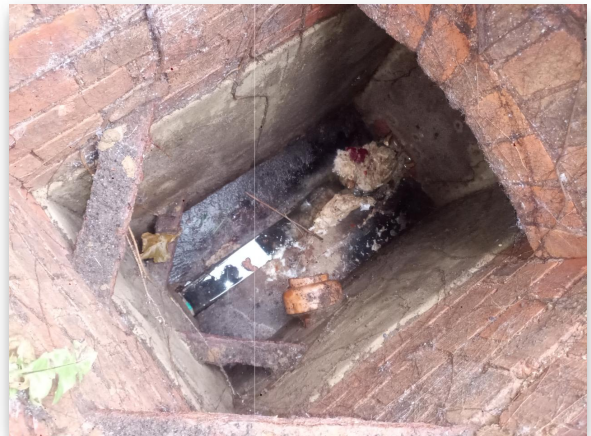
We found MH2 was holding water, extensive jetting was successful in clearing the main trap and also revealed the rodding cap stuck in the line prevent flow which we have now removed, there is a connection within the MH we have been unable to survey due the MH being 1.7m deep, this line runs to a WC internally.

Fig 4.4: MH2 blocked, now clear

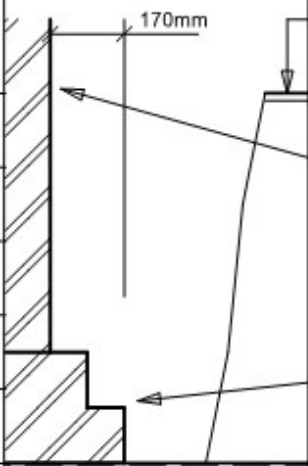
Trial Hole Log No.1

Location: Rhs rear corner of extension

Ground Level				
		Concrete				
		Brickwork				
		Double Step				
0.5		Moist Brown fine to medium gravelly silty CLAY	74kpa		Soil @ 0.5m	Root @ 0.5m
1.0		Very dry Brown fine to medium gravelly silty CLAY	140kpa		Soil @ 1m	Root @ 1m
1.5		TRIAL HOLE TERMINATED

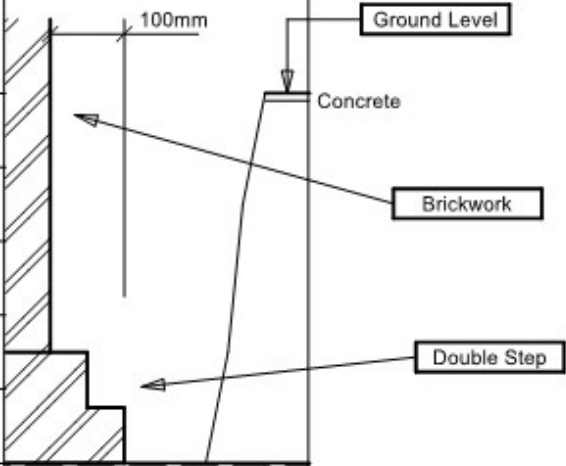
Trial Hole Log No.2

Location: Rear left corner of extension

Ground Level				
		Concrete				
		Brickwork				
		Double Step				
0.5		Moist Brown fine to medium gravelly silty CLAY	82kpa		Soil @ 0.5m	Root @ 0.5m
1.0		Very dry Brown fine to medium gravelly silty CLAY	140kpa		Soil @ 1m	Root @ 1m
1.5		TRIAL HOLE TERMINATED
