INSURANCE INCIDENT REPORT

222 Finchley Road
London
NW3 6DH

QG1U1287632

13th September 2024

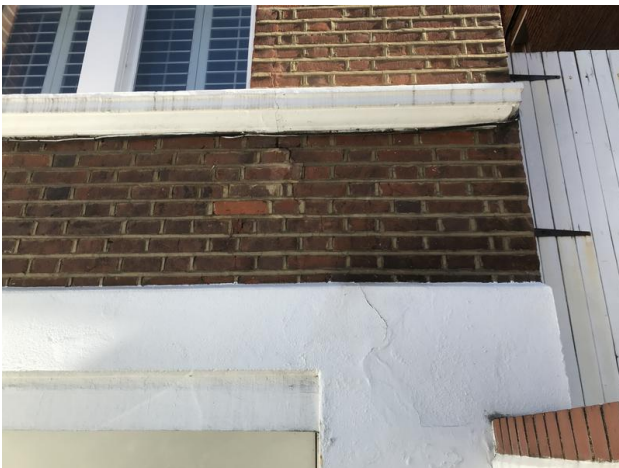
Minor cracks were noted on the front wall above the garage door in the render and brickwork.

There are also several minor cracks on the front wall, in the render to the garage door, in the bricks just above this, in the brick arch over the RH ground floor window and above the main entrance door brickwork. These appear to be due to movements in the brick arches and lintel rather than subsidence of the foundations. Access internally would be required to comment further.

Photo 5 - Minor crack to render and bricks

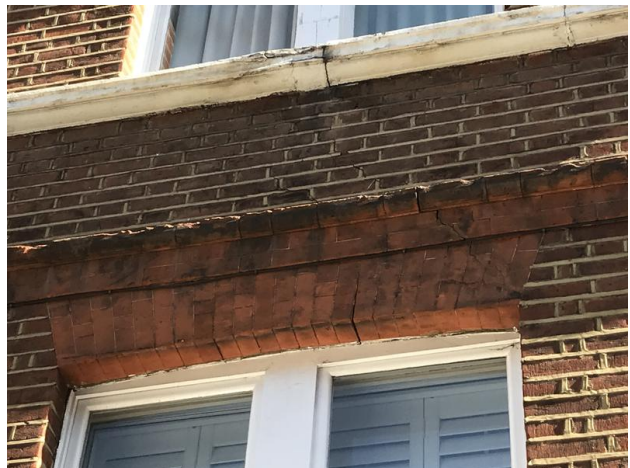
Further cracks were noted higher up above the brick arch.

Photo 6 - Crack to brick arch

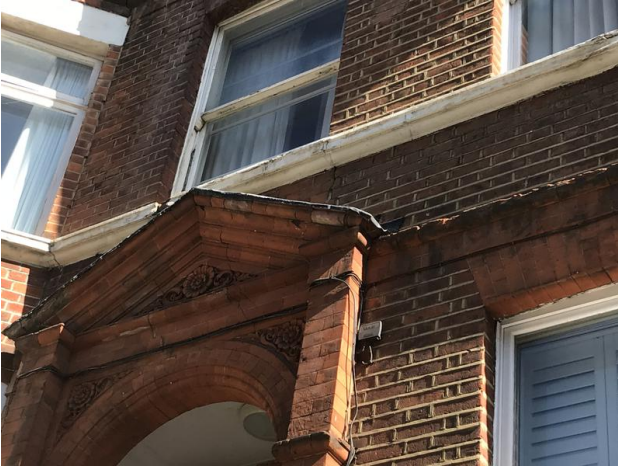
General cracking was noted to the decorative birch arch and capital above the main front entrance door.

Photo 7 - Minor above portico

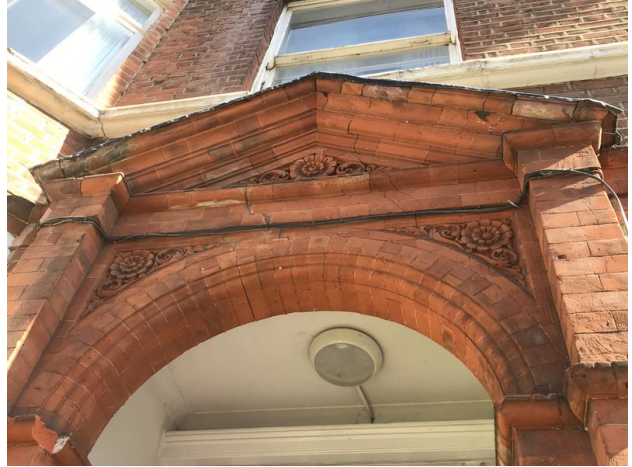
Photo 8 - Crack to decoarative portico

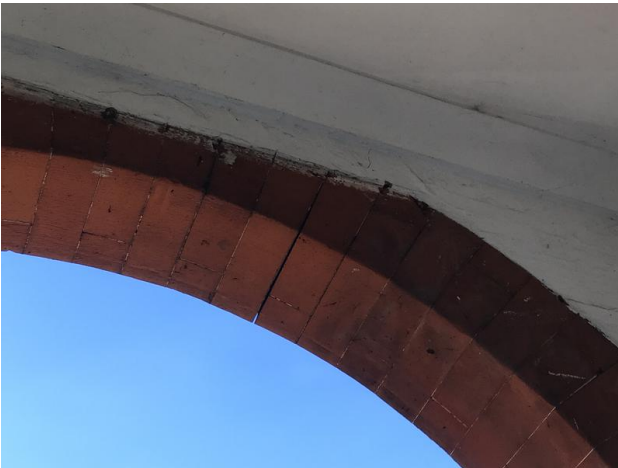
Photo 9 - Crack to arch

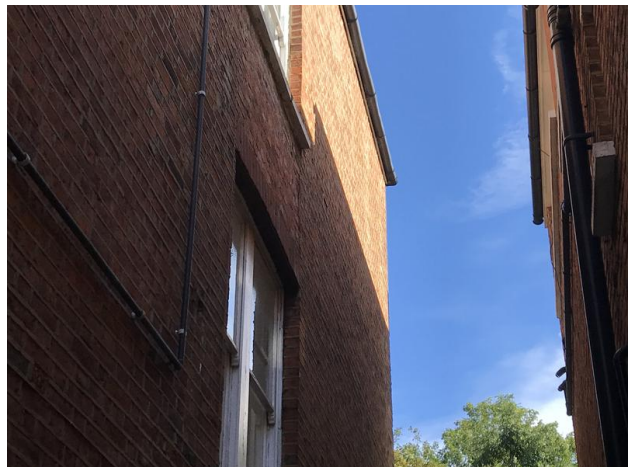
Our inspection of the right hand flank wall was very limited since could not access the side alley. We were however able to see a long vertical crack to the rear between the lower and upper landing windows. We were able to view this from the first floor windows on the landing. The crack externally was around 12mm wide below the second floor window but below the first floor window the wall had been repointed so we could not see any crack to

correspond with that seen inside.

Photo 12 - Crack between windows

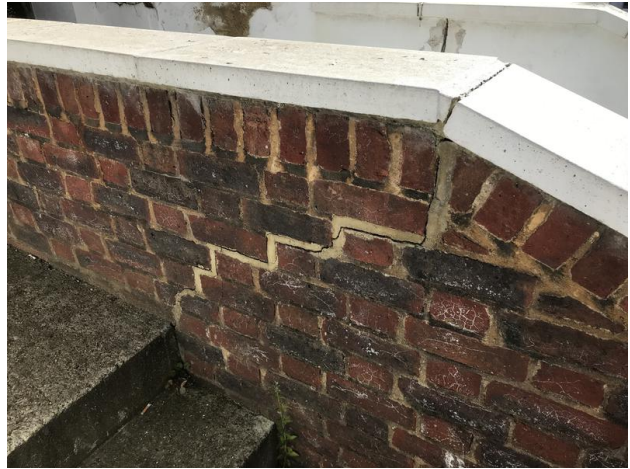
There are further significant cracks to the right hand side wall of the entrance steps, which have been previously repaired and opened up. These are around 12mm wide near the front and around 5mm wide higher up the wall. These are likely to be due to the shallow foundations of these steps. They are also just with influencing distance of the London Plane tree in the highway.

Photo 14 - Crack to boundary wall RH side

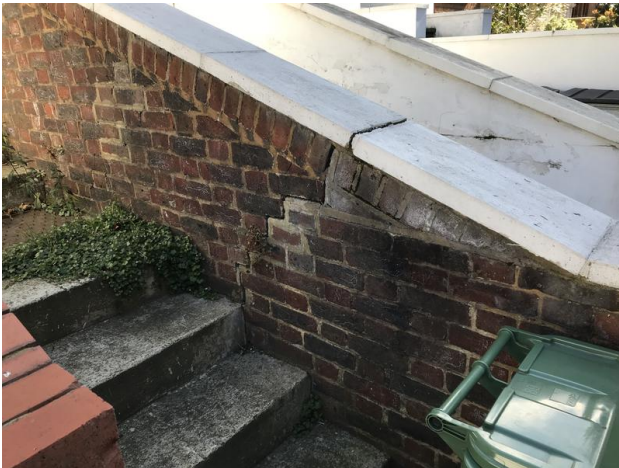
Photo 15 - Crack to boundary wall near street

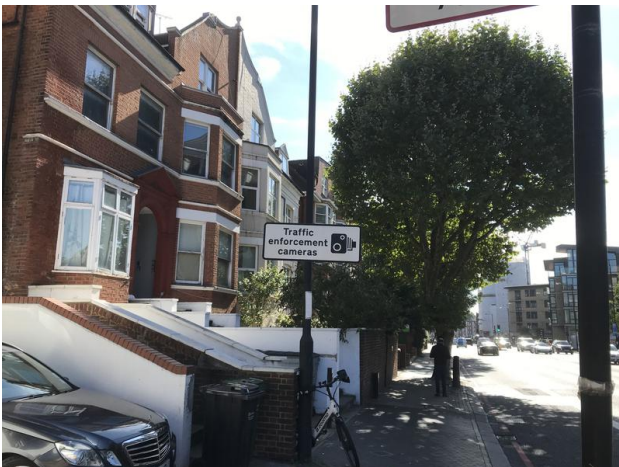
Photo 17 - London Plane 15 from steps

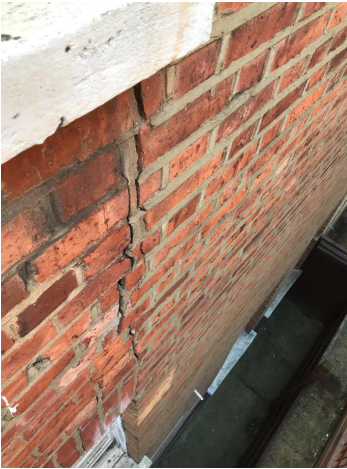
Photo 19 - Flank wall below upper window

These cracks coincided with that seen externally. Access through the windows revealed a large vertical crack externally below the upper landing window.

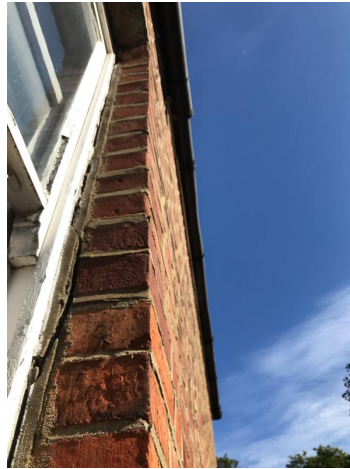
Photo 20 - Reveal pulling out

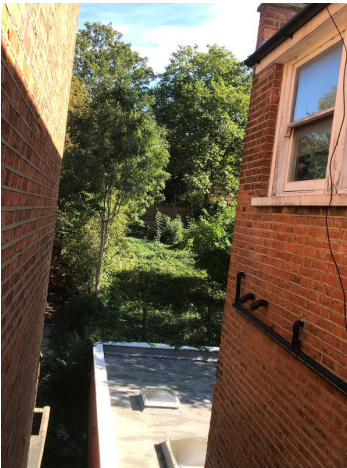
There are numerous trees growing at the rear of the property within a potentially influencing distance, which could adversely affect the stability of the foundations. Where the sub-soils are cohesive, clay soils, trees will draw moisture from the clay, resulting in shrinkage of the clay and associated subsidence of the site. This can cause foundations to move downwards. This movement induces stress on the building materials and when the stress exceeds the strength of the material, cracks will develop. These are detailed in the site plan that follows.

Without full access to the property at the rear, and flat A on the ground floor, we are unable to positively confirm the causes of damage. The pattern of cracks, and distortion towards the rear clearly shows this property has subsided. The direction of movement is towards the rear right hand side so we strongly suspect this is due to the London Clay subsoil and the large amount of trees in the rear garden.

Photo 21 - Trees to rear

It is recommended that the trees, suspected to be affecting the property, are subject to maintenance / removal works to reduce the risk of instability of the house foundations. Expert advice should be sought from an arboriculturist as to the most appropriate course of action for these trees. These actions may include significantly lowering the height of the trees and maintaining them at this lower height, to reduce water demand or complete removal. The specialist will be able to recommend the most appropriate time to remove any trees, and whether removal needs to be carried out in stages. In certain circumstances, the removal of high water demand, mature trees growing in cohesive, shrinkable clay sub-soils, can lead to rapid re-hydration and associated swelling of the clay, leading to lifting of the foundation. This is known as recovery. In order for an arboriculturist to assess the site and any potential tree related damage, they may require trial pits and laboratory analysis of soil samples to determine the type and classification of the soils beneath the wall foundations.

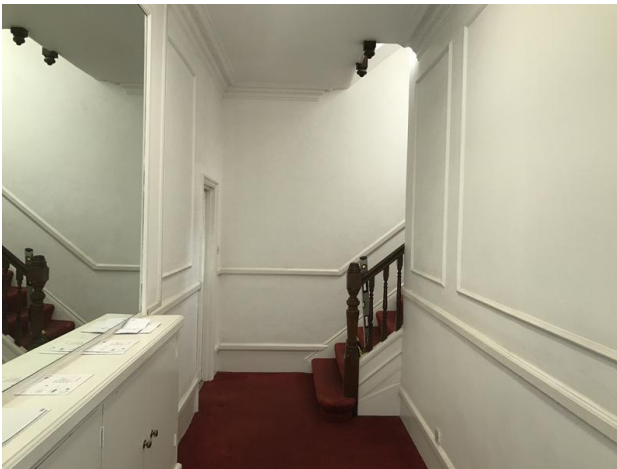
Access was gained to the hall, stairs and landing. No cracks were noted on the ground floor hallway.

Photo 23 - Ground floor entrance

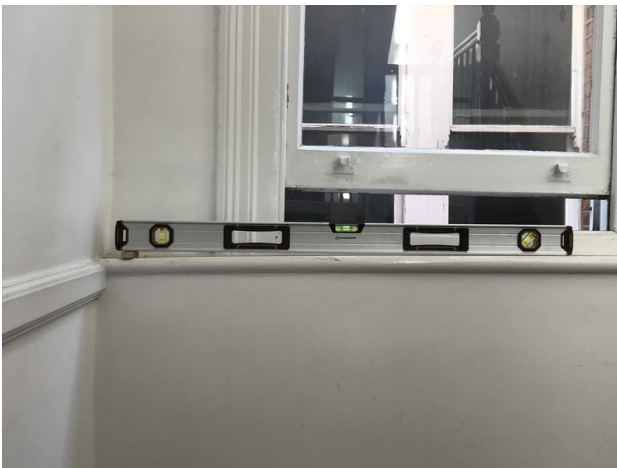
Significant distortion of the window sill was measured at 12mm per metre towards the rear.

Photo 25 - 12mm drop to rear

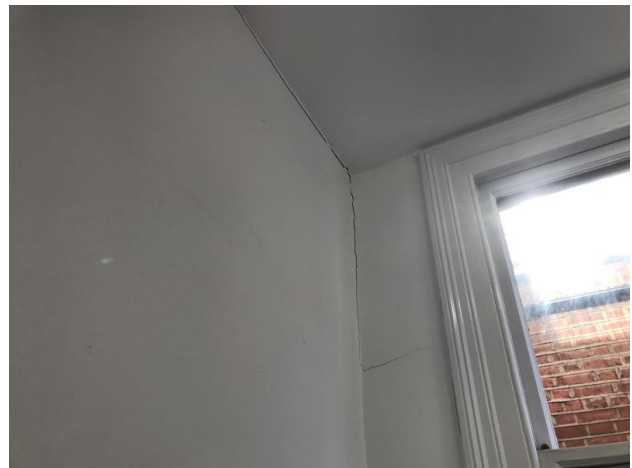
On the first floor landing to the right hand side there was a long vertical crack extending up to the ceiling around 4mm wide and a further diagonal crack around 1.5mm under the window.

Photo 26 - Crack up to ceiling 4mm

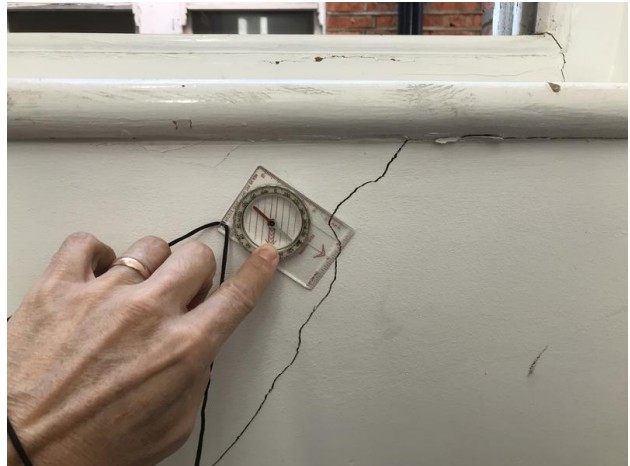
Photo 28 - 1.5mm wide

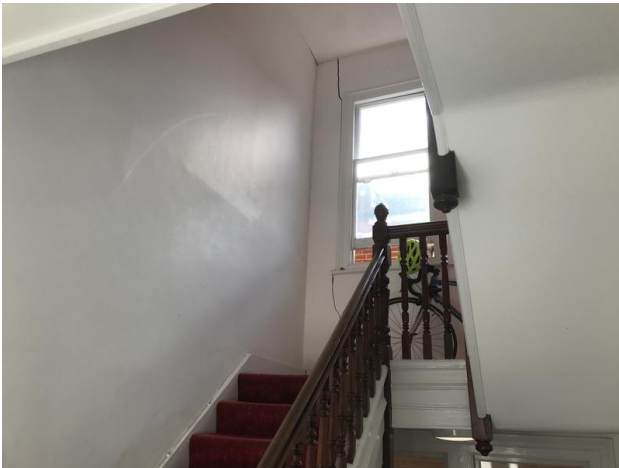
Photo 29 - Upper half landing

On the first floor half landing the cracks were more severe with a crack below the window at 6mm wide but around 12 to 14mm at ceiling level.

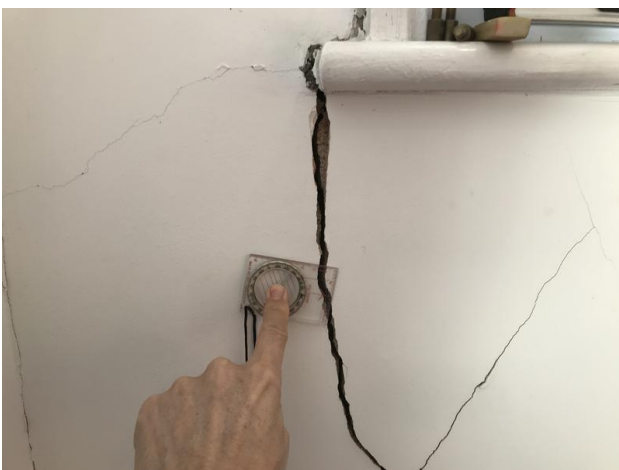
Photo 31 - 6mm wide

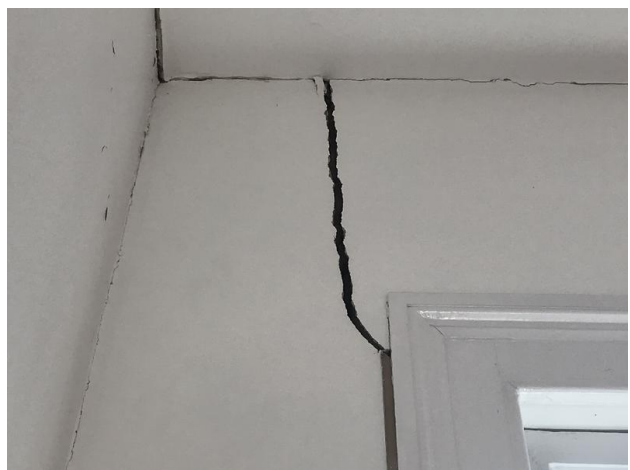
In this instance the damage is Category 3.

Photo 32 - 12- 15mm wide at ceiling

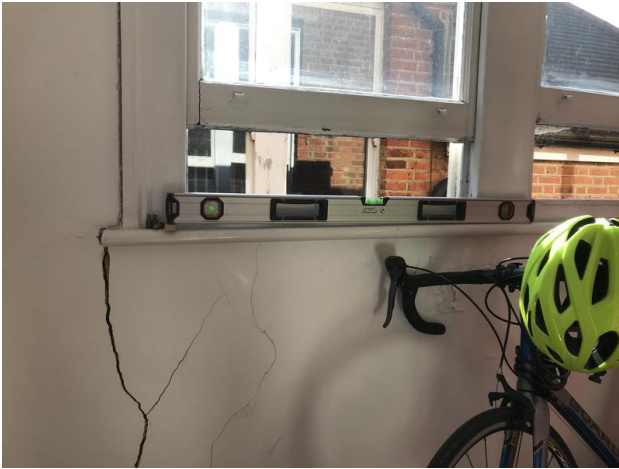
Significant distortion of the window sill was again measured at 12mm per metre towards the rear.

Photo 33 - 12 out or level to rear

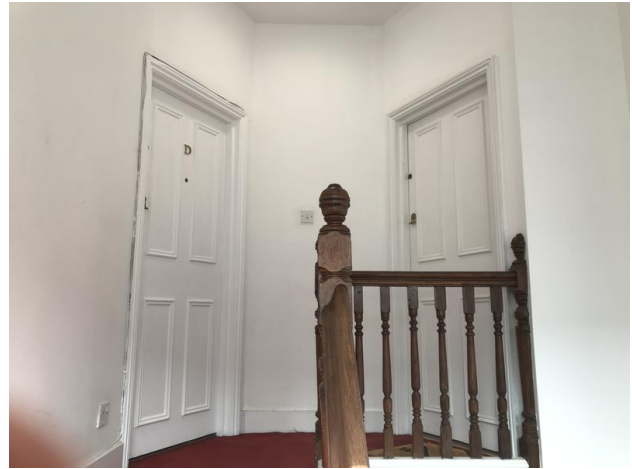
Access was gained to flat D on the upper floor at the front. No significant cracks were observed.

Photo 34 - Access to flat D only
