ARBORICULTURAL IMPACT ASSESSMENT REPORT

15 Chalcot Square,
London,
NW1 8YA

OUR REF: TRA 0479

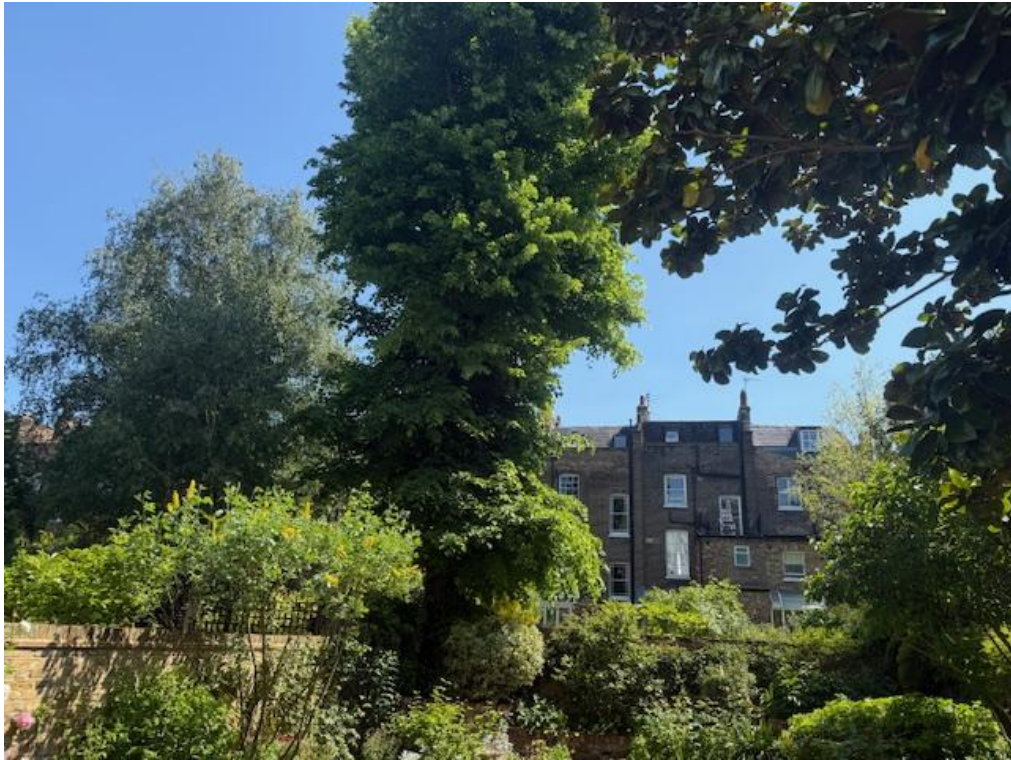
- 4.2. *Comments on specific trees:* The highest quality tree within the survey is T2, a mature lime tree growing in a raised brick edged shrub bed in the rear corner of the garden. The tree is prominent in the surrounding area and offers good screening and amenity value. The tree is currently managed with cyclical crown reduction works, likely to reduce shading to the property and surrounding gardens.

Photo 1. Tree T2 growing in the rear corner of the garden.

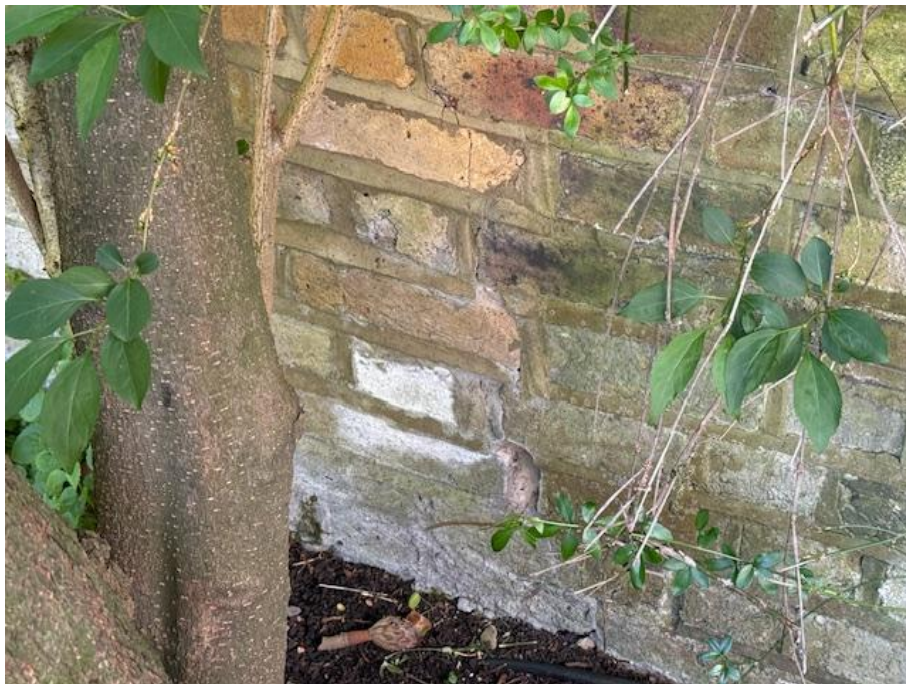
4.3. Along the south west boundary T5 is a triple stemmed magnolia growing within the shrub bed adjacent to the boundary wall. The tree is in good condition with good visual amenity value, however step cracking shows that the roots of the tree are causing direct damage to the boundary wall.

Photo 2. Previous repairs to the boundary wall adjacent to T5, with further cracking indicating tree root encroachment.

T5	Magnolia grandiflora (Southern magnolia)	EM	240, 150, 110	3	8(2)	10	5	4	4	4	Fair	20+	B2	3.65	41.86	Tree growing in shrub bed between path and brick boundary wall. Triple stemmed from 0.2m. Wall showing signs of cracking from root encroachment. Good amenity value.	None.
T6	Sambucus nigra (Elder)	M	250	2	6(2)	7	2.5	3	2	3	Fair	10+	C2	3	28.28	Off-site tree growing in neighbouring garden behind 2m brick wall. Foliage partially obstructing garden steps.	Prune back to boundary line.
T7	Viburnum tinus	EM	200	1	4(0)	6	0.5	2	2	2	Fair	10+	C2	2.4	18.1	Off-site tree behind wall. Unable to view base. In contact with side of building.	None.
S8	Ilex aquifolium (Holly), Camellia japonica (Camellia)	Y	50	1	1.3(0)	4	0.5	1	1	1	Fair	20+	C2	0.6	1.13	Small bushes in raised bed at rear of garden. Limited screening or amenity due to size and location.	None.
