PLANNING AND LISTED BUILDING APPLICATION TO LONDON BOROUGH OF CAMDEN

NEWTON HOUSE, 207 HIGH HOLBORN, WC1V 7BW

SCHEDULE OF WORKS

COWIE MONTGOMERY ARCHITECTS

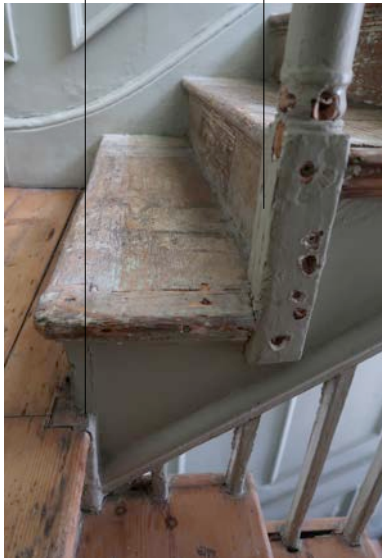
I.1 base of newel post at turn where the post was cut off.

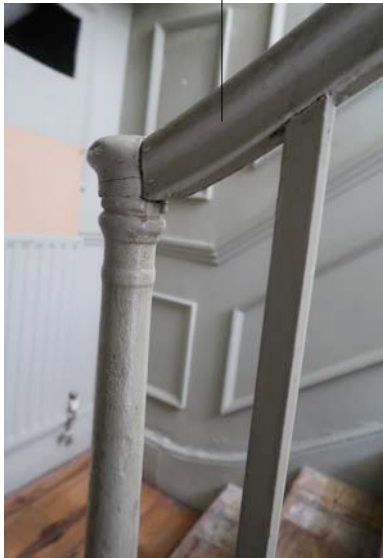
I.1 newel post was moved up one step and cut in and screwed to stringer.

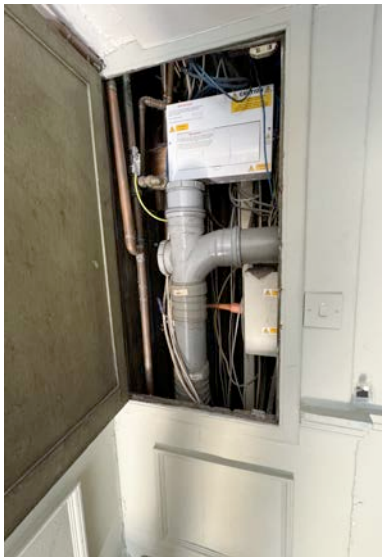
I.2 riser congested with water, gas, electrical and foul wastes services plus redundant services without support, containment or fire compartmentation or fire barriers, in shaft of former goods hoist up from ground floor retail.

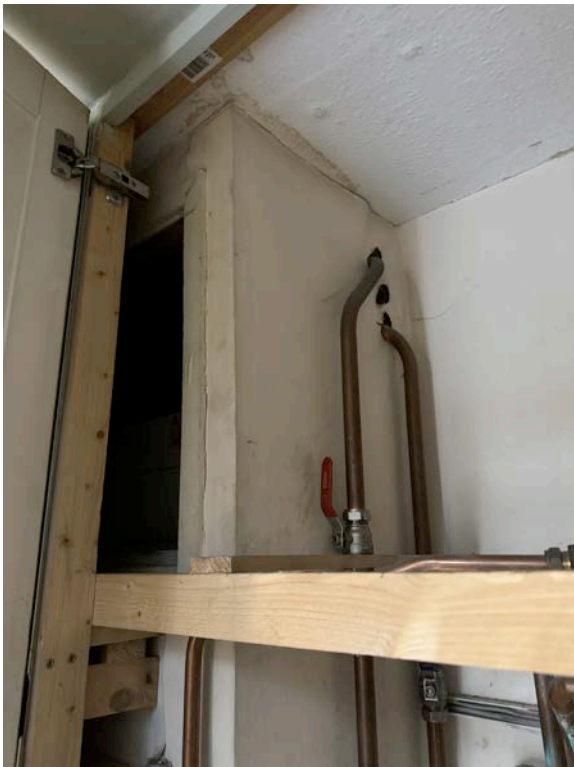
3.7 riser within hot water cylinder cupboard. Riser congested with water, gas, electrical and foul wastes services plus redundant services without support, containment or fire compartmentation or fire barriers.

- 3.7 Removal of plasterboard riser shaft, cupboards, hot water cylinder.
- 3.8 Removal of timber boxing-in built off the stair flight from 2nd to 3rd floors.

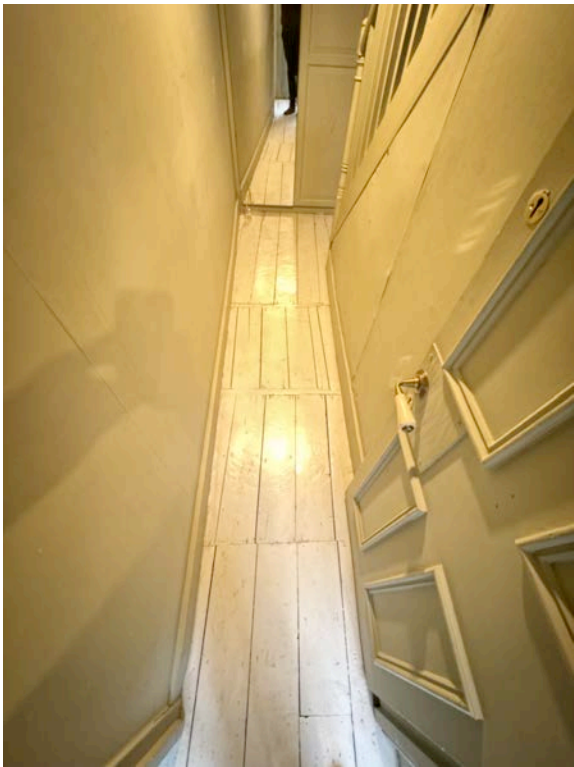
3.6 corridor flooring of short board lengths with hardboard lined infill under stair flight (right) and partition (left) apparently built over later. Boards not parallel to those of front room i.e. not of 1848. Modern fire door (foreground). Stair flight is not original to 1848 house and was installed c.1911 and subsequently rebuilt.

- 3.6 Sections of short cut timber board flooring removed and replaced with lengths of board lapped to existing with boards to be reclaimed Baltic pine of matching size.

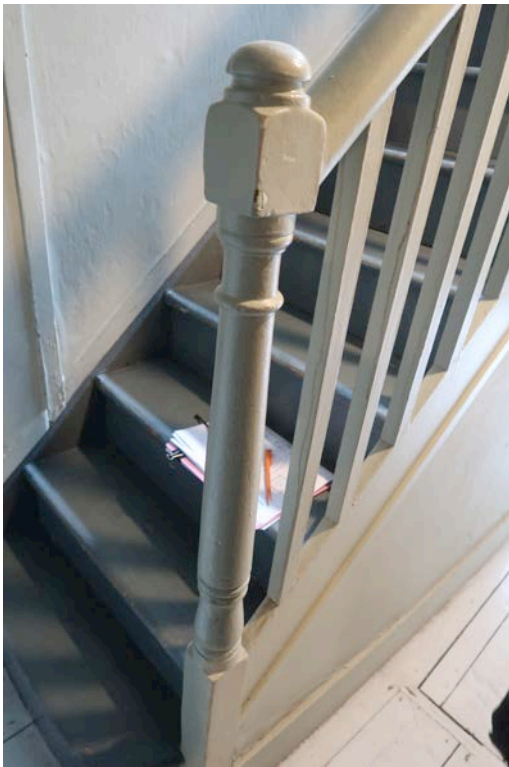
Relatively modern treads with less wear than flight below and turned newel post apparently re-used from first construction of this flight, matching newel at top of stair. Newel and stair sit on the floor, not built into it. Fibre board infill above stringer (far) and hardboard infill below stringer (near).

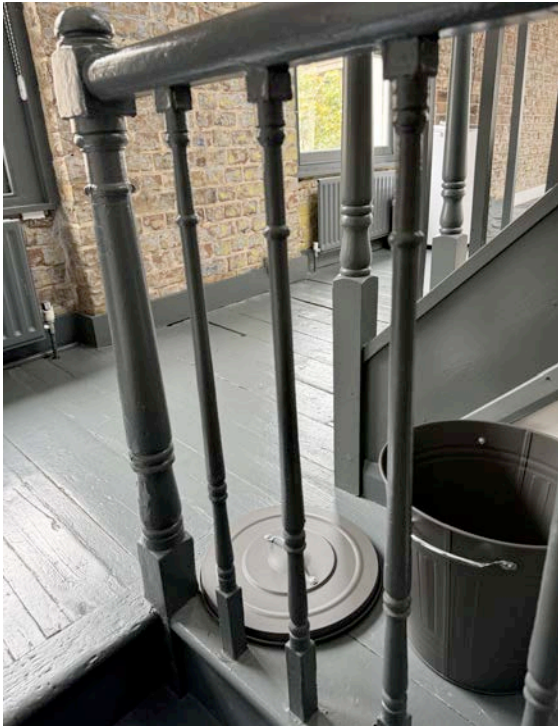
Turned newel at top of flight and four turned balusters. All the rest removed and handrail cut for modern partitions.

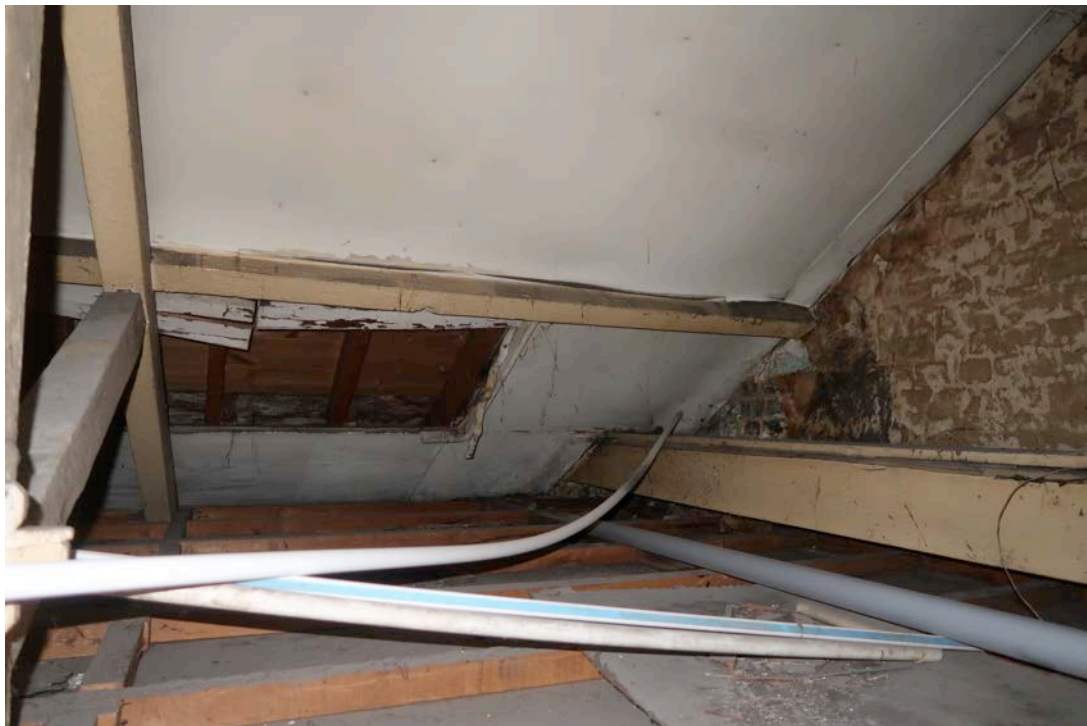
Rear roof space with 1976 rafters and plasterboard ceiling, infilled rooflight originally over back stair. Rainwater pipe from rear gutter formerly in timber boxing to the Newton Street front outlet, now in pvcU pipe. Lining of plasterboard nailed under roof rafters. There is no evidence of any ceiling at the bottom of truss line before 1976.

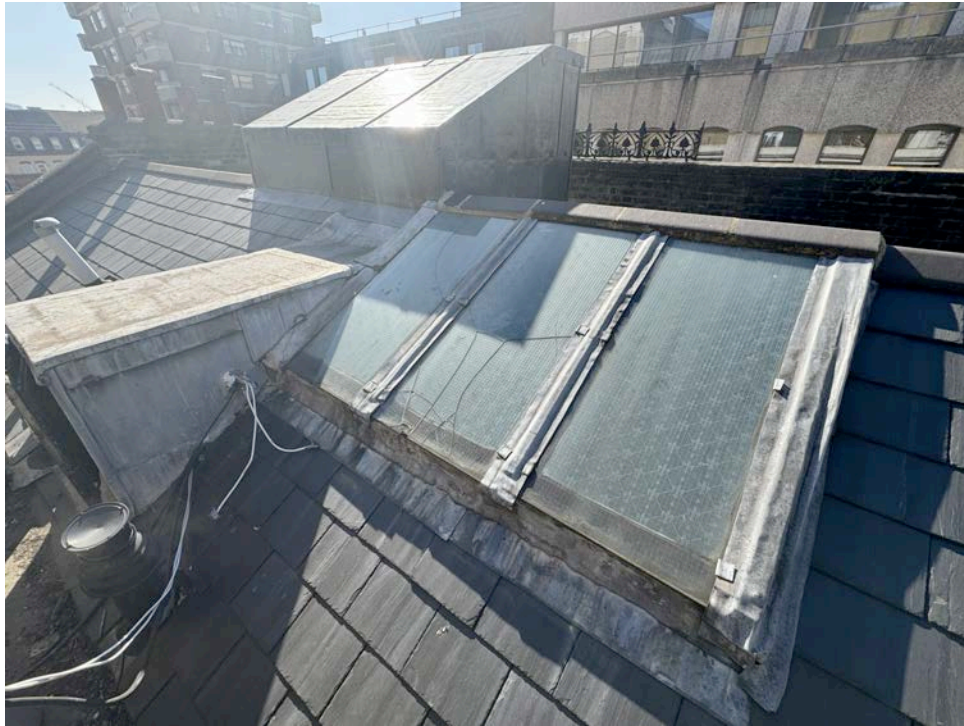
Rear slope of roof with roof access overrun, surviving half of rooflight on rear face and modern hatches across the ridge line.

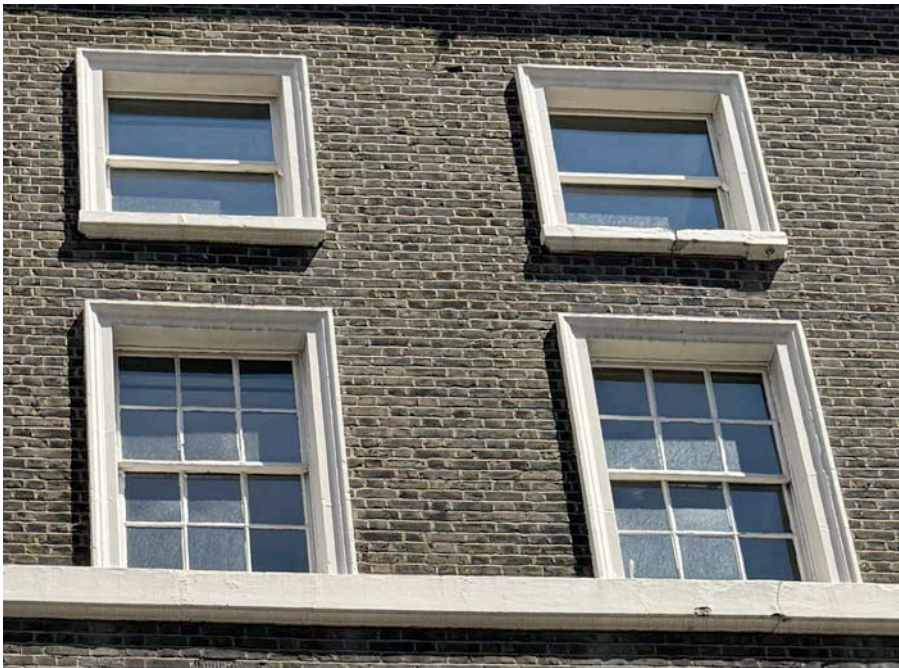
Third and fourth floor windows to Newton Street external view.

Third floor 1848 originals.
Fourth floor modern sashes to be replaced.

- 4.10 Replacement of window sashes with new matching original historic pattern.

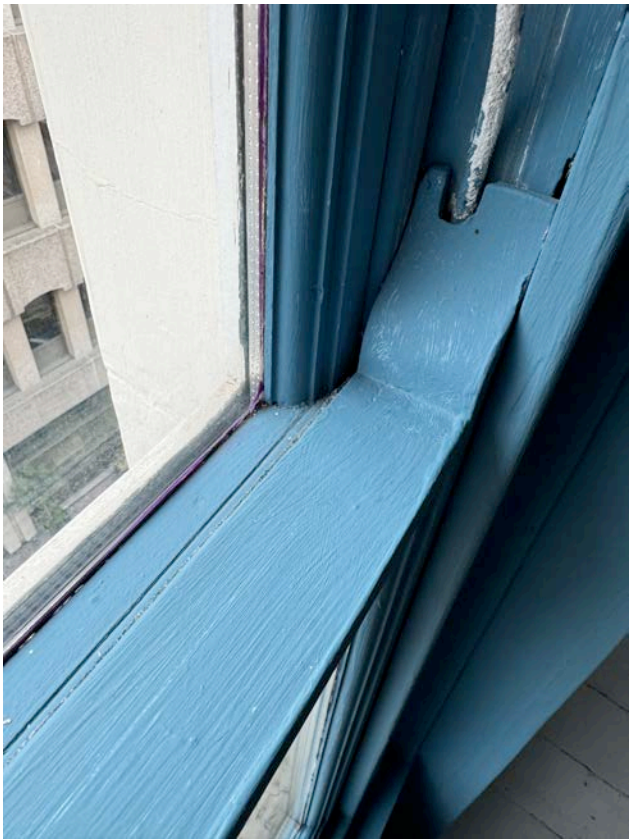
Fourth floor modern sash detail.

Double glazed single units and horns to each sash. No glazing bars. Sashes to be replaced.

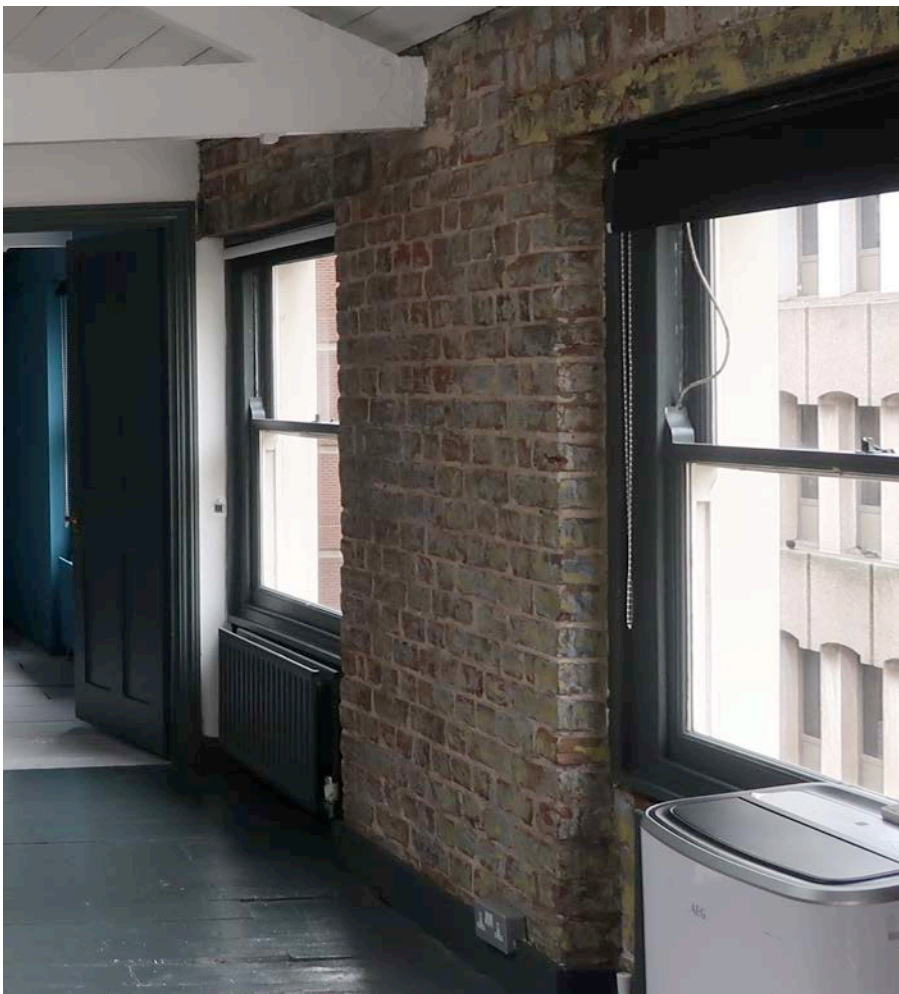
Fourth floor windows to Newton Street internal view.

Modern sashes to be replaced.

Walls are exposed brick previously plastered then painted then paint removed.

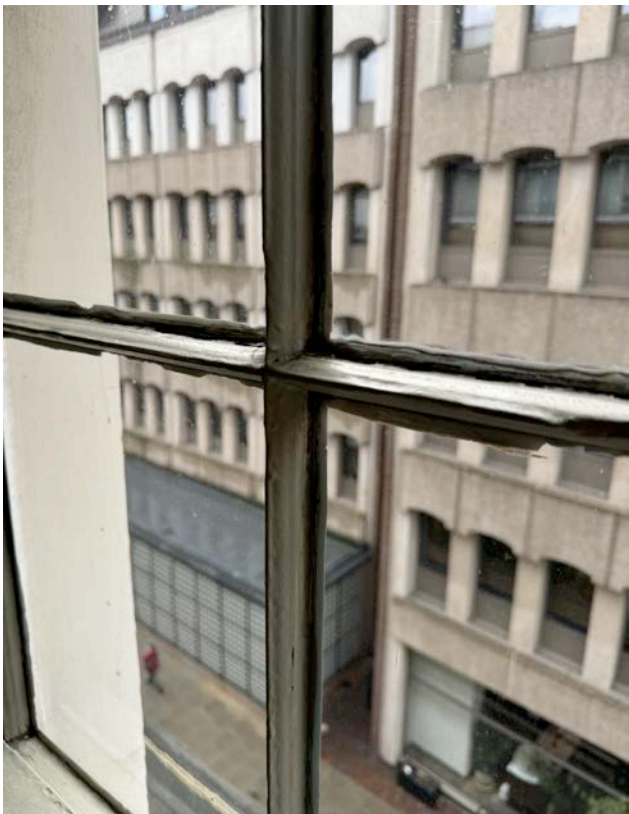
Third floor 1848 window detail.

Glazing bar profiles at cruciform.
Ovolo and fillet profile to be copied in 4th floor replacement sashes.

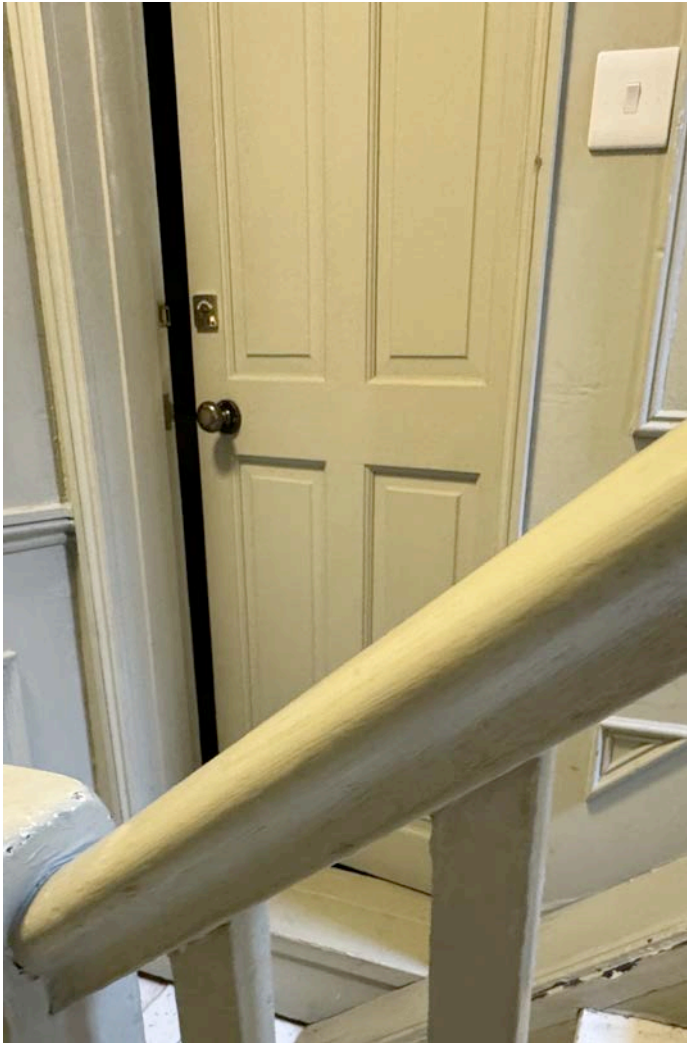
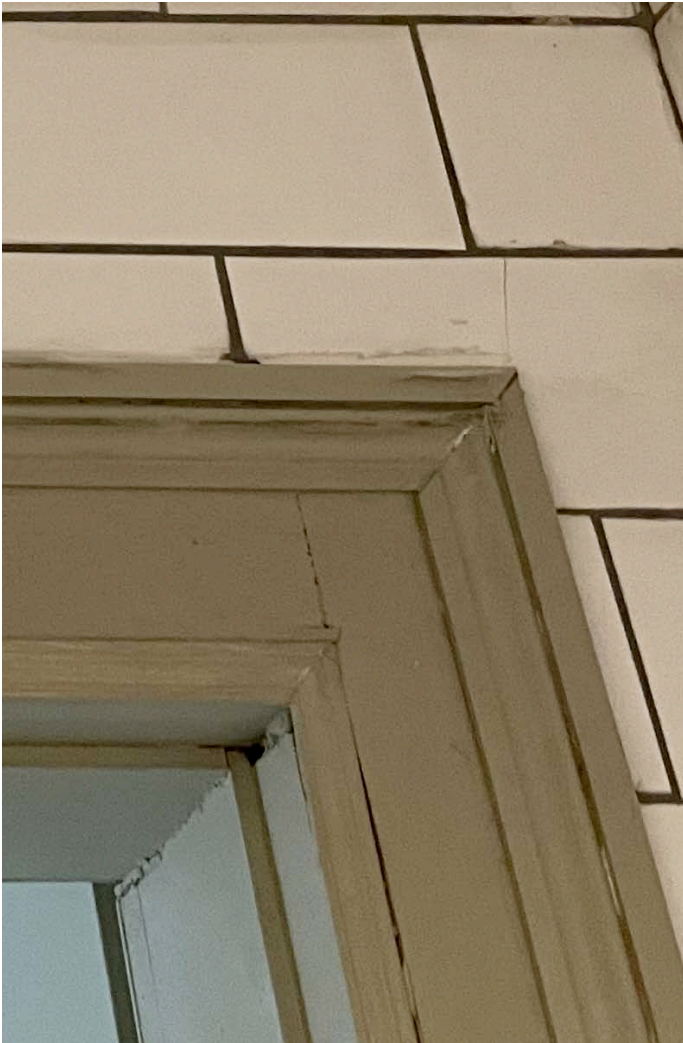
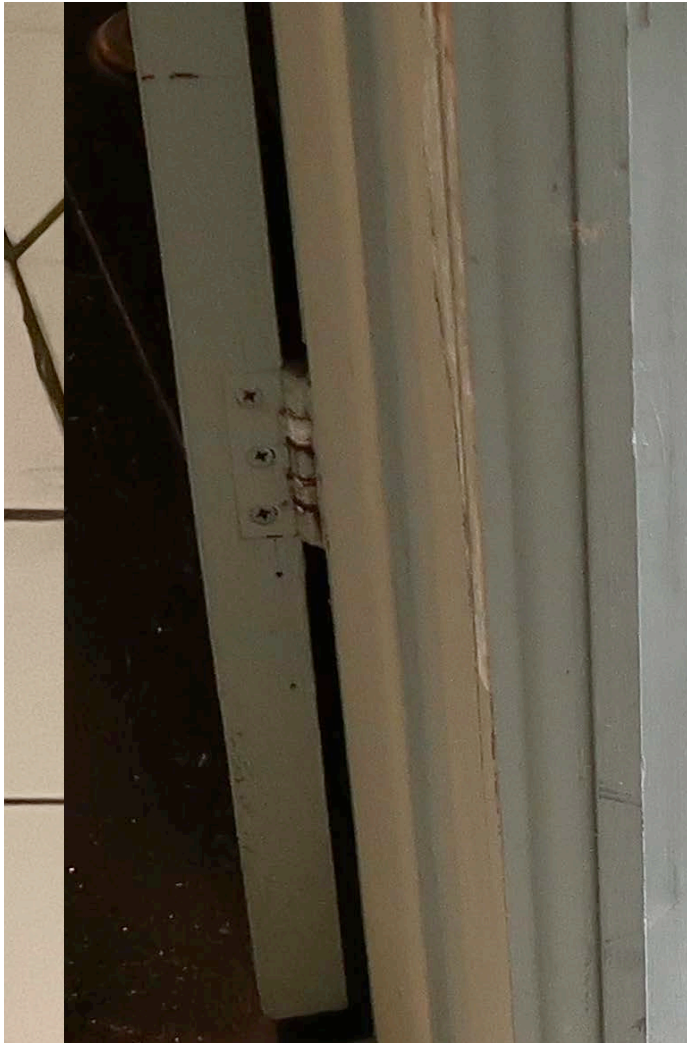
D.2.3

Door opening and door are post-1976.

The door opening is in the approximate location of an original 1848 opening but set higher up to suit the raised bathroom floor level.

Georgian style raised and fielded six panel door cut down in width and sourced from elsewhere. Linings and pinned-on stops and profiled architraves all installed when the opening was formed. Cast iron butt hinges. Phillips head screws.

- 2.2 Half landing and lower steps and newels outside bathroom made up of various alterations removed and replaced.
- 2.3 Bathroom door replaced with new panelled joinery door, frame and architraves (see below for existing door).

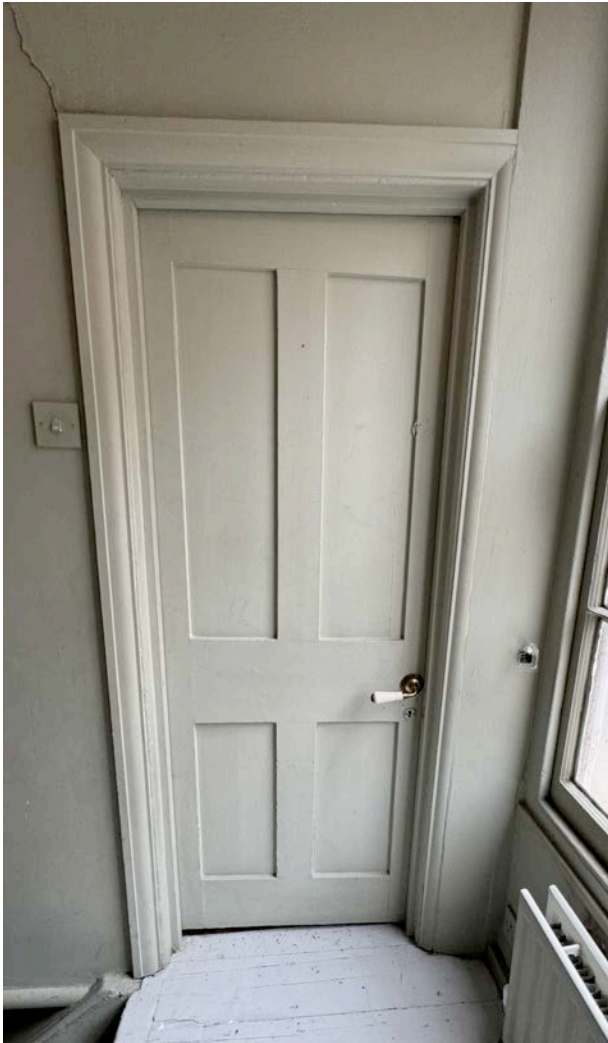
D.3.1 staircase face

Head of opening drops 30mm right to left following deflection of the modern partition that was built over the stair void. Four panel door leaf cut down to fit width and cut to taper across the top. The opening has deflected more since the door was hung in 1976 and side frames are not vertical.

Door leaf evidently one of four of similar pattern sourced elsewhere and installed during the 1976 works. Cast iron butt hinges. Modern ironmongery.

Note the modern partition clashes into the original window reveal lining and the architrave of 1930's pattern is scribed to fit. The original partition was demolished and the current one installed out over the stair void to enclose on the formerly open side stair up to fourth floor.

- 3.1 Removal of non load-bearing cross partition on grid B of 20th century framing and 1976 infills, linings, fireline board and including door (see below for existing door).

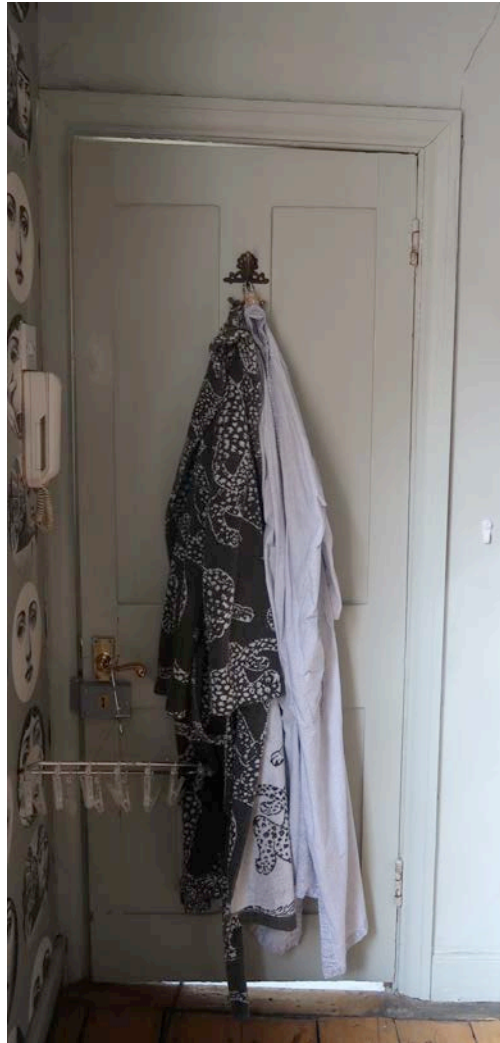
D.3.1 room face

Note the board running under the skirting, counter the boards which infills the gap where the original partition was demolished.

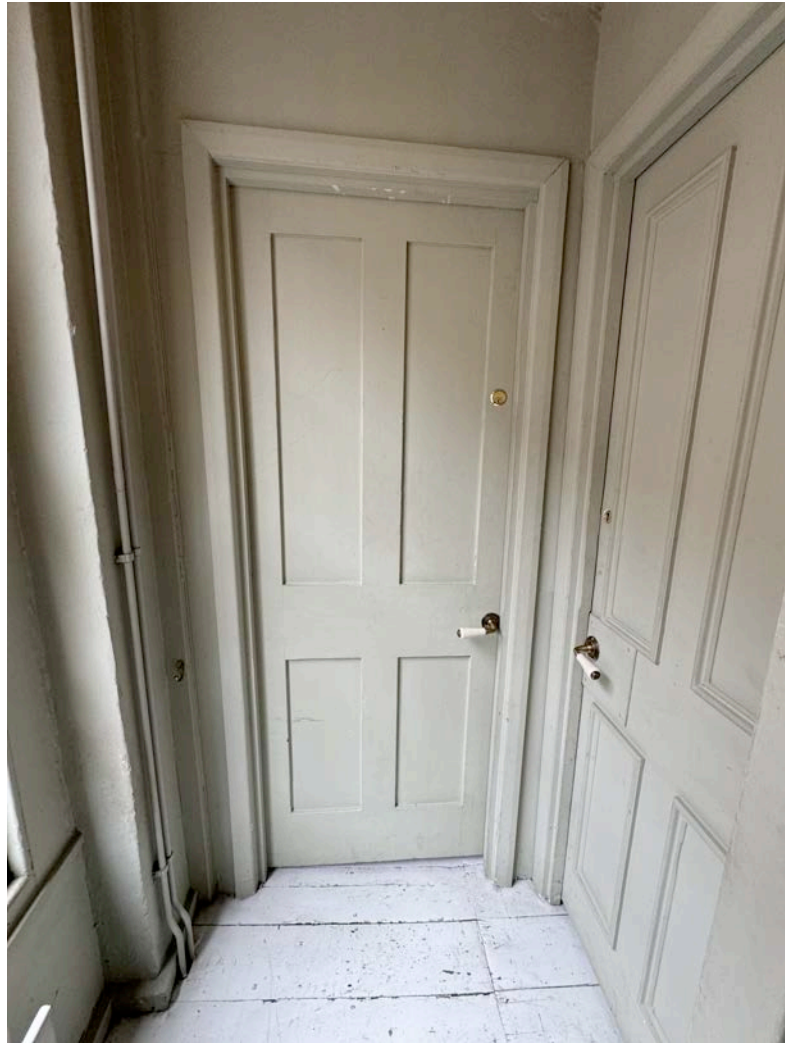
D.3.2 (left) and D.3.3 (right) staircase faces

D.3.2 opening cut through a timber stud screen that was strengthened and clad in various linings during the 1976 works. The door, linings and chamfered architraves were part of those works.

Four panel door leaf. Door leaf evidently one of four of similar pattern sourced elsewhere and installed during the 1976 works. Cast iron butt hinges. Modern ironmongery.

Note that the window reveal lining and architrave and plaster linings have been removed and heating pipes installed.

- 3.2 Removal of non load-bearing infill partitions on grid A, including 20th century framing, 1976 door infill and over-linings and including door (see below for existing door).

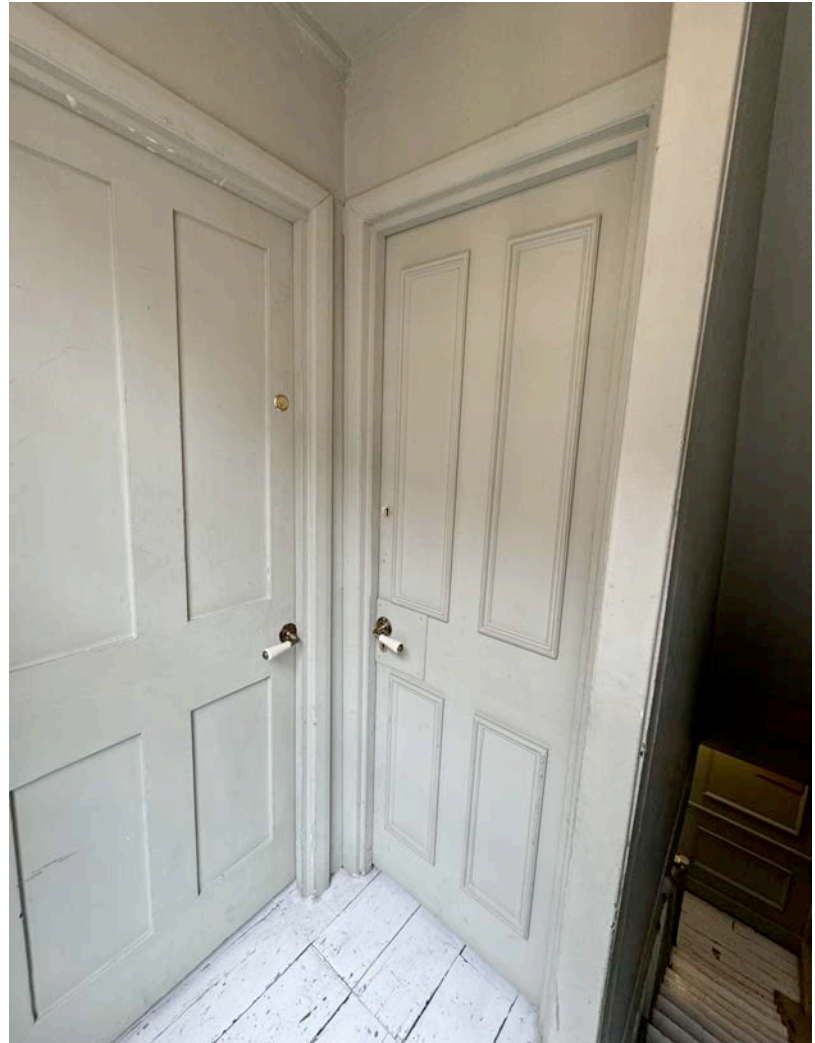
D.3.2 (left) and D.3.3 (right) staircase faces.

D.3.3 is installed in the partitions forming a corridor to the former top floor flat, installed during the 1976 works. The door, linings and chamfered architraves were part of those works.

Door leaf is a fire door blank with mouldings applied to resemble panelling. Cast iron butt hinges. Phillips screws. Modern ironmongery.

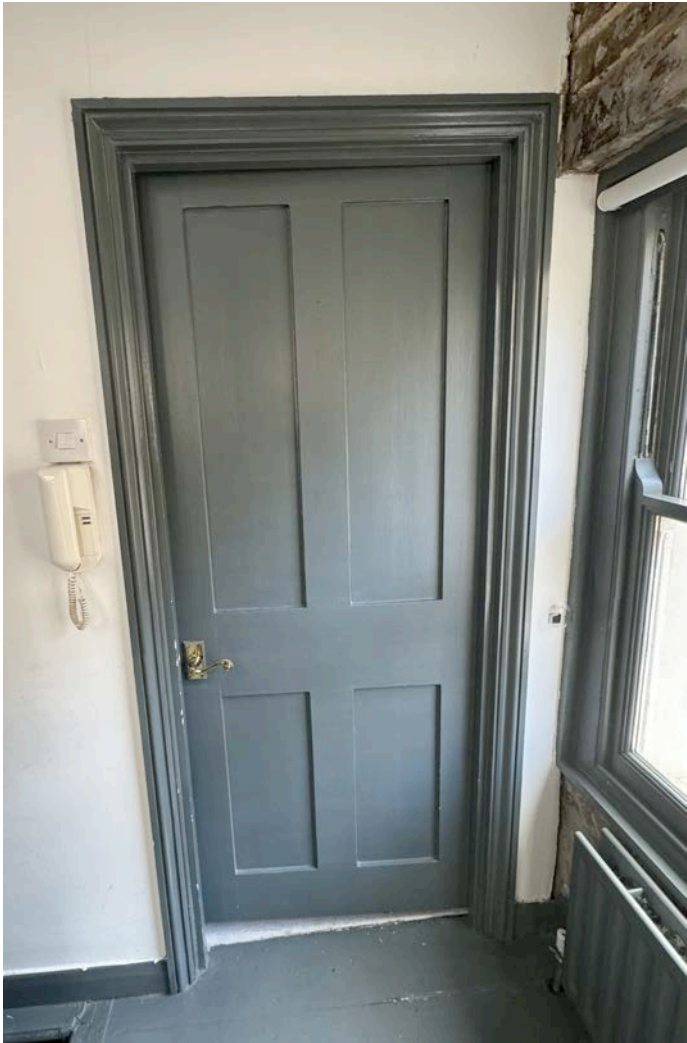
D.4.1 staircase face

The bedroom partition was built during the 1976 works. The door, linings and ogee architraves were part of those works.

Four panel door leaf cut down in height to fit in frame installed tight under the truss above. Door leaf evidently one of a four of similar pattern sourced elsewhere and installed during the 1976 works. Cast iron butt hinges. Modern ironmongery.

Note that the window reveal lining and architrave and plaster linings have been removed and replacement double glazed sashes without glazing bars installed. Front room walls are exposed brick previously plastered then painted then paint removed.

- 4.1 Removal of non load-bearing cross partition on grid A built in 1976.
- 4.2 Removal of non load-bearing bathroom partitions, plasterboard ceilings and fit-out built in 1976.

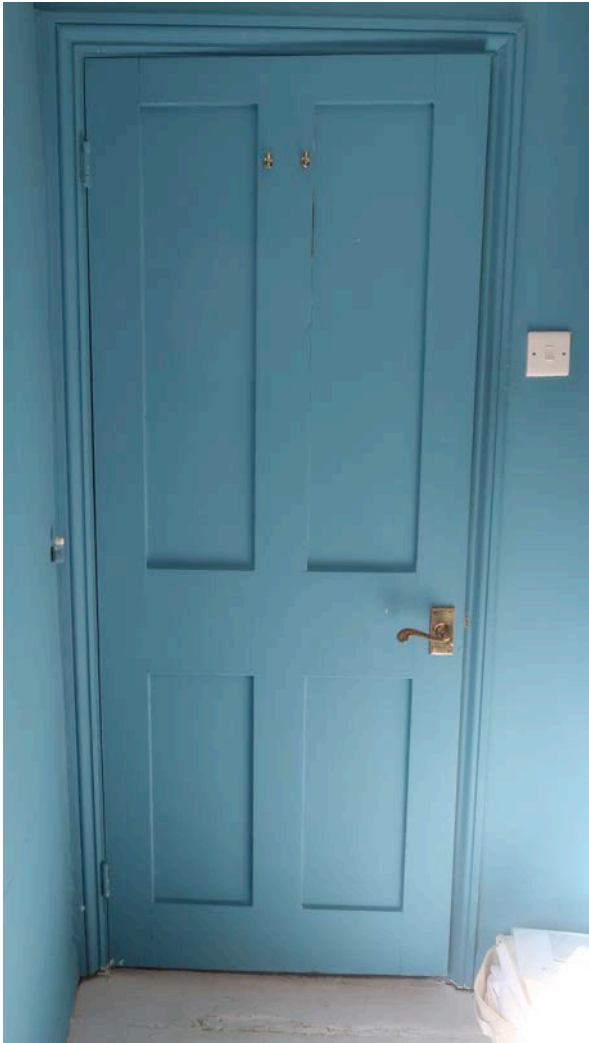
D.4.1 room face

Note the external walls of the back room have plasterboard linings.

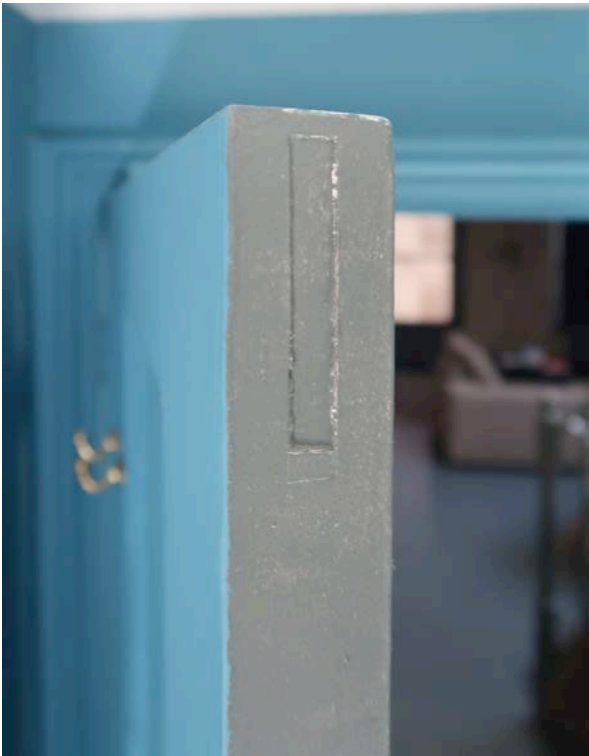
D.4.1 detail

Note leaf cut down to fit frame height limited by the truss above.

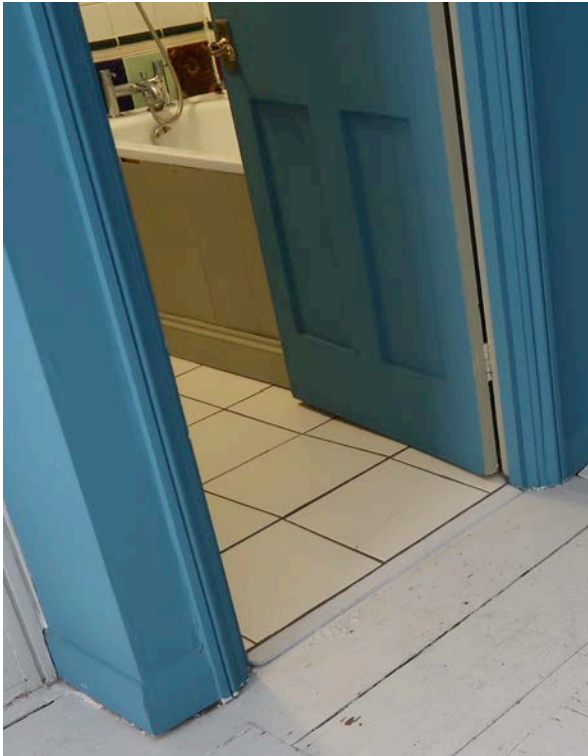
D.4.2 bathroom door

The bedroom partition was built during the 1976 works. The door, linings and ogee architraves were part of those works.

Four panel door leaf evidently one of a four of similar pattern sourced elsewhere and installed during the 1976 works. Cast iron butt hinges. Modern ironmongery.
