Crack and Level Monitoring

Provider Name: My Home Needs

Client: Questgates

Address: 222 Finchley Road, London, NW3 6DH

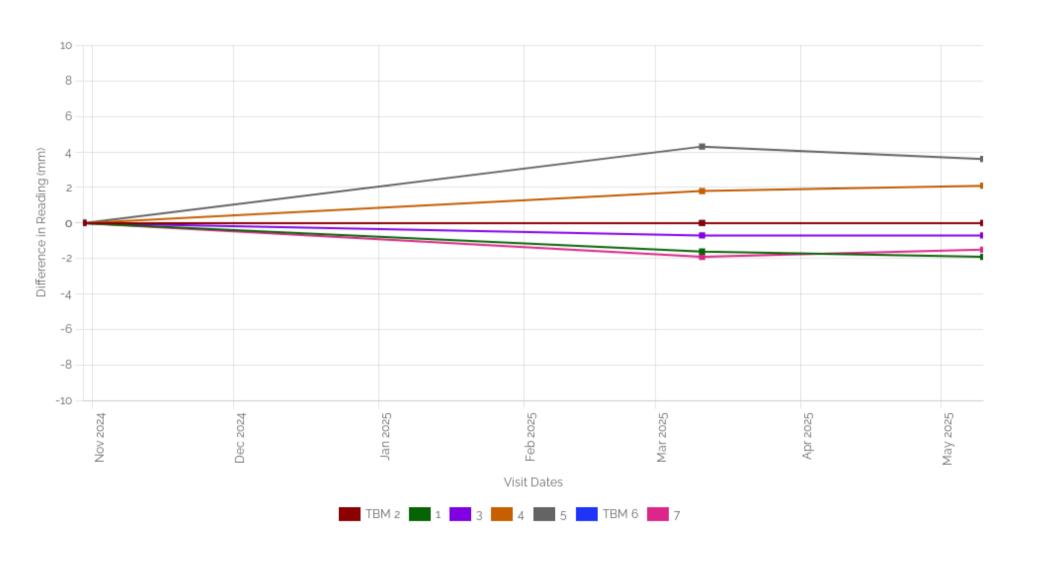
Level Readings Chart (Points TBM 2 - 7)

Visit 1	Visit 2	Visit 3	Visit 4	Visit 5	Visit 6	Visit 7	Visit 8
	29/10/24	10/03/25	09/05/25					
TBM 2	0	0	0					
1	0	-1.6	-1.9					
3	0	-0.7	-0.7					
4	0	+1.8	+2.1					
5	0	+4.3	+3.6					
TBM6	0	0	0					
7	0	-1.9	-1.5

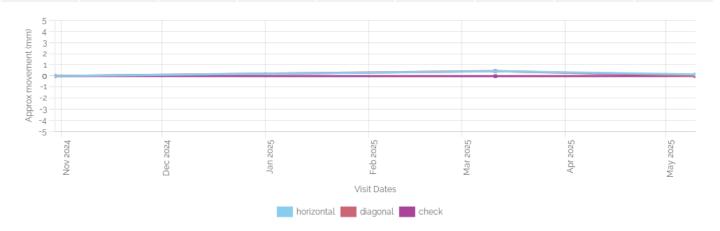
Right of wall after gate before stairs - Crack Readings Differences (Displayed in Millimetres)

Visit 1	Visit 2	Visit 3	Visit 4	Visit 5	Visit 6	Visit 7	Visit 8
	29/10/24	10/03/25	09/05/25					
Н	0	0.41	0.13					
D	0	0.44	0.01					
С	0	-0.02	-0.01
