The Morton Partnership

20th February 2025

RE: 53 OAKLEY SQUARE, LONDON NW1 1NJ

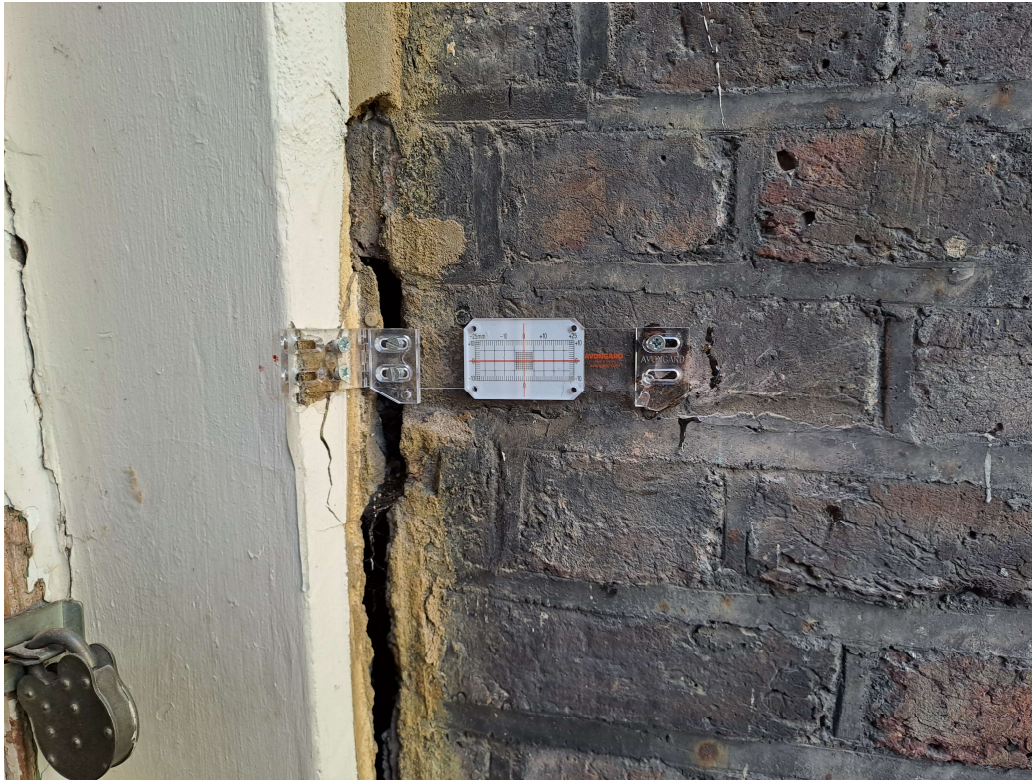
Photograph 1: tell tale monitor installed across junction

Having looked at the data from the corner tell tale, this is quite unexpected. This shows movement varies between a maximum of -7mm (crack closing and getting smaller in width) in December 2024 and +14mm (crack opening and getting wider in width) in October 2024. I have formulated a table below showing the movement over the period of monitoring.

The one noticeable trend is that the crack gets wider in the summer months and closes up again between late autumn and spring. This would lead us to conclude that in the summer months, the clay sub soils under the rear extension shrink in volume due to ground water being extracted from the large trees in the back garden. As the clay sub soils shrink in volume, this causes the rear extension to drop and rotate away from the rear wall of the main house, causing the crack to widen. In the wetter months, it appears that the clay sub soils rehydrate and expand in volume, pushing the rear extension upwards and causing the joint or crack to close.

From reviewing the data, it is likely that the roots from the large trees in the rear garden extend under the foundations of the rear extension and this is leading to changes in moisture content of the clay sub soils which then causes expansion and contraction of this material which then leads to differential movement of the extension in relation to the main house.

There are a number of options available to remedy this problem. The first is to carefully manage the trees and prune them back. This will result in them extracting less moisture from the ground under the rear extension and therefore the moisture content of the sub soils will remain constant which will prevent the seasonal changes in volume of the clay sub soils.

The preferable option would be to manage the trees and continue to monitor the situation. This would involve appointing an arboriculturist to survey the trees and provide advice regarding appropriate measures for pruning and managing the trees. If the council owns the trees, you will need to contact them and ask them to carry out the works. If the tree is owned by the freeholder, they are responsible for the management of the trees.
