VICTORIA HOUSE - Second Floor Louvre Replacement / Reglazing

Louvre removal and re-glazing principles

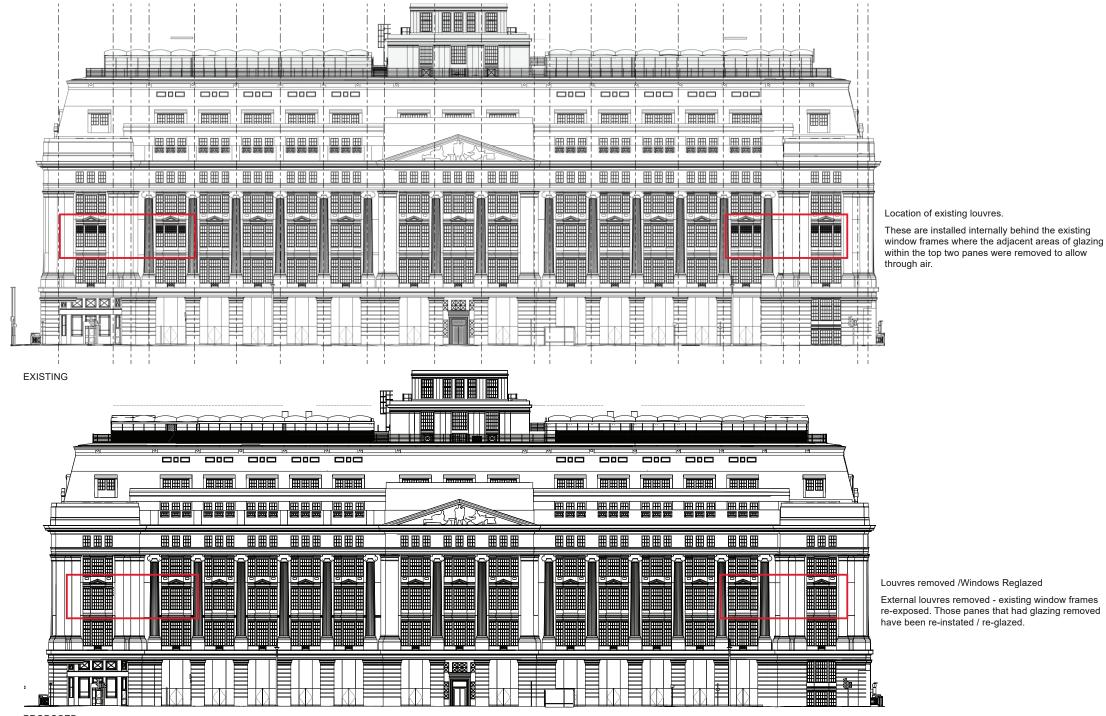
Existing metal louvres sat internal to the original existing window frames.

Historically glazing had been removed from corresponding window panes to allow air passage through.

Non - glazed areas that require re-glazing.

Historic louvre elements carefully removed to reveal existing window behind.
