Basement Impact Assessment: 33 South Hill Park London NW3 2ST

**Prepared for: David Mikhail Architects**

Reference:13.032.4

Date: 5<sup>th</sup> March 2014

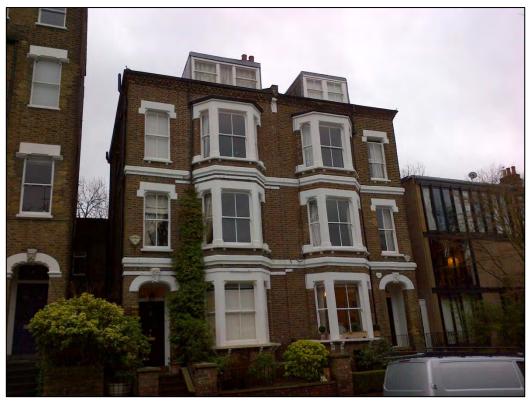
Photograph One: Front view of 35 and 33 South Hill Park. Note the strapping above and below bay windows of No. 35. No. 33 has had them mostly removed, but wall bolts still remain visible.

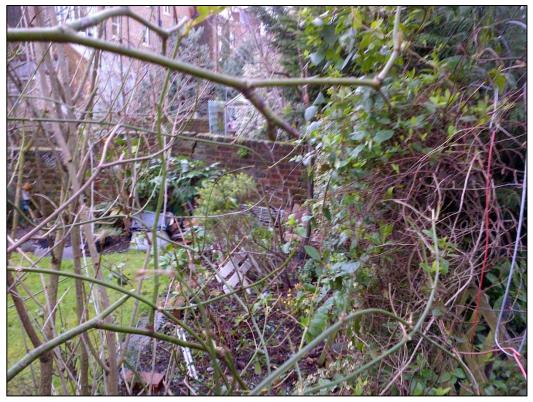
In the rear garden to No.35 the rear part of the 35/37 boundary wall was seen to have cracked and rotated downslope, away from the SHP properties and towards the Parliament Hill properties; this is irrelevant to the proposed basement. Other cracking in the boundary walls appeared to be associated with normal seasonal shrinkage/swelling of the clays beneath the foundations to these walls.

Photograph Two: Garden wall of number 37 South Hill Park showing large crack and leaning towards Parliament Hill gardens

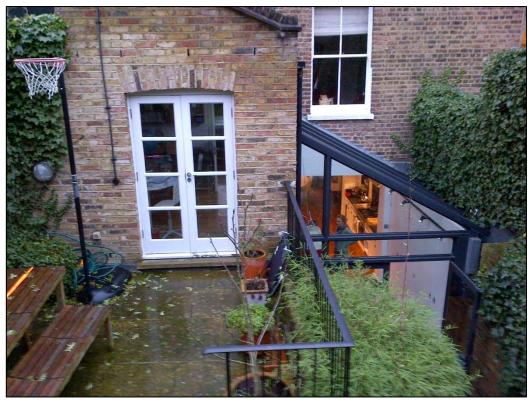
Photograph Three: Rear garden in No. 33, showing the variable ground levels.

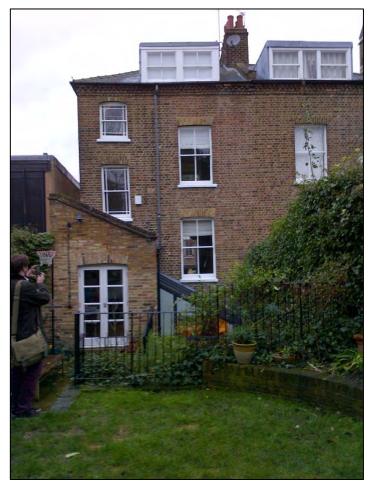
Photograph Four: Rear view of No. 33, showing the large height difference with No. 31 South Hill Park (to left).

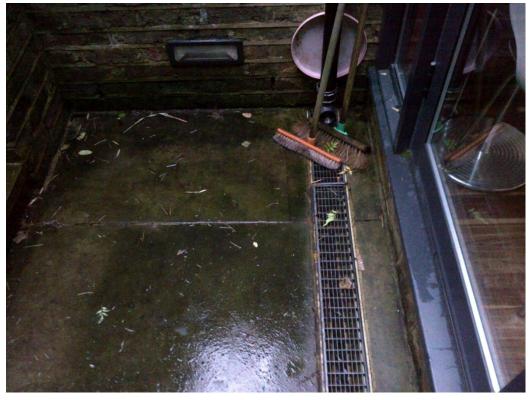
Photograph Five: Channel drain in rear garden patio area.
