**STRUCTURAL FEASIBILITY ASSESSMENT OF
PROPOSED INTERNAL ALTERATIONS,
TO 46, 47/47A BEDFORD ROW
LONDON WC1**

Client: MPG Holborn LP
Cavendish House,
18 Cavendish Square,
London
W1G 0PJ

Date: February 2014

Ref: JC/REP/15221~frep REV3

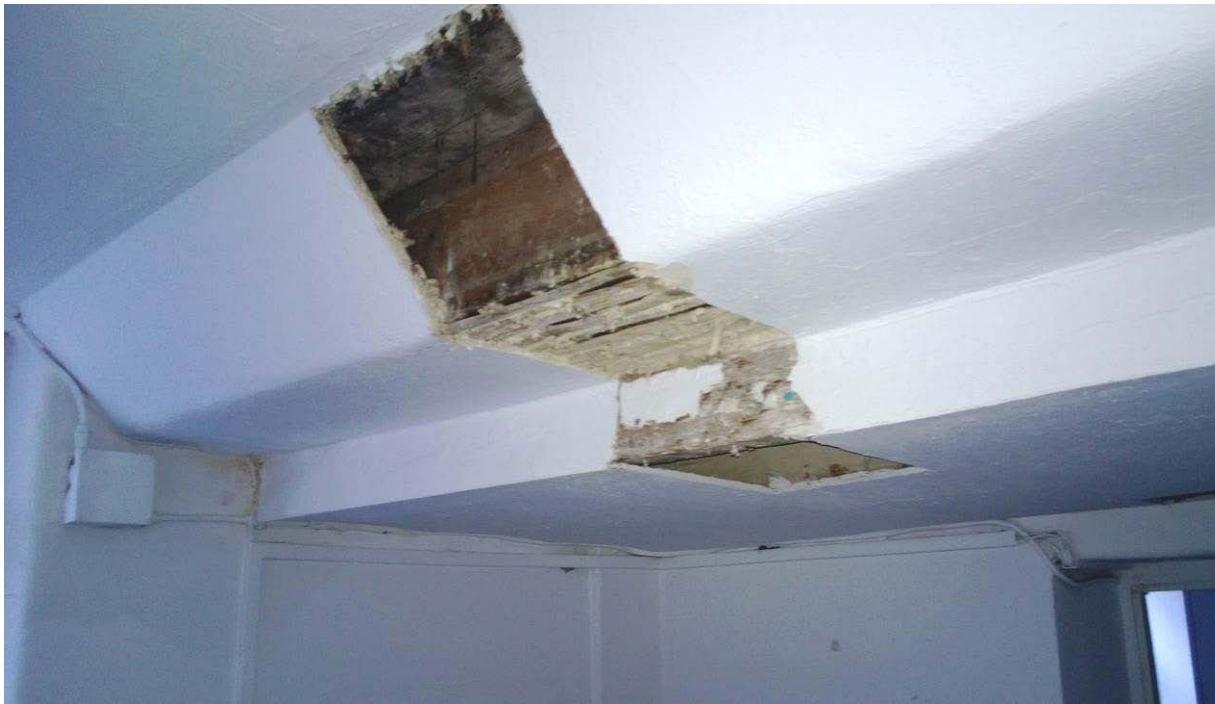
- 3.1.1 Removal of the suspended ceiling in this area to No. 46 does not present any structural implications. It is also proposed to remove the door jamb in this area; it is assumed the lintel over is supported on the adjacent load bearing wall and this will not be an issue.

Photograph 1: Suspended ceiling near stair to basement of No. 46 (see 3.1.1 within report).

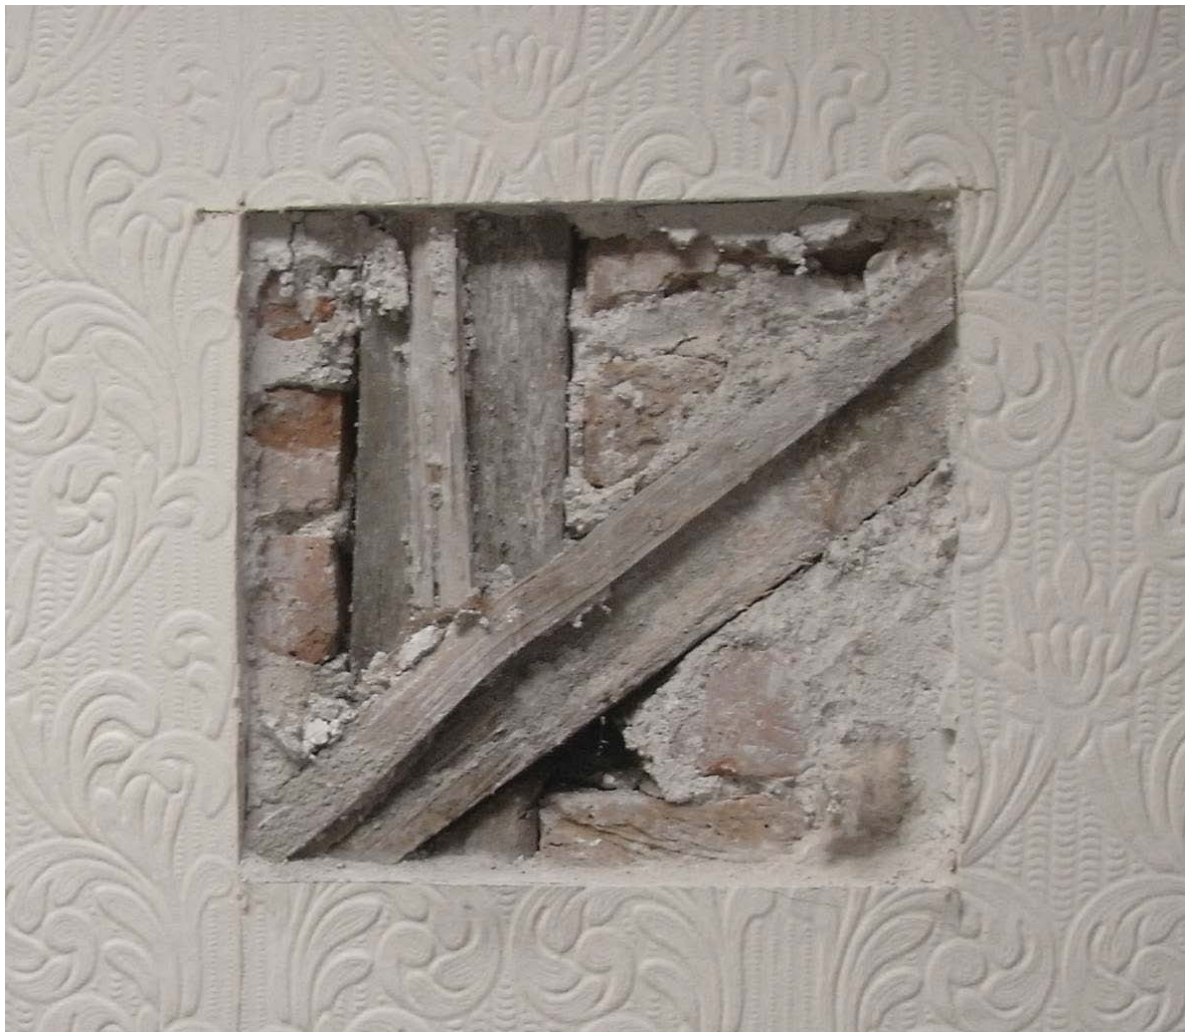
- 3.2 Ground Floor
- 3.2.1 This wall is timber studwork with masonry infill; this varies from the other forms of construction in the house which are generally timber partitions with masonry load bearing walls. The masonry may have been added to this timber framed wall for fire resistance or sound proofing when the building was converted to flats. The wall appears to be non-loadbearing, prior to removal of the wall we will require further opening up at first floor to confirm the first floor is not supported on this wall.

Photograph 2: Masonry infill to timber framed wall, entrance hallway to Ground Floor of No. 46 (see 3.2.1 within report).

- 4.4.1 Prior to removal of the timber and masonry wall in the entrance lobby of No. 46, the floor above should be opened up and inspected (see 3.2.1).

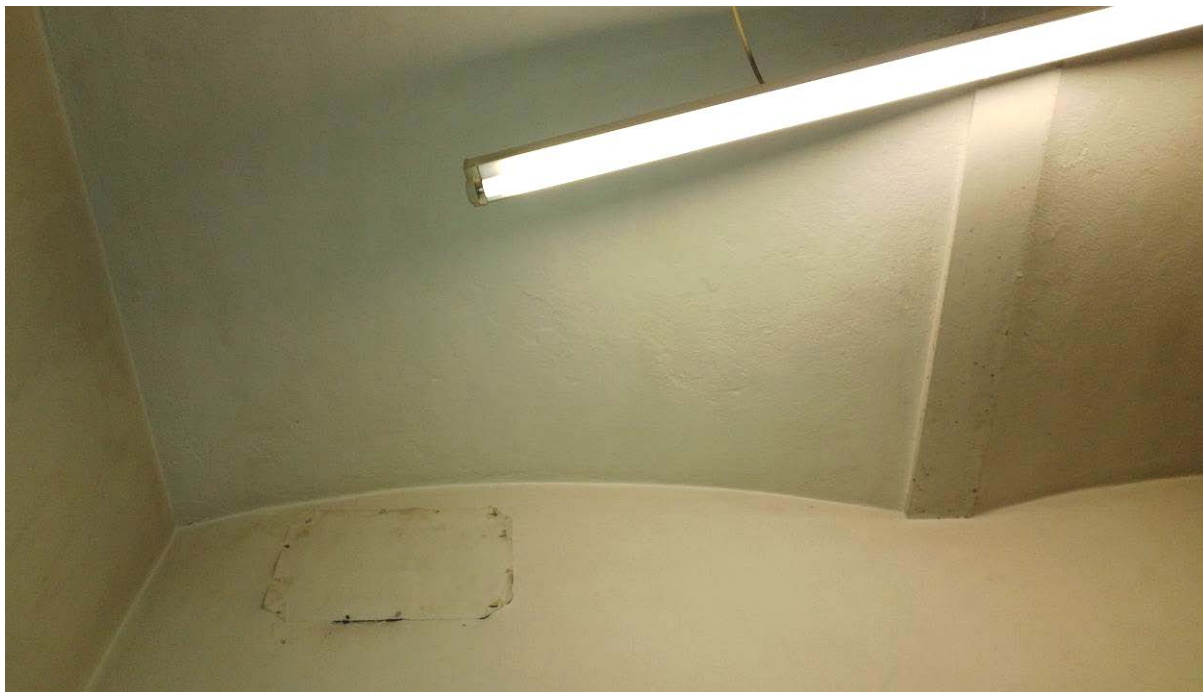
- 3.2.2 The wall to be removed at this location supports a brick vault over the adjacent room. A new steel section 152UC30 will have sufficient capacity to withstand both the vertical and horizontal loading from the vault. This new steel will form a downstand below the ceiling. New padstones will be required within the existing masonry walls.

Photograph 3: Vaulted ceiling to ground floor of No 46 (see 3.2.2 within report).

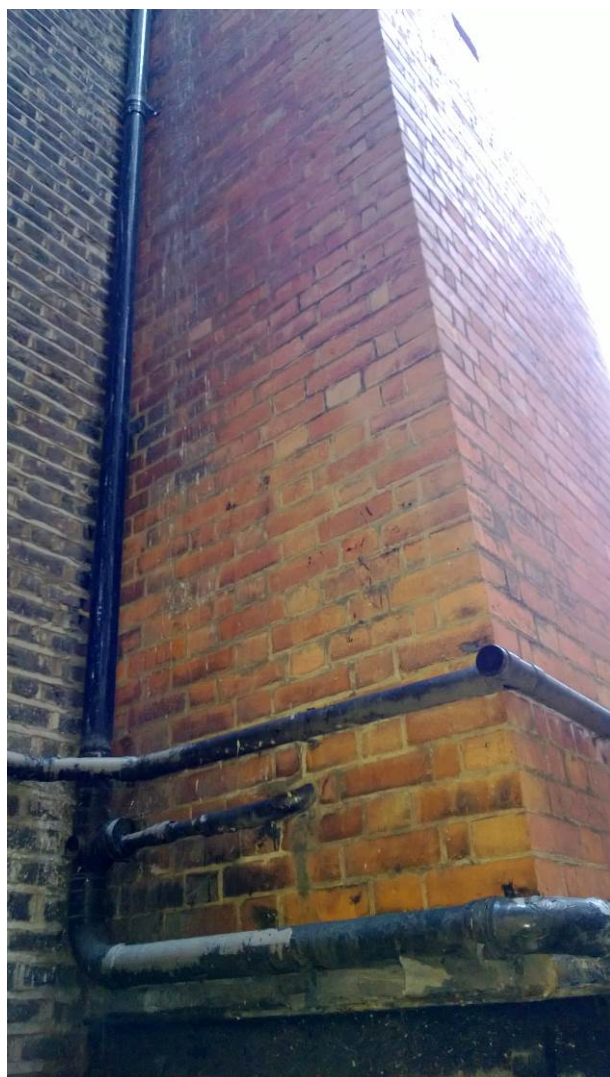
- 3.6.1 This brick side extension to the rear of No. 46 is independent of the main structure, and was constructed as a later addition. It is supported on steel beams onto the masonry walls of the single story building within the courtyard. Removal of the addition will not affect the stability of the main building.
- 3.6.2 Prior to construction of any temporary works to access the brick extension for demolition, the steel supporting the masonry must be inspected as the steel beams are exposed and vulnerable to corrosion.
- 3.6.3 As with 3.6.1, this rear extension to 47A is a later addition to the rear of the property. Appropriate demolition procedure should be carried out for its removal, but overall its removal does not present any structural implications for the main structure.

Photograph 4: Side extension to rear of property (see 3.6.1 within report).

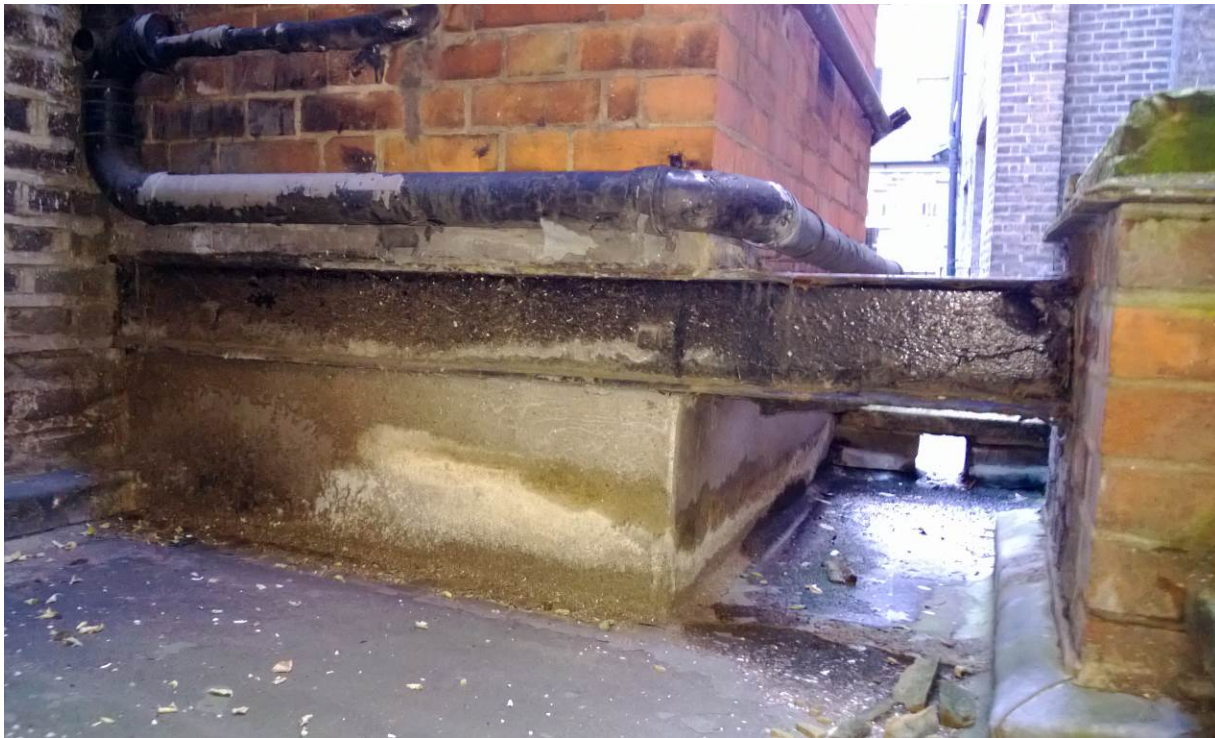
Photograph 5: Steel beam supporting side extension (see 3.6.1 within report).

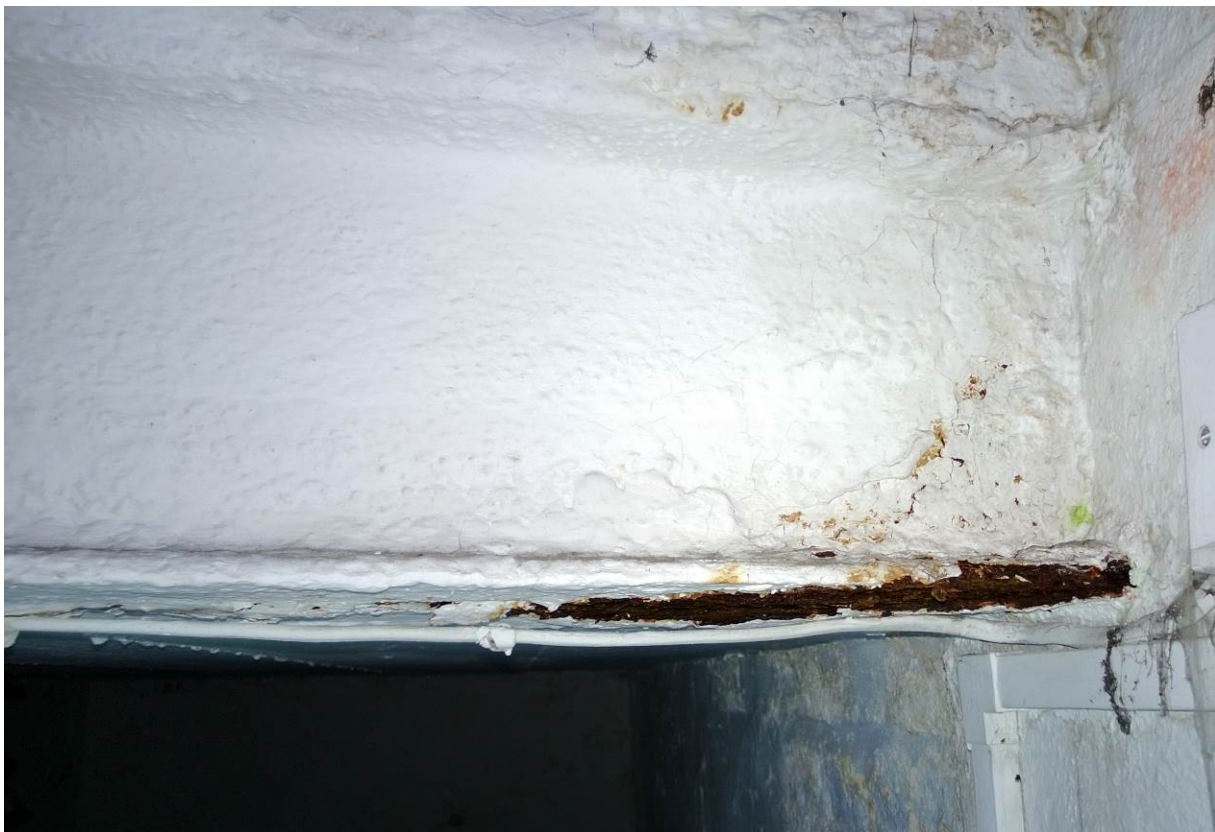
- 2.7 One area of concern we would like to highlight is a corroded steel beam to the rear of 47A which requires replacement. This will be discussed below.

- 3.1.6 Within an existing covered lightwell to the rear of the basement an existing steel is severely corroded at the end embedded in the external masonry wall. This beam requires replacement, a new steel, 152UC23 will support the ground floor single story masonry wall above. The new beam is to be galvanised and painted for additional corrosion protection.

Photograph 6: Corroded external steel beam to rear of No. 47 (see 3.1.6 within report).
