THE ELMS, FITZROY PARK, HIGHGATE, LONDON, N.6.

A SUPPLEMENTARY REPORT ON THE SCOPE TO RECOVER AND REINSTATE DISPLACED WINDOW-JOINERY TO BE READ IN CONJUNCTION WITH THE REPORT OF AUGUST, 2013, PROVIDING ASSESSMENTS OF THE POTENTIAL EFFECTS OF THE WORKS DESCRIBED IN THE ENFORCEMENT NOTICE PROPOSED FOR RETENTION AND THE POTENTIAL EFFECTS OF THE FURTHER PROPOSED WORKS ON THE PARTICULAR ARCHITECTURAL AND HISTORIC INTEREST AND SIGNIFICANCE OF THE PROPERTY, SUBMITTED IN SUPPORT OF APPLICATIONS FOR LISTED BUILDING CONSENT AND PLANNING PERMISSION

FEBRUARY, 2014

PAUL VELLUET – CONSERVATION, DEVELOPMENT AND PLANNING

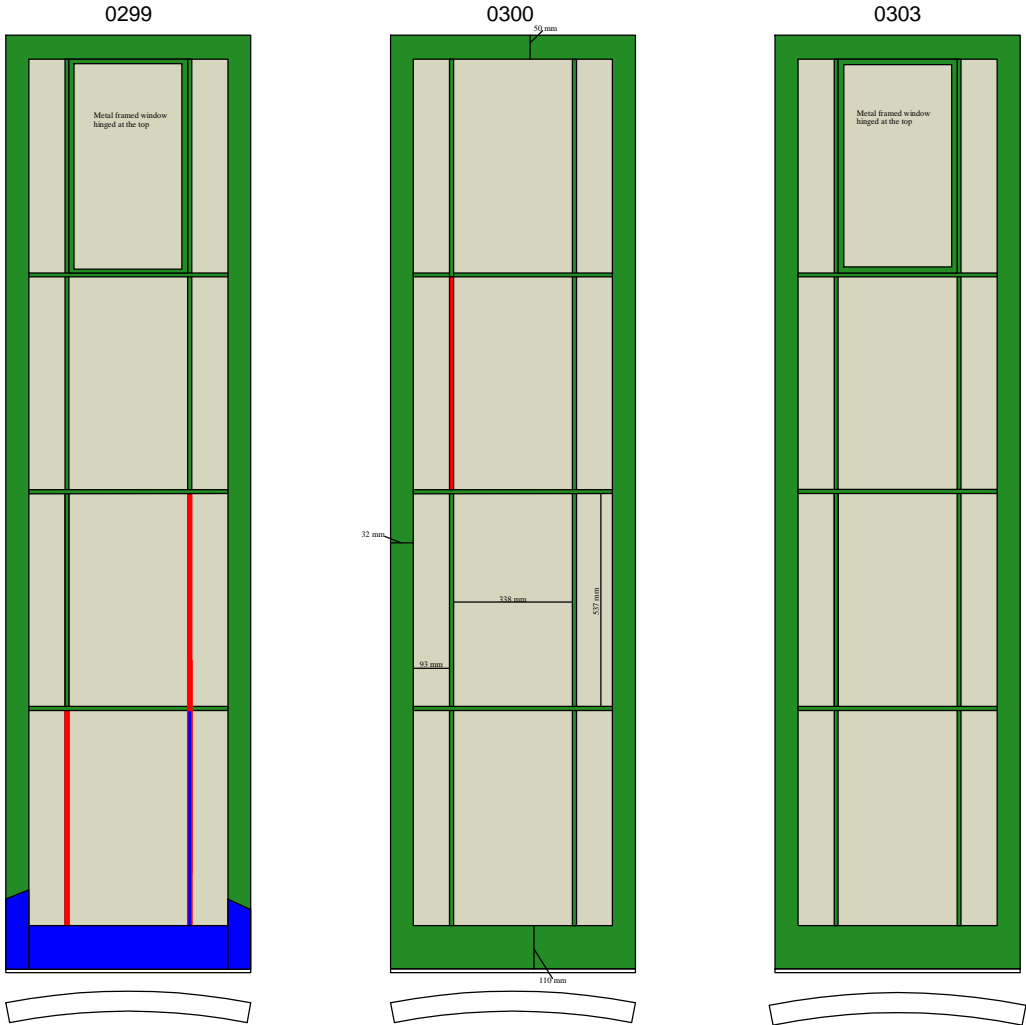
IW/G.5 - Library

These doors have the most exquisite glazing mouldings. They appear to match those on windows EW/G.18, 16, and 19. Interesting that all these are in the same area of the original house. An attempt has been made to strip these glazed doors resulting in damage to the glazing bars, many of which will require repair or replacement

0300 is a door. Also extant are two of the mullions, one from an outside edge and the other from the hinge side of 0300.

The sill is in two parts and both are extant though would require some work to make them servicable.

Window IW/G.5: Insufficient displaced elements of the frames survive to justify reassembling and reinstalling the frames. Recommend the retention of the existing frames in situ, the setting aside of the existing casements and the repair of the three, surviving displaced casements and their reinstallation in place of the existing casements.

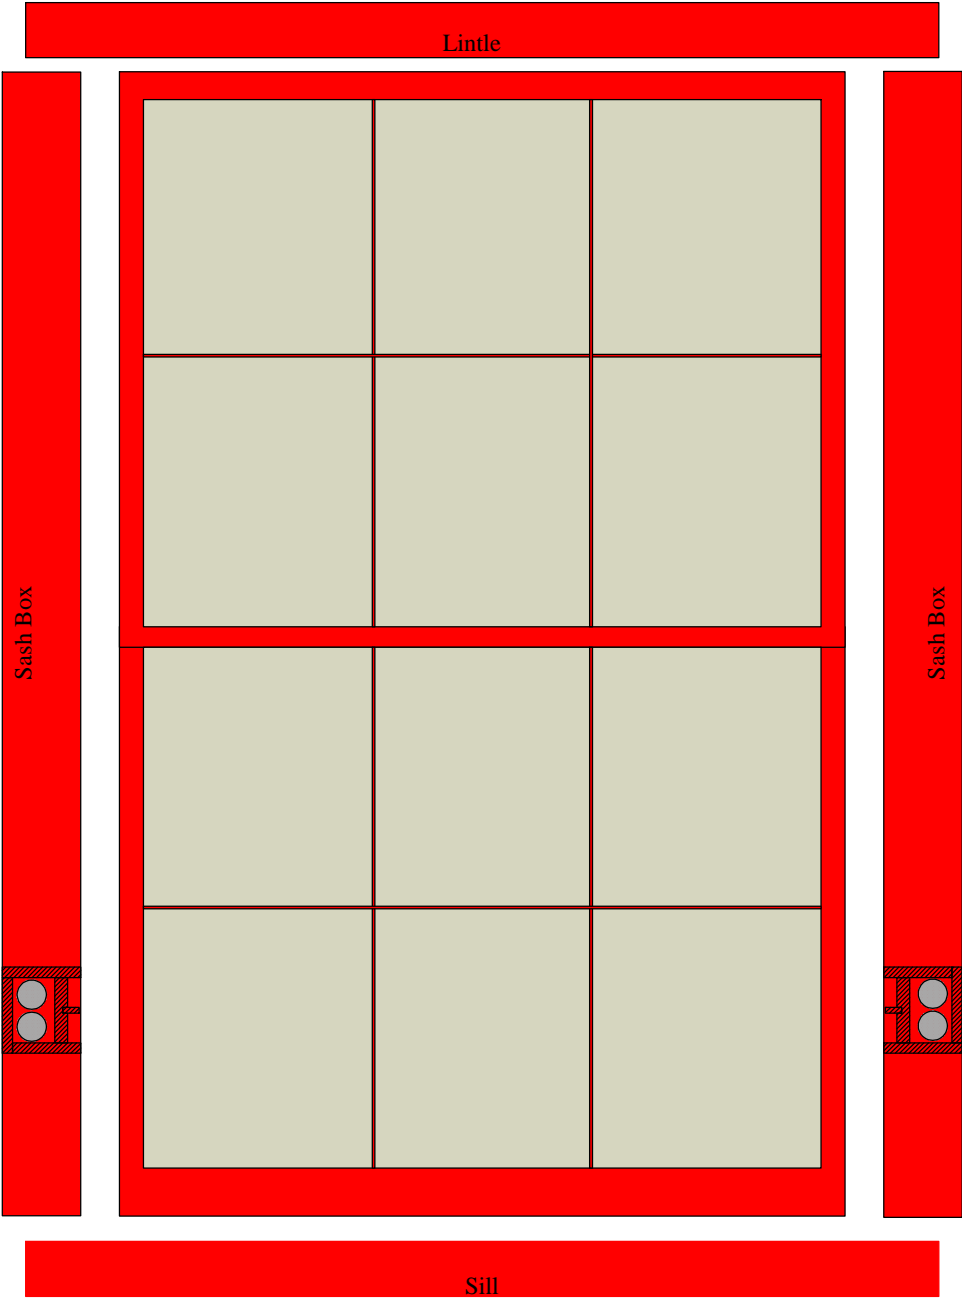
EW/F.11 (O'Shea Window 1)

This window is one of five of identical dimensions.
As this window is on the north elevation of the building it has no sunshade.

Window EW/F.11: No displaced window-joinery survives. Recommend the retention of the existing window-joinery in situ.

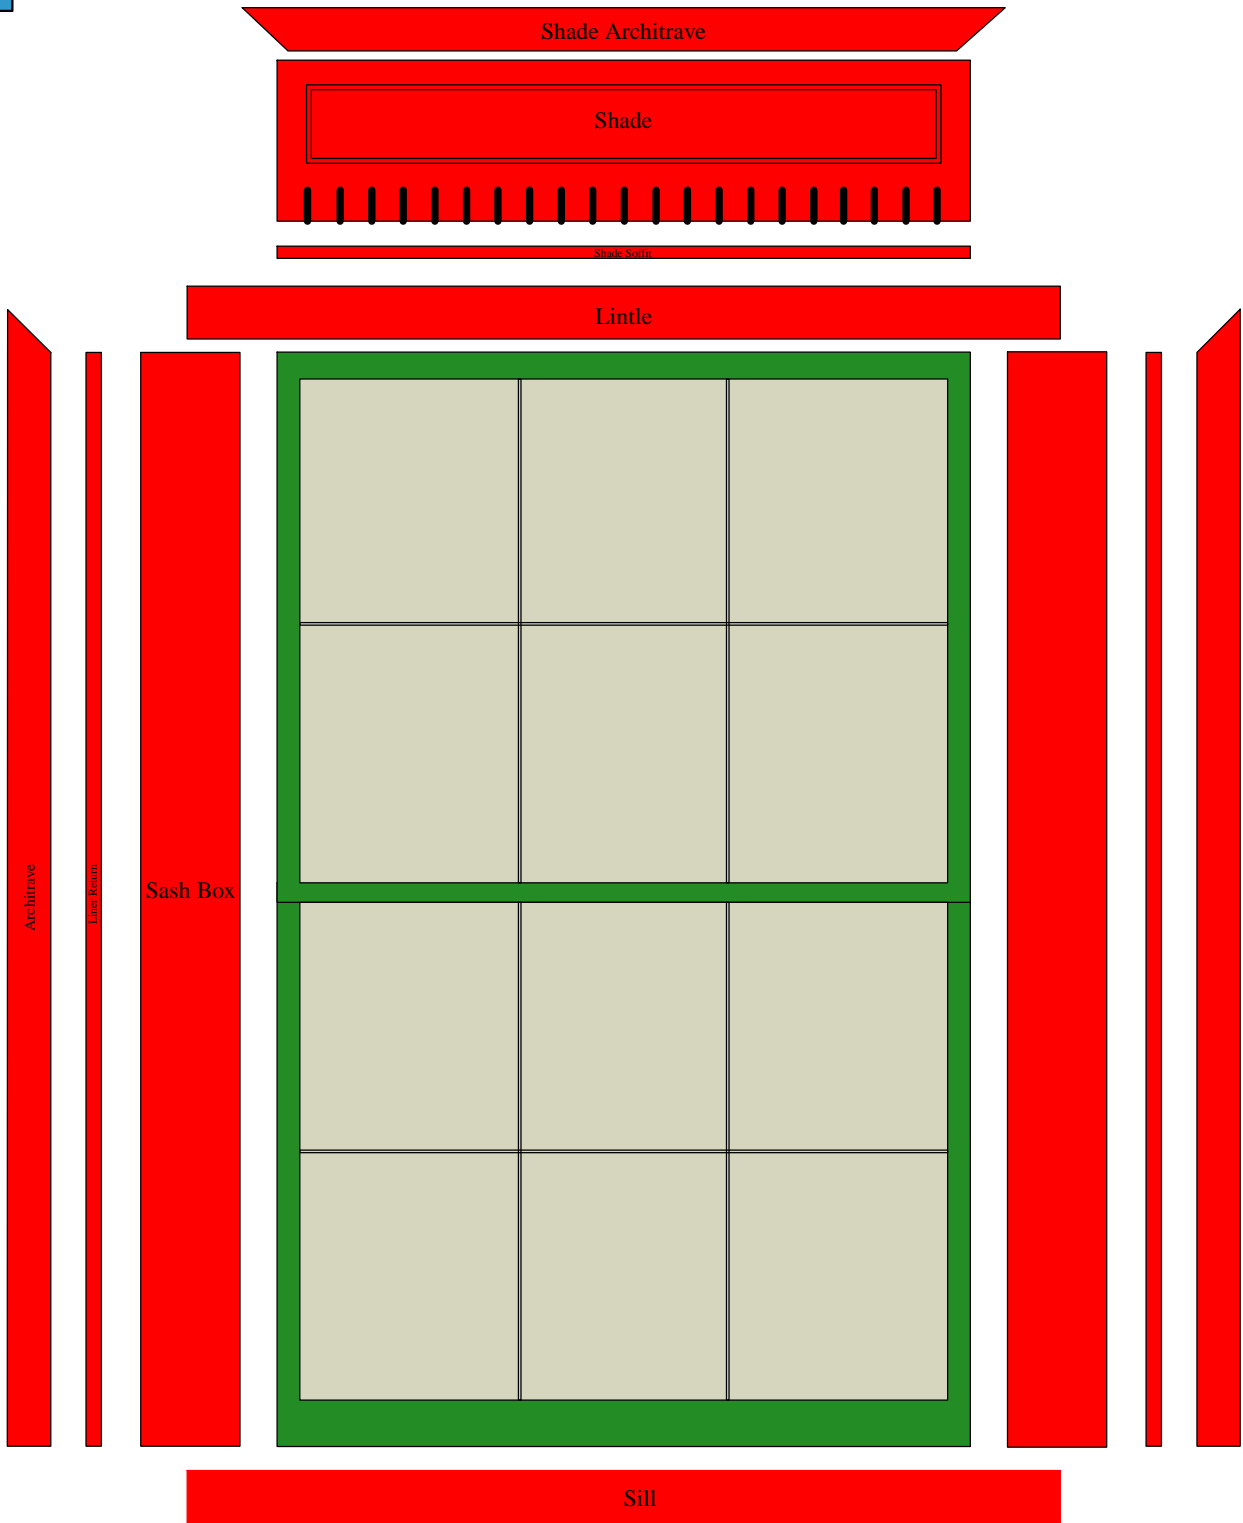
EW/F.13 (O'Shea Window 3)

It is likely that many of the joints will have to be replaced during the restoration process

Window EW/F.13: No displaced elements of the frame survive. Recommend the retention of the existing frame in situ and the exploration of the potential for adapting and repairing the two, surviving sashes and/or the existing frame, to accommodate the sashes; replacing the existing sashes, and the reinstatement of the awning-box to appropriate traditional detail.

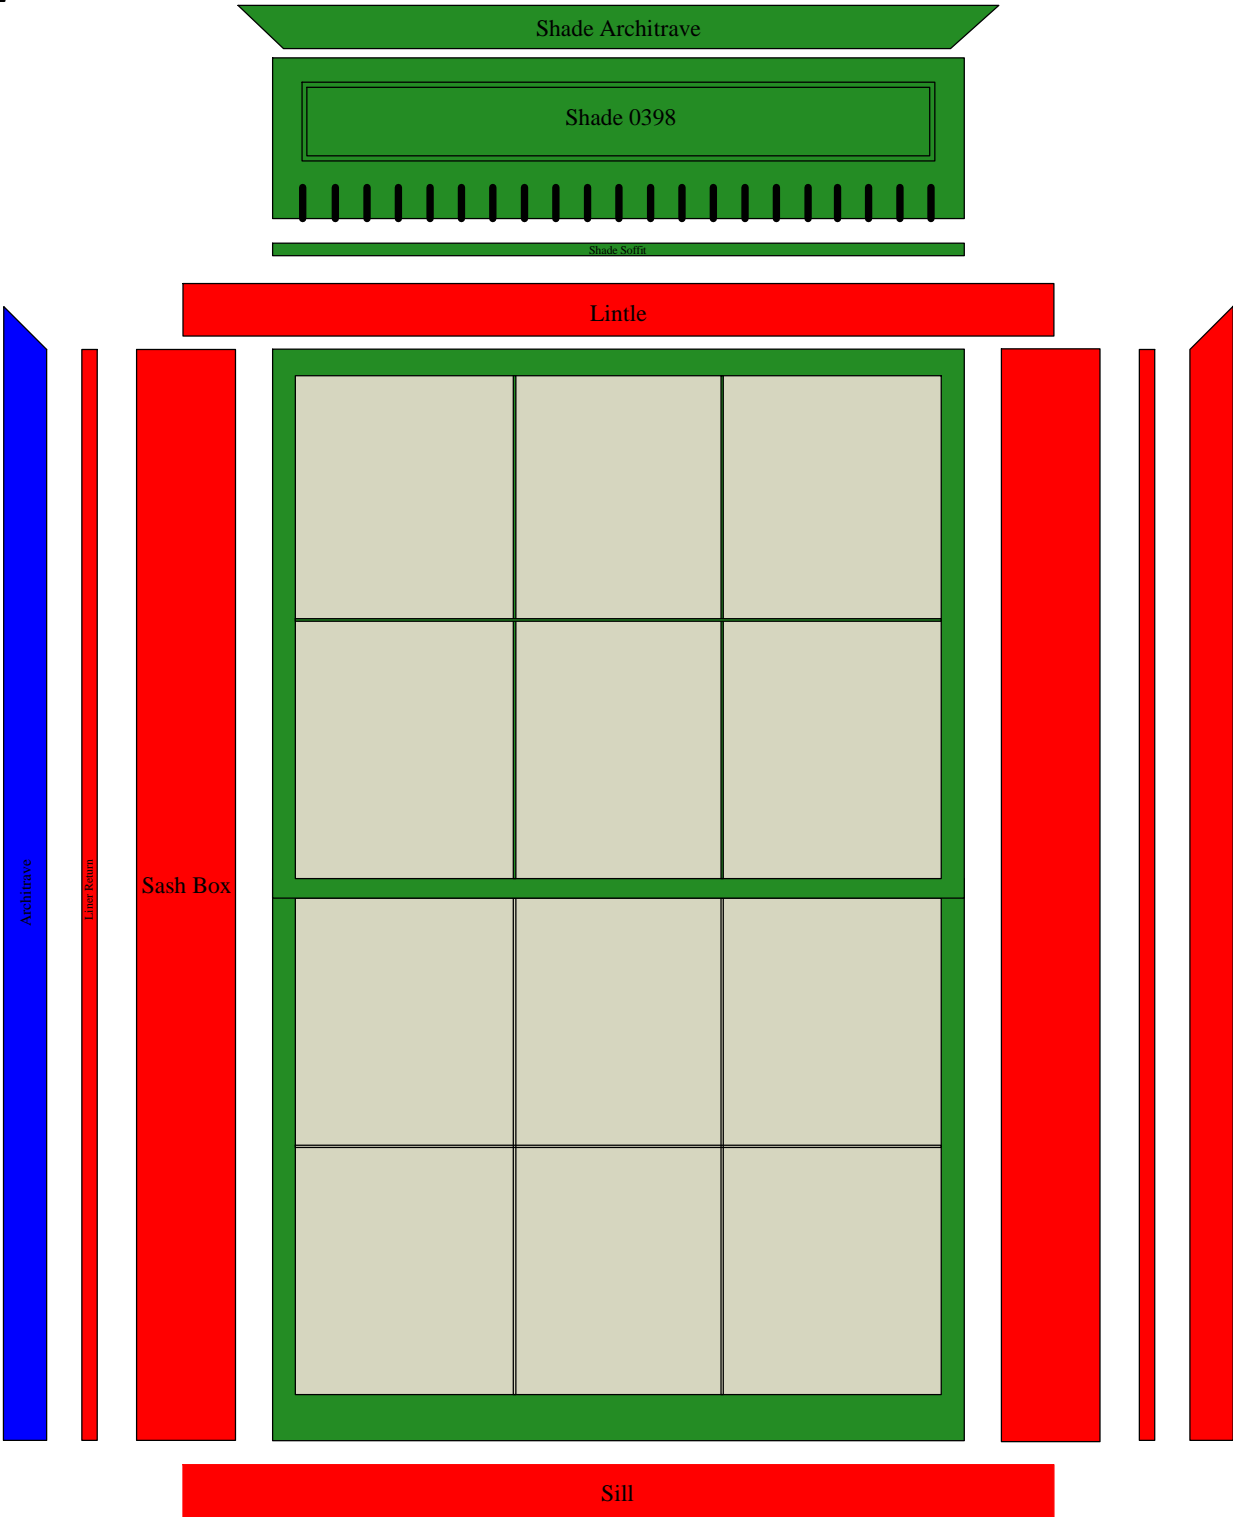
EW/F.15 (O'Shea Window 5)

It is likely that many of the joints will have to be replaced during the restoration process

Window EW/F.15: Insufficient displaced elements of the frame survive and in repairable condition to justify their reassembly and reinstallation. Recommend the retention of the existing frame in situ and the exploration of the potential

for adapting and repairing the two, surviving sashes and/or the existing frame, to accommodate the sashes; replacing the existing sashes, and the repair of the awning-box.

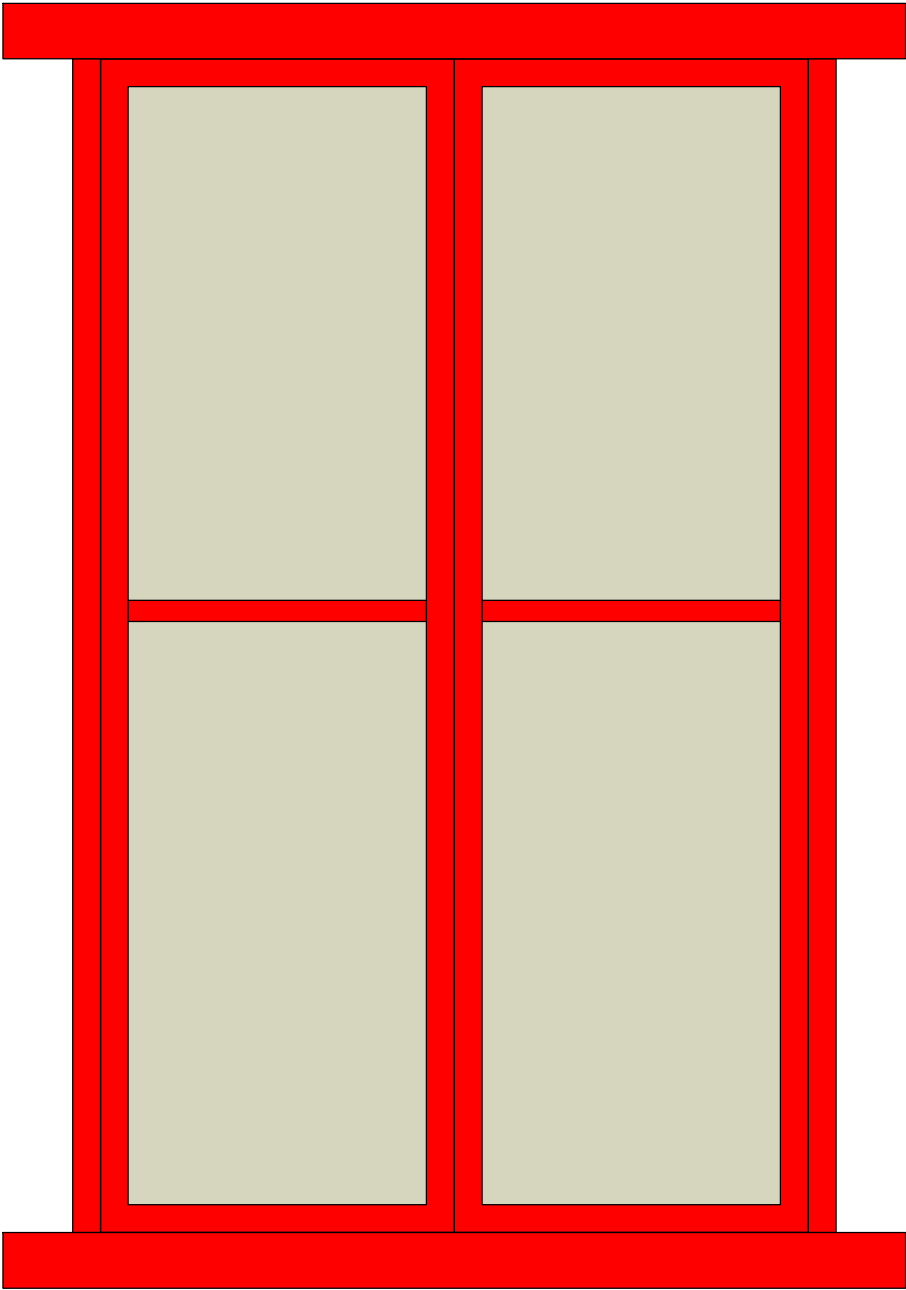
EW/F.17 (O'Shea Window 7)

When scaling this window should be the same height as windows 1, 2, 3, 4, 5, 6, and 8, and the same width as window 12 directly beneath.

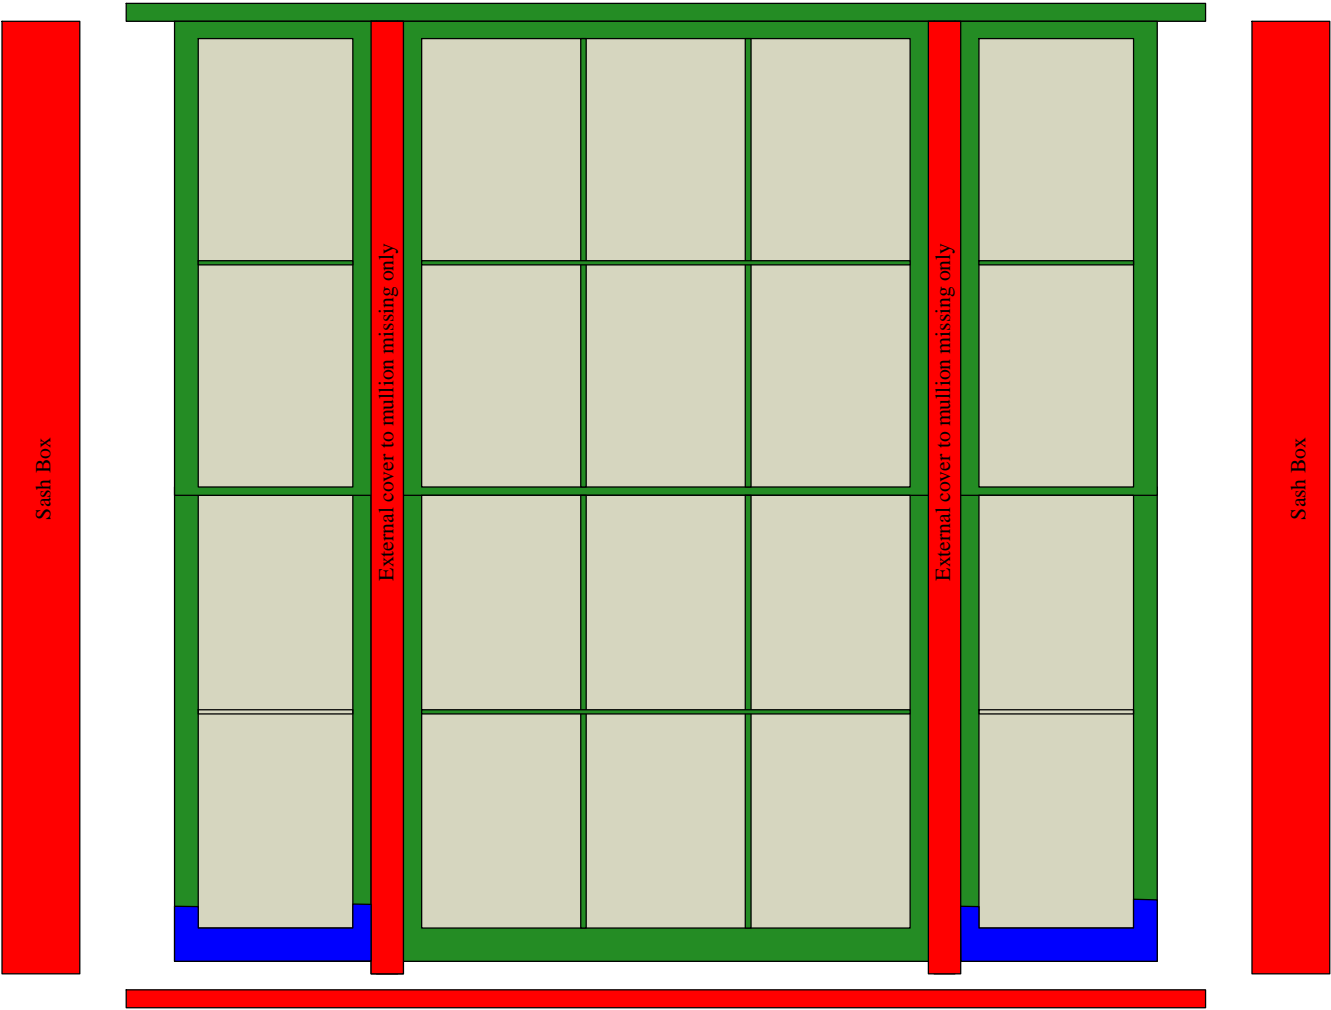
EW/F.18 (O'Shea Window 8)

This window appears to be a replacement, the paint layers are thinner than elsewhere and the timber is in better condition for no reason. There is no sunshade.

Window EW/F.18: Surviving displaced modern, poorly detailed sashes of no architectural or historic interest and do not contribute to the special interest or significance of the property. Insufficient of the frame survives to justify reassembling and reinstalling the frame. Recommend the retention of the existing window-joinery in situ.

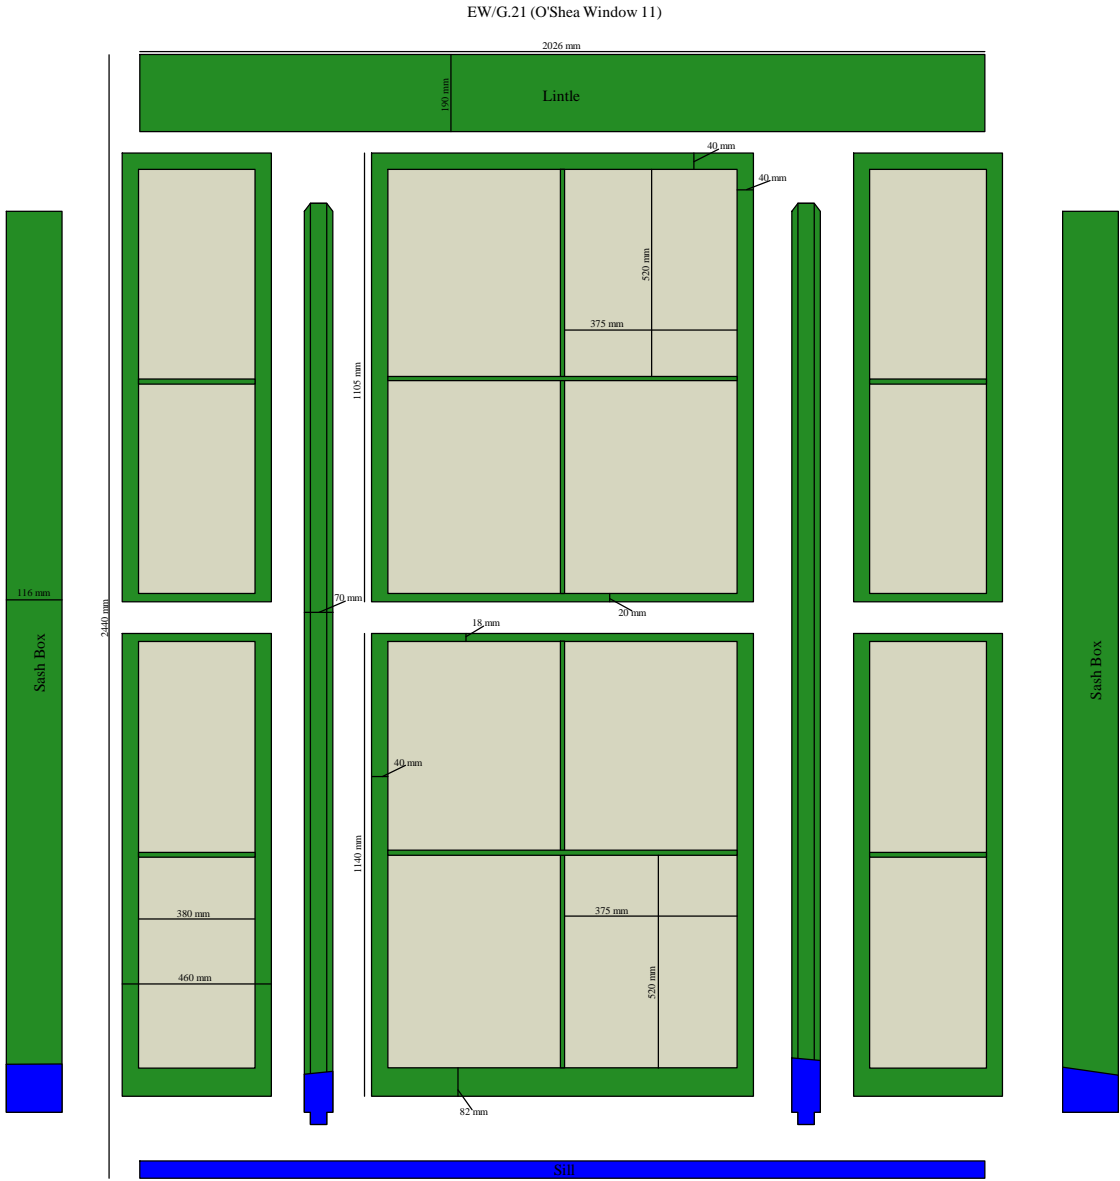
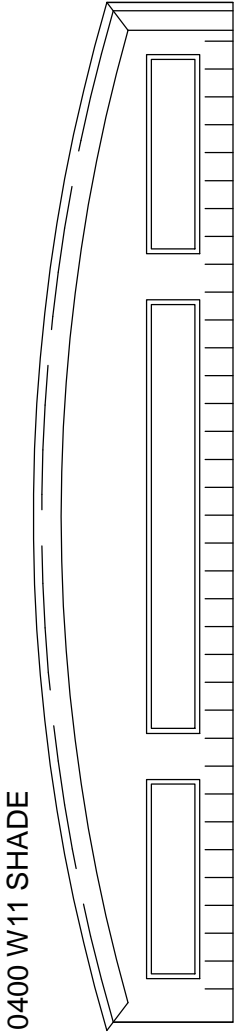
The shade to EW/G.21 exists but is in bad condition and will require substantial repair and replacement.

Window EW/G.21: Displaced window-joinery survives. Recommend the repair and reinstallation of the frame and the six sashes, replacing the existing window joinery, and reinstating the awning-box, which is beyond reasonable repair, to appropriate traditional detail.

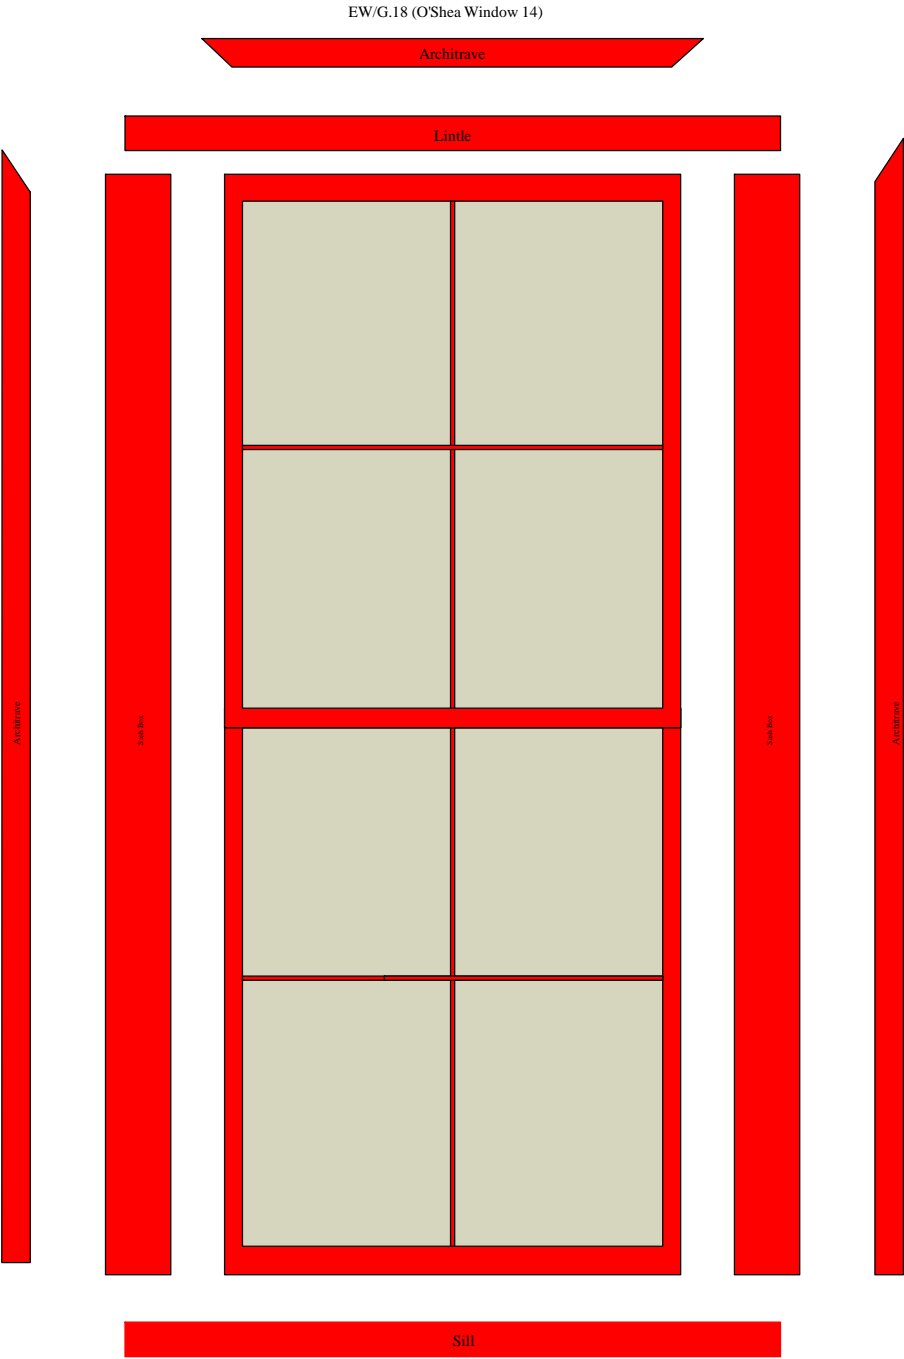
Glazing bars are the same profile as the Library doors.

Window EW/G.18: No elements of the displaced window-joinery survive. Recommend the retention of the existing window-joinery in situ.
