Arboricultural and Planning Integration Report: 10 Laurier Road, London, NW5 1SG

Ref: ASH/AIA/PW/6025:13

Arboricultural Report

Location: 10 Laurier Road, London, NW5 1SG
Ref: ASH/AIA/PW/6025:13
Client: Wilkinson King Architects
Date: 25th June 2013
Date of Inspection: Friday 14th June 2013
Prepared by: Philip Wood BSc(Hons)LAM.

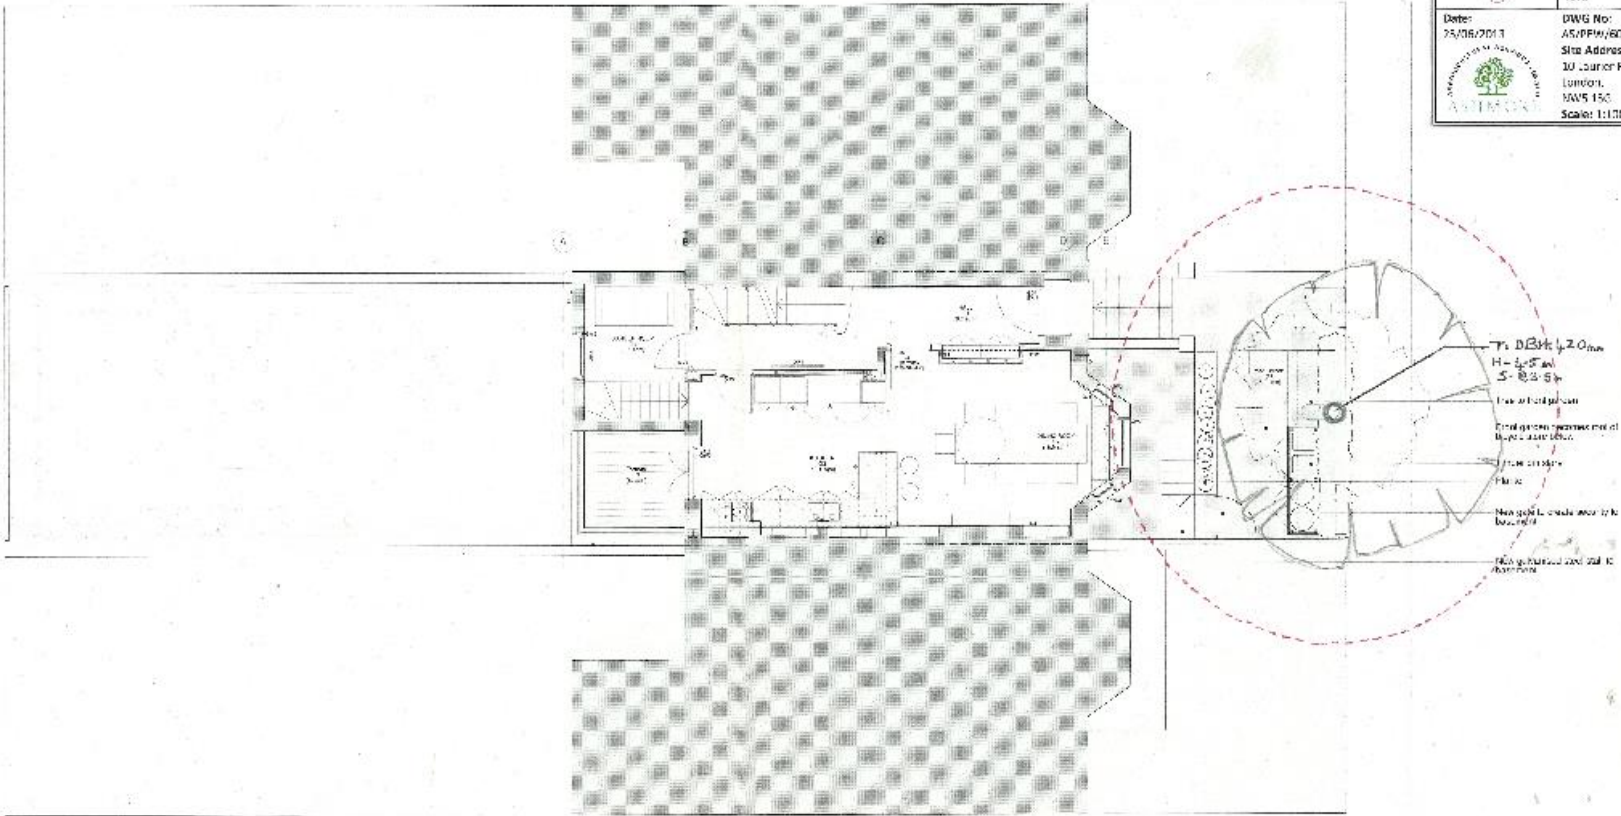
Tree Survey Site Plan

- 6.12 The RPA of the tree (shown with red dotted line) has been illustrated on the Tree Survey Plan in Appendix A and it can be seen that there is a large incursion into the RPA of T1, though the tree is recommended for removal regardless of the development. This incursion is considered acceptable due to the need for the tree to be removed and planning approval should not be withheld on tree grounds.
