CAMDEN STABLES MARKET

TACK ROOM BUILDING

STRUCTURAL APPRAISAL

Rev: 1
Date: 15/01/2015
Project No: 3788
Ref: P:\Projects\3788\Documents\Reports\3788-pm-rpt-0115ksa.doc

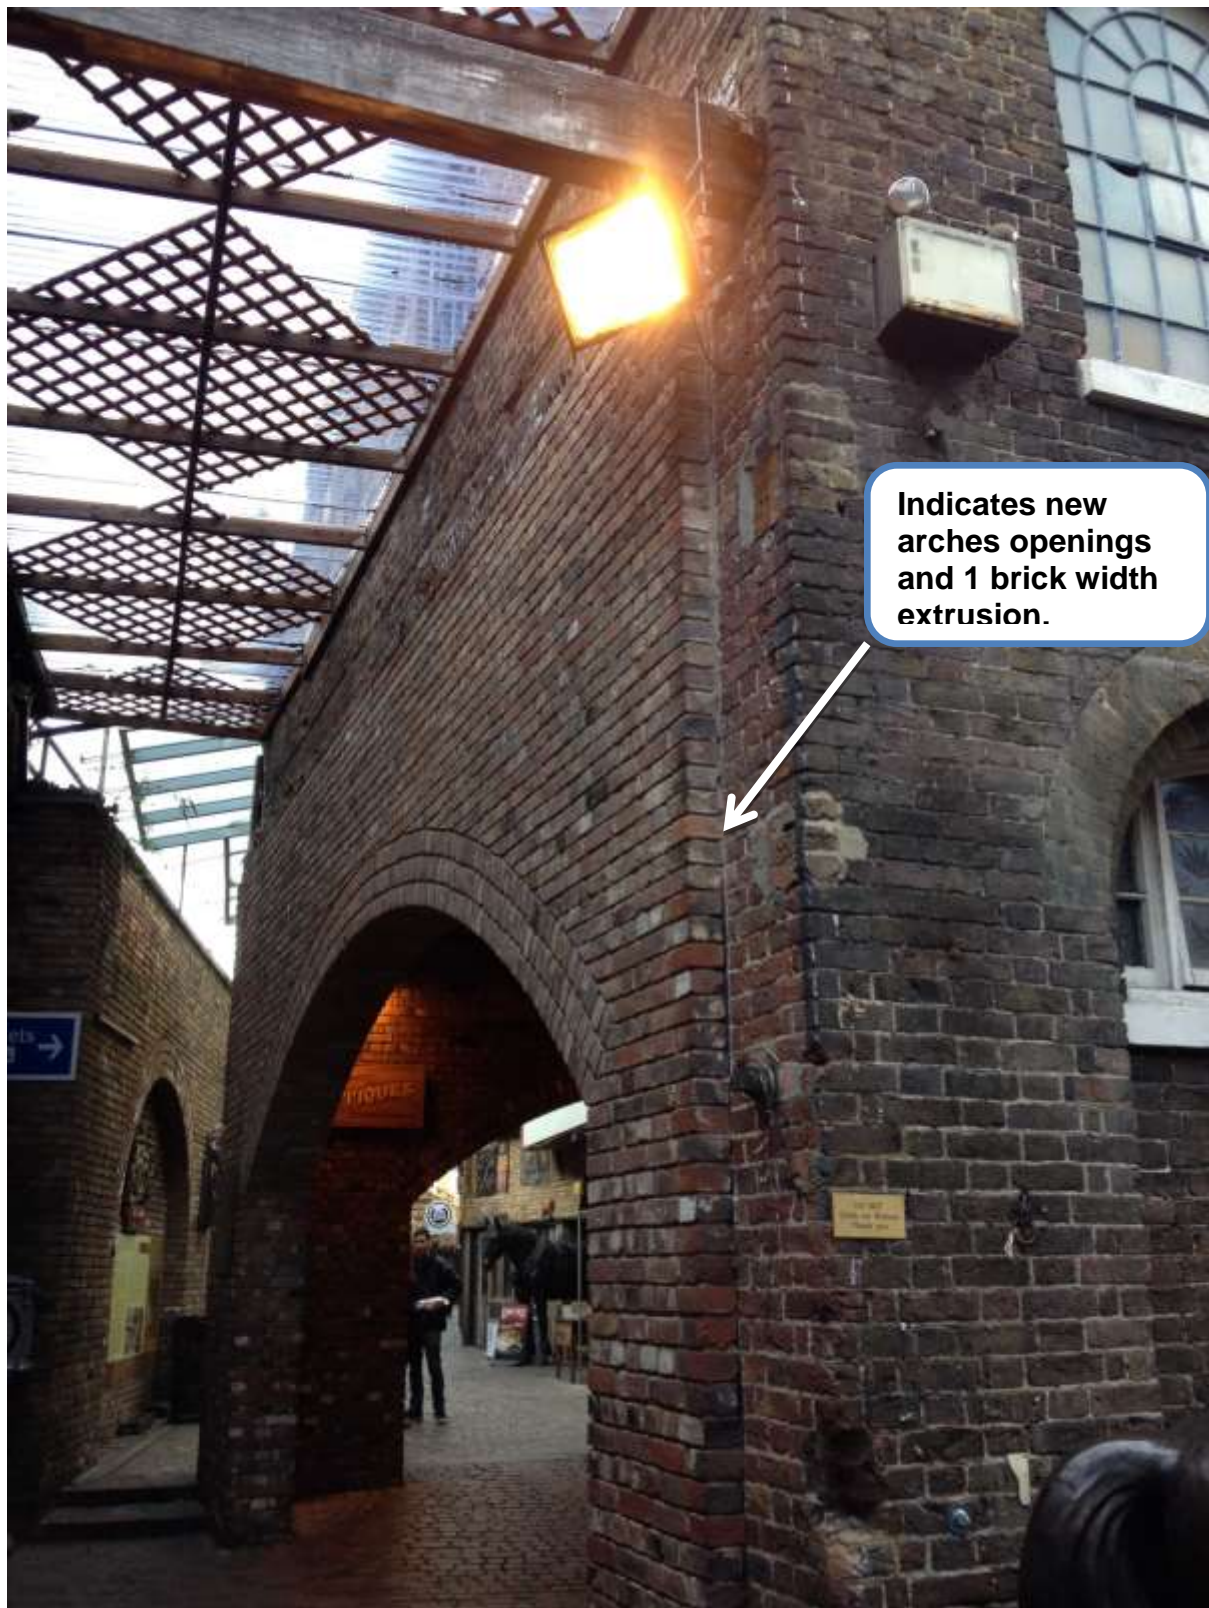
Fig 1

The most recent and visible involved the creation of two large arched openings in the Southern and Western Elevations. **Fig 1** The arches are believed to be structural and supporting the existing section of the wall above, and are approximately 1 brick wider on the outer face.

The proposed works consist of replacing the ground floor south and west elevations which are currently brick arches, and repairing the upper levels of both elevations. The design consists of reinstating the traditional brickwork openings as outlined by Stephen Lavarant Heritage Architecture Ltd drawings, and Walsh drawings 3788-01-P2.

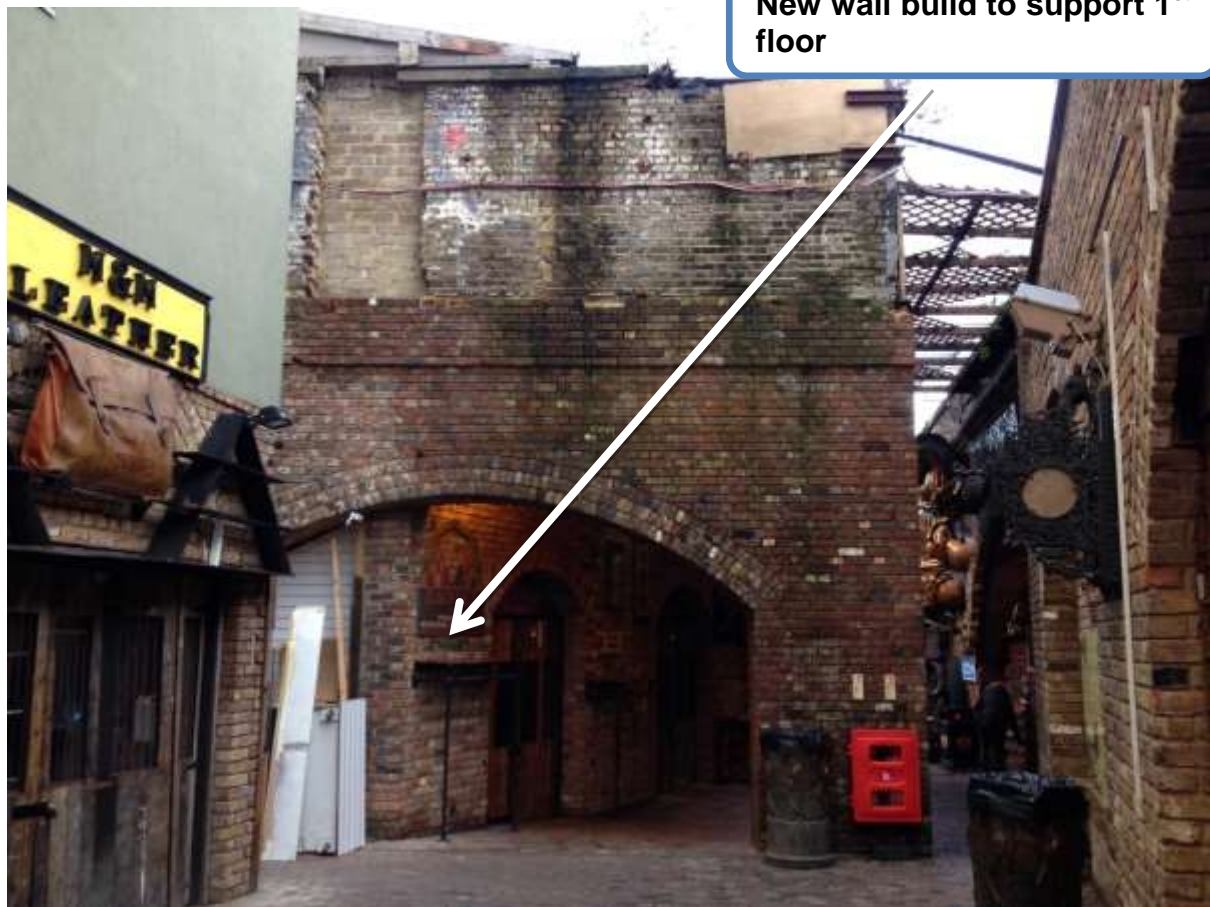
Fig 2

This has been achieved by constructing a new load bearing wall at a slight angle to support the existing 1st floor slab, and resulted in the removal of one of the existing cast iron columns further to the west. **Fig 2**

The building is in generally fair condition, apart from South-western corner of the building. **Fig 2** demonstrates the existing condition of the various masonry walls.

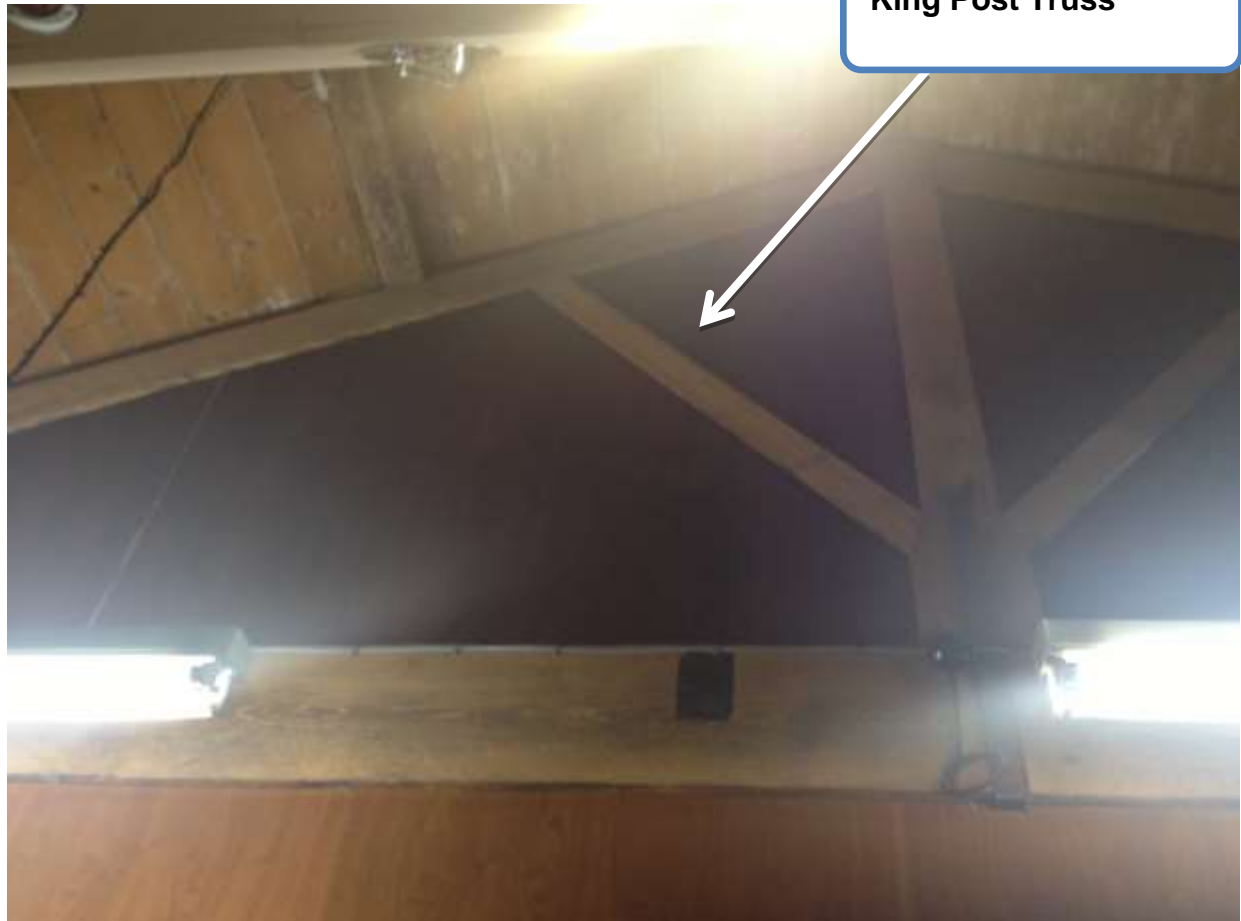
Fig 3

Roof: The roof is believed to be of traditional King Post Truss construction, supporting timber rafters that in turn support a slate roof. **(Fig 3)**

King Post Truss

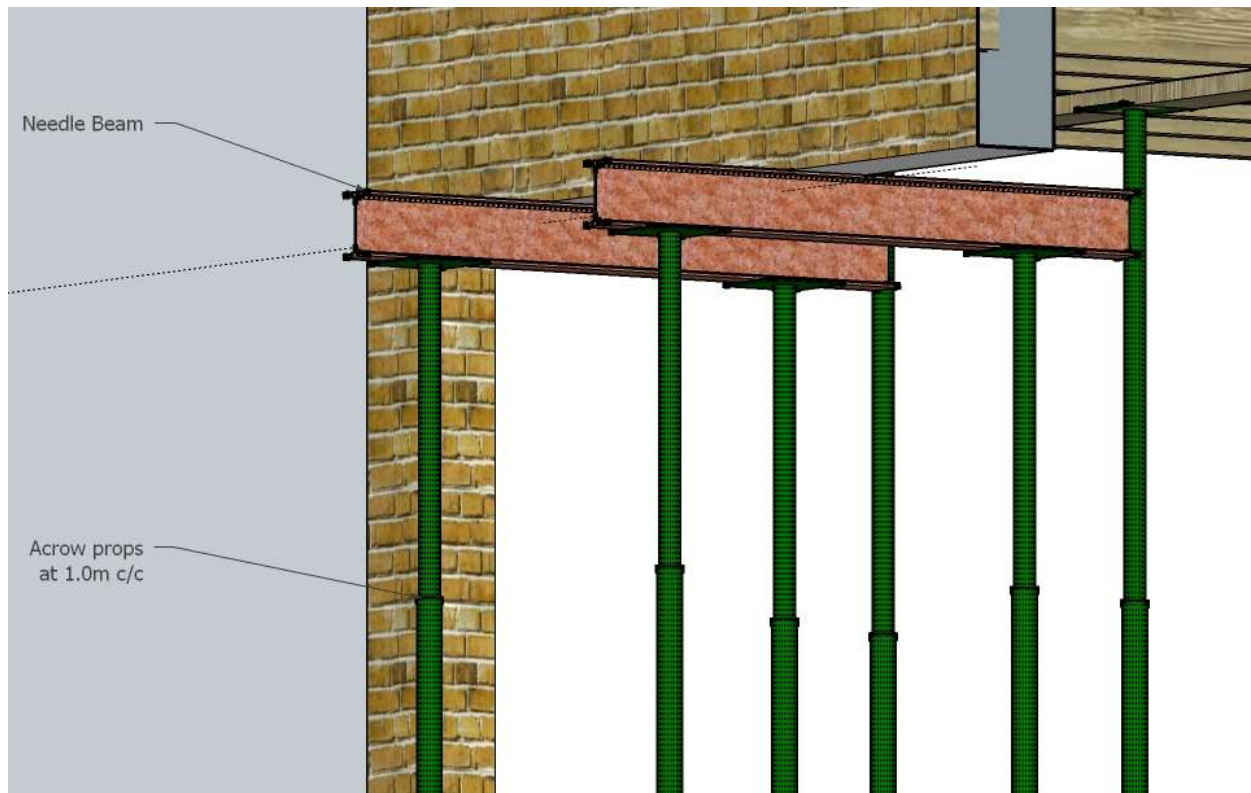
Fig 4

Proposed Wall Needles

3. Make temp opening in wall at approximately 900mm spacing to allow needle beams to pass through at upper section.
4. Install props and needle beams at above spacing and dry pack into place **Fig 4.**
