Ref: 1343

10th September 2013

Re. Spread Eagle, 141 Albert Street, London, NW1 7NB.

Further to our recent visit on 31st July 2013 to the above property, we write to outline our findings in respect of the cracking to the front elevation and the use of part of the first floor as a function room for customers use.

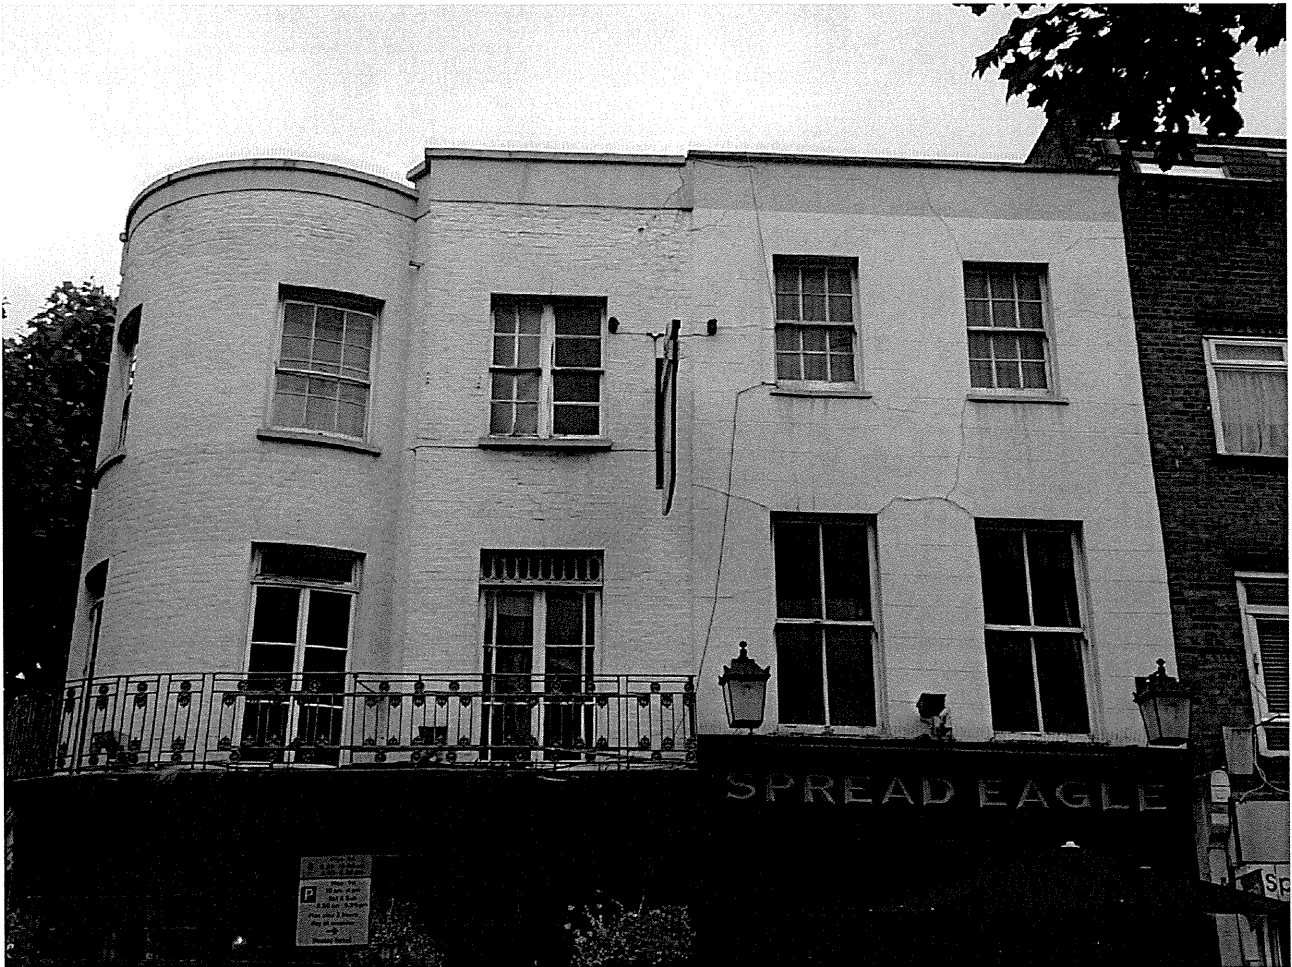
Photograph 1 – Parkway Elevation

From our inspection it could be seen that numerous cracks were observed to the Parkway Elevation. These cracks appear to be in the region of 1 to 3m wide and are all located at the heads and cills of the windows to this elevation. Further cracking was observed approximately 1 to 3mm to the parapet wall which conceals the roof behind.

All the cracking to the external Parkway elevation are dirty in colour and show no signs of fresh cracking or movement. We have observed these cracks in the past during previous visits and they appear to be similar in nature and therefore historic.

Therefore we would recommend that a program of repair works and redecorations be carried out during the next project in order to preserve the existing wall, to repair the cracking and prevent any possible ingress of water into the cracks.

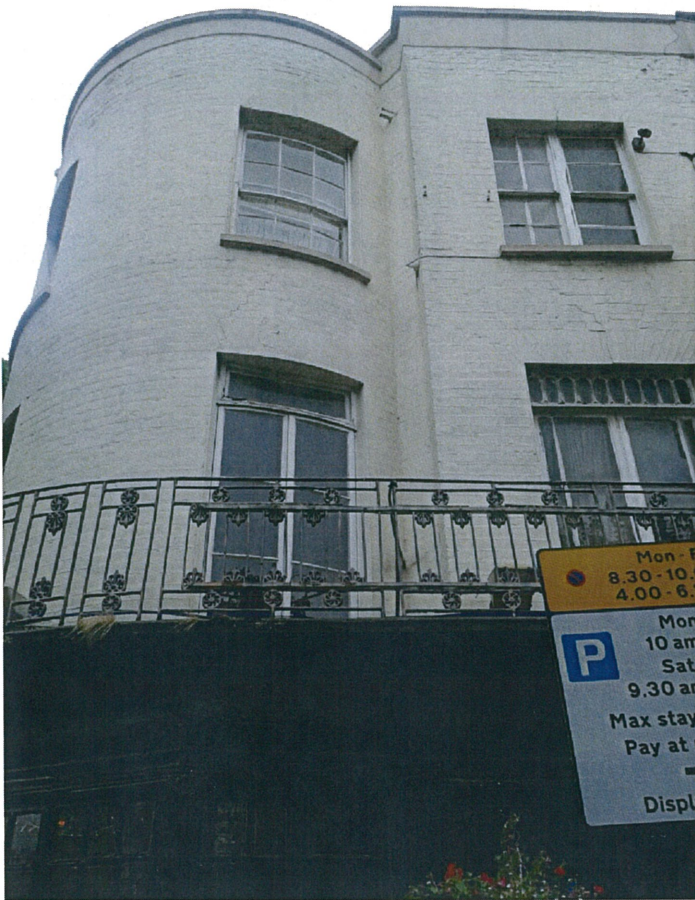
Photograph 2 – Left side Parkway Elevation

The second window from the left at first floor has a vertical crack rising from the centre of the slider course arch up to the window above. At the crack location the arch appears to have dropped slightly to the left hand side.

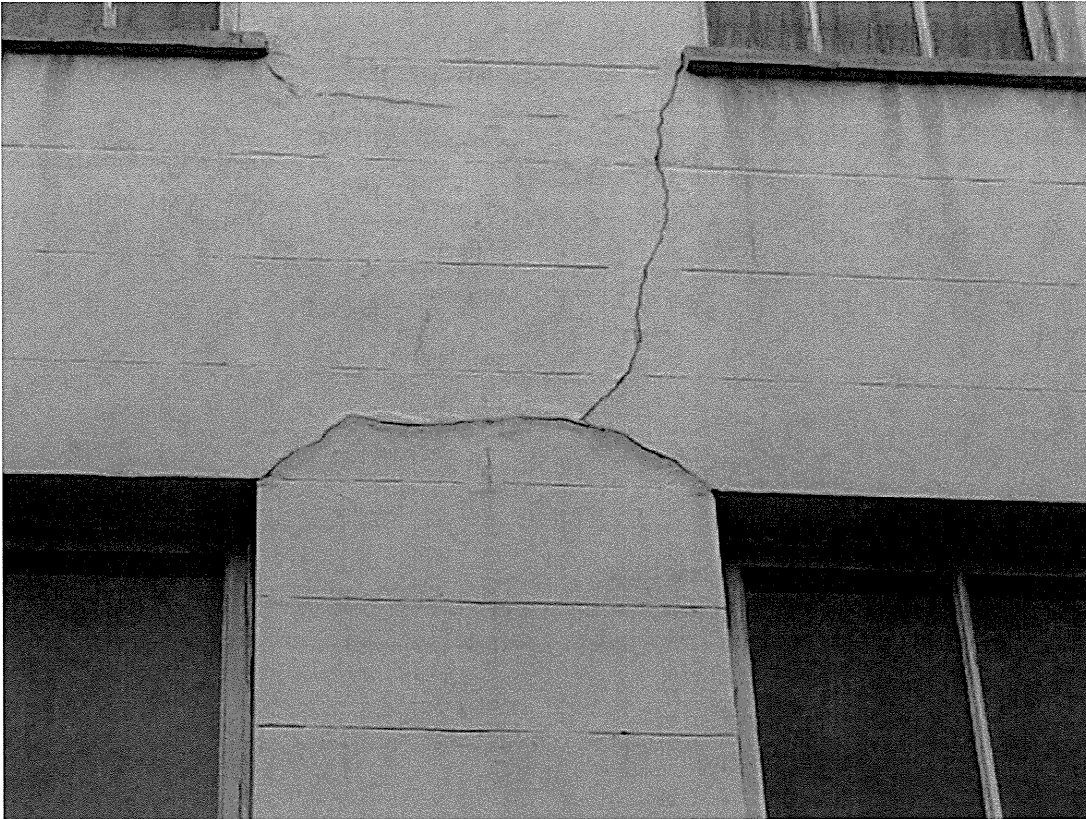
Photograph 4 – Cracks in render over windows at first floor

- All external cracking to the render walls is to have the render removed in a narrow 'V' slot along the crack to expose brickwork behind. Repair crack as above and refill notch with render to match existing.

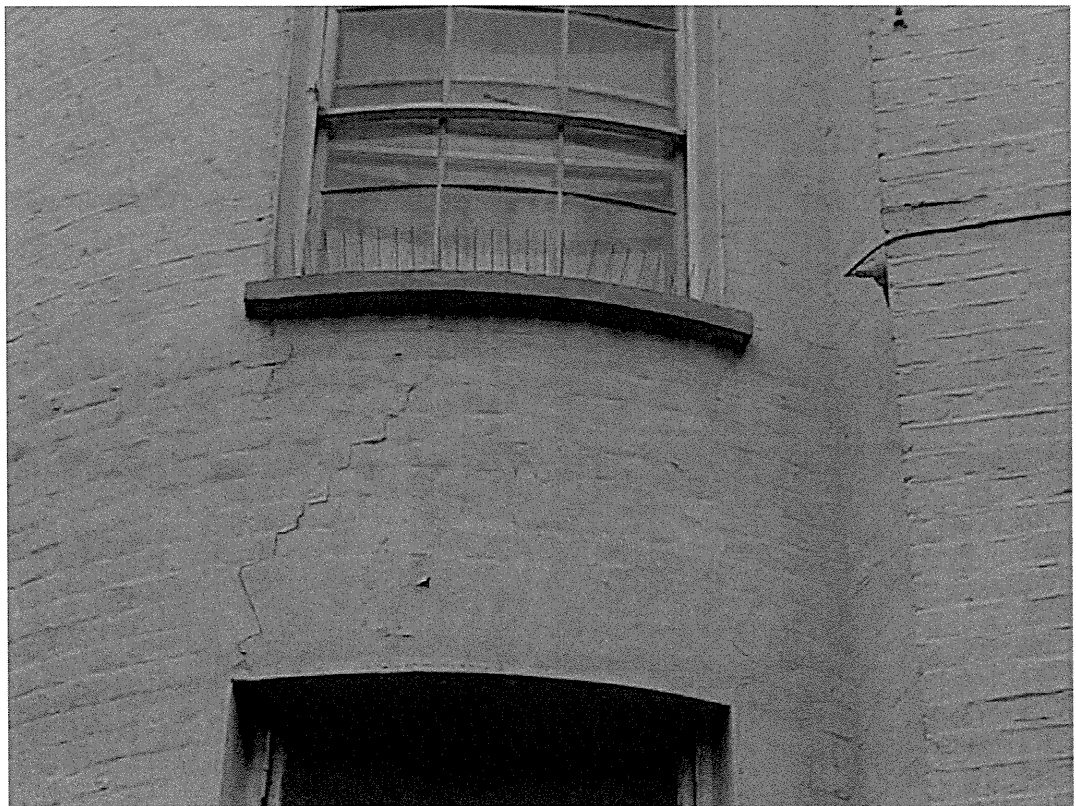
Photograph 5 – Cracks in painted brick over windows at first floor

- Carry out small section removal of existing pointing and mortar to confirm if lime mortar is present.
- All external cracking to painted face should have paint removed along the crack to expose the crack. Mortar joints along crack to be raked out by 35mm in depth and repointed in lime mortar (or epoxy mortar), with any cracked brick repaired with epoxy mortar.

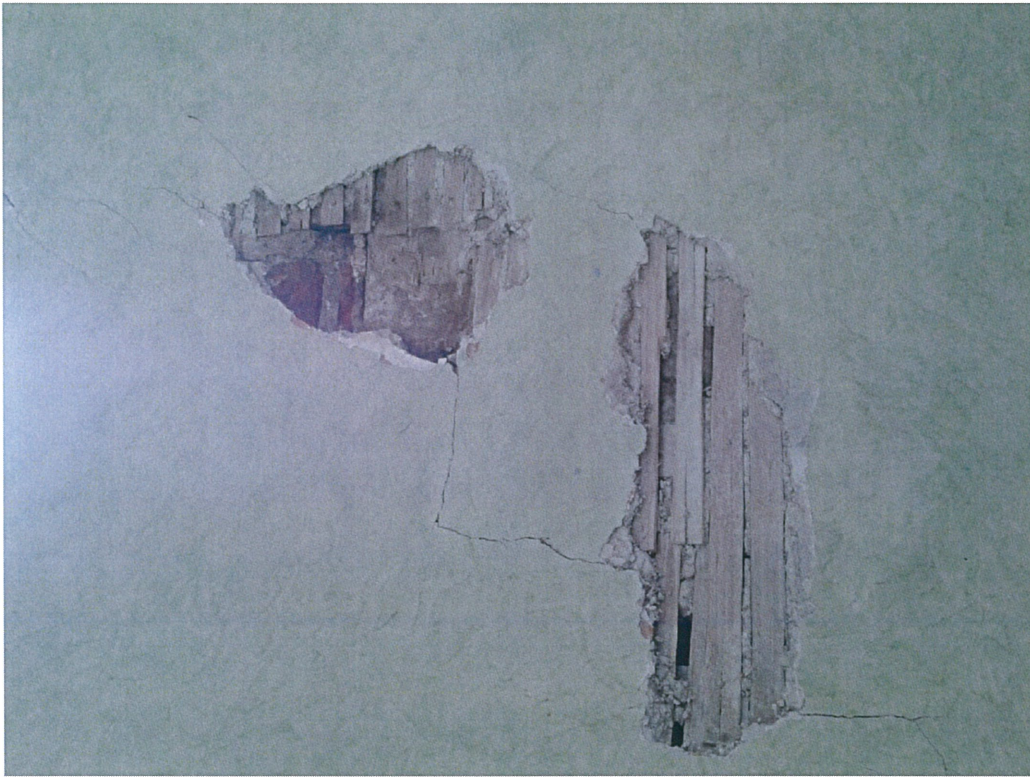
1 to 5mm cracking was observed on various places internally to the curved wall to the stairs from first floor to second. The curve replicates the profile of the stairs but is set against the flat front elevation on Parkway. The wall is constructed of the original studwork to form the curve with a lathe and plaster finish. The cracking has been caused by the deterioration of the lime mortar which was seen to be very loose and crumbly.

Photograph 6 – Cracks in render internally to curved wall at brick junction

- Cracking to internal wall of staircase to have existing lime mortar removed retaining the existing lathes and applying new lime render internally to suit the curve.

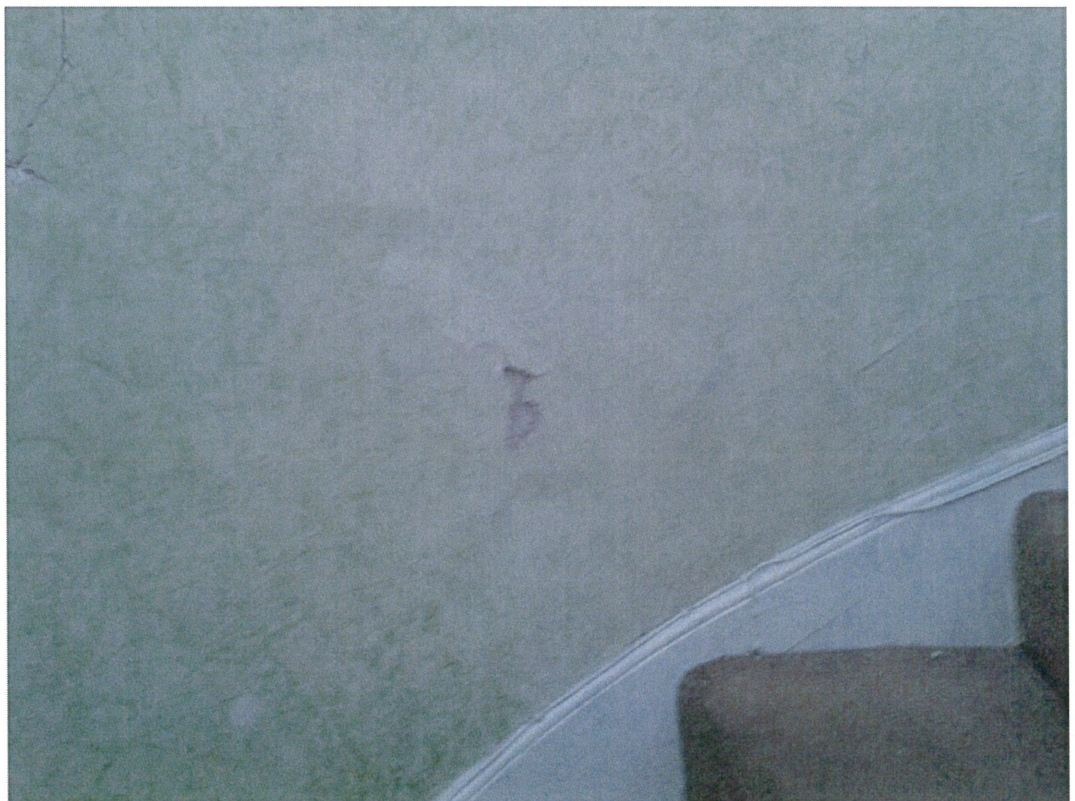
Photograph 7 – Further cracks in stairwell
