# Arboricultural Assessment Report

## Preliminary Report on Trees

<b>For:</b>	<b>Client:</b>	Oriel Services Limited
	<b>Insurer:</b>	[REDACTED]
<b>Site:</b>	<b>Policyholder:</b>	[REDACTED]
	<b>Risk Address:</b>	13 Laurier Road, London NW5 1SD
<b>Refs:</b>	<b>OCA Ref:</b>	54631
	<b>Client Ref:</b>	7380724
	<b>Insurer Ref:</b>	[REDACTED]

<b>Survey By:</b>	Gemma Holmes		
<b>Title:</b>	Arboricultural Technician	<b>Date:</b>	29 November 2013
<b>Report By:</b>	Andrew Graham		
<b>Title:</b>	Senior Consulting Arborist	<b>Date:</b>	11 December 2013

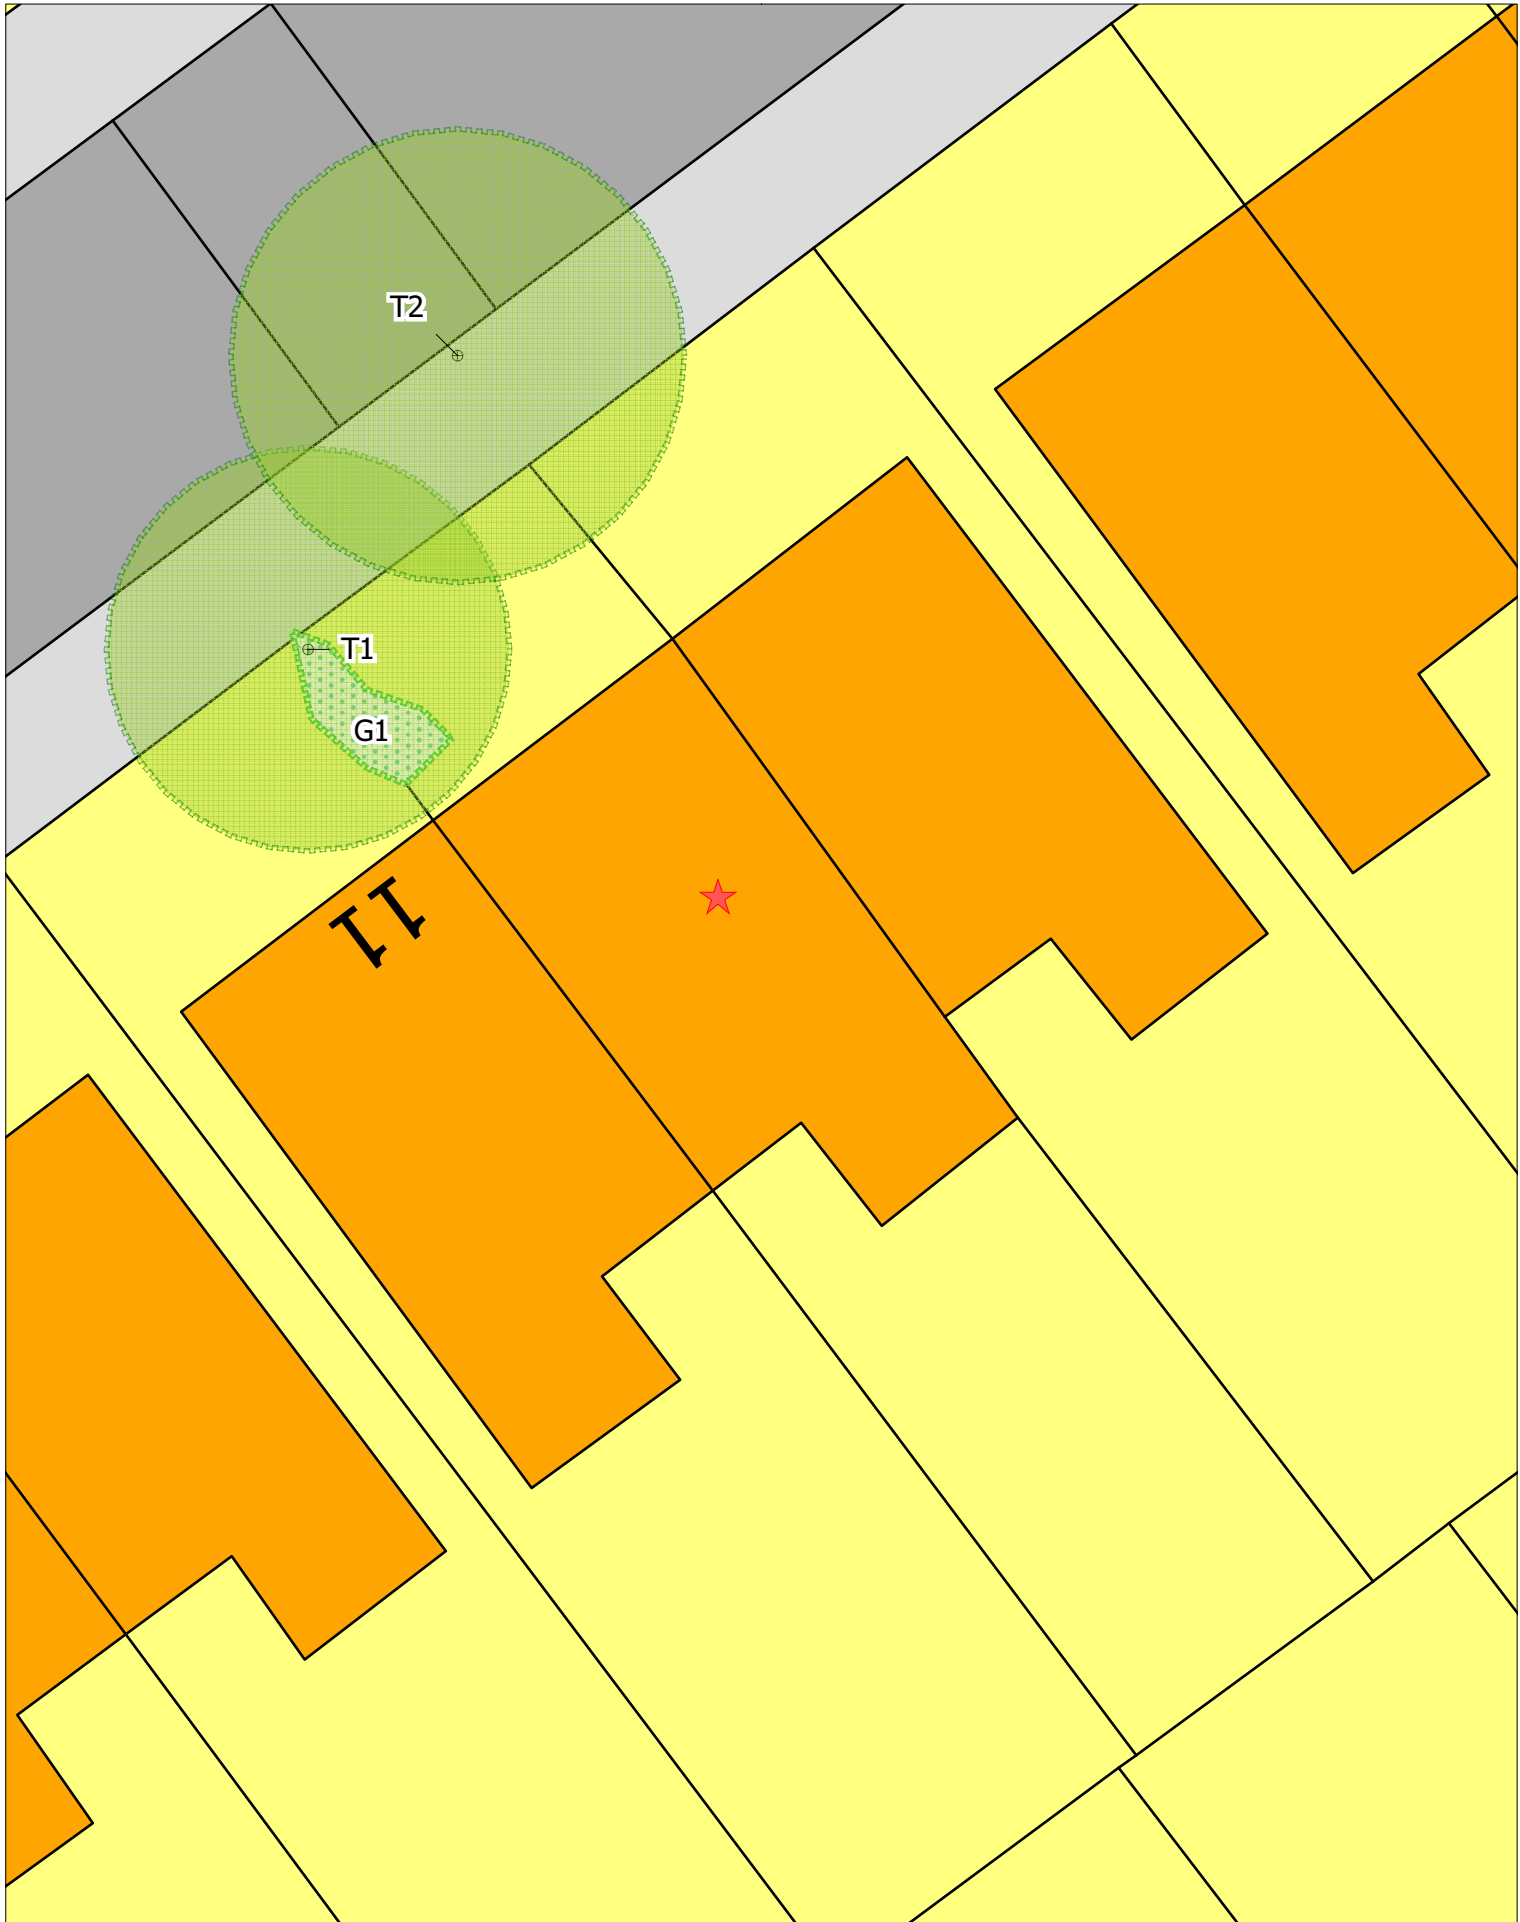
Location: 13 Laurier Road, London, NW5 1SD  
 Job Ref.: 54631  
 Survey Date: 29/11/2013  
 Scale: 1:150 @ A4

Located within the insured front garden are False Acacia T1 and Privet, Fuchsia and Ivy G1. Located within the adopted footpath between the insured property and number 15 Laurier Road is Whitebeam T2.

Roots relating to Leguminosae (Laburnum, Robinia, Honey Locust, Broom & Pagoda tree), Pomoideae (Apple, Cotoneaster, Hawthorn, Pear, Pyracantha, Quince, Rowan, Snowy Mespil & Whitebeam) and Fuchsia Spp have been recovered during investigations. Given the proximity to the location of the trial pit/borehole's we consider that these roots have emanated from False Acacia T1, the Fuchsia within G1 and Whitebeam T2.

Therefore and in order to provide a long-term solution to the current subsidence damage we recommend that the drains be repaired and made 'watertight'. Furthermore, that T1 False Acacia is removed to minimise tree root activity up on the soil in the vicinity of the main area of damage.

Tree No:	Species	Works Required
T1	False Acacia	Fell to as close to ground level as is practicable and treat stump with an appropriate herbicide to prevent future growth

Tree No:	Species	Works Required
T2	Whitebeam	Fell to ground level and grind out the stump
