“ BASEMENT IMPACT ASSESSMENT ”

22 FERNCROFT AVENUE, HAMPSTEAD,

**Reference: 1250/Report File BIA 1
11th. December 2013**

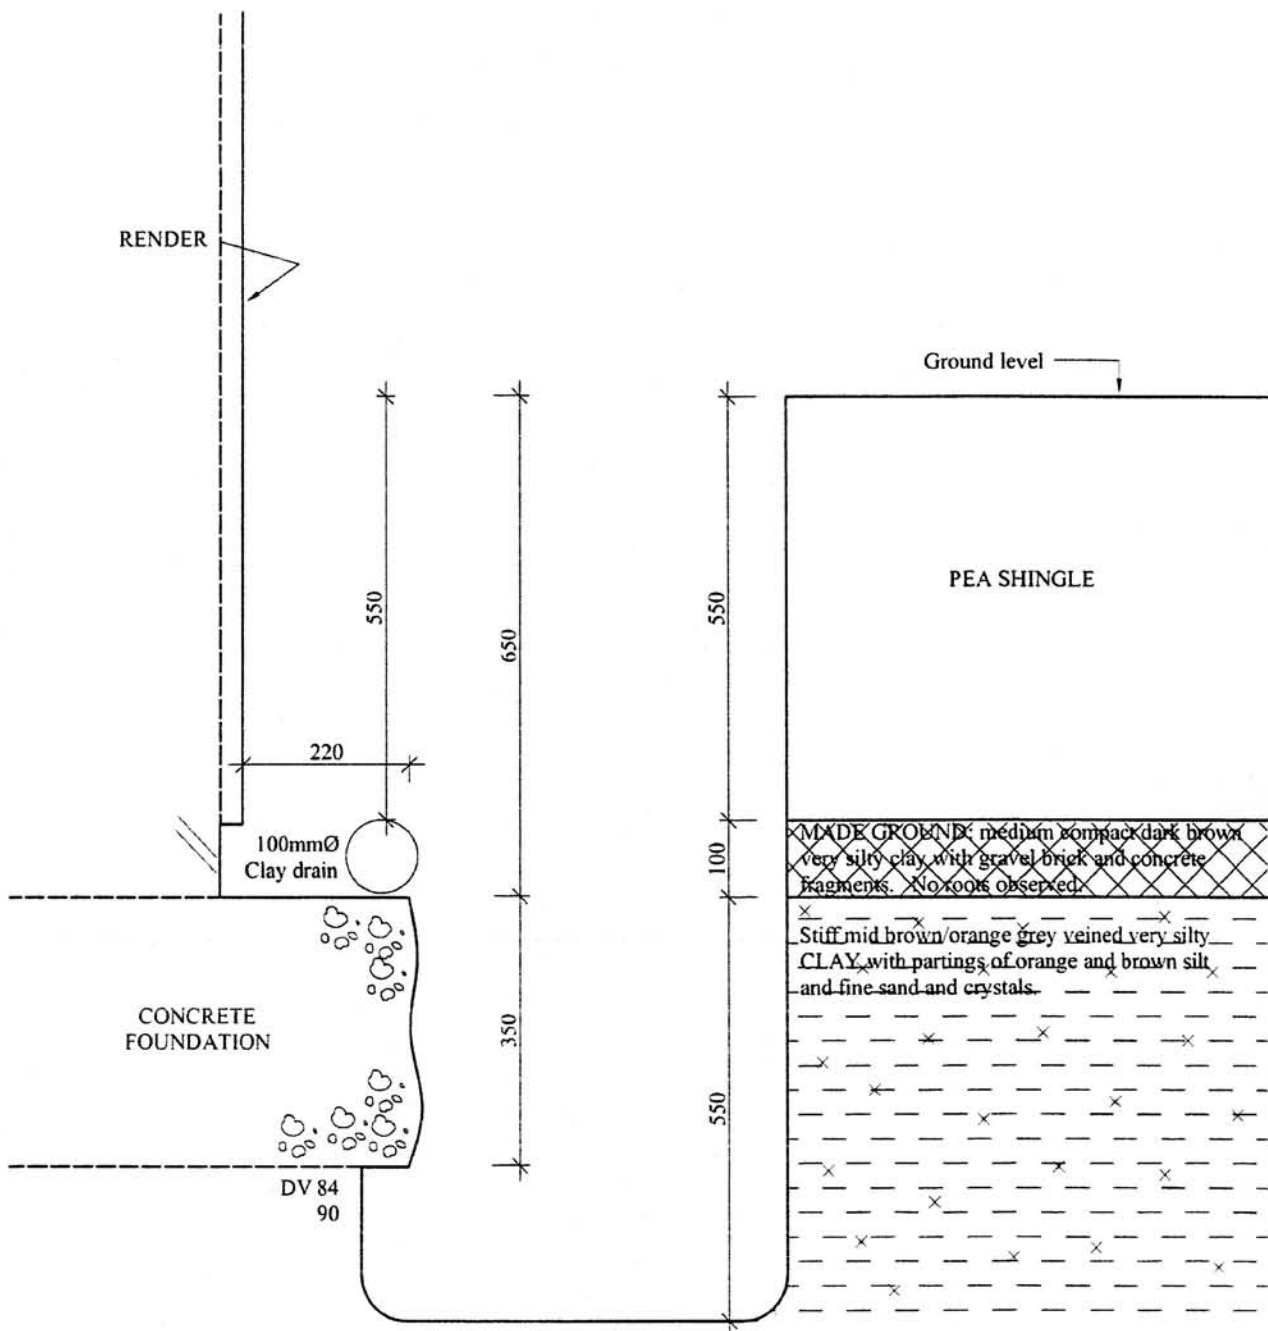
Client: J D Bennett	Scale: N.T.S.	Sheet No: 1 of 1	Date: 23.3.11
Location: 18 Ferncroft Avenue, London NW3	Job No: 2553	Trial Pit No: 1	Weather: Fine
Excavation Method: Hand tools		Drawn by: JG	Checked by: ME

FOR STRATA BELOW 1200mm - SEE BH LOG

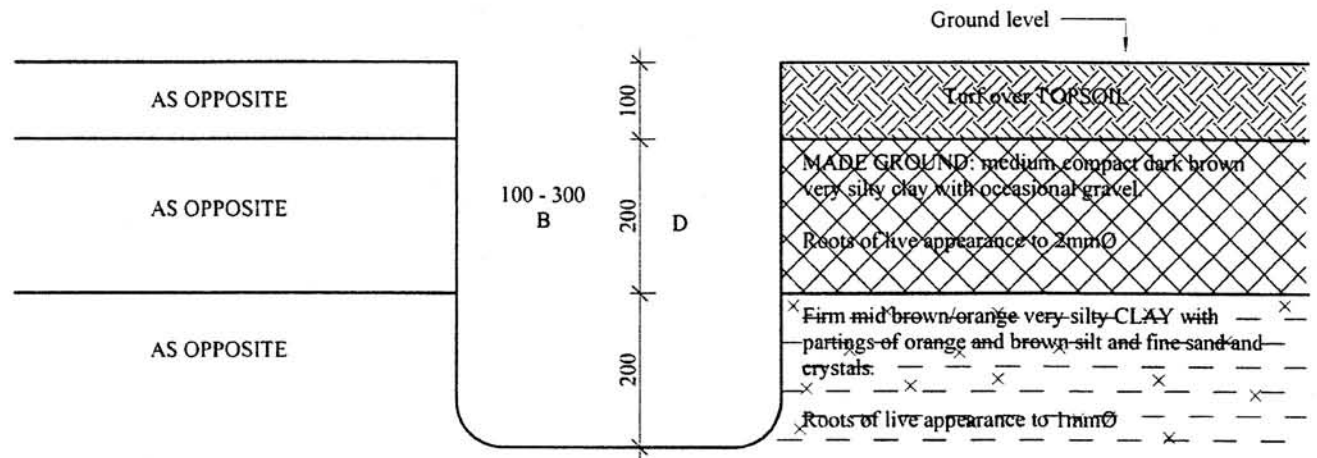
Client: J D Bennett	Scale: N.T.S.	Sheet No: 1 of 1	Date: 23.3.11
Location: 18 Ferncroft Avenue, London NW3	Job No: 2553	Trial Pit No: 2	Weather: Fine
Excavation Method: Hand tools		Drawn by: JG	Checked by: ME

FOR STRATA BELOW 500mm - SEE BH LOG
