Our ref: 5333.0007

**Re: 80 Guilford Street, London WC1.**

This letter is to be read in conjunction with the attached a report carried out by Gulliver Timber Treatment Ltd. The report details findings of a timber and damp survey carried out at the property on December 4<sup>th</sup> 2013. This letter summarises the findings of the damp and timber survey and presents a structural appraisal on the condition of the existing structure.

### **Re: 80 Guildford Street London WC1N 1DF**

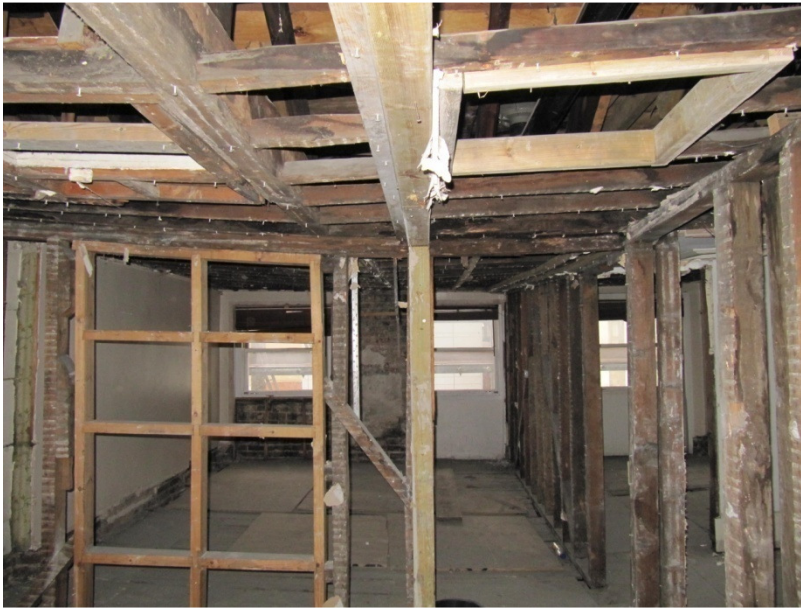
1. The existing roof is in a poor state of repair, water ingress over a prolonged period of time has lead to a large proportion of the roof affected by wet rot and an associated infestation of Wood Boring Weevil. The roof is poorly designed, with a lack of lateral restraint leading to outward movement of the front wall. Repairs have been undertaken with the introduction additional timbers, this has been poorly carried out with a lack of engineering input. Roof loading is currently transferred onto the third floor through the internal partitions, large deflections are visible indicating inadequate strength of the support at third floor, see photo 1.

*Photograph 1. Third floor showing deformation in the roof timbers.*

It is recommended that a new roof be constructed utilising steel beams clear spanning from party wall to party wall; ensuring that load bearing partitions are not required at third floor thus allowing maximum flexibility for future use. When the roof is replaced flashing and render above roof level can be replaced to ensure longevity of the new design. The new roof will also incorporate restraint straps to prevent any risk of movement on the front elevations.

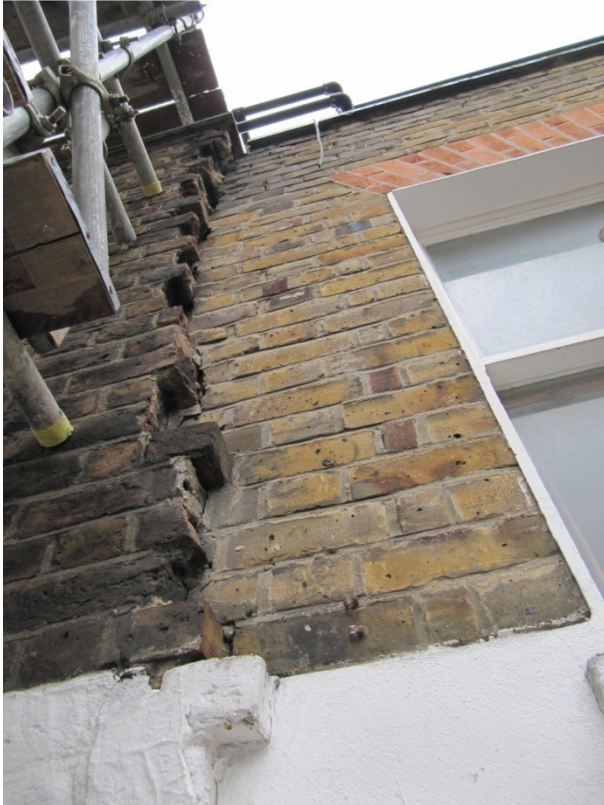
6. The front elevation has in some locations become detached from the party walls, see photo 2. A number of strapping details have been provided to re-connect the front elevation back to the party walls and at floor level, the straps are to be installed over all floors. It is considered that the front wall should be rebuilt from third to roof due to the extent of the movement.

*Photograph 2. Dislocation of front elevation from Party wall.*

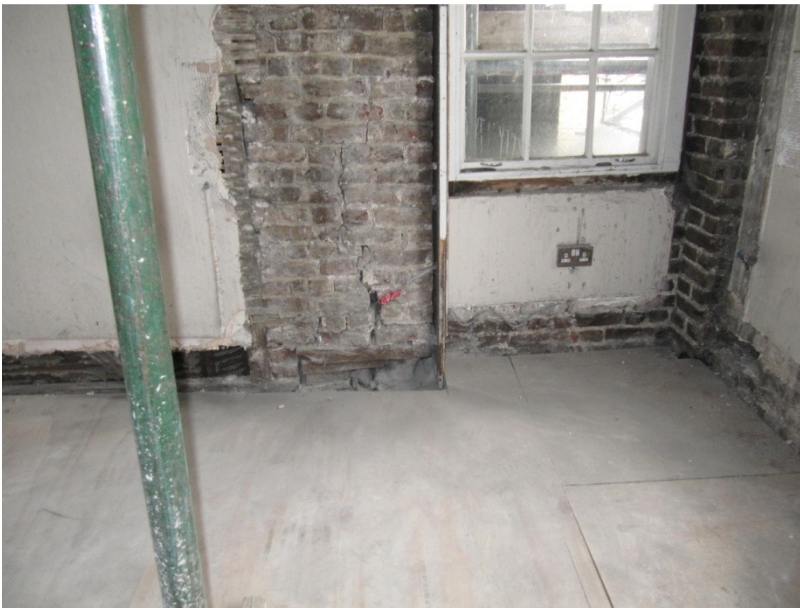
8. A number of internal walls have cracked, in particular at the internal corner at the rear, adjacent to the stairs, see photo 3. A combination of re-building and crack repair using “Helibar” bed joint reinforcement (or similar approved) is required.

*Photograph 3. Cracking in rear wall adjacent to stair case.*

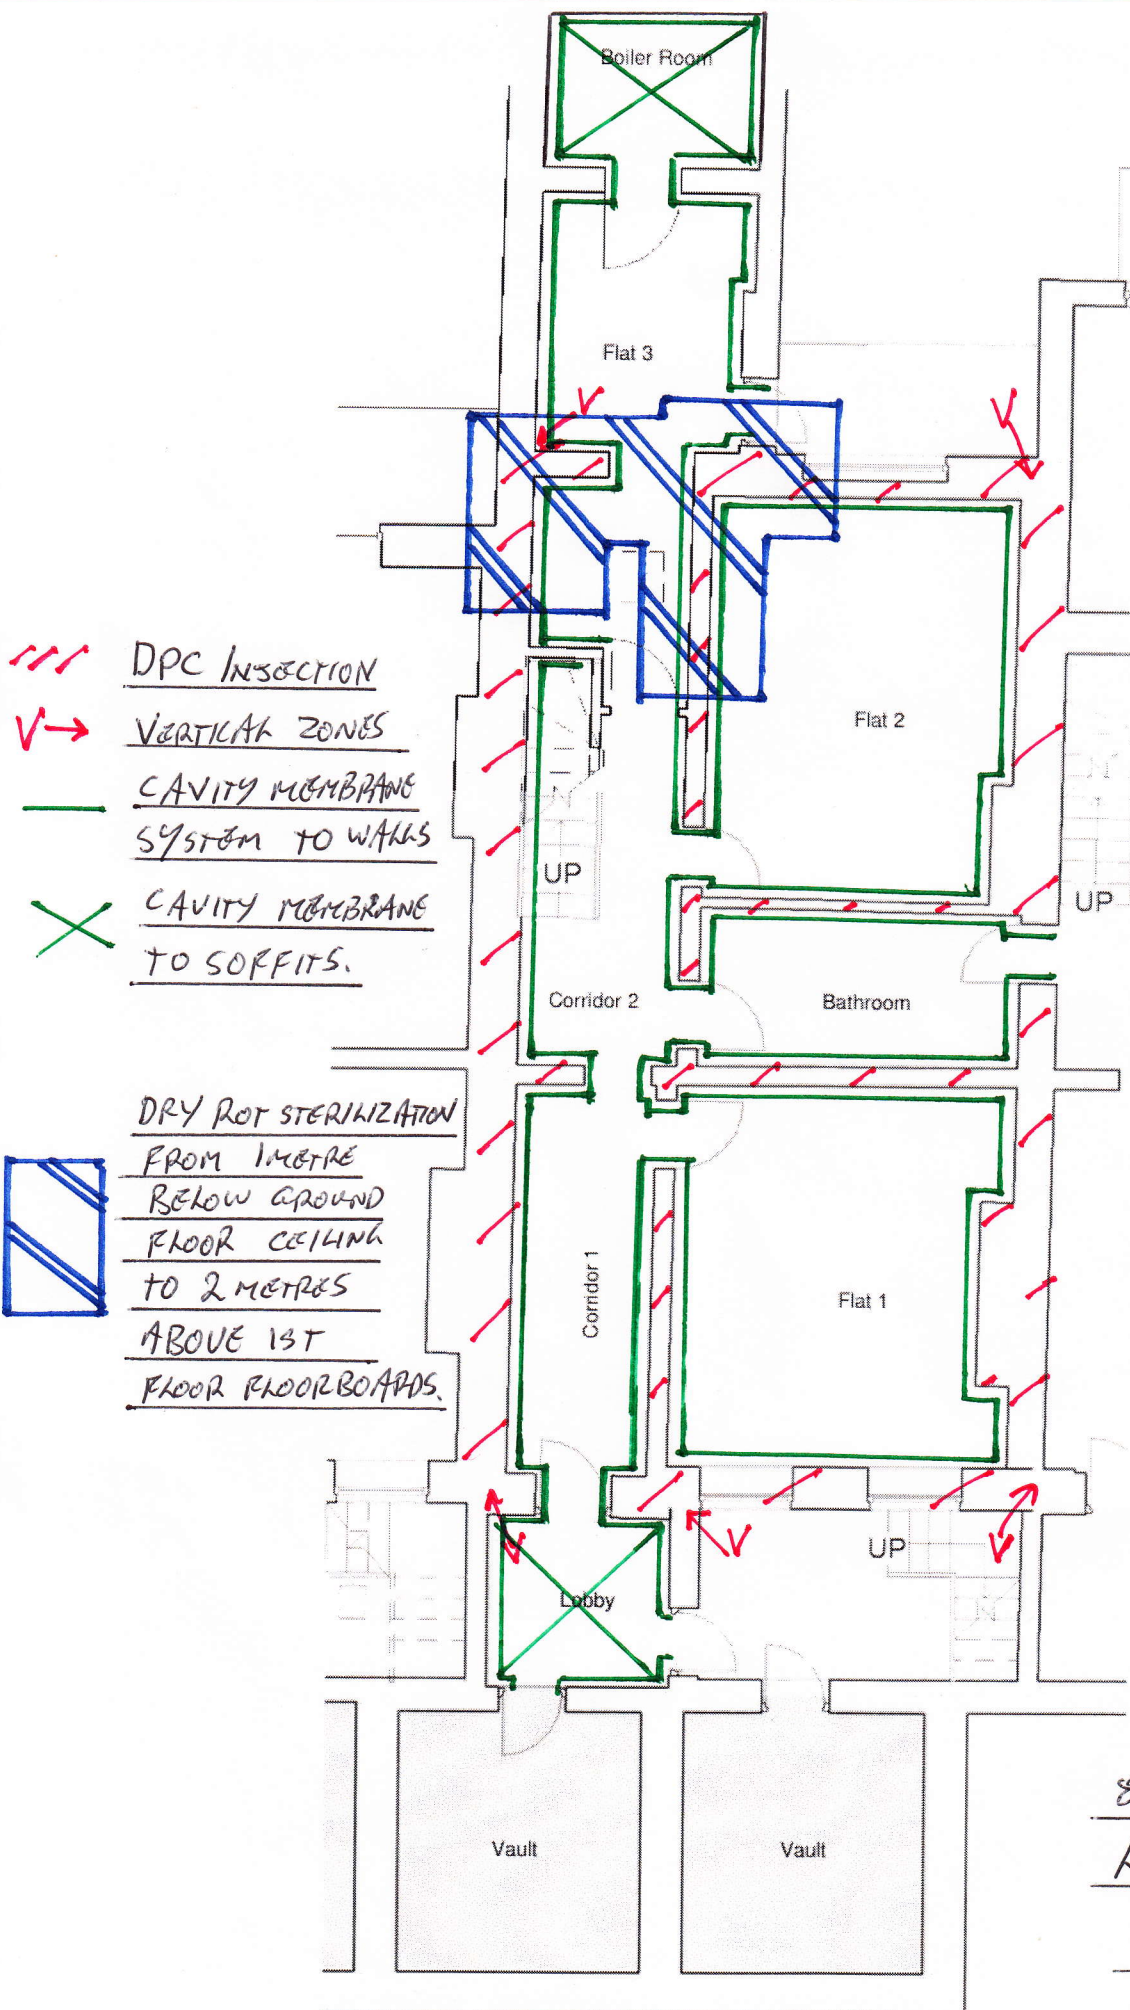
**Basement Floor Plan**

An attack of Dry Rot (*Serpula lacrymans*) was noted to be affecting the area indicated on the attached sketch plan. In particular the following timbers were seen to be affected:- flat roof timbers, floor timbers and bonding/framing timbers.

DRY ROT STERILIZATION  
 FROM 1 METRE  
 BELOW GROUND  
 FLOOR CEILING  
 TO 2 METRES  
 ABOVE 1ST  
 FLOOR FLOORBOARDS.

- B) Drill and inject a new horizontal chemical damp-proof course to walls as indicated on the attached sketch plan.

- C) Carry out Dry Rot fungicidal masonry treatment to areas as indicated on the attached sketch plan.

- D) Install cavity membrane waterproofing system to wall and soffit surfaces as indicated on the attached sketch plan. Install dry lining to walls and soffits, to be left with plaster skim finish. Install suitable drainage and sump pump systems (2 number) to work in conjunction with cavity membrane waterproofing
