ENGINEERS REPORT

**Interested Underwriters per
Chambers & Newman Ltd
TBA**

261 Goldhurst Terrace, London, NW6 3EP

Our Ref: L/2012/27371/S/MLL/kh/gpa

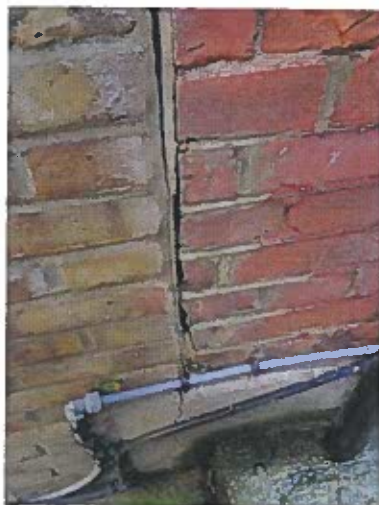
This shows the vertical crack to the left side of the extension at the junction with the main building extending to the ground.

At the junction between the main building and the single storey rear extension we noted a tapered crack approximately 10mm wide at roof level narrowing to approximately 2mm when reaching the ground. This appeared reasonably fresh and consistent with rotation of the single storey extension away from the main building.

The pattern of cracking is consistent with subsidence of the foundations of the single storey extension away from the main building towards the rear. Ground investigations revealed that the foundations of the extension were relatively shallow by modern standards, although consistent with the age of construction. The foundations were found to bear onto clay subsoil which was noticeably drier at the rear when compared to the soil retrieved from the front of the property, and contained roots.

Clay is a plastic material and is therefore susceptible to shrink or swell depending on changes in moisture content. In this case we consider the most probable cause of the movement to have been shrinkage of the clay substrata during dry weather conditions in the latter part of the summer of 2012 aggravated by moisture uptake from the ground by the large mature London Plane tree in close proximity.

To assess whether movement is progressive a period of monitoring is required and monitor studs have been fixed over the main areas of damage. If it is not possible to stabilise the structure by dealing with the cause of the problem, a scheme of underpinning of the existing foundations may need to be implemented.

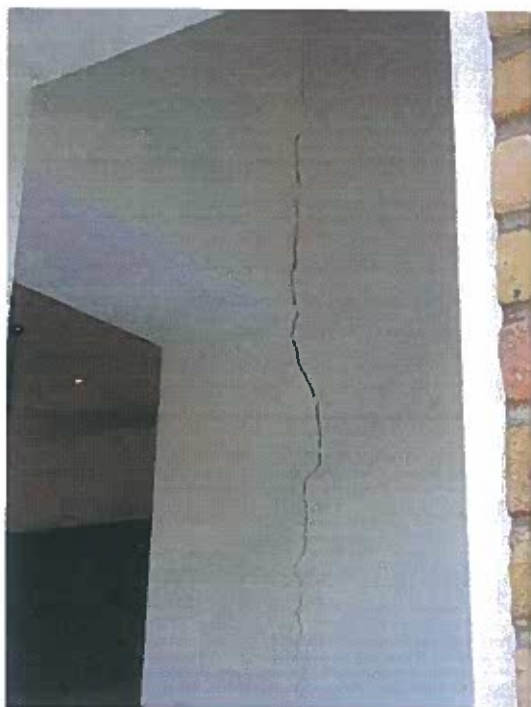
At the junction between the rear elevation of the main buildings and the extension to the right hand side we noted a vertical crack up to 5mm wide at roof level narrowing to hairline when reaching the ground. Below the centre of the threshold door to the extension we noted a stepped crack 2mm wide extending from the bottom of the threshold to the ground. This cracking is consistent with subsidence of the foundations to the single storey extension away from the main building.

This is a general view of the vertical crack within the single storey extension to the right hand side at the junction with the main building.

In this room we noted some minor hairline cracks at the wall ceiling junction related to general plaster stresses and shrinkage. At the junction between the extension and the main building we noted a vertical crack to the right hand side with a width of approximately 5mm at ceiling level and narrowing to hairline width when reaching the floor. A similar crack was evident to the internal wall on either side and this extended over the wall ceiling junction to the left hand elevation, the crack increased in width up to 10mm. There was some distortion of the kitchen worktop as it extended to a shelving unit within the extension and also some unevenness to the tiled floor at the junction.

The cracking is consistent with subsidence of the foundations of the single storey extension towards the rear.
