Arboricultural Consultancy for Aviva

1. Case Details

| Insured | Mr Martin Jourdan | Address | 55 Shirlock Road, London, NW3 2HR | | |

Scope of Report: To survey the property and determine significant vegetation contributing to subsidence damage, make recommendation for remedial action and assess initial mitigation and recovery prospects. The survey does not make an assessment for decay or hazard evaluation.

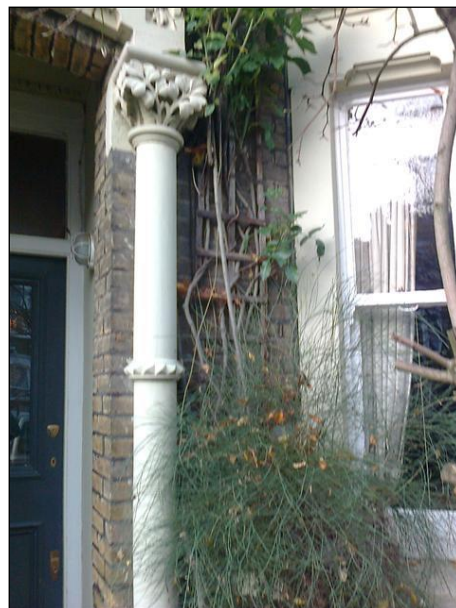
SG3 - Mixed species group

In assessing the potential drying influence of the vegetation on site, T4 (Lime) and T7 (Birch (Silver)) are considered the dominant feature and accordingly we have identified them as the principal cause of subsidence. T1 (Magnolia), C1 (Clematis), TG2 (Cypress), S1 (Bamboo), S2 (Rose), SG3 (Mixed species group) and T6 (Magnolia) are also considered to retain a contributory influence.

| Tree No. | Species | Age Cat | Approx. Height (m) | Distance to Building (m) | Ownership | Action | Requirement |
|---|--|---|---|---|---|---|---|
| SG3 | Mixed species group x1 Broom, x1 Rose. | 1 | 3 | 0 | C - Insured | Remove | Remove and treat stump to inhibit regrowth. |

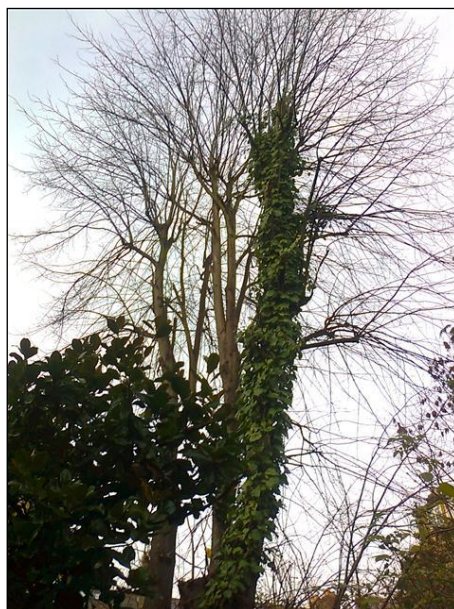
T4 - Lime

Roots recovered from TP/BH2 have been formally identified as Lime spp. The most likely origin of the roots is T4 (Lime). Such circumstances confirms the potential for T4 (Lime) to influence soil volumes and to contribute to the damage observed.

| Tree No. | Species | Age Cat | Approx. Height (m) | Distance to Building (m) | Ownership | Action | Requirement |
|---|--|---|---|---|---|---|---|
| T4 | Lime | 3 | 16 | 5 | D - Unknown | Remove | Remove and treat stump to inhibit regrowth. |
