Agar Grove

PERS Audit Report

On behalf of **The London Borough of Camden**

Project Ref: 28732/002 | Rev: A | Date: December 2013

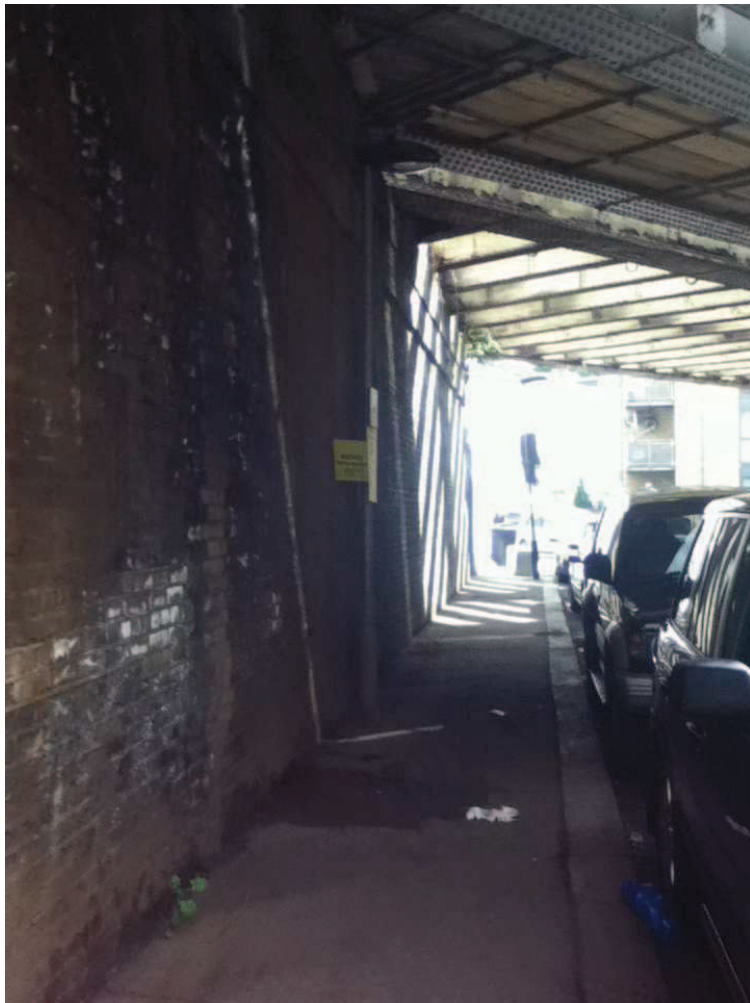
- 2.3.5 Both sides of the narrow pavements are lined with parked cars which reduce crossing opportunities and sightlines. In addition to this the many private crossovers were steep, and made the gradient of the footway uneven and the link difficult to pass for the mobility impaired or those pushing wheelchairs or pushchairs. This is shown in Figure 2.1.

Figure 2.1: Baynes Street, Looking West from St Pancras Way, Showing Narrow Pavement and Parked Cars.

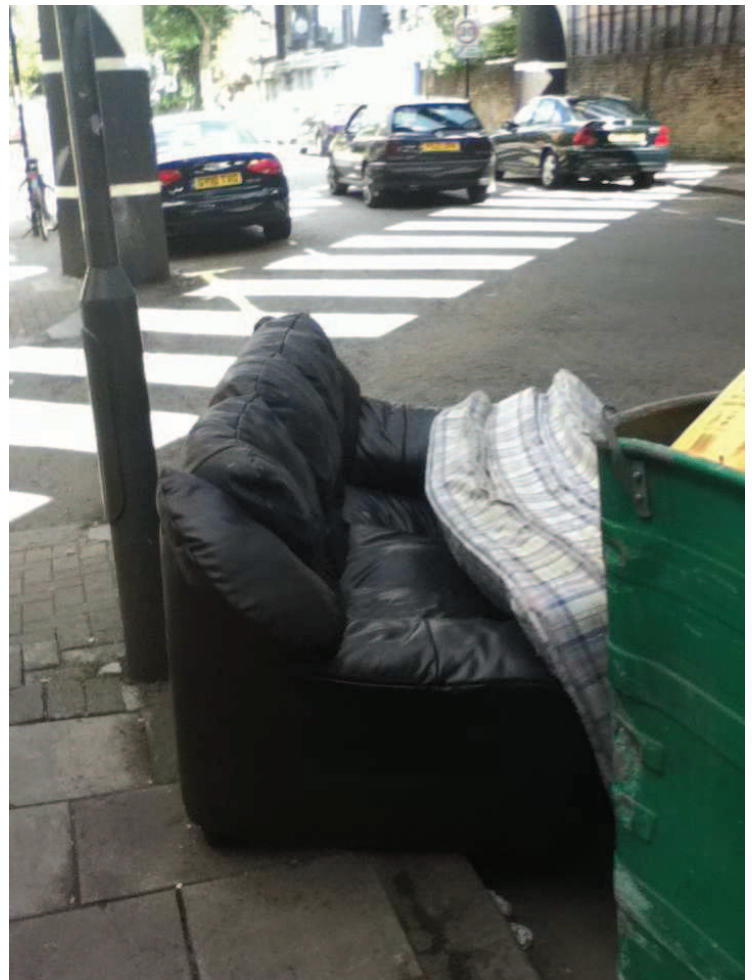
- 2.3.6 The link was littered with fly tipping towards to the eastern end on the audit day, as shown in Figure 2.2.
- 2.3.7 Foliage improved the quality of the environment and made the link more attractive towards the western end, with an attractive link to the Grand Union Canal.

Figure 2.2: Baynes Street, Looking West from St Pancras Way, Showing Fly tipping under the Railway Bridge.

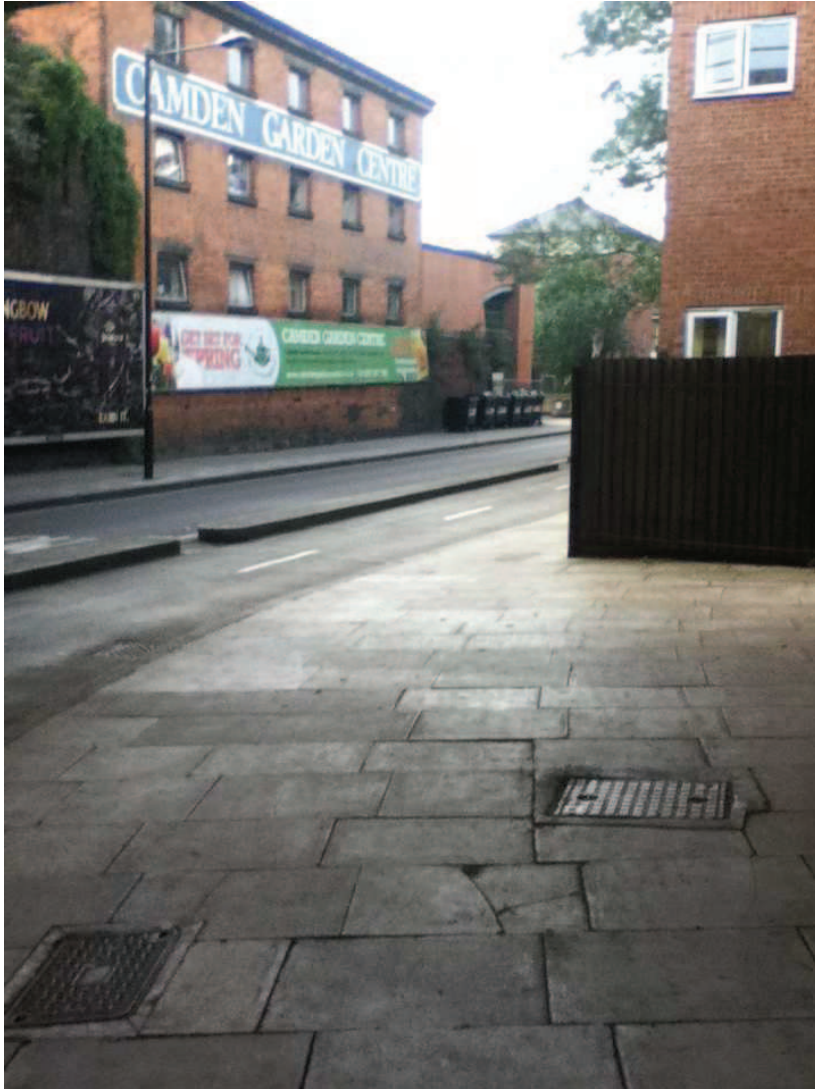
- 2.3.10 Under the railway bridge, there was the opportunity for concealment as the paved area extended back to the bridge from the fence which restricted the width to the south. This area could provide concealment for a group of people in an area which did not appear to be particularly well lit after dark. This is shown in Figure 2.3.

Figure 2.3: St Pancras Way Looking South from Baynes Street, Showing Place for Concealment under Railway Bridge.

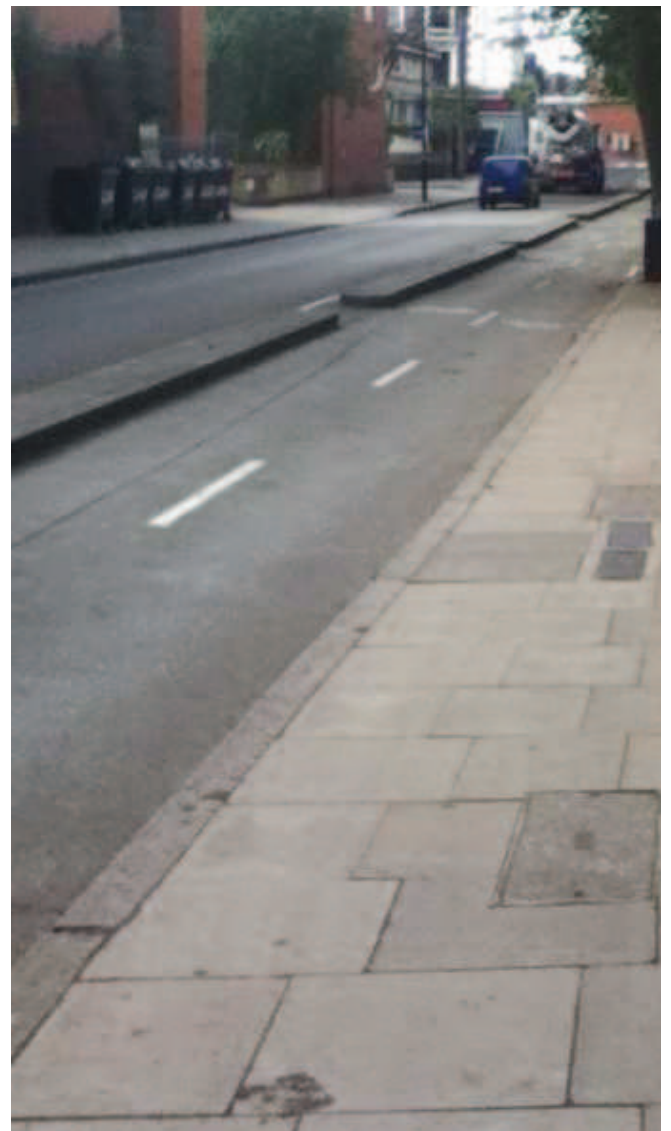
- 2.3.11 The contraflow cycle lane separated cyclists from pedestrians, with breaks in the raised kerbs marking it in. However these breaks were not aligned with dropped kerbs on the footways on either side of the carriageway, restricting pedestrian crossing capabilities. The cycle lane provided some colour contrast, though it may benefit from some resurfacing to enhance the colour contrast. This is shown in Figure 2.4.

Figure 2.4: St Pancras Way Looking South, Showing Separated Contraflow Cycle Lane.

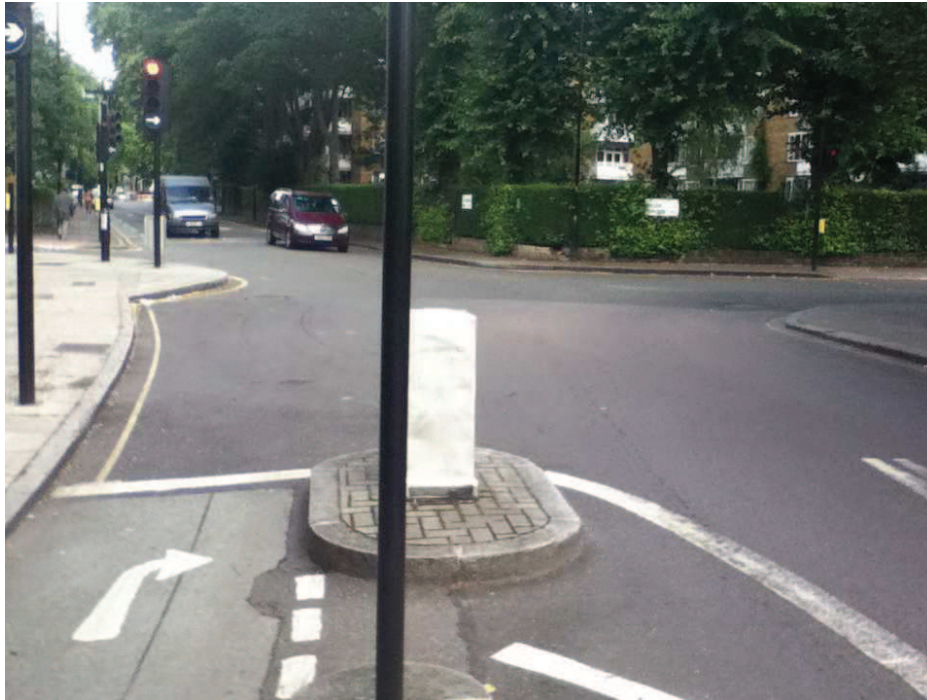
- 2.3.15 St Pancras Way lacked a crossing point on its southern arm at the intersection with Agar Grove and Randolph Street. Signalised crossing facilities were provided on all other arms of the junction, yet this arm lacked dropped kerbs. This is shown in Figure 2.5.

Figure 2.5: St Pancras Way Looking North Across Agar Grove, Showing the Cycle Facility and Lack of Pedestrian Crossing Facilities on Southern Arm of Crossing.

- 5.1.3 The audit of crossing points found that there was no requirement for any immediate works. A review is required though to assess the potential for providing some form of pedestrian crossing facilities on the southern arm St Pancras Way where it intersects with Agar Grove and Randolph Street. Currently there is no facility here and it is not clear why this is.

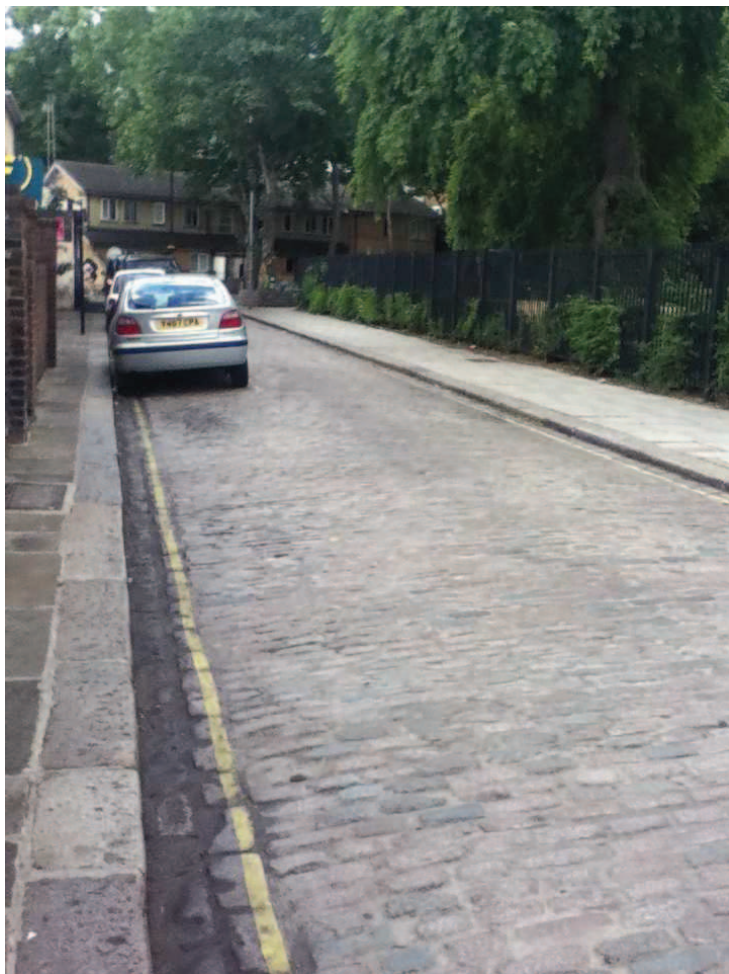
- 2.3.16 The footway to the northbound carriageway of Agar Place was the fourth link which scored as 'Amber'. Agar Place is shown in Figure 2.6, as shown the pavement to the northbound carriageway is extremely narrow. During the audit no persons were observed to use this link, preferring to either walk in the road or cross to the footway on the opposite side of the carriageway.
- 2.3.17 This link did not appear to be passable by a person in a wheelchair or with a pushchair due to its restricted width. The link provided access to some houses and a garage, though there were few suitable crossing points or dropped kerbs provisions to reach these from the footway on the opposite side of the carriageway.
- 2.3.18 A high quality tactile crossing point was provided where Agar Place met Agar Grove.

Figure 2.7: Agar Place Looking North, Showing Narrow Aavement and Lack of Crossing Facilities

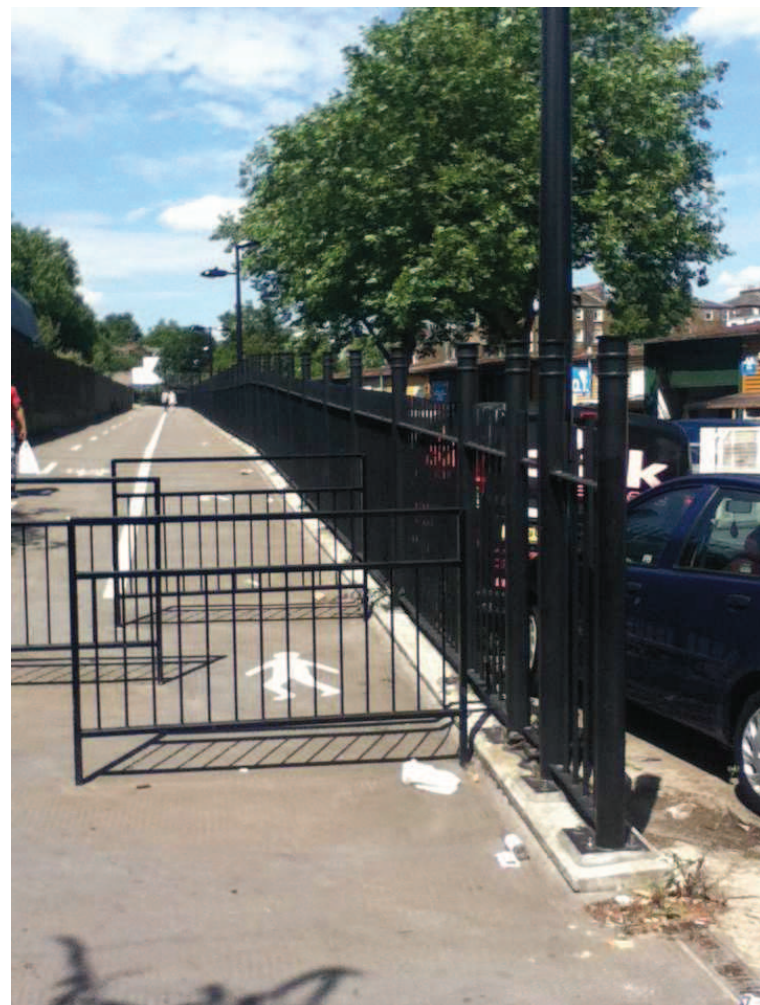
- 2.3.25 The pedestrian and cycle link itself was however of a high quality and provided a vital link to the Agar Grove Estate from the south. This is shown in Figure 2.7. The link could be improved if it were linked directly to the Agar Grove Estate, opening up the link more and making it feel safer.

Figure 2.6: Camley Street Pedestrian and Cycle lane, Looking North from Camley Street. This Picture Shows the Enclosed Nature of the Link and Delineation Between Pedestrians and Cyclists.

- 5.1.5 The links were all of an acceptable or good standard, requiring no immediate works. The cycle and pedestrian link between Agar Grove and Camley Street was noted as having potential in the redevelopment of Agar Grove; if the link were to be accessible from within the state it would not only improve estate accessibility but also the level of safety on the link. It was also noted that St Pancras Way and Baynes Street would benefit from some light maintenance works and cleaning. Though Baynes Street did not score highly, Randolph Street provides an acceptable alternative route for residents without significantly extending walking distance.

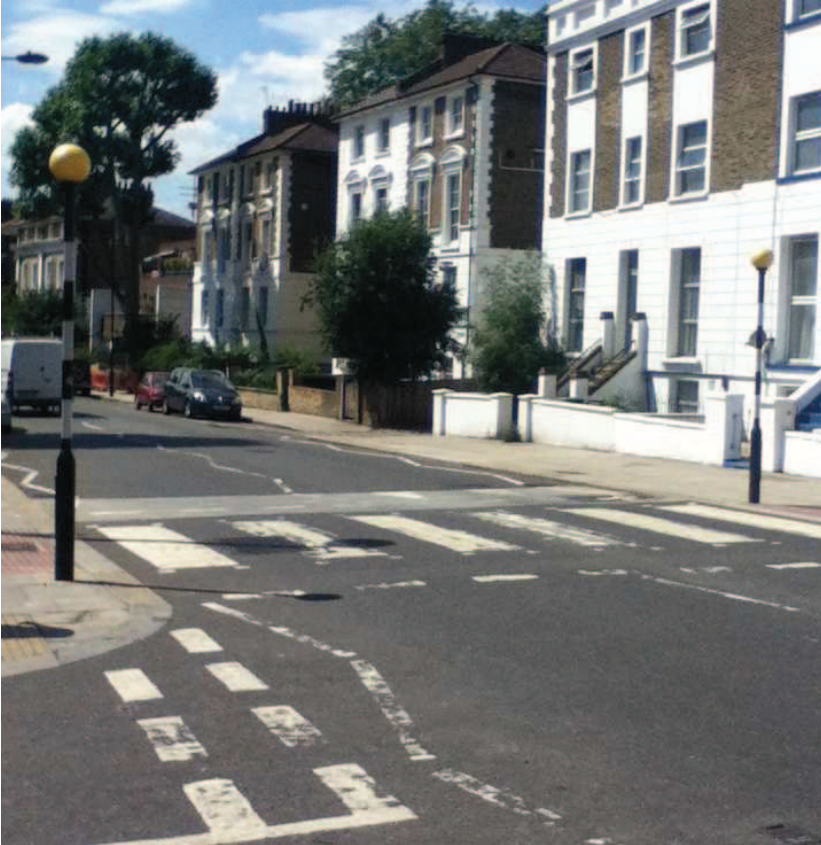
3.3.6 The review found the crossing had good quality tactile information and colour contrast, though some of the road markings would benefit from re-painting. This is shown in Figure 3.1.

Figure 3.2: Crossing point 1, Near to Intersection of Agar Grove and Murray Street and Taken from Estate Access

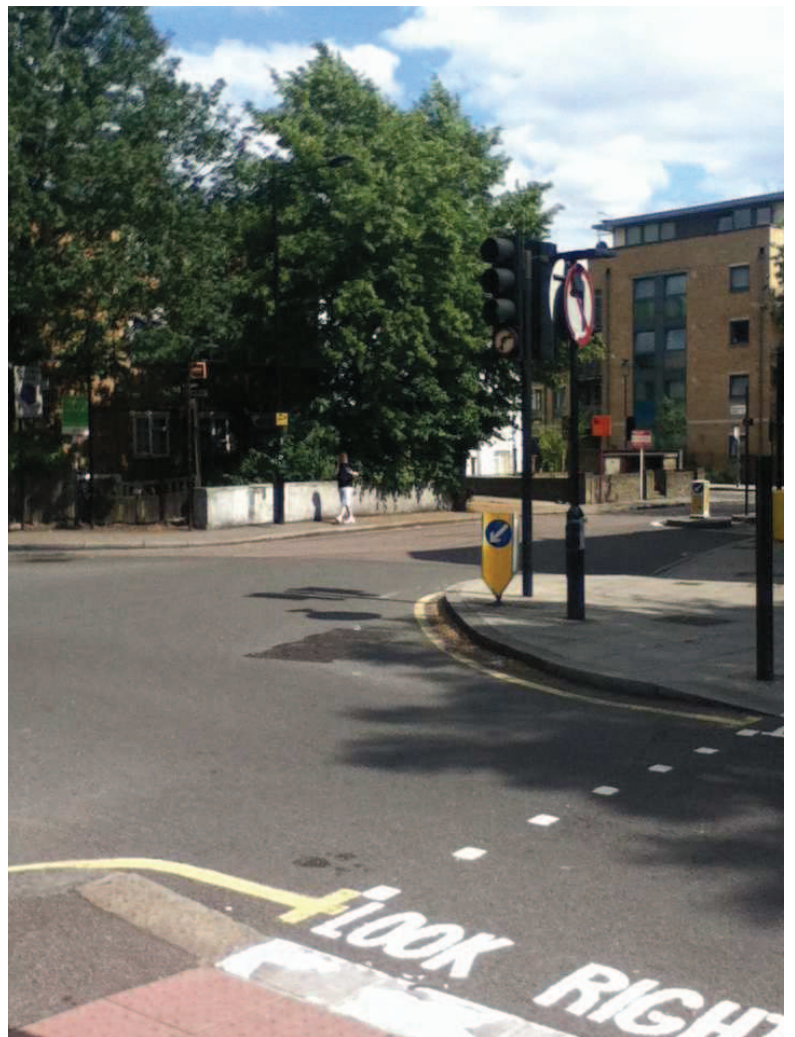
Figure 3.1: Crossing point 2, Looking from Randolph Street Towards Lack of Crossing Facilities on Southern Arm of St Pancras Way.

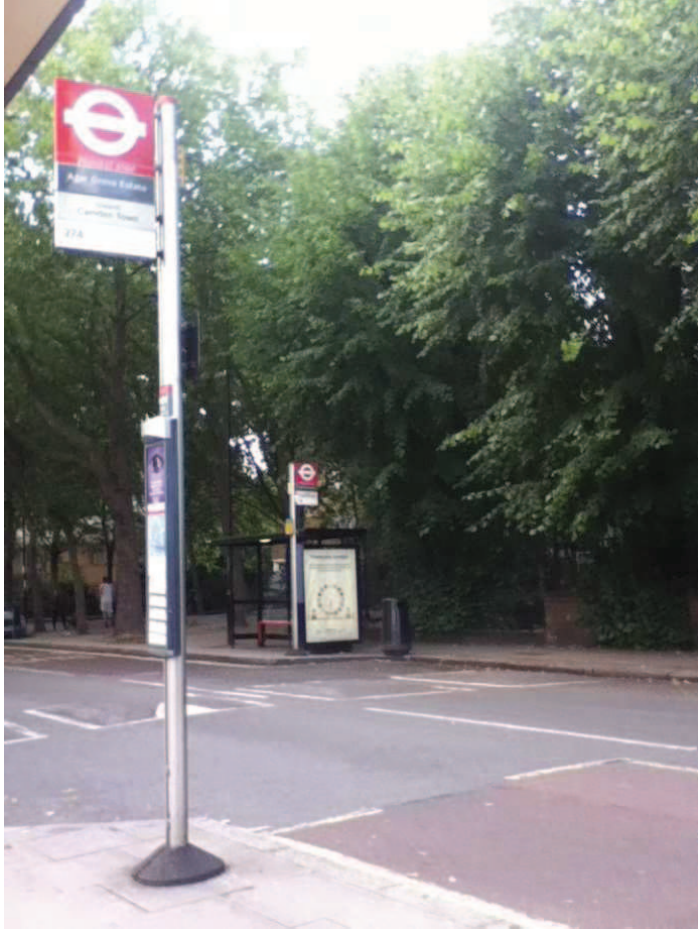
Figure 4.1: Agar Grove Estate Bus Stops, Showing Built Out Waiting Areas and Provision of Shelter and Seating.

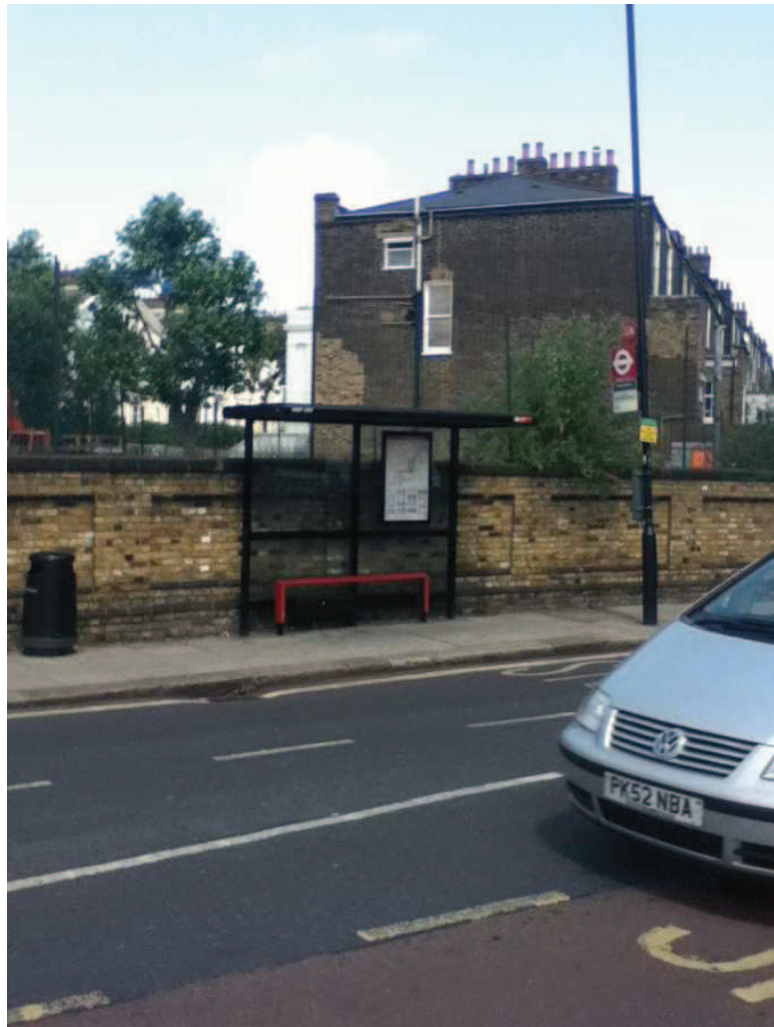
Figure 4.2: Murray Street Eastbound Bus Stop, Showing Lack of Dropped Kerbs and Facilities Provision.

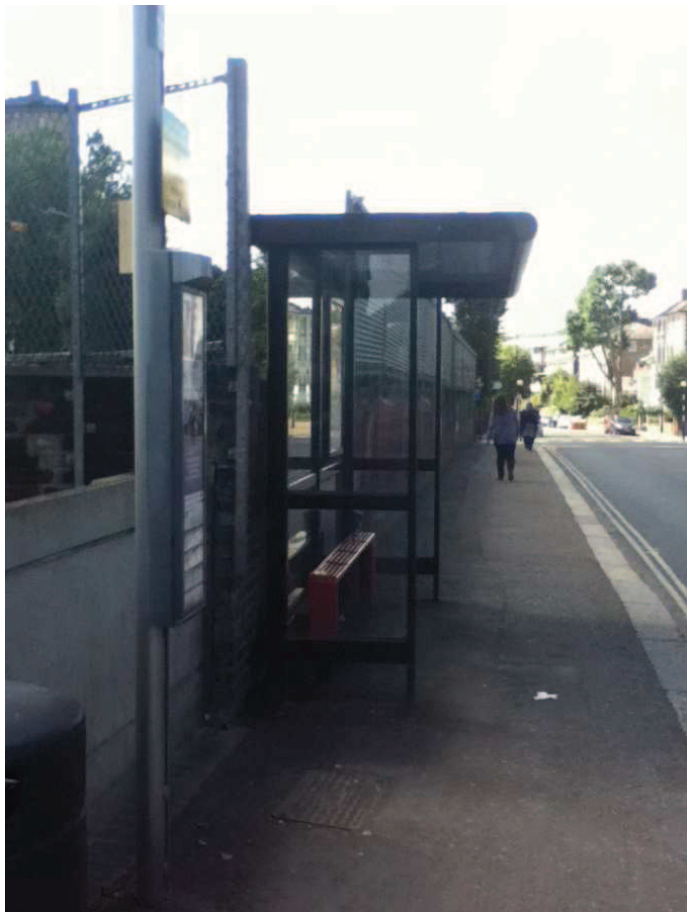
Figure 4.3: Murray Street Westbound Bus Stop, Showing Narrow Pavement.
