Athlone House Ltd

Tree quality survey for
Athlone House,
Hampstead Lane, London N6

October 2013

Catherine Bickmore Associates Ltd

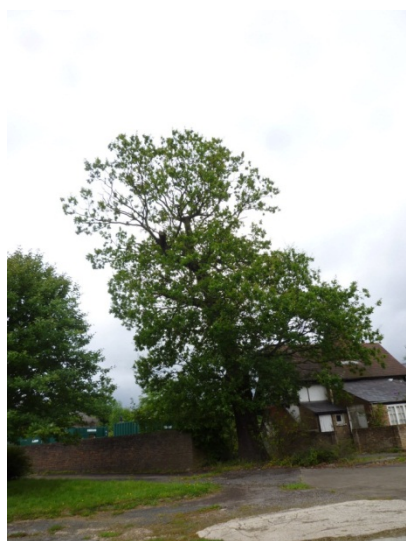
- 3.5 Oak 905 is located to the immediate south side of the Gatehouse with a foot path to the north and hard standing to the south. The trunk itself is outside the application area but within the ownership. The oak included decay in the lower trunk recorded as part of an investigation in 2004. Die back (photo P1) that was recorded in the crown in 2007 was still apparent in 2012. A comparison of photographs from that time with August 2012 also showed a thinner canopy cover in this part of the tree suggesting an on going decline in vigour.

- 3.6 The tree leans to the west (photo P1). Previous recommendations to reduce sail area of the tree through reducing its height by not less than 30 per cent to a minimum of 4.5m have not been undertaken. This tree continues to provide a significant risk to the adjacent Gatehouse building, and the entrance drive to Athlone House. The tree was classed as grade B quality on account of its current condition and life expectancy of over 20 years assuming recommended tree works were undertaken.

P1:Oak no. 905 showing die back in the crown and slight lean

- 3.7 Prior to the start of works tree protection barriers should be erected on the southern side of the tree to extend out for 5m to protect the tree canopy from demolition and construction vehicles. This should remain in place for the duration of the demolition and construction works for Athlone House and could be incorporated as a part of the fencing to define the construction area for the contractors. The barrier would need to be removed to enable the landscape works to be undertaken.

- 3.9 The removal/breakup of the hard standing and the replacement of the entrance gates/wall foundations should be undertaken following a method statement under supervision of an arboriculturalist. The construction of the drive and euro bin surface within the root protection area should apply a no dig method note: this would result in a slight increase in levels to be accommodated in the detailed design of the drive.

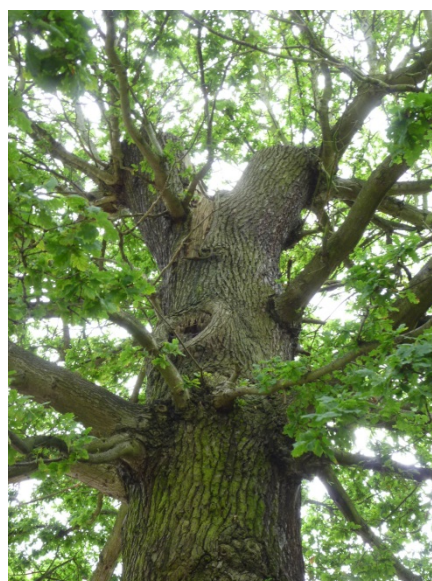
- 3.4 Oak 905 and 906 were located either side of the entrance, off Hampstead Lane. However, previous poor maintenance and possibly their location close to previous buildings/hard standing (associated with the former Hospital use) may have affected their condition. Both these oaks were severely lopped over 10 years ago resulting in a poor form, in particular oak 906 with regrowth now forming a pollard (photo P2).

Caenwood Court. Previously there was hard standing along the southern side of the oaks with a building to the north. Now there is a hedge and raised planting bed together with hard standing on the east side with grass and shrubs on the south western side. The dense canopy provides some containment of views of the north western part of Caenwood Court and Athlone House (photo P3). The regrowth from previous lopping appears vigorous however there were significant cavities and decay in the upper trunk and close to ground level (photo P2). The condition of the tree needs to be monitored annually on account of the decay. Re pollarding is recommended on account of likely weak union of branch regrowth. In the absence of re pollarding the continued re growth could result in future structural instability and failure close to vulnerable locations of the main entrances of Caenwood Court and Athlone House. This tree merited a category A retention classification mainly for landscape qualities.

P2:Oak no. 906 showing former lopped and pollarded branches and cavities at height with a relatively vigorous re-growth

- 3.14 Prior to the start of works tree protection barriers should be erected along side the root protection area of oak trees 906 and 912. This should remain in place for the duration of the demolition and construction works for Athlone House and could be incorporated as a part of the fencing to define the construction area for the contractors.

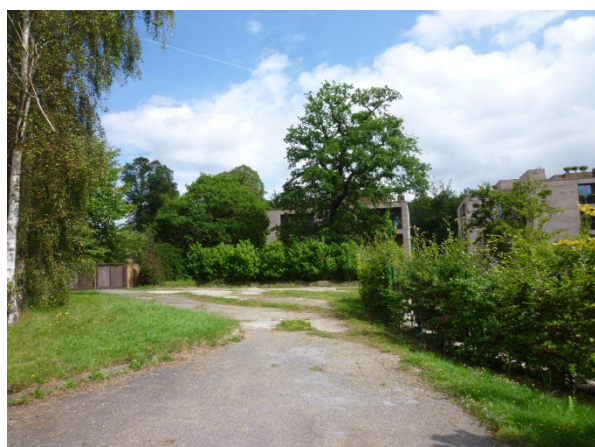
- 3.12 Oak 912 on the eastern boundary with Caenwood Court, retains a reasonable form although the crown is slightly unbalanced (photo P3). At c18m height it is significant in certain restricted views in the immediate vicinity along Hampstead Lane and between Athlone House and the north western side of Caenwood Court. A road was previously located along the western side of the trunk and has since been grassed over and a line of laurel bushes established within the canopy spread. Some hard standing also remains within the vicinity. There are areas of hard standing on its western side.

- 3.13 Minor die back on the eastern side of the crown has been removed on account the potential risk to occupants of Caenwood Court. Wet brown slime mould was previously recorded in a cavity at the base of the trunk with a further cavity recorded at a higher level. The recommendations of 2004 survey to lighten the three main branches by about 2m and to re balance the crown have still to be implemented. Regular inspection of the tree should be undertaken on account of its proximity including overhang to the central drive way of Caenwood Court. The tree provides a significant landscape feature between the two properties with a Category A retention classification.

P3:Dense low canopy of oak no. 905 next to taller oak no. 912 showing slight lopsided crown

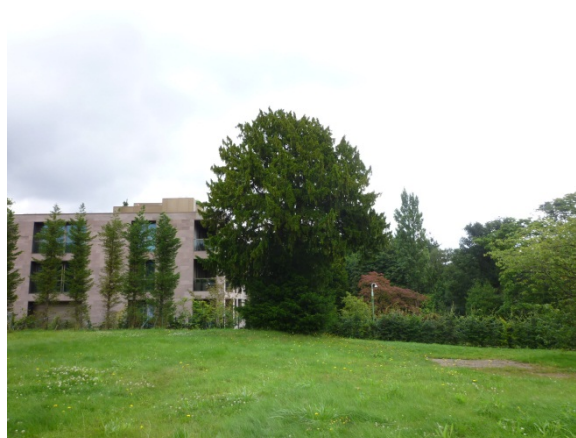
- 3.17 Yew 955 is a mature tree is located on slightly sloping ground with a reasonable form and condition (photo P4). It is classed as category A retention quality. Yew 955 was previously adjacent to the southern side of the single storey accommodation block extension to Athlone House and had the majority of the lower branches removed exposing the lower trunk. These branches have re-grown to provide an indented lower canopy to the ground unsynchronised with the main canopy. Removal of the lower canopy back to expose the main trunk is recommended. The north eastern part of the root protection area has been affected by changes in ground levels as a result of landscape works within Caenwood Court.

P4: Yew no. 955 with epicormic re growth on the lower trunk creating a lower canopy, with row of Leyland in background on left and Caenwood Court boundary hedge on right.

- 3.19 Prior to the start of works tree protection barriers should be erected to incorporate the root protection area, and areas for planting to the north and south. Depending on the construction

method, it may be necessary to slightly adjust (reduce by around 1m) the tree protection fencing to enable construction access to the eastern side of the pond.

- 3.20 Preparation of the ground for tree and shrub planting and areas of grassland within the root protection area should be undertaken by hand so as not to result in root severance. As far as possible the planting should avoid areas with a high density of roots.

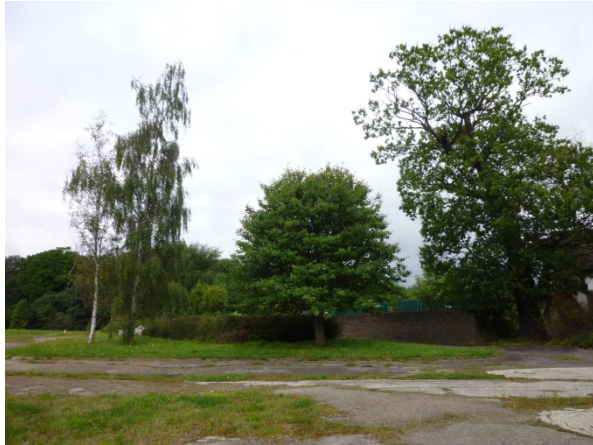
- 3.25 To the south west of the existing entrance, group no 901-904 comprised three semi mature birch and a Swedish whitebeam (photo P5) in an area of open grass adjacent to hard standing. The whitebeam no 904 in particular is developing into a reasonable tree although still relatively small in height it forms a local feature by the entrance and was allocated a category B retention class. It is to be retained as part of the landscape proposals.

- 3.27 Of the silver birch, no. 903 was the dominant and larger of the group of three birch. It was allocated a category B retention class on this account. The smallest birch no. 901 had lost its leader and was suppressed by the adjacent trees and was making poor growth. It was of limited merit retention and allocated category C. Birch 902 retention category C included die back in the crown and was to some extent suppressed by the larger birch 903. The group would be replaced as part of the landscape proposals by other trees including cedar and magnolia (drawing 9135/07 rev J).

P5: Swedish whitebeam no. 904 near the entrance between group of birch no. 901-903 and oak no. 905, also showing existing hard standing

- 3.26 Prior to the start of demolition works tree protection barriers should be erected to extend to beyond the edge of the canopy and along the edge the existing hard standing, and for the duration of the works. The removal/break up of adjacent hard standing within the root protection area should be undertaken following a method statement so as to not damage underlying roots. On the south western side of the tree, within the root protection area, the adjacent area of the proposed drive should be a no dig construction (extending that required for oak 905).

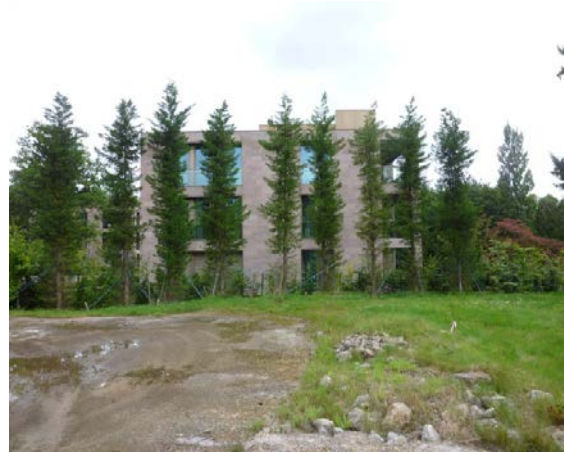
- 3.23 A row of nine Leyland cypress were planted sometime in 2009 along the boundary with Caenwood Court as semi mature trees to provide immediate screening. They are still guyed and establishment has been slow although some trees were showing extension growth was beginning to take place in 2013. The slow establishment may be attributed to the poor ground conditions in this area including the possible remains of a foundation slab (pers. com). The proposals include for their retention as short term screening for the duration of the works. Prior to the start of demolition works tree protection fencing is recommended along the western side of the planting.

P6: Row of nine Leyland cypress along eastern boundary planted as a temporary screen

- 3.24 Following the completion of the construction works, the cypress would be removed so the eastern boundary area can be replanted ((Dwing 9135/07 rev J). The alleviation of compacted ground and removal/breaking- up of any remaining underlying hard standing is recommended to improve growing conditions for the final planting.

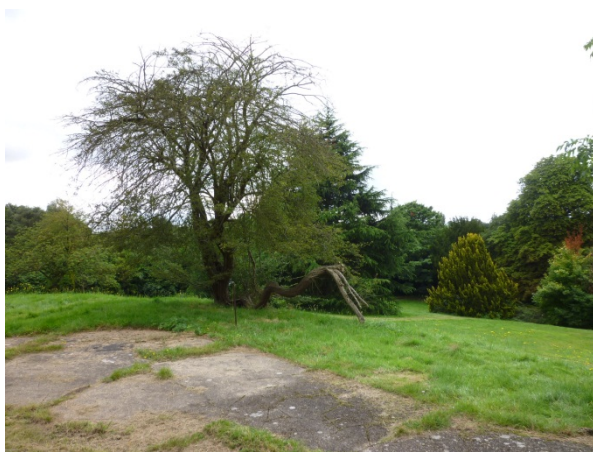
- 3.28 Two trees of no special merit were located to the south side of the house. At the southern end of the terrace by the corner of Athlone House no. 958 was a multi stemmed moribund hawthorn (photo P7). One of the main stems had split off and was dead. The main standing

trunk was hollow. It was allocated a U category as unsuitable for retention and would be removed as part of plans for the rebuilding of Athlone House.

P7: Moribund hawthorn no. 958 on south western corner of the terrace of Athlone House

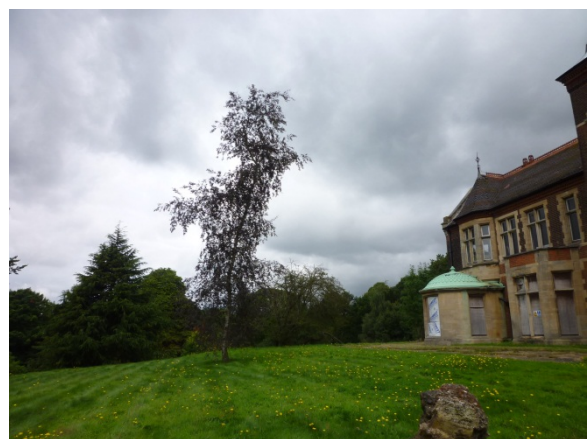
- 3.29 Tree no.957, a semi mature purple leaved birch (photo P8), was located in the lawn on the south side of Athlone House. It was a straggly specimen with a poor growth rate and was allocated a Category C retention class of no particular merit to the immediate or wider landscape. Although it would be possible to retain, it is included for removal within the landscape proposals.

P8: Purple leaved birch no. 957 to the south of Athlone House

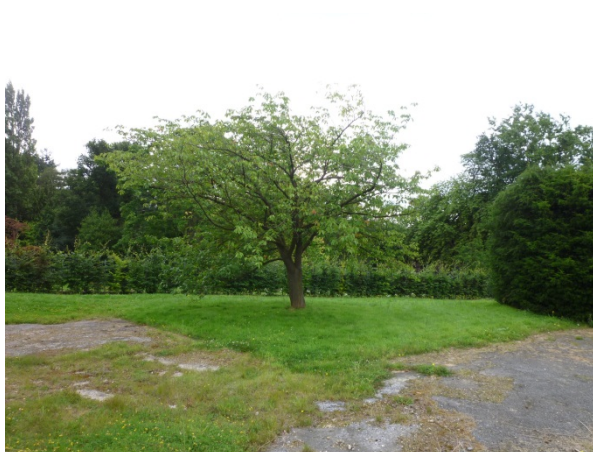
- 3.21 This mature cherry was located in open grass to the south of the yew. It was showing signs of decline including general die back of the crown (photo P9) and was considered to be of no special merit with a Category C retention class.

P 9: Cherry no. 956 near eastern boundary

- 3.22 Its location would be directly be affected by the location of the pond affecting around 40% of the root protection area and it is recommended for removal. On its eastern side planting of trees and shrubs would enable the establishment and long term development of trees along the eastern garden boundary.

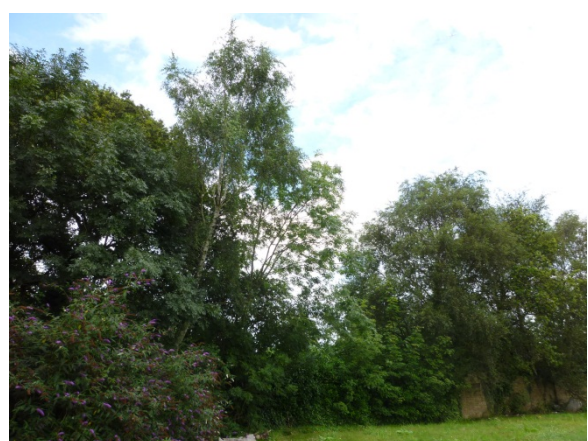
- 3.30 Nos. 22 and 23, an ash and a birch, were located along the boundary wall as semi mature self-set volunteers (photo P10). The ash was growing out of the wall. Neither of the trees was of any merit and was allocated a Category C retention class.

P10: Trees along and overhanging northern boundary wall

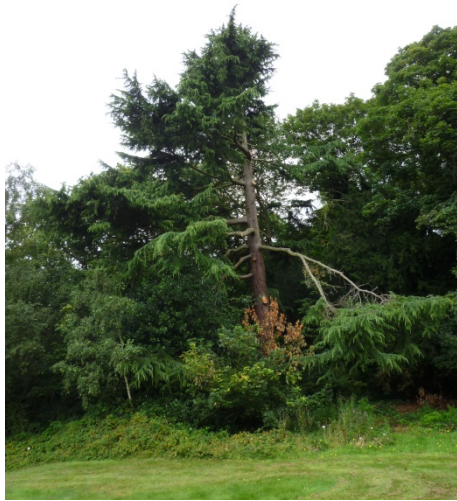
- 3.31 Trees nos 11 cedar, 959 cherry, and 965 false acacia, were located on a bank on the eastern edge of the woodland to the north west side of the house. Cedar no 11 was the tallest tree on the eastern edge of the wooded area (photo 11), however significant branch drop in 2011 have resulted in a lopsided crown and impaired condition. It has been allocated a Category B retention class.

P11: Cedar no 11 on northern edge of woodland belt showing lopsided canopy on account of branch drop.
