APPENDIX 3

PHOTOGRAPHS

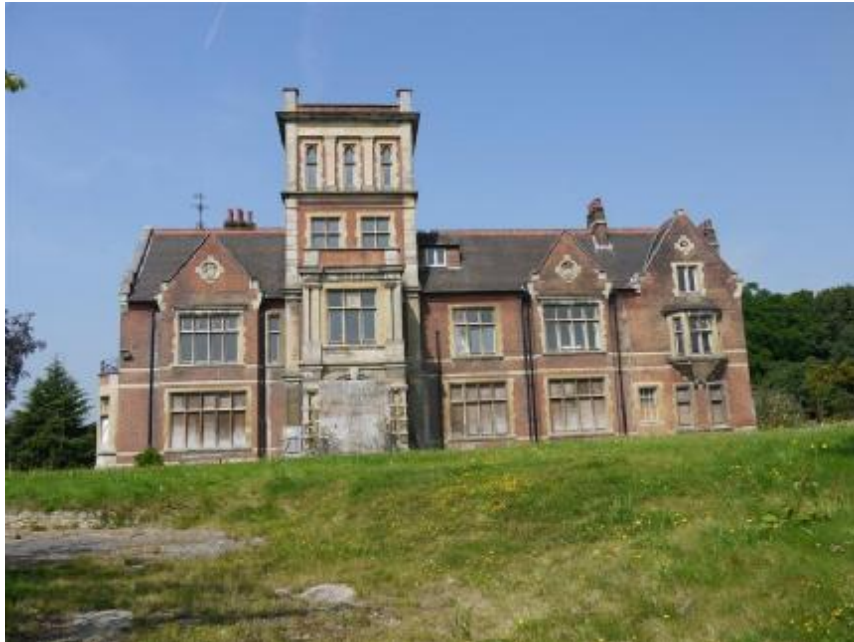
Photograph 1

Photograph Number	Description/Comment
1	Eastern Elevation – General view
2	Eastern Elevation – Southern (left hand) section – General view
3	Eastern Elevation – Showing stained brickwork, vegetation growth, worn masonry detail and defective brickwork joint to the Southern (left hand) section
4	Eastern Elevation – Southern (left hand) section – Showing vegetation behind the Gable wall, defective pointing to ridge tiles and loose/displaced plain tiles
5	Eastern Elevation – Southern (left hand) section – General view of the gable wall showing worn and stained brickwork and masonry surround to the First Floor window
6	Eastern Elevation – Southern (left hand) section – Showing worn and soiled masonry surround to the Ground Floor window
7	Eastern Elevation – Southern (left hand) section – Showing fracture to the masonry between the Ground and First Floor window openings
8	Eastern Elevation – Southern (left hand) section – Showing worn/eroded masonry surround, transoms, mullions and sill section to the Ground Floor window

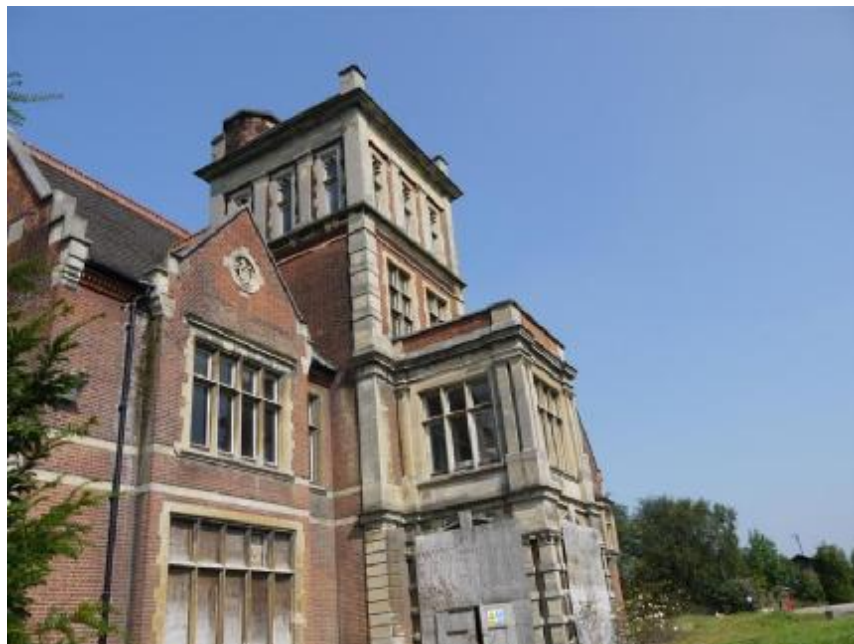
Photograph 10

9	Eastern Elevation – Southern (left hand) section – Showing worn brickwork to the gable, soiled brickwork adjacent to the rainwater pipe and soiled masonry surround to the First Floor window
10	Eastern Elevation – General view of the Main Entrance
11	Eastern Elevation – Showing worn and eroded brickwork to the entrance enclosure to the Flat Roof to the Tower and worn and eroded masonry projections and surrounds
12	Eastern Elevation – Showing worn and eroded masonry to the left hand of the Main Entrance at First Floor level
13	Eastern Elevation – Showing stained and eroded masonry to the left hand of the Main Entrance at Ground Floor level
14	Eastern Elevation – Showing worn and eroded masonry surrounds, soiled masonry detail and soiled brickwork to the upper section to the Tower and above the Main Entrance
15	Eastern Elevation – Showing soiled and worn masonry surround to the Main Entrance at Ground Floor level

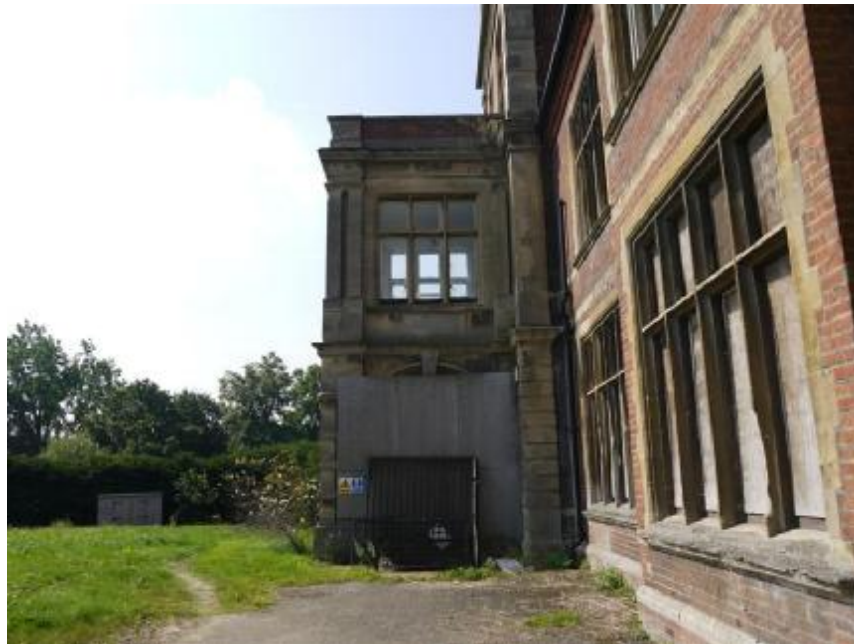
Photograph 17

Photograph Number	Description/Comment
17	Eastern Elevation – Showing soiled and worn masonry to the right hand of the Main Entrance
18	Eastern Elevation – Showing vegetation growth and worn and eroded masonry to the right hand of the Main Entrance at high level
19	Eastern Elevation – Showing vegetation growth and worn and eroded masonry details, sills and projections to the right hand of the Main Entrance at mid-height
20	Eastern Elevation – Showing damaged, worn and eroded masonry to the right hand of the Main Entrance doors
21	Eastern Elevation – Showing worn paving to the Main Entrance
22	Eastern Elevation – Central Area – Showing worn and missing ridge tiles, minor vegetation growth to the gable, uneven/displaced and patch repaired plain tiles and window addition at Second Floor level
23	Eastern Elevation - Northern (right hand) section)– Showing uneven ridge tiles, worn and eroded brickwork and masonry to the chimney stack and worn, soiled and patch repaired brickwork and vegetation adjacent to the rainwater pipe

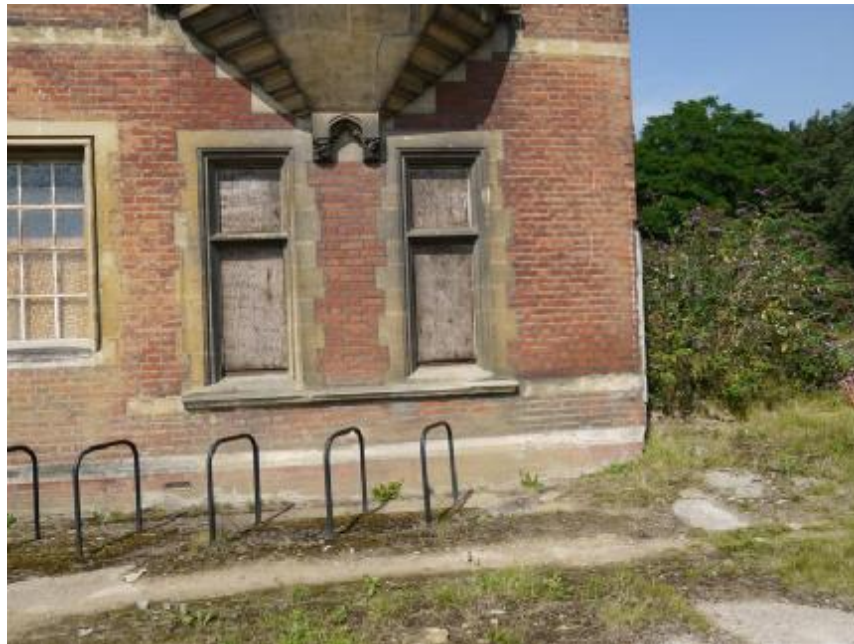
Photograph 31

30	Eastern Elevation – Northern (right hand) section – Showing fracture to the brickwork above the Ground Floor window opening
31	Eastern Elevation – Northern (right hand) section – Showing worn and soiled brickwork and masonry surrounds to the Ground Floor windows
32	Southern Elevation – General view

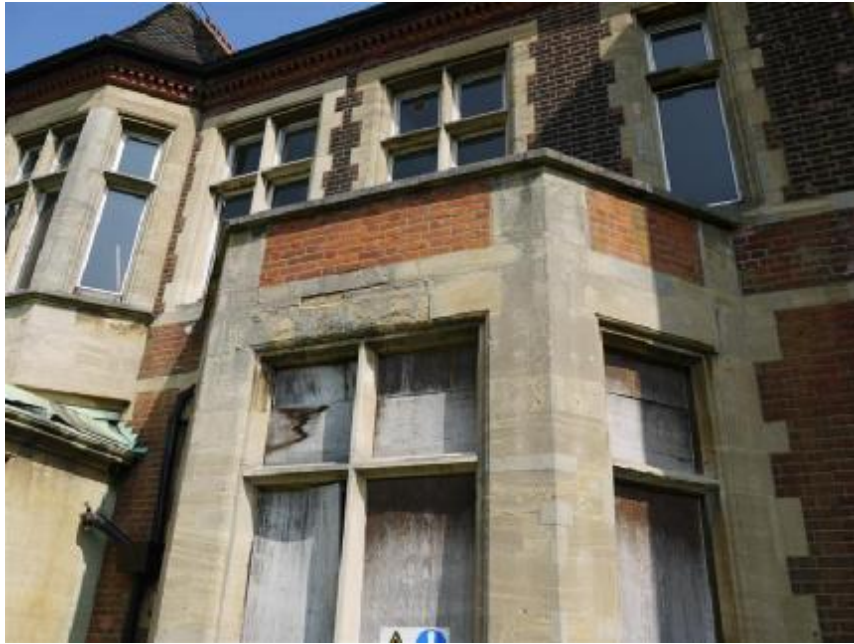
Photograph 47

46	Southern Elevation – Central section – Showing fractured masonry above the left hand Bay window and worn and eroded masonry surfaces
47	Southern Elevation – Central section showing worn and eroded masonry surfaces

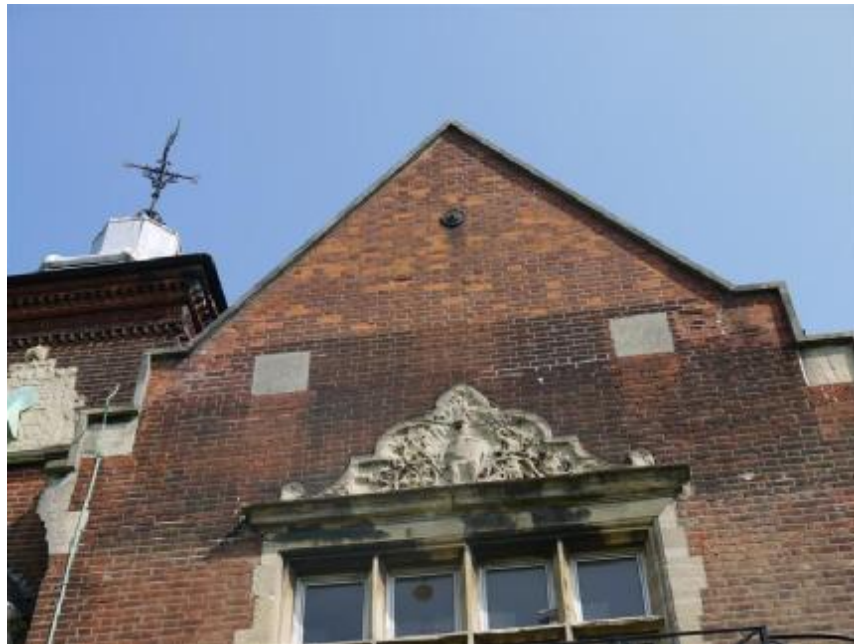
Photograph 55

54	Southern Elevation – Eastern (right hand) section – Showing worn and eroded brickwork joints to the Gable wall, soiled and spalled areas of brickwork and brickwork fracture beneath the coping to the right hand
55	Southern Elevation – Eastern (right hand) section – Showing structural tie to the Gable and worn and soiled brickwork and masonry surfaces
56	Southern Elevation – Eastern (right hand) section – Showing worn and eroded masonry surfaces to the Ground Floor window
57	Southern Elevation – Eastern (right hand) section – Showing worn and soiled brickwork surfaces and worn and eroded masonry surfaces to the First Floor window
58	Western Elevation – General view
59	Western Elevation – Northern (left hand) section – Showing non-original extension and chimney stack
60	Western Elevation –Northern (left hand) section – General view showing worn and soiled brickwork and masonry surfaces
61	Western Elevation – Northern (left hand) section – Showing missing ridge tile and worn and soiled brickwork to the gables

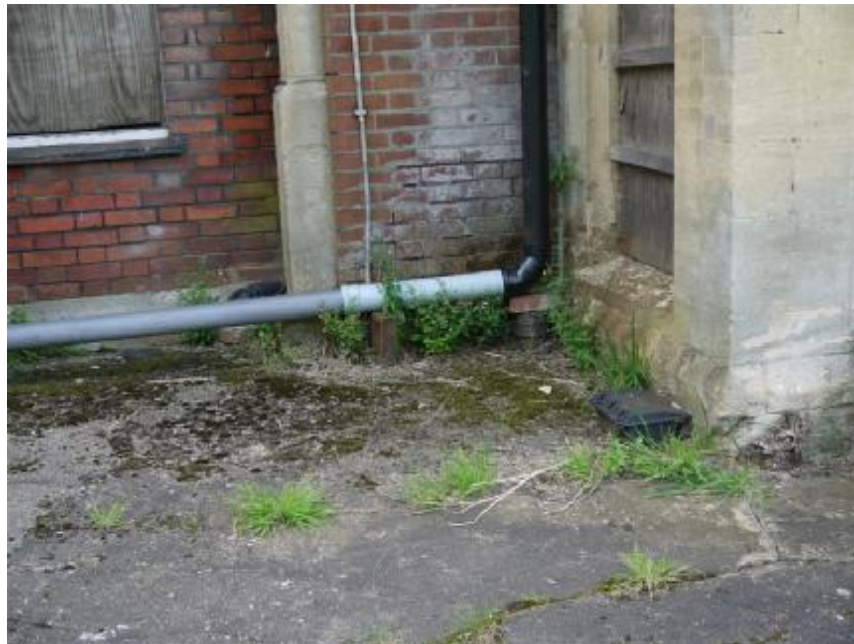
Photograph 65

Photograph Number	Description/Comment
64	Western Elevation – Northern (left hand) section – Showing worn and eroded masonry corbel to the Gable
65	Western Elevation – Northern (left hand) section – Showing soiled brickwork at low level and temporary rainwater pipe connection
66	Western Elevation – Northern (left hand) section – Showing open joint below the masonry corbel and adjacent brickwork
67	Western Elevation – Northern (left hand) section – Showing worn and soiled brickwork surfaces and open joint to the lintel above the First Floor window opening
68	Western Elevation – Northern (left hand) section – Showing worn and soiled masonry to the Ground Floor window
69	Western Elevation – Northern (left hand) section – Showing damaged and soiled brickwork to the right hand of the Ground Floor window
70	Western Elevation – Northern (left hand) section – Showing damaged masonry feature above the window to the right hand of the single storey Bay projection

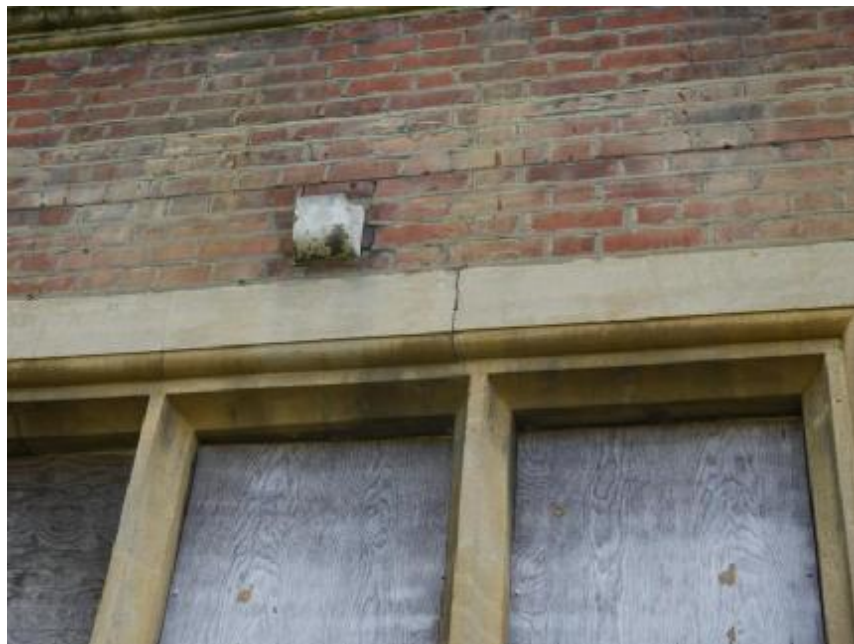
Photograph 72

71	Western Elevation – Central Section – Showing worn and soiled brickwork to the Gable and worn and eroded masonry surround and transoms to the First Floor windows
72	Western Elevation – Central section – Showing open joint to the masonry surround above the Ground Floor window opening and soiled brickwork above
73	Western Elevation – Central section - Showing worn and eroded masonry sill/transoms to the Ground Floor external door opening
74	Western Elevation – Central Section – Showing worn surfaces to the timber balustrade/handrail at First Floor level and fracture to the masonry surround above the Ground Floor window
75	Western Elevation – Southern (right hand) section – Showing worn and eroded brickwork and masonry at low level
76	Western Elevation – Southern (right hand) section – Showing worn and soiled brickwork to the Gable and parapet wall with heavily worn and eroded masonry surfaces above the First Floor window

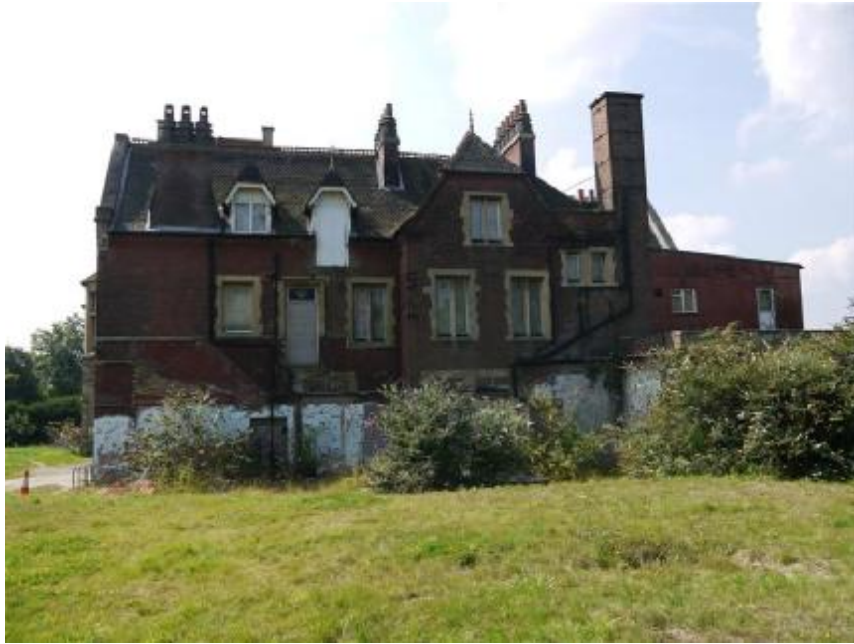
Photograph 79

77	Western Elevation – Southern (right hand) section – Showing heavily worn/patch repaired masonry surfaces to and below the First Floor window
78	Western Elevation – Southern (right hand) section – Showing worn and soiled masonry with support strap below the displaced masonry above the Ground Floor window
79	Northern Elevation – General view

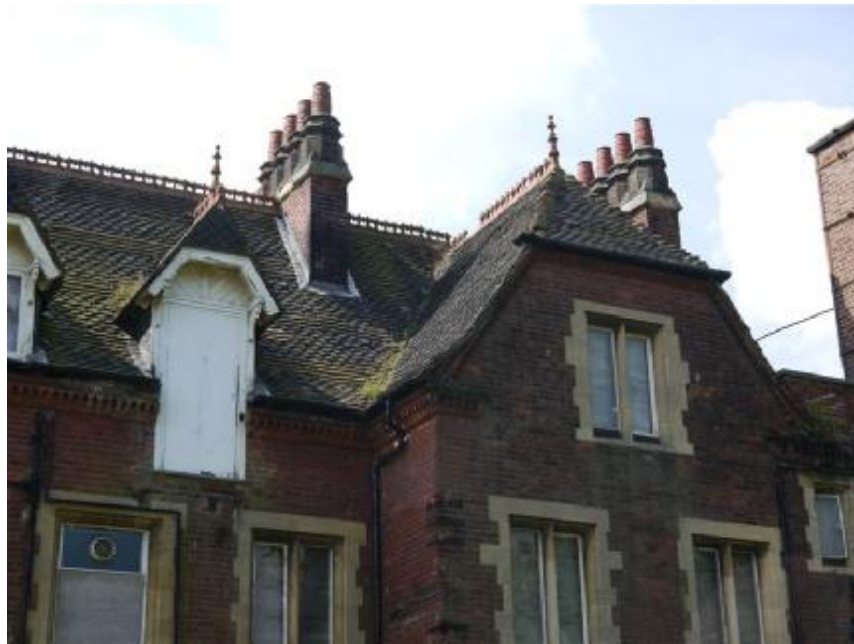
Photograph 81

Photograph Number	Description/Comment
80	Northern Elevation – Eastern (left hand) section - Showing vegetation to the pitched roof and areas of displaced plain tiles
81	Northern Elevation – Central section – Showing vegetation to the pitched roof, displaced and patch repaired plain tiles, worn and eroded brickwork to the chimney stacks and soiled/worn brickwork generally
82	Northern Elevation – Western (right hand) section – Showing the non-original extension and chimney stack, vegetation to brickwork and general staining to brickwork surfaces
83	Northern Elevation – Western (right hand) section – General view
84	Northern Elevation – Eastern (left hand) section – Showing fractured brickwork, soiled/worn brickwork surfaces and damaged masonry band where building previously removed
85	Northern Elevation – Eastern (left hand) section – Showing toothed and soiled brickwork and plaster surfaces where extension building previously demolished

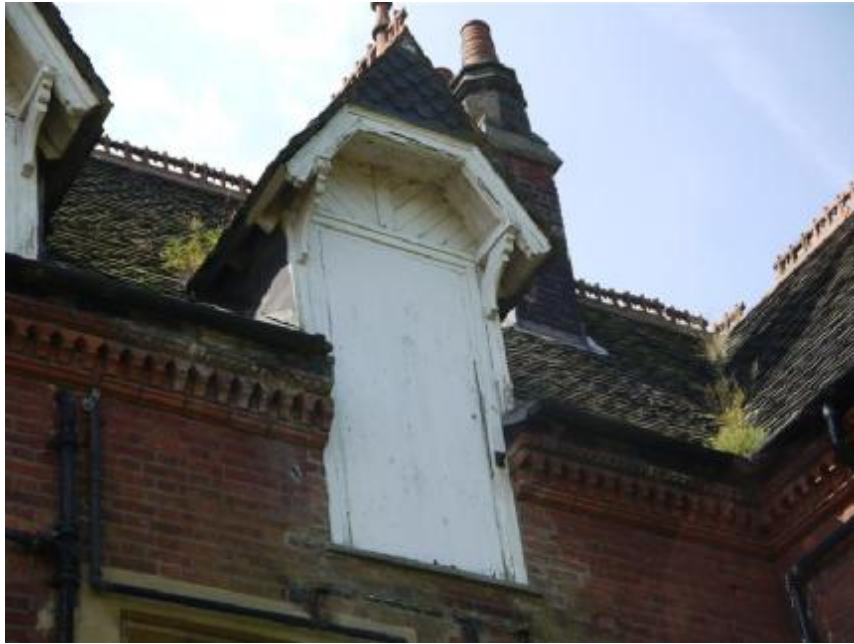
Photograph 87

86	Northern Elevation – Eastern (left hand) section – Showing heavily soiled brickwork to the chimney stack
87	Northern Elevation – Central section – Showing vegetation to the pitched roof and soiled brickwork adjacent to the First Floor door opening
88	Northern Elevation – Western (right hand) section – showing heavily soiled brickwork, straps to the left hand of the Gable and vegetation to the high level brickwork
89	Northern Elevation – Western (right hand) section – Showing low level plaster to the external wall where extension building previously demolished
90	Northern Elevation – Central section showing stained and infilled brickwork and low level plaster to the external wall where extension building previously demolished
91	Garden area facing towards to the Hampstead Lane Site Entrance
92	Vehicle circulation area adjacent to the Eastern Elevation
93	Access path adjacent to the Eastern Elevation

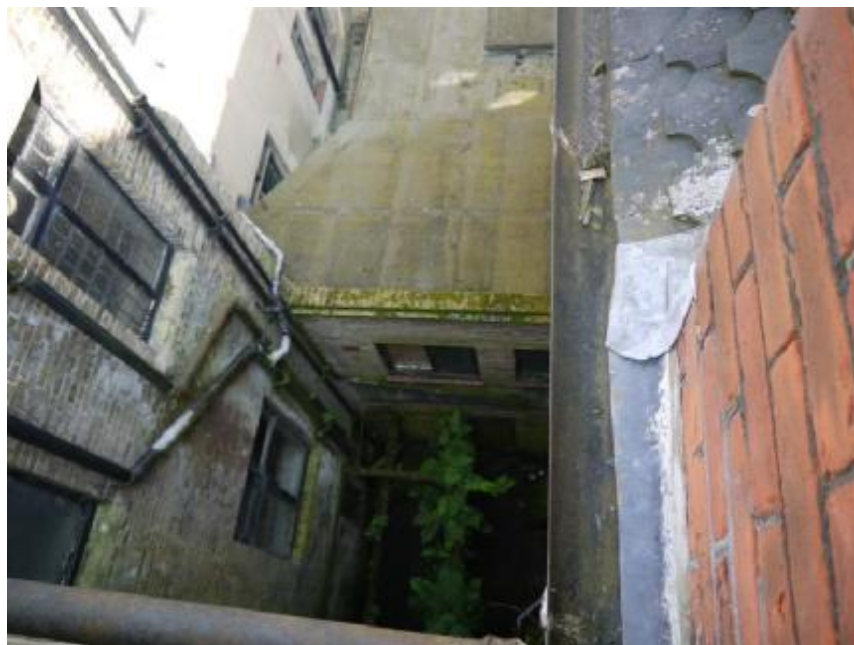
Photograph 116

Photograph Number	Description/Comment
115	Internal Elevations – Showing soiled brickwork beneath the overflows to the Light Well elevation and damaged coping to the parapet to the mineral felt covered flat roof area
116	Internal Elevations – Showing heavily stained brickwork at Ground Floor level and vegetation growth at Basement level
117	Internal Elevations – Showing heavily stained brickwork at Ground Floor level and vegetation growth at Basement level
118	Internal Elevations – Showing worn and eroded brickwork to the chimney stack to the right hand of the Eastern elevation and damaged ridge tiles to the pitched roof to the internal of the Light Well
119	Internal Elevations – Showing the worn brickwork and masonry to the central chimney stack to the Eastern elevation
120	Roof Areas – General view of the lead feature roof to the Western Elevation and the adjacent pitched roof areas
121	Roof Areas – General view of the pitched roof to the left hand of the Eastern Elevation showing vegetation to the valley areas

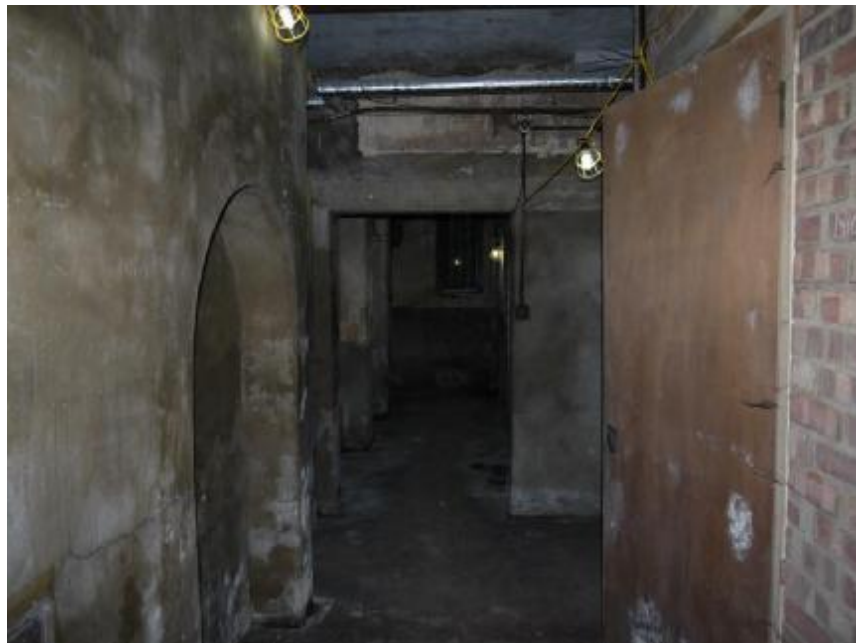
Photograph 264

261	Basement – Showing water damaged shelving to the central area of the Southern section of the Basement
262	Basement – Showing fungal growth to the wall within the Southern section of the Basement
263	Basement – Showing mould growth to the internal door to the Southern section of the Basement
264	Basement – General view of the Circulation area to the Southern section of the Basement
265	Basement – General view of the Circulation area to the Northern section of the Basement
266	Basement – Showing fungal growth to the floor/wall to the Northern section of the Basement
267	Basement – Showing hot water tank
268	Basement – Showing the corroded rainwater pipe to the Northern section
