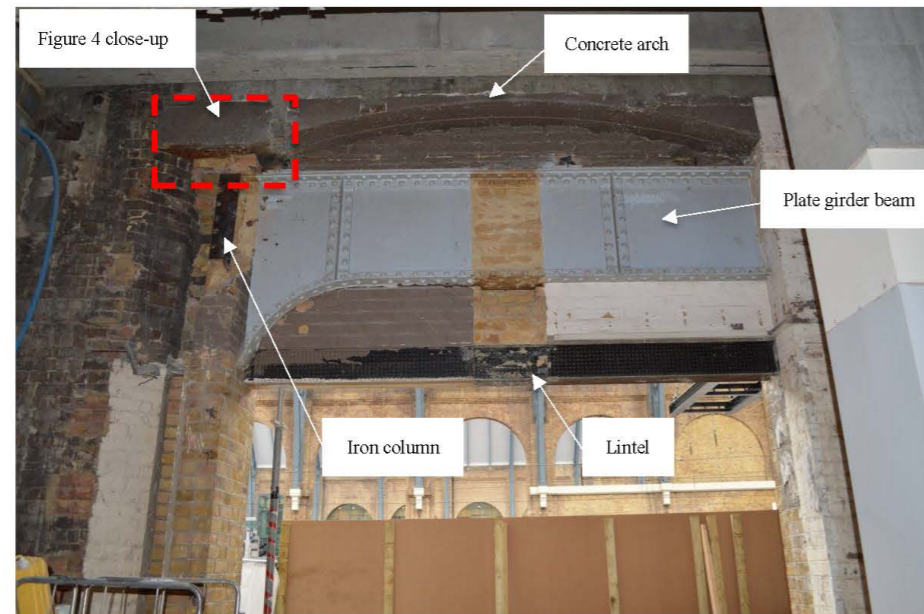
Figure 3: Rear elevation of infill panel, with annotations

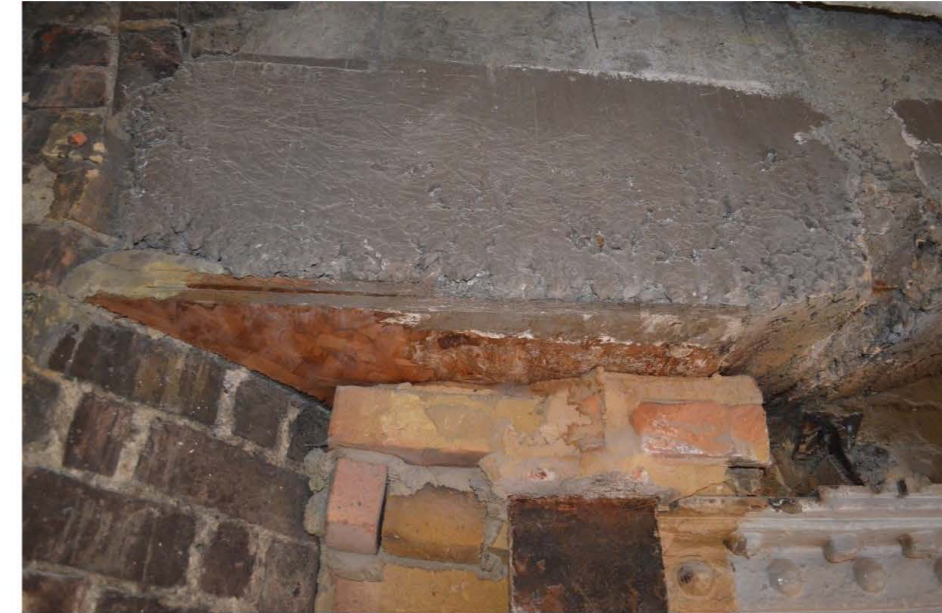
Adjacent to this layer of bricks beneath the timber packers is the end of a metal section attached to the top flange of the plate girder beam (Figure 4). Similar sections can be seen at regular centres on the beam across all three arched openings.

Figure 4: Close up of connection detail at left hand end of concrete arch

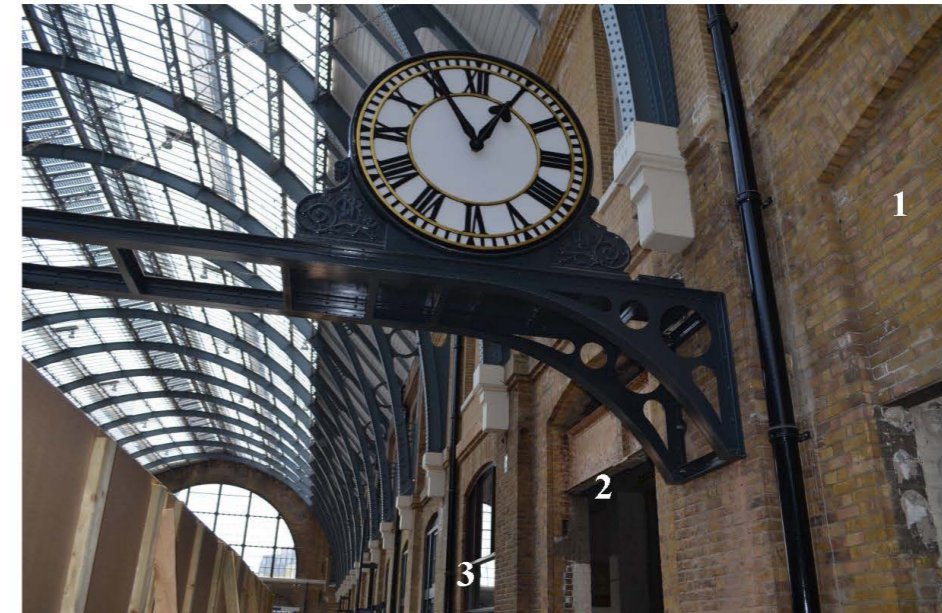
The clock (Figure 5) is supported between archways 1 and 2 and is fixed in place with a series of 8 bolts drilled through the masonry pier (Figure 6). When drilling these bolt holes, the contractor reported that no metalwork was impacted in the drilling of these holes.

Figure 5: Clock located between central and right hand opening on ground floor of facade (as viewed from platform side). Arches reviewed during site investigations numbered on diagram.
