## 4 Assessment

### 4.1 Archway 1

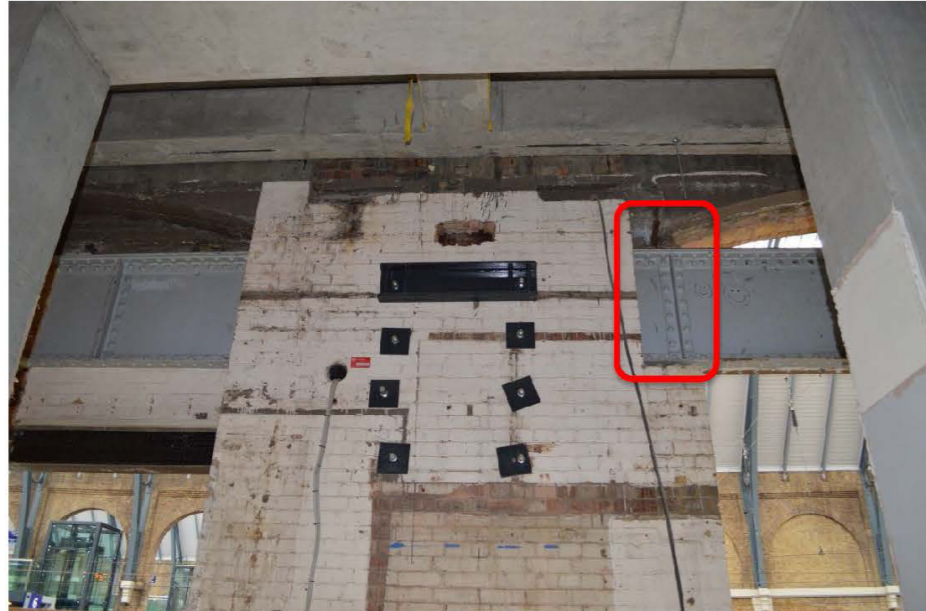
Figure 6: Rear view of connection between steelwork supporting clock and masonry pier. Image shows archway 1 on left hand side and archway 2 on right. Brickwork appears to have been removed around plate girder beam (in red).

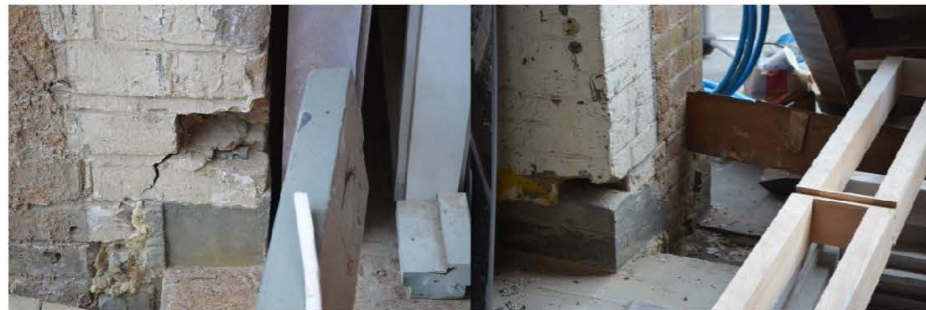
Figure 7: Individual brick removed near base of piers of central opening. From left image, crack noted emanating from removed brick.

Individual bricks have been removed near the base of the piers of the central openings (Figure 7). This area is to be filled with a Sika®-Armorex® L2 High Flow cementitious grout or similar to avoid further damage to the masonry pier.

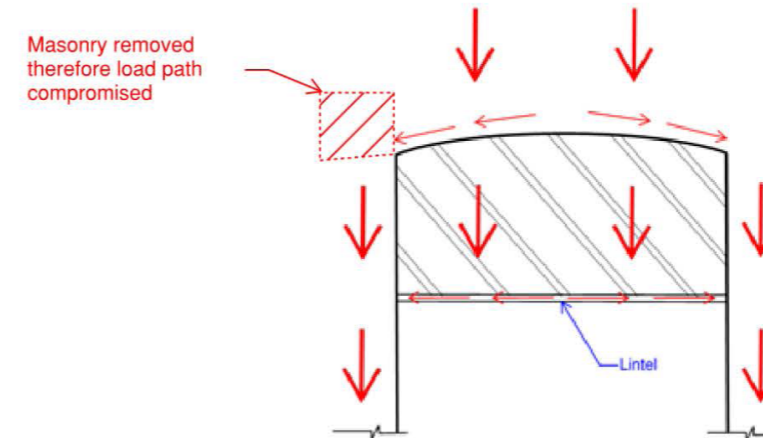
- The concrete arch (likely to be constructed after the bomb damage, Figure 3), is not adequately supported at the north end. The brickwork that would have provided some support has recently been removed and shuttering plywood appears to have been left in place (Figure 9).
- The masonry infill does not appear to be supporting the arch above (the gap between the infill panel and the arch above is not fully mortared on the inside face; the similar panel in archway 2 has been removed without any problems). However, because of the removal of the brickwork (previous point) the infill may be providing some temporary support to the arch (Figure 8).

Figure 8: Load path for front elevation of infill panel.

Prior to the removal of the infill panel, the concrete arch, visible on the rear elevation must have a suitable load path. Initially, this will involve the temporary support of the arch, either from the plate girder beam or from the floor slab (to be decided by contractor). Once these temporary works are in place, a concrete column shall be constructed up to the underside of the arch (see ENG-SKE-TSOS-001), whilst ensuring that the pouring of the column takes place in suitable increments to prevent blowout of the existing masonry structure. Ties shall also be required between the concrete and existing masonry to ensure the two act in tandem in resisting the vertical load from above. Once these works have been completed, the infill panel can be removed as demonstrated in the indicative construction sequence shown in ENG-SKE-TSOS-001. Care must be taken not to damage the front façade when removing the infill panel as this will have important heritage implications.

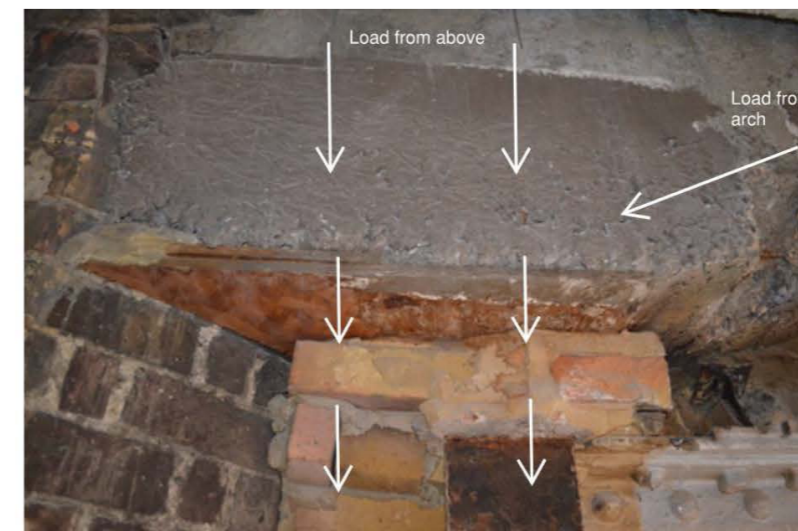
Figure 9: Load path from concrete arch to masonry pier and iron column.

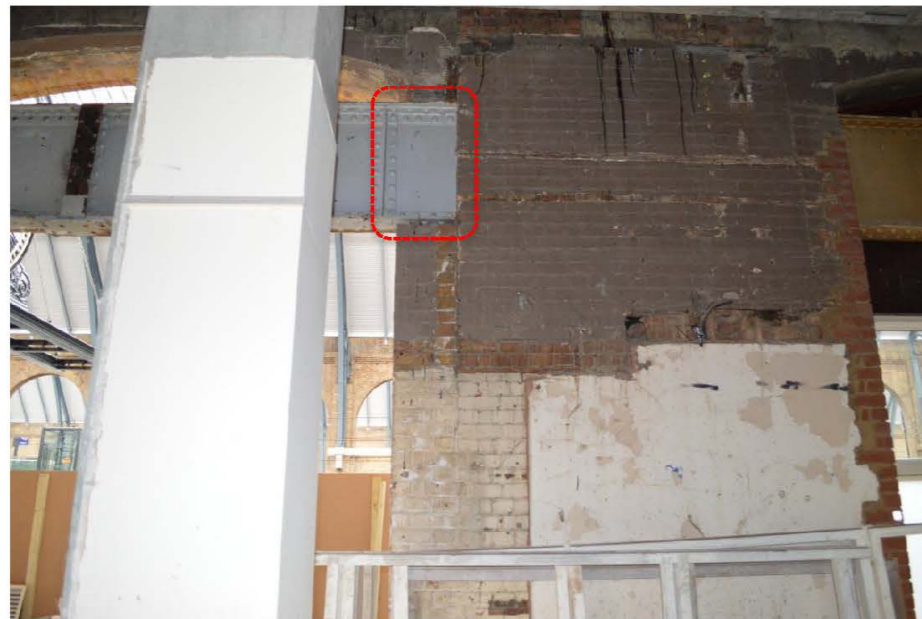
- Brickwork appears to have been removed at both ends, that would have been partially supporting the concrete arch above (Figure 11). At present, archway is only supported by brick packing onto plate girder beam.
- Beam is not continuous through masonry piers (as not encountered during drilling for clock), and beam bearing left onto brickwork unknown (Figure 10). However once area has been infilled (as recommended in section 5), beam will be carrying no significant load.
- Brick pier is not fully supported at ground level (Figure 7). Pier below plate girder beam is of more recent construction.

Figure 11: Masonry pier adjacent to central opening with brickwork removed around plate girder beam. Similar detail at other end.

During the visual inspection, it was noted that in archway 2 the brickwork around the plate girder beam has been removed (Figure 11). This will affect the load path from the arch above into the masonry pier. To remedy this, a concrete infill shall be implemented (see ENG-SKE-TSOS-004 for details).
