Photographic survey of brickwork for 2 Clorane Gardens  
(To accompany file note dated 12 September 2013)

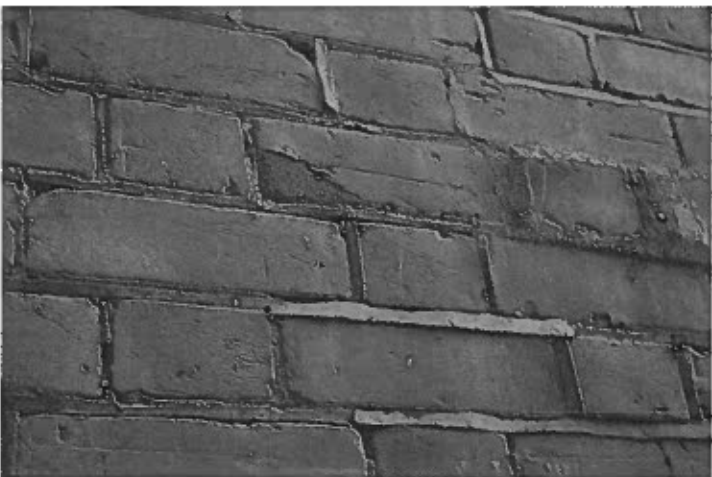
pointing problems07.JPG

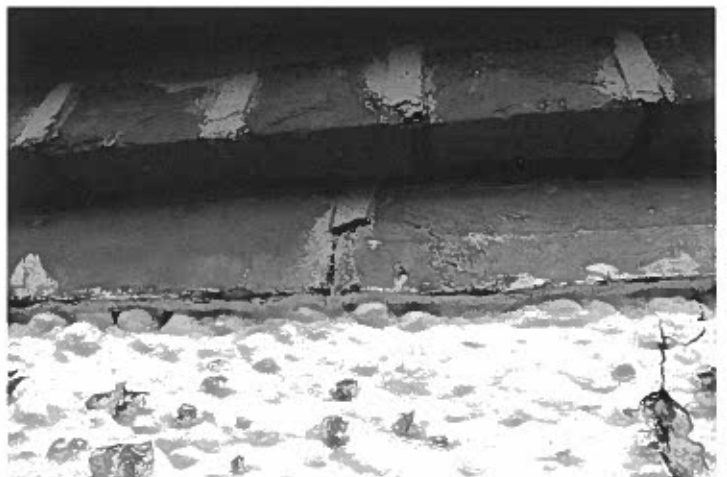
pointing problems08.JPG

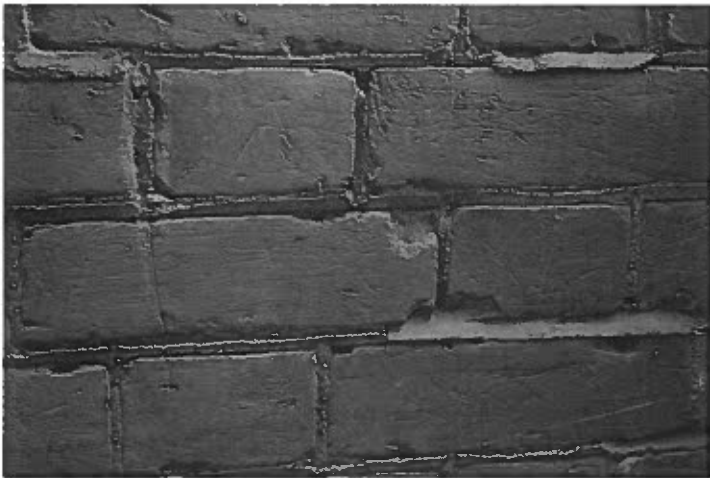
pointing problems09.JPG

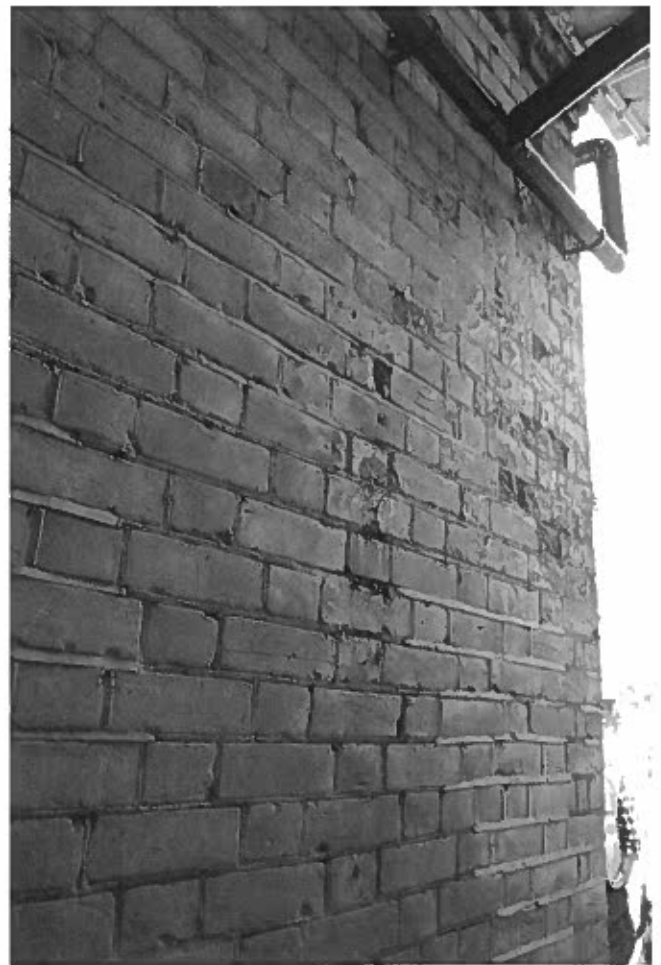
pointing problems and spalling10.JPG

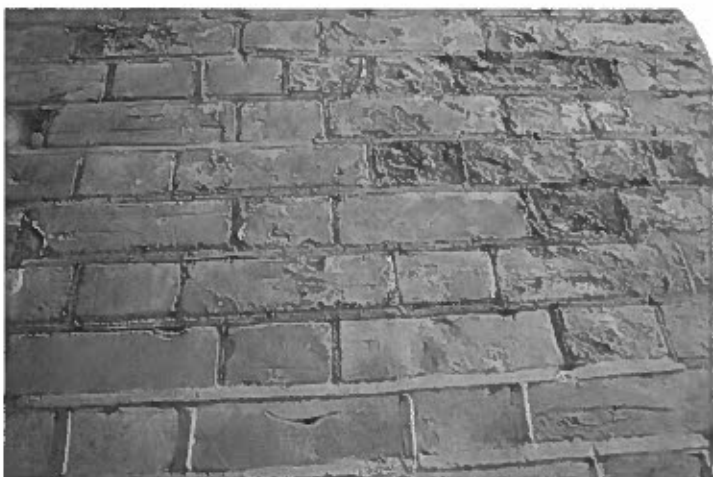
pointing problems and spalling11.JPG

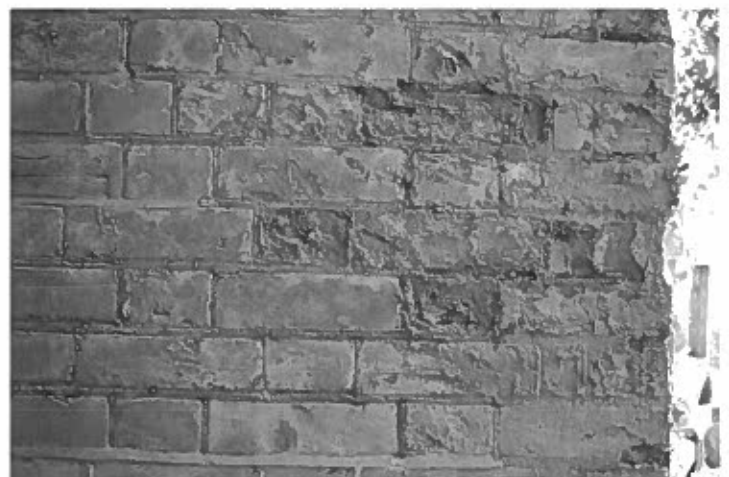
spalling12.JPG
