4216 - The Elms Veranda - Condition Report

<u>Description :</u>	Grade II listed detached house. 1838 - 40 by George Basevi. With later alterations. A tented veranda with thin 'cast' iron columns
<u>Address :</u>	N6 6HS
<u>Generated on :</u>	10/06/2013
<u>Building stages :</u>	- Condition Report
<u>Building trades :</u>	- Masonry - Metalworks
<u>Stakeholder :</u>	
<u>Drawings :</u>	- Columns - 001 (Condition Report) - Columns - 002 (Condition Report) - Columns - 003 (Condition Report) - Columns - 004 (Condition Report) - Gutter detail (Condition Report) - Reusable strip (Condition Report) - Roof members - 001 (Condition Report) - Roof members - 002 (Condition Report) - Roof members - 003 (Condition Report) - Roof members - 004 (Condition Report) - Tie bars (Condition Report) - Zinc roofing (Condition Report)

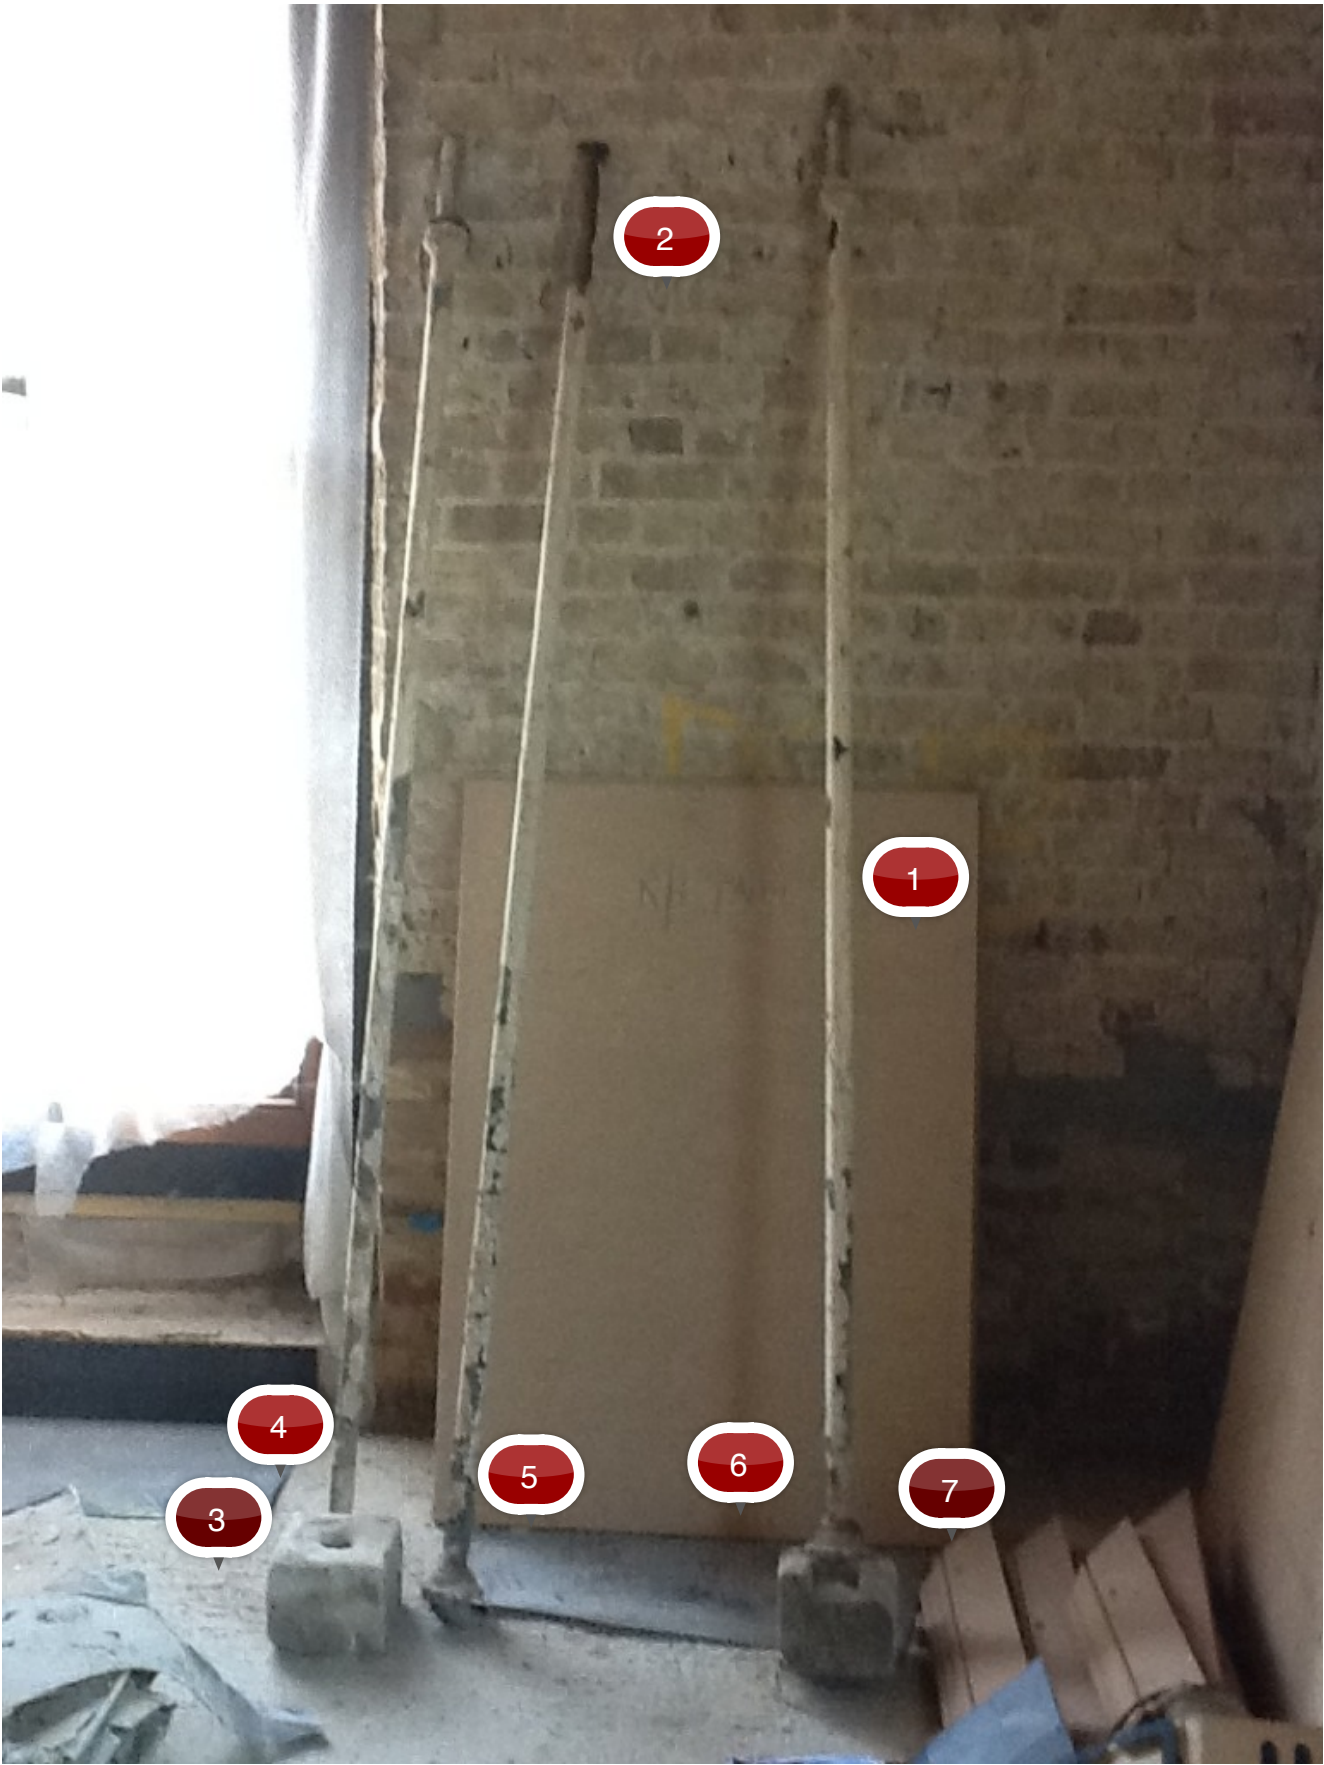
Observation #1

Column 001:

The overall dimensions - 2490mm x 40mm.

NB. Assumed same for each column - possible wrought iron considering the form of corrosion.

Stone Base dimensions - 180mm x 180mm x 150mm (assumed the same for each.)

5 no. Base. Stones remain - 1 detached - 1 missing.

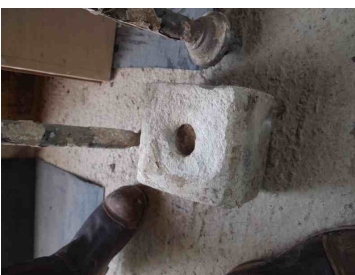
Observation #3

Column 003:

Still attached to stone base in reasonable condition with minor weathering. For dimensions see observation #1.

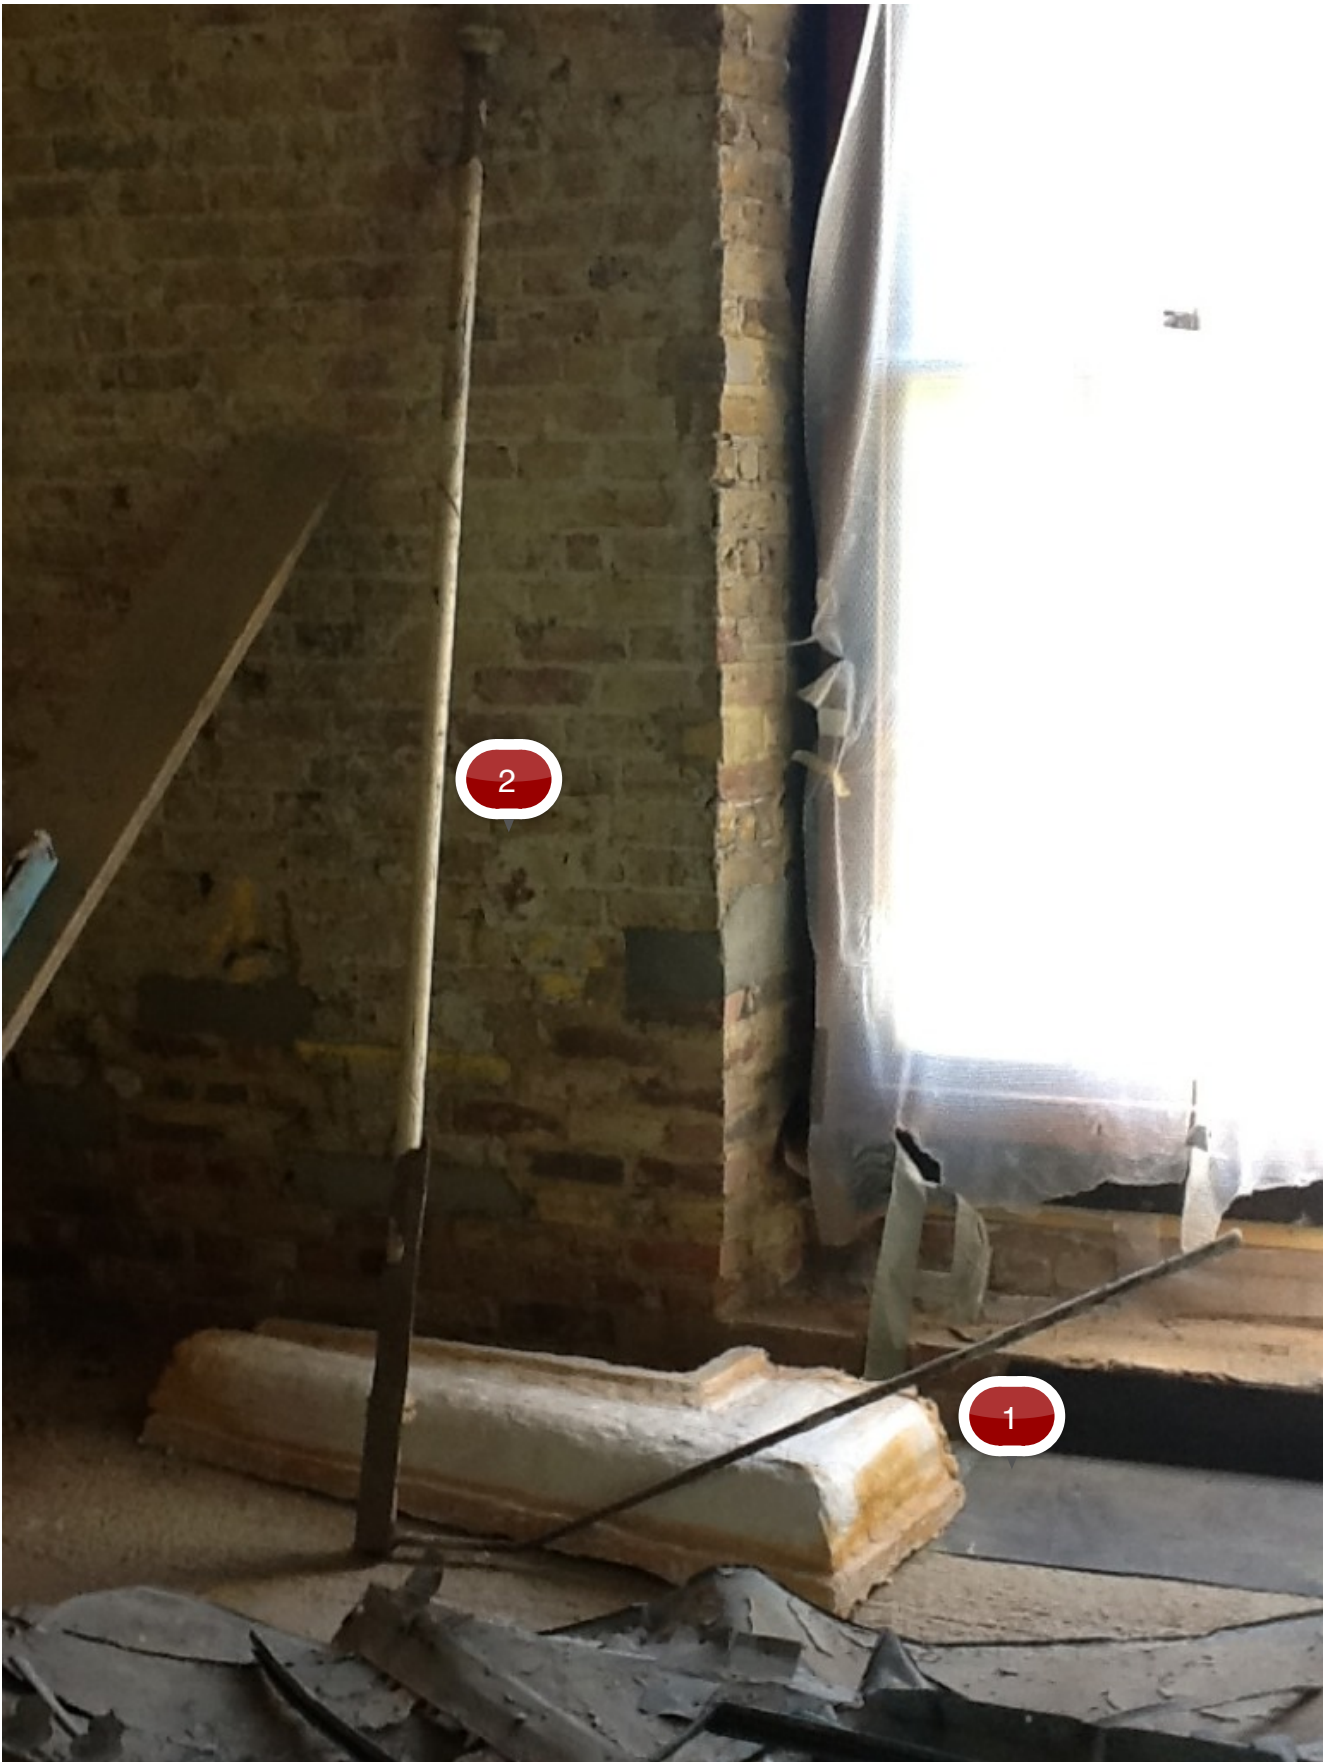
Observation #1

Round tie bar 20mm diameter - 1500mm overall length, still attached to column 004.

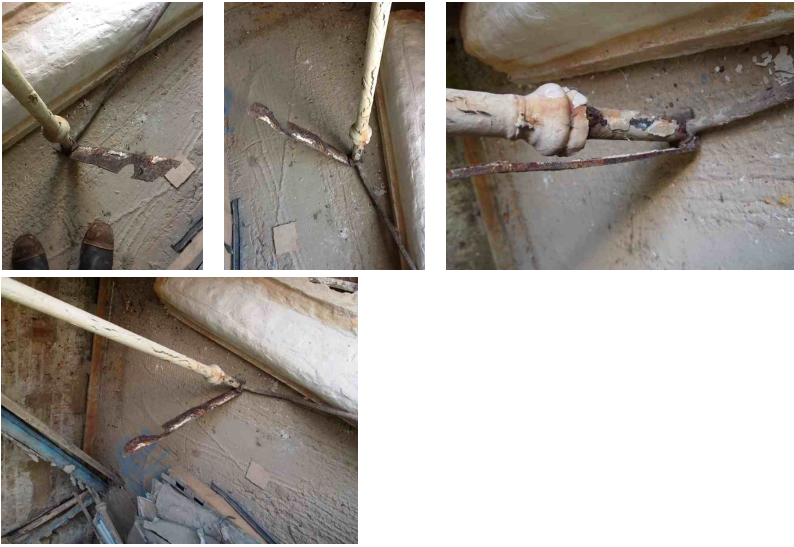
Observation #2

Slight corrosion above the collar at the base of column 004.

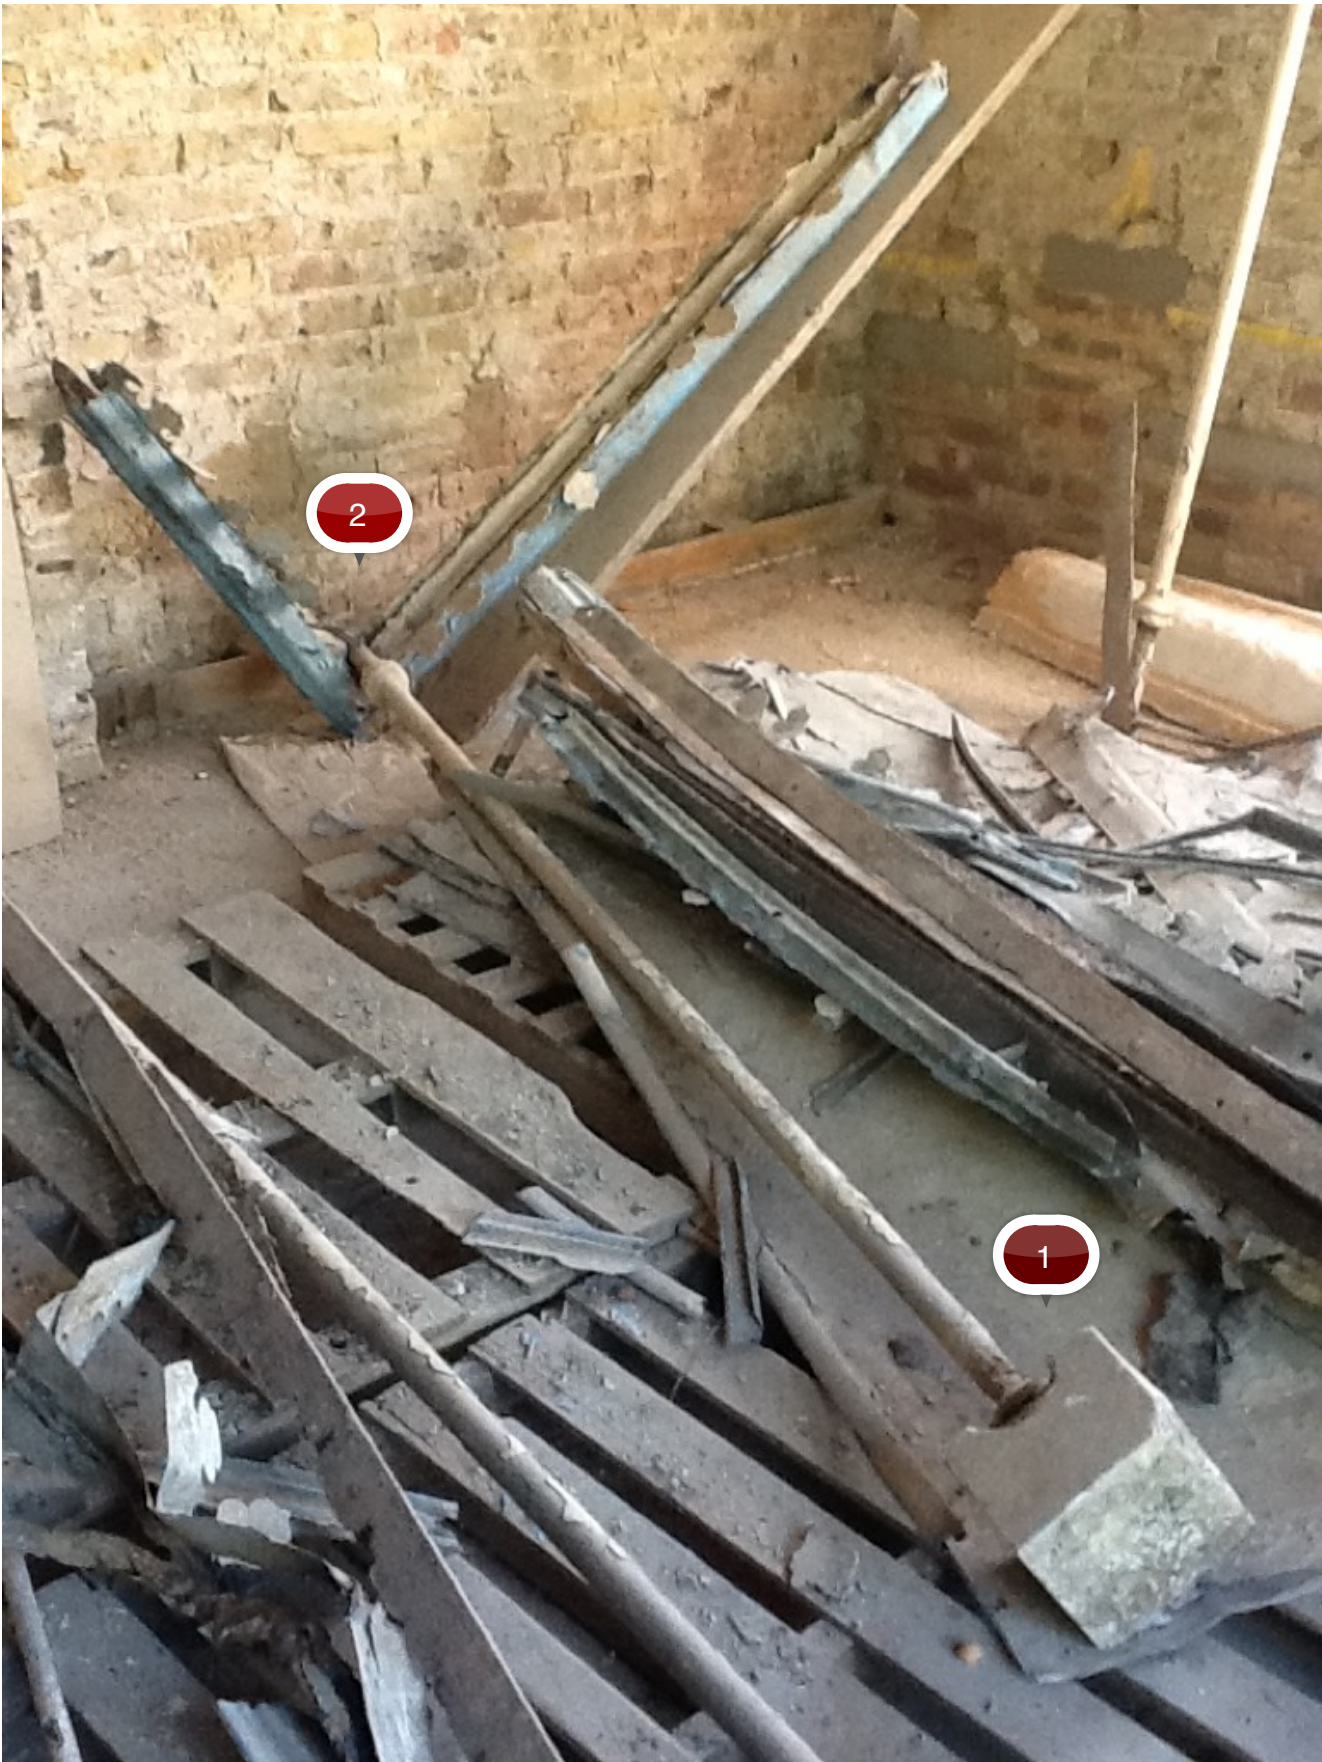
Observation #1

Slight waste at base of column 005, with broken base stone - as on column 001

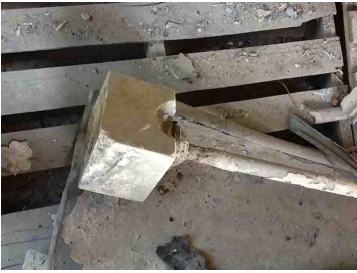
Observation #2

Column 005 remains attached to guttering, steel plate structure and decorative zinc work. Evidences construction methods.

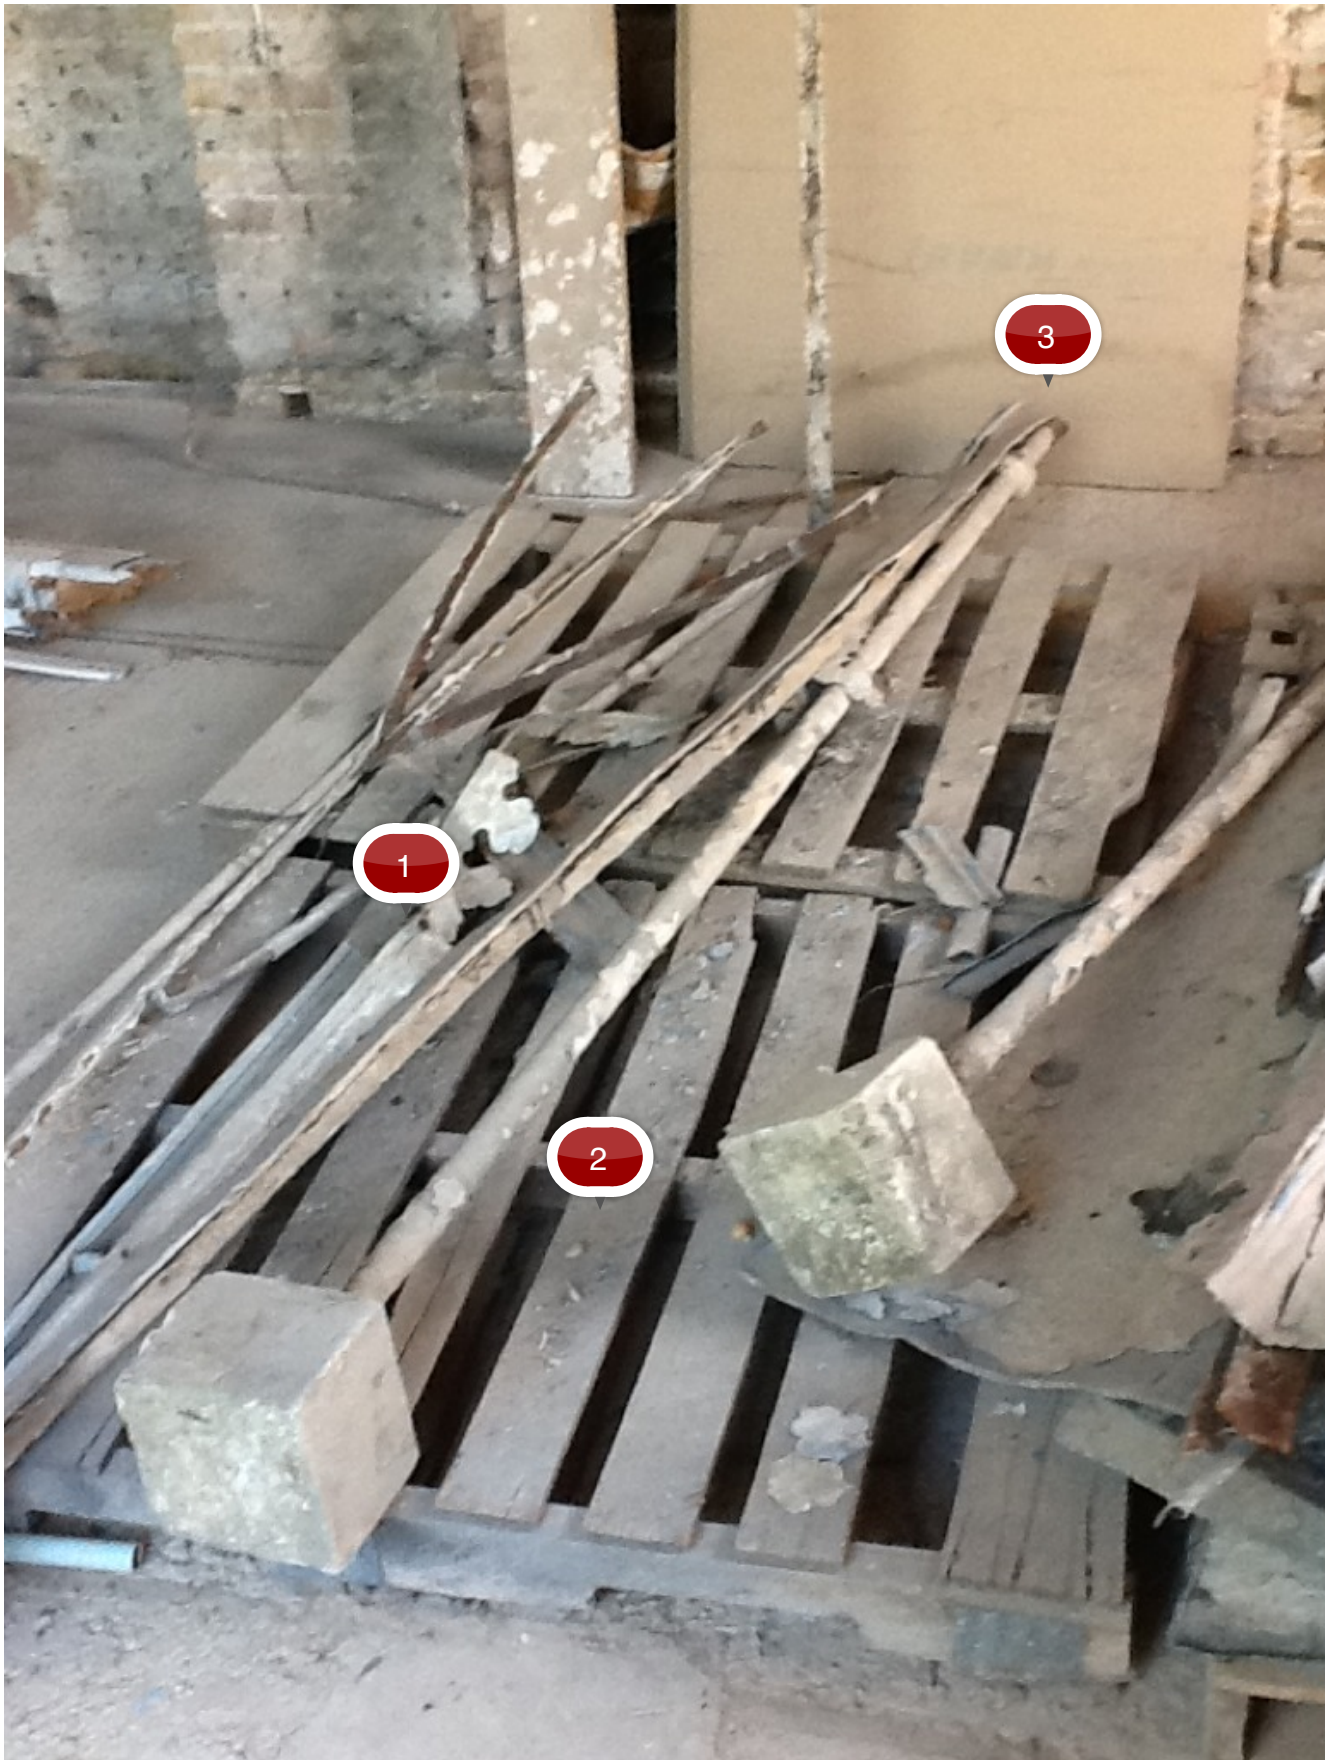
Observation #1

Steel strip 3540mm x 60mm x 6mm - with excessive corrosion along the length. Remains attached to column 006.

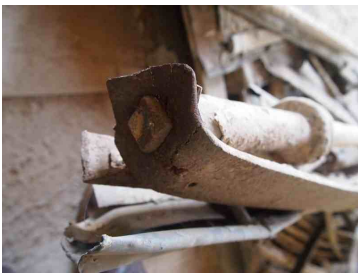
Observation #3

Connection to steel strip in tact

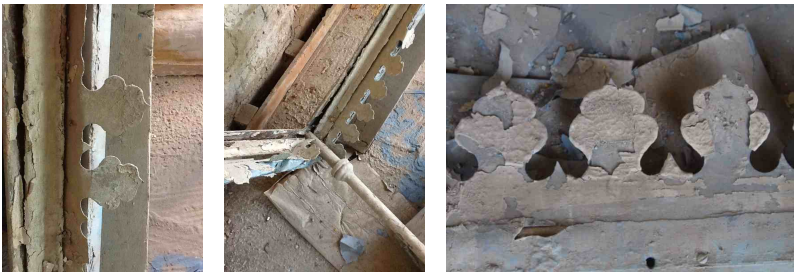
Observation #3

Section detail. Most guttering severely damaged or distorted.

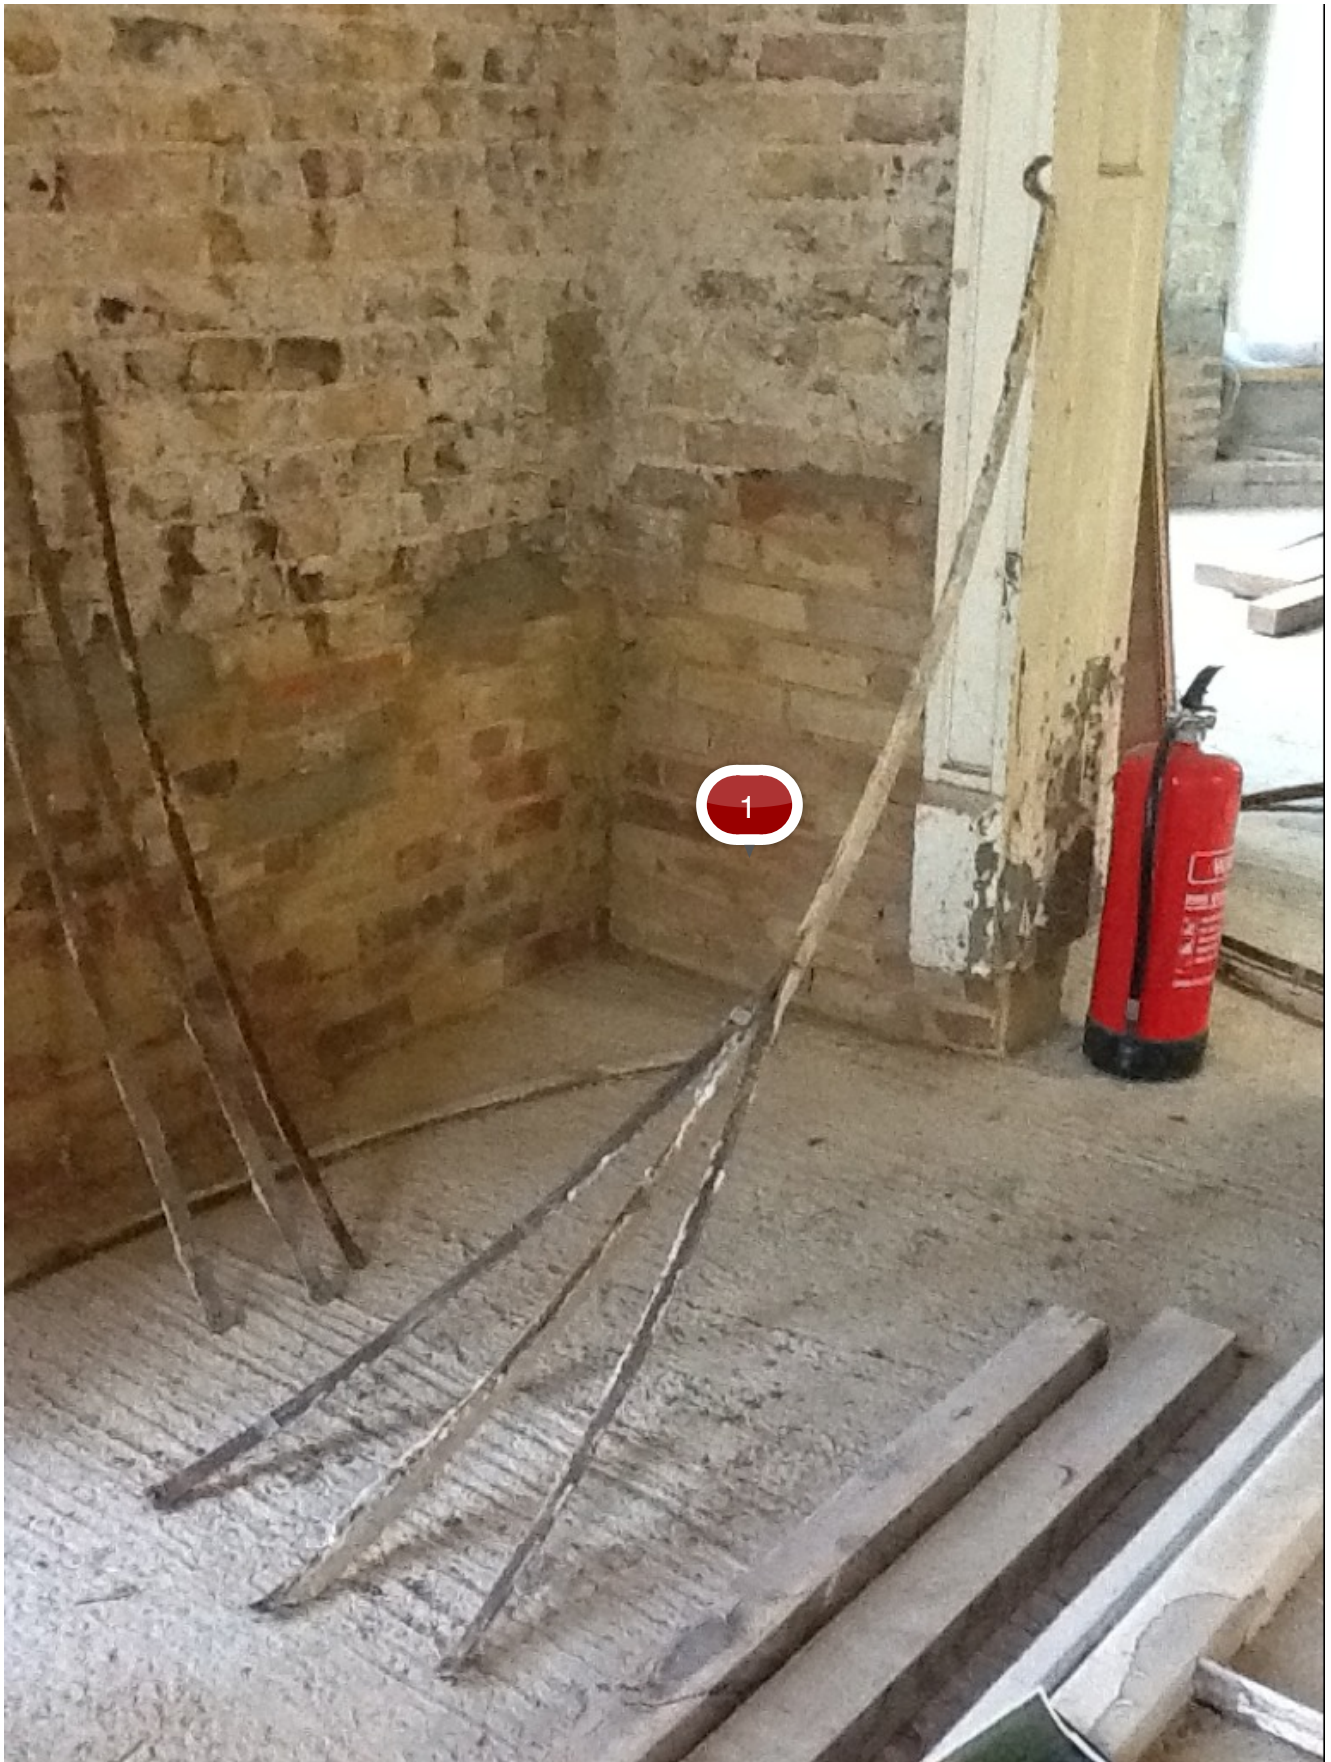
Observation #1

Most intact roof member, with sections still attached. Evidence of 'plaster' coating as per others.

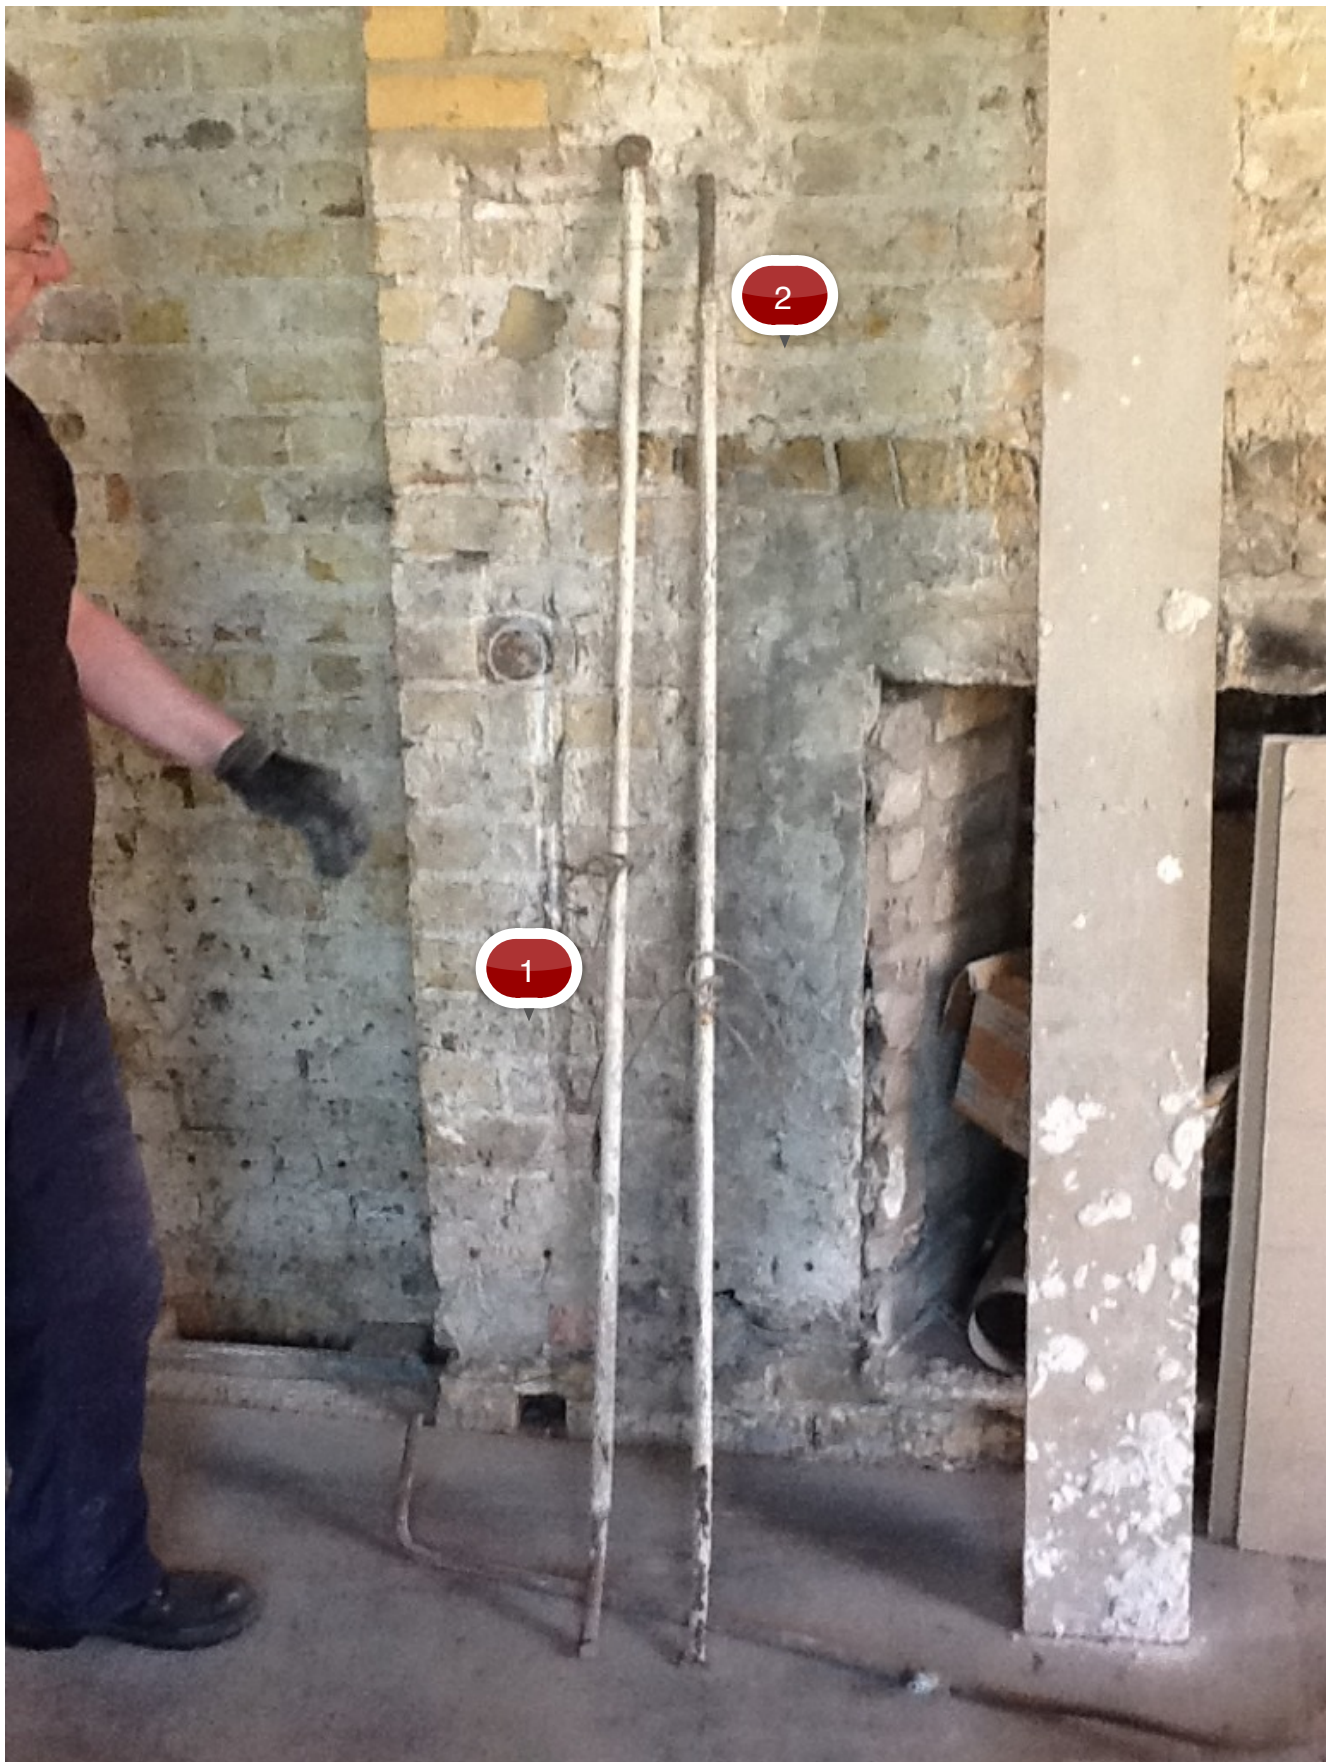
Observation #1

Tie bar:
1740mm x 20 diameter with broken end. Connection point intact.

Missing connection point and broken end.

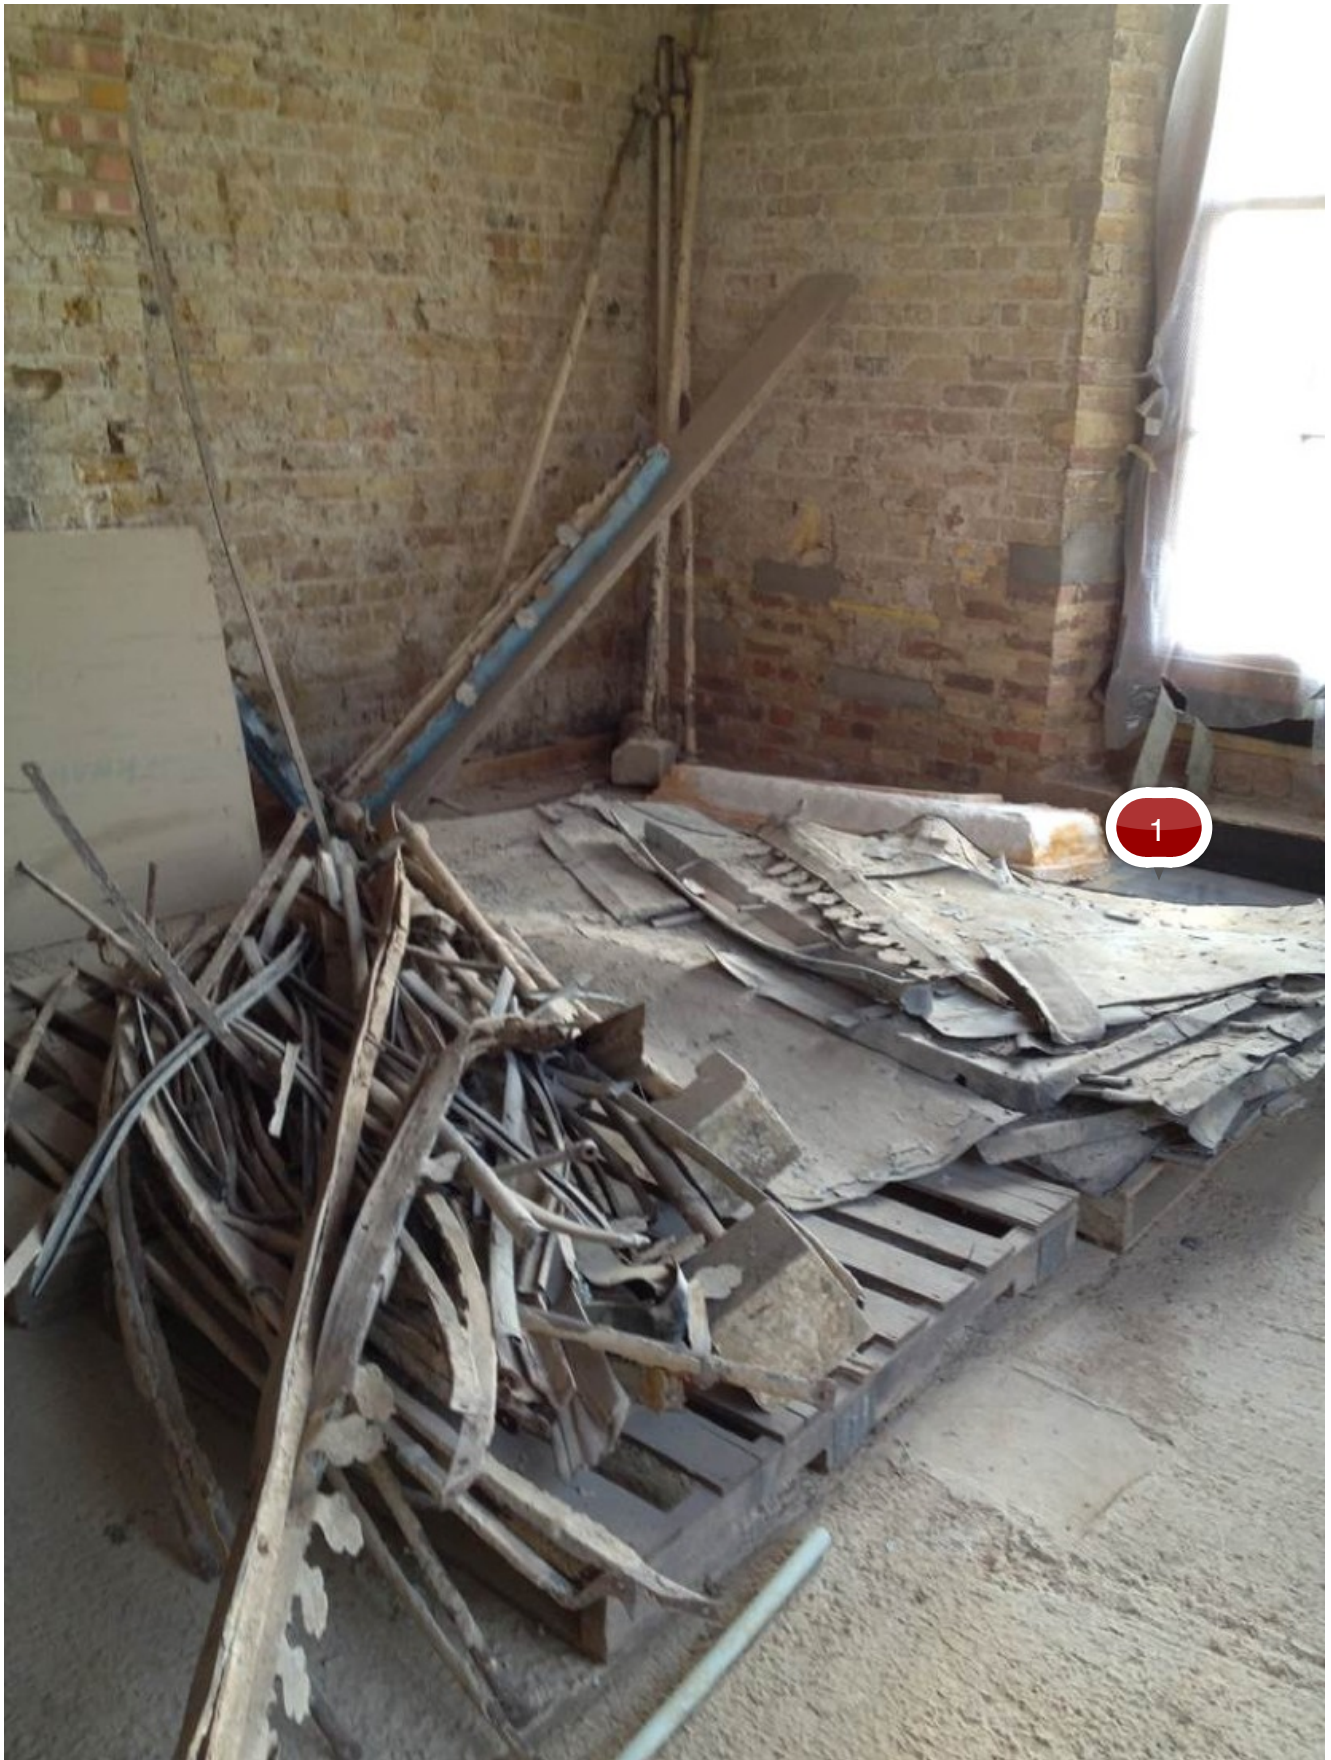
Observation #1

Zinc roofing severely damaged and not in a condition for reuse.
