SHEAR TEST

CLIENT: CJ O'Shea

SITE ADDRESS: 42-45 Belsize
Park, London,
NW3 4EE

REPORT NUMBER: SC-550-ST-001

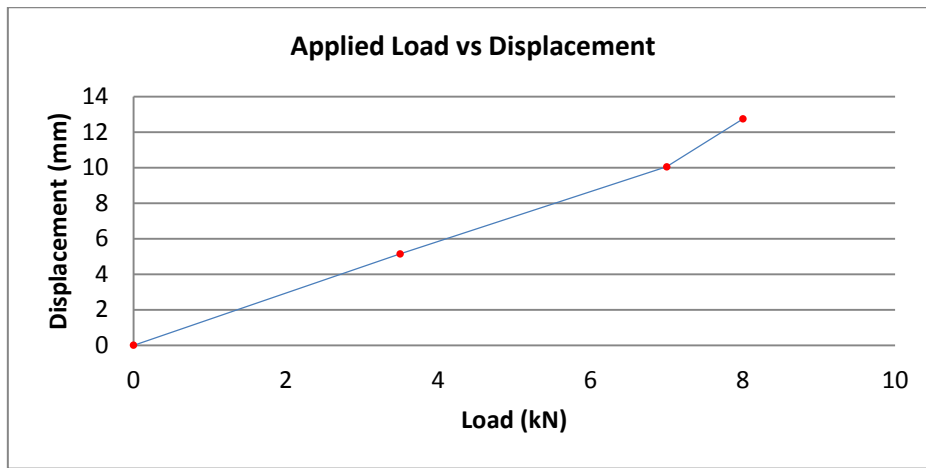
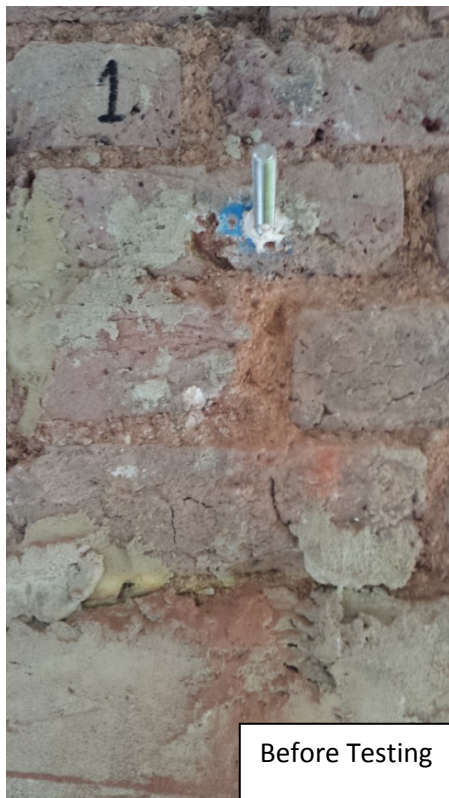
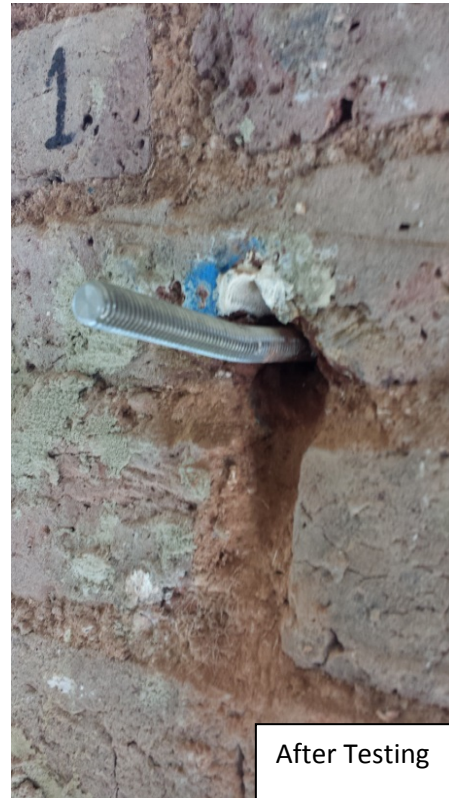
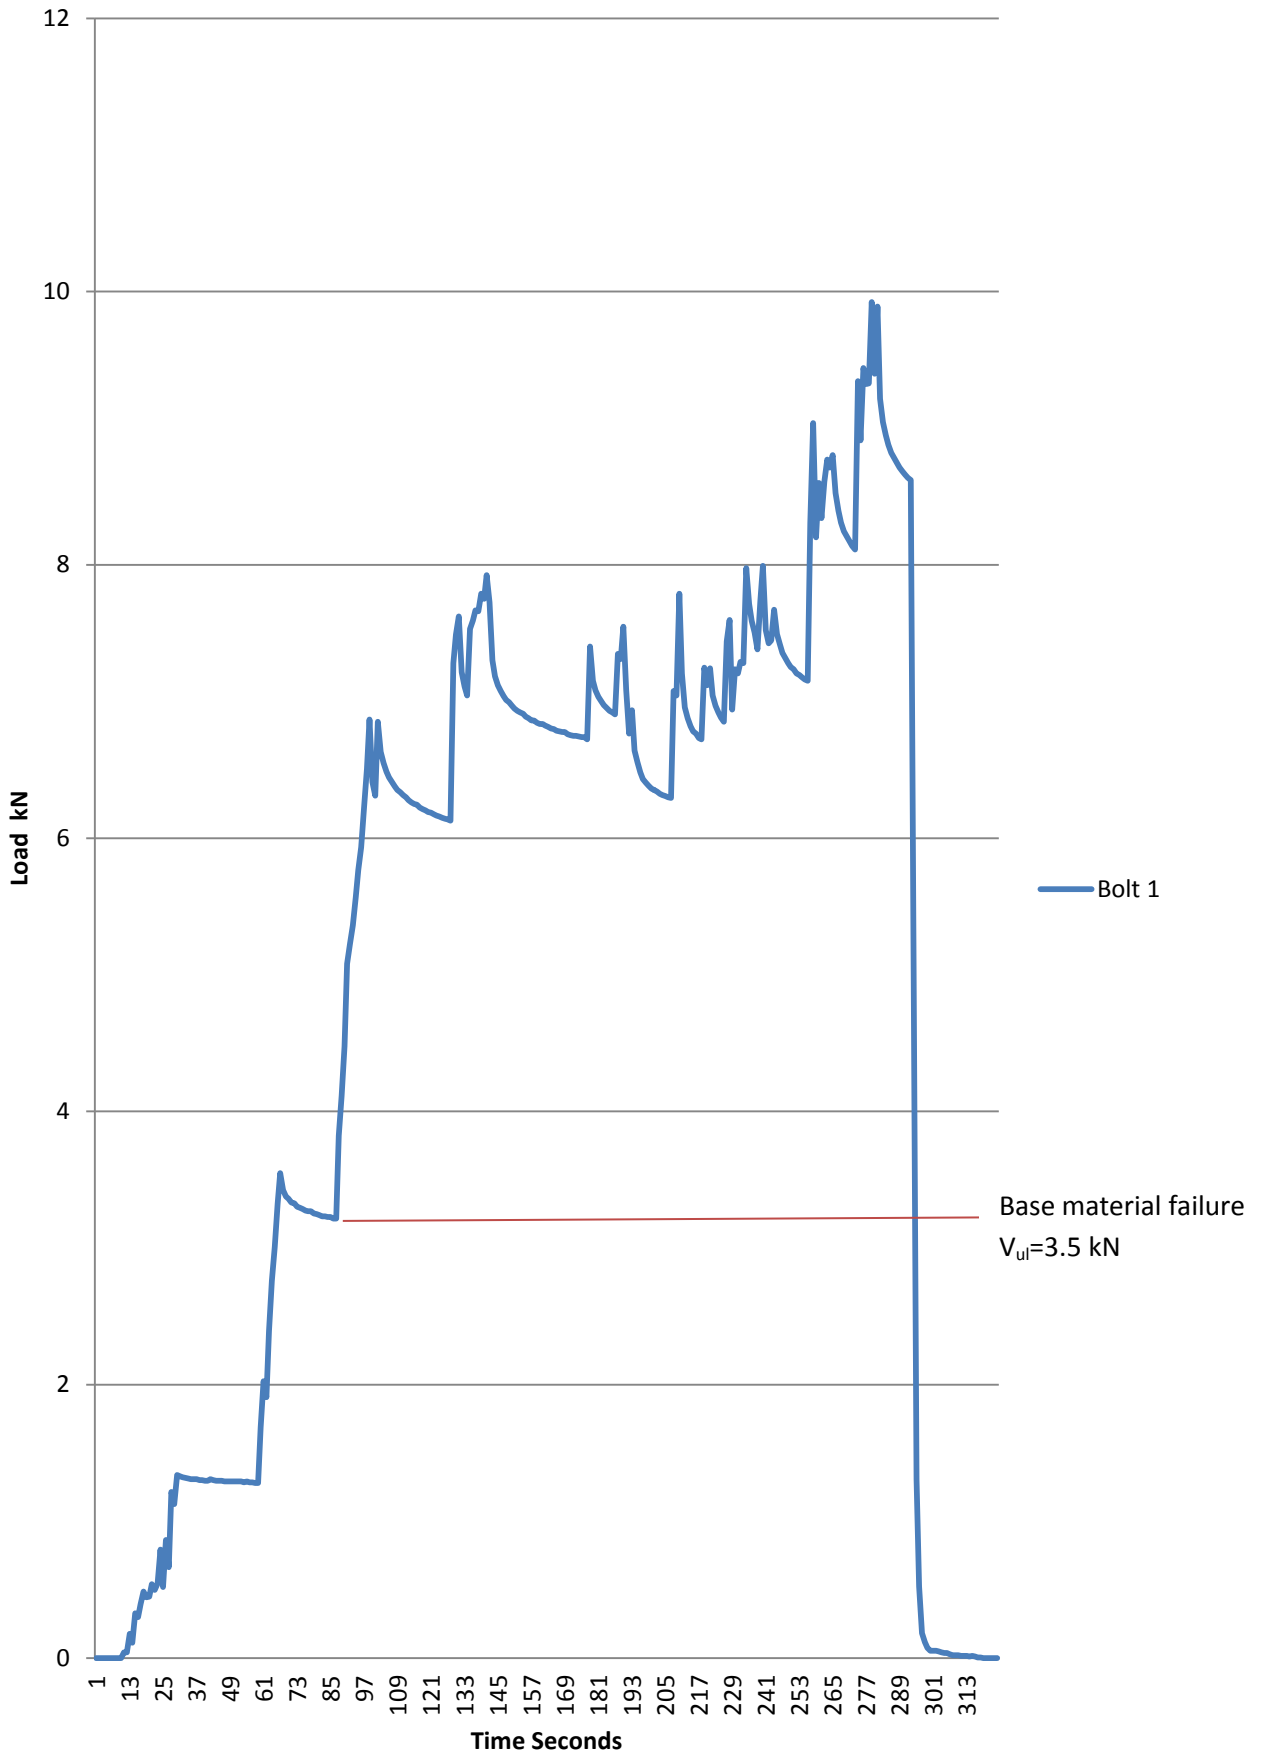
Bolt 1

BOLT #1 - Ground Floor		
LOAD APPLIED	GAUGE READING	DISPLACEMENT
kN	mm	mm
0	18.75	0
3.5	13.6	5.15
7	8.7	10.05
8	6	12.75

Base material Fail

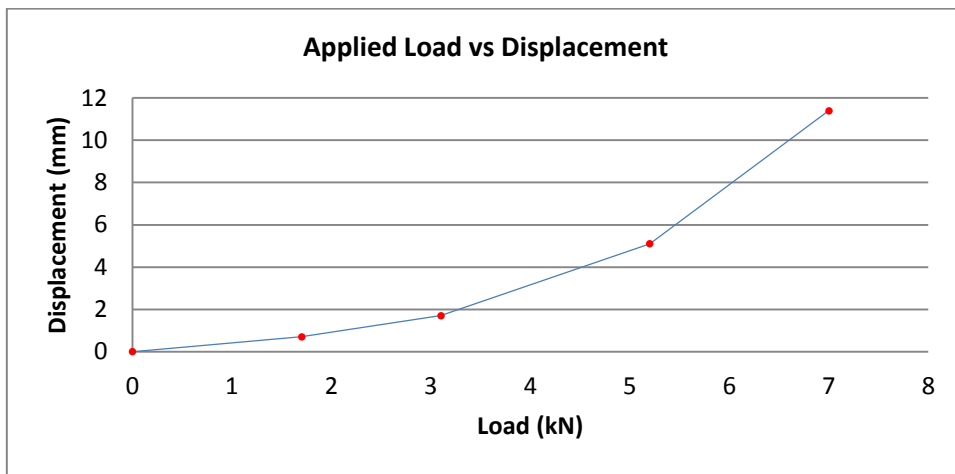
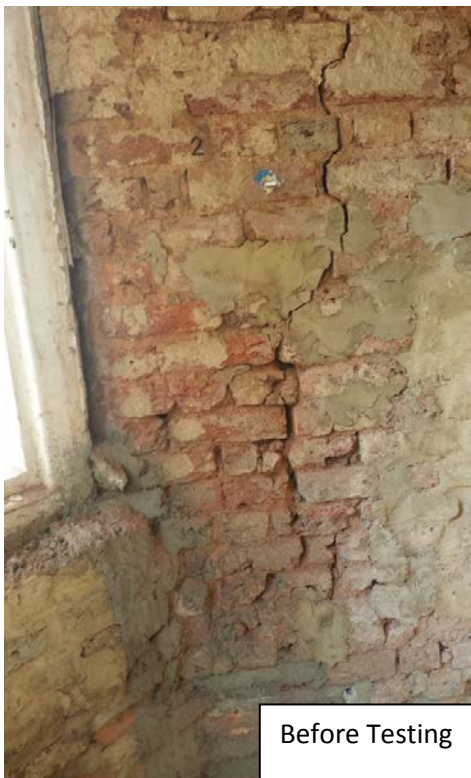
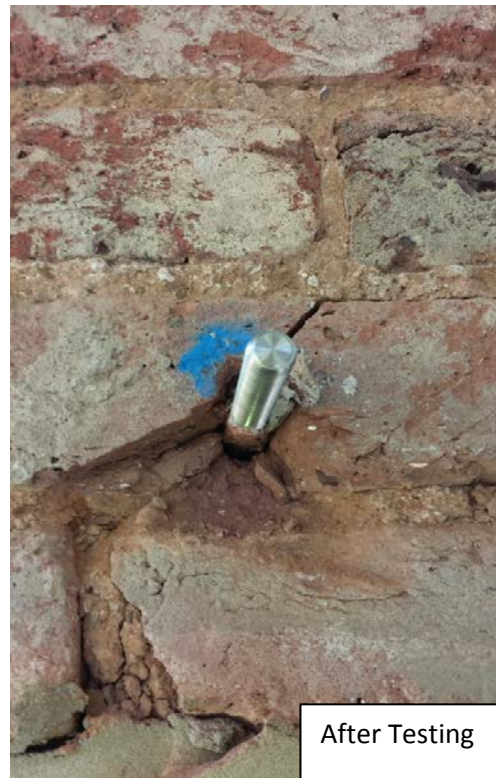
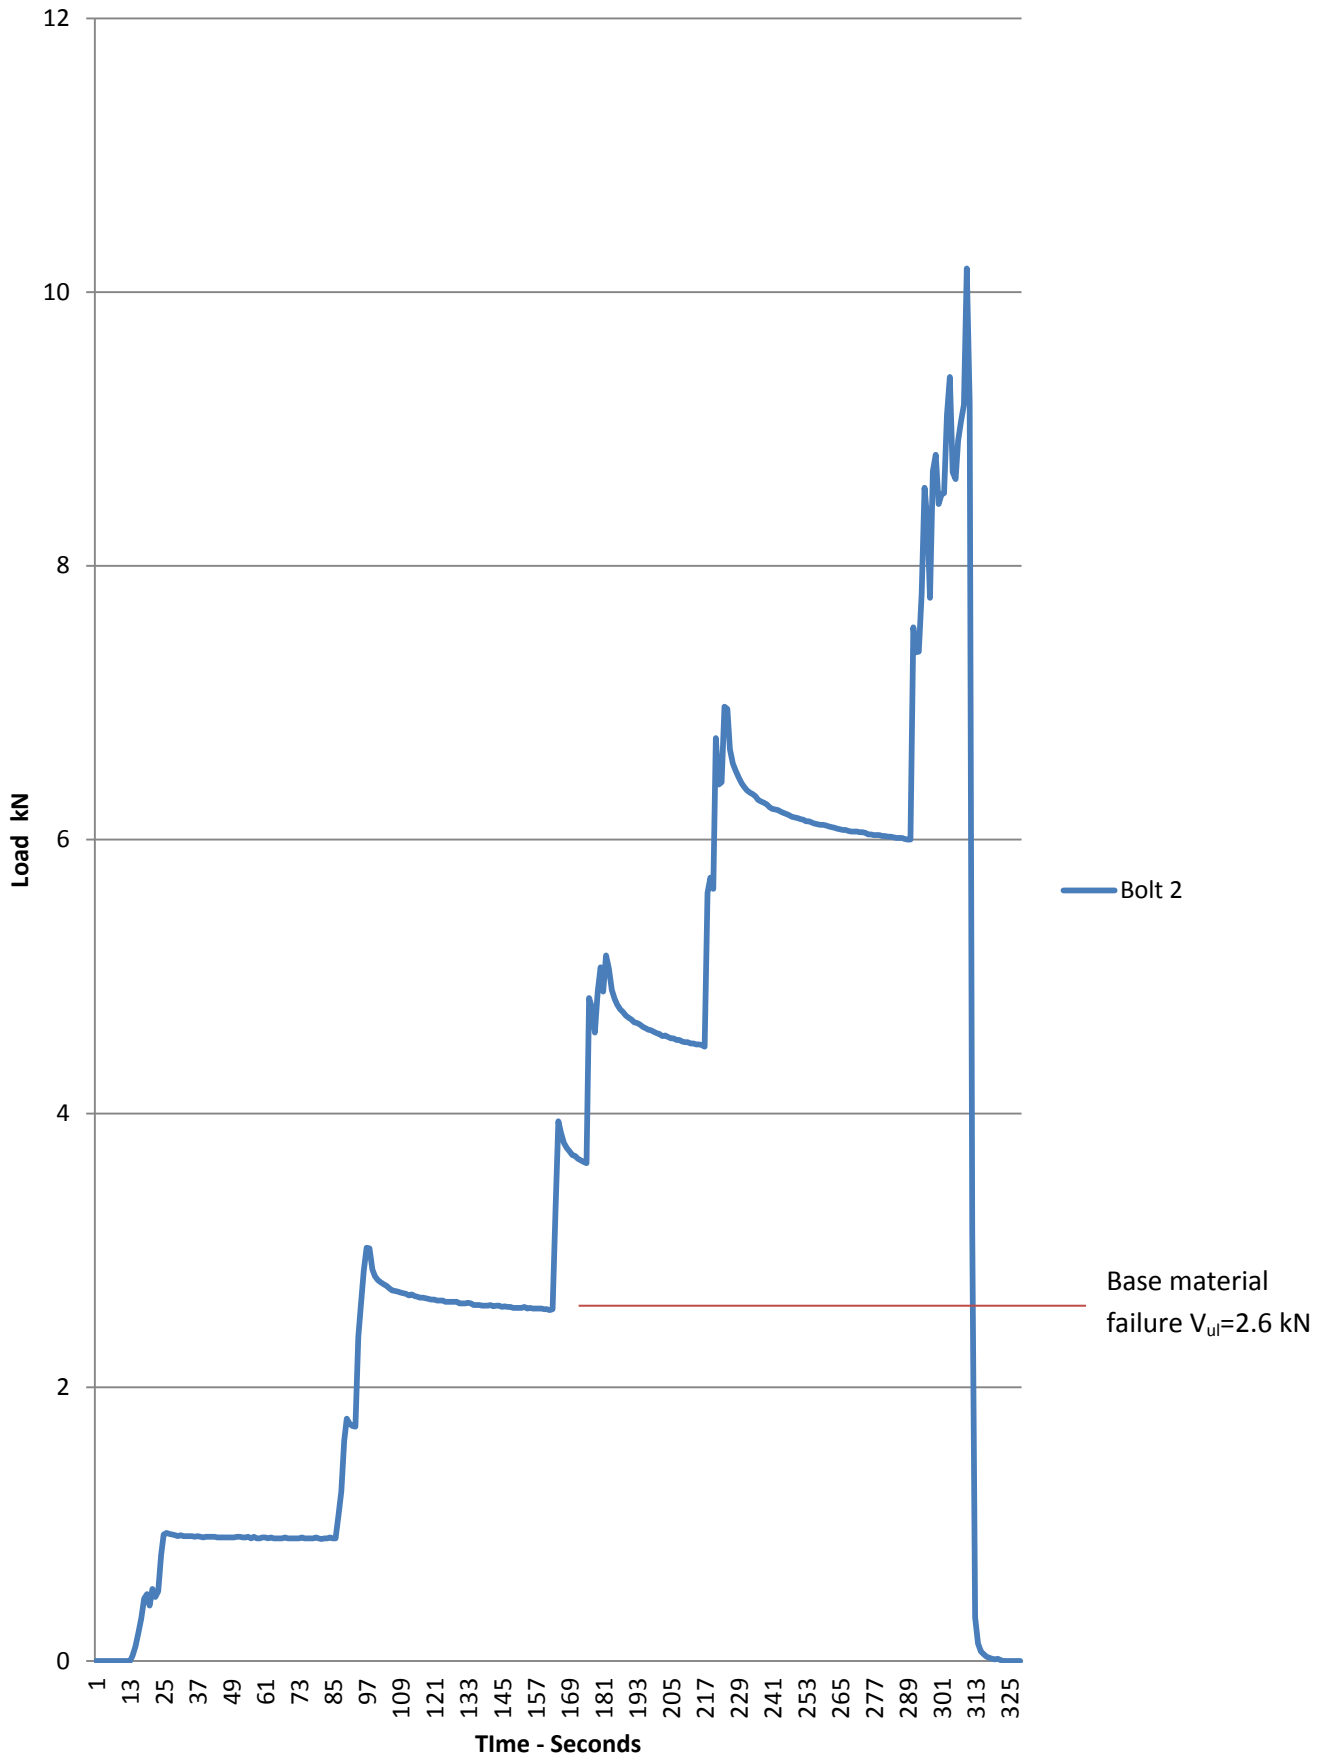
Bolt 2

BOLT #2 - Ground Floor		
LOAD APPLIED	GAUGE READING	DISPLACEMENT
kN	mm	mm
0	19.4	0
1.7	18.7	0.70
2.6	17.7	1.70
5.2	14.3	5.10
7	8	11.40

Base material Fail

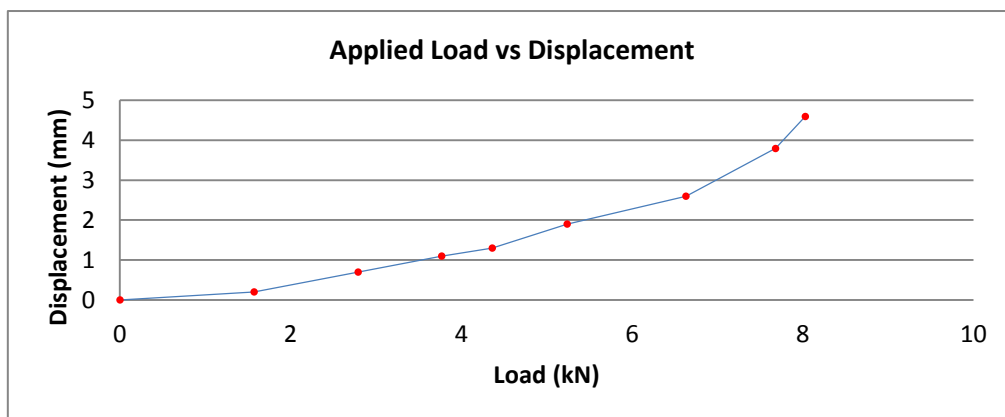
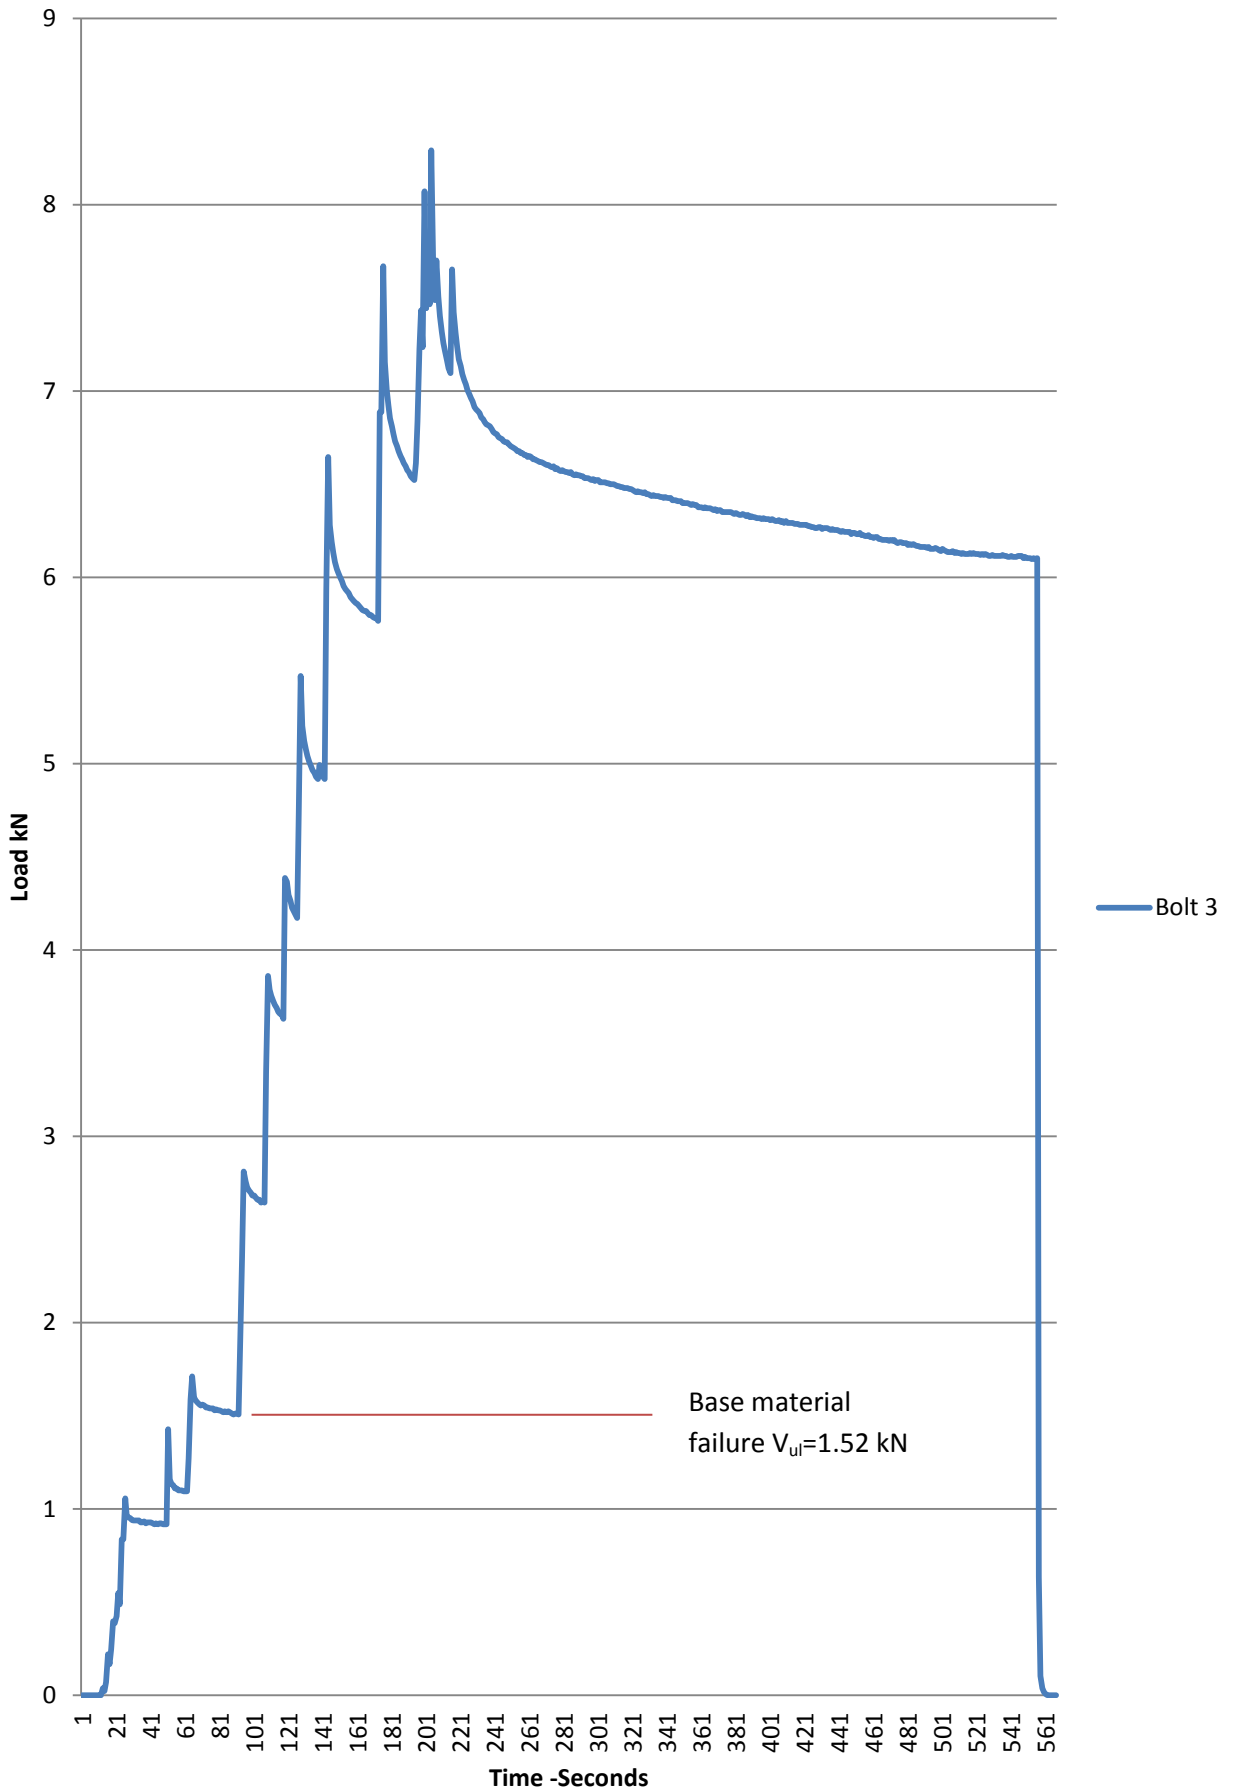
Bolt 3

BOLT #3 - Ground Floor		
LOAD APPLIED	GAUGE READING	DISPLACEMENT
kN	mm	mm
0	20.6	0
1.52	20.4	0.20
2.79	19.9	0.70
3.77	19.5	1.10
4.36	19.3	1.30
5.24	18.7	1.90
6.63	18	2.60
7.68	16.8	3.80
8.03	16	4.60

Base material Fail

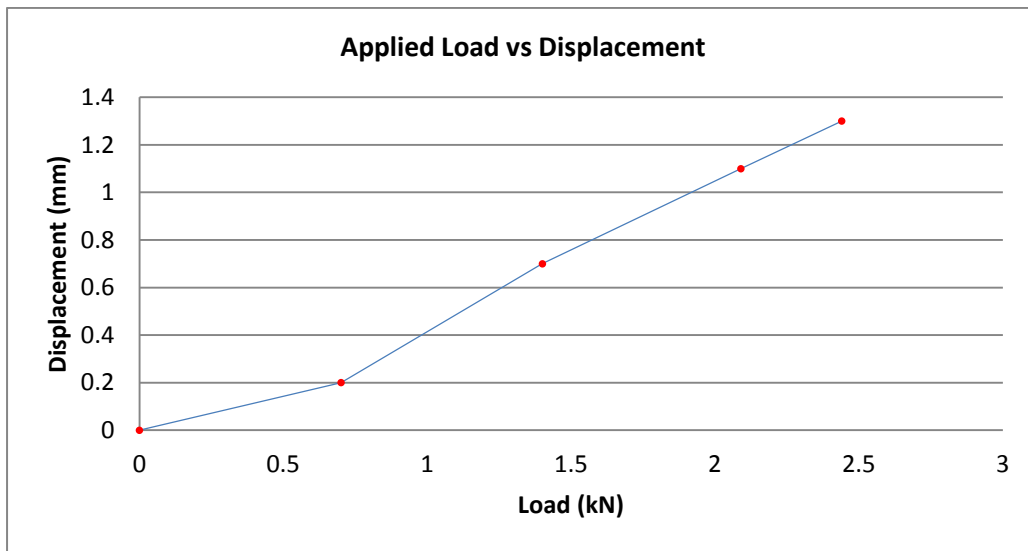
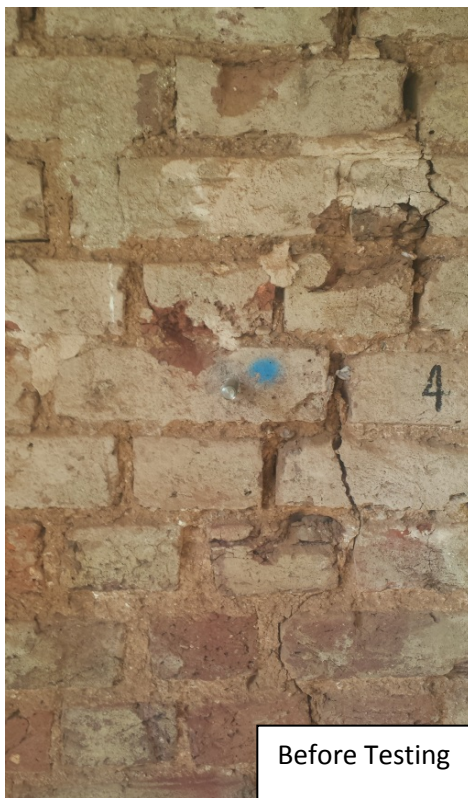
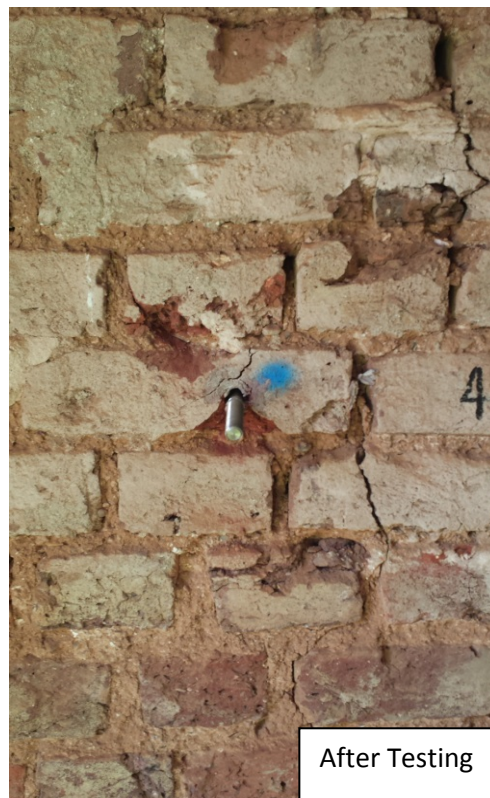
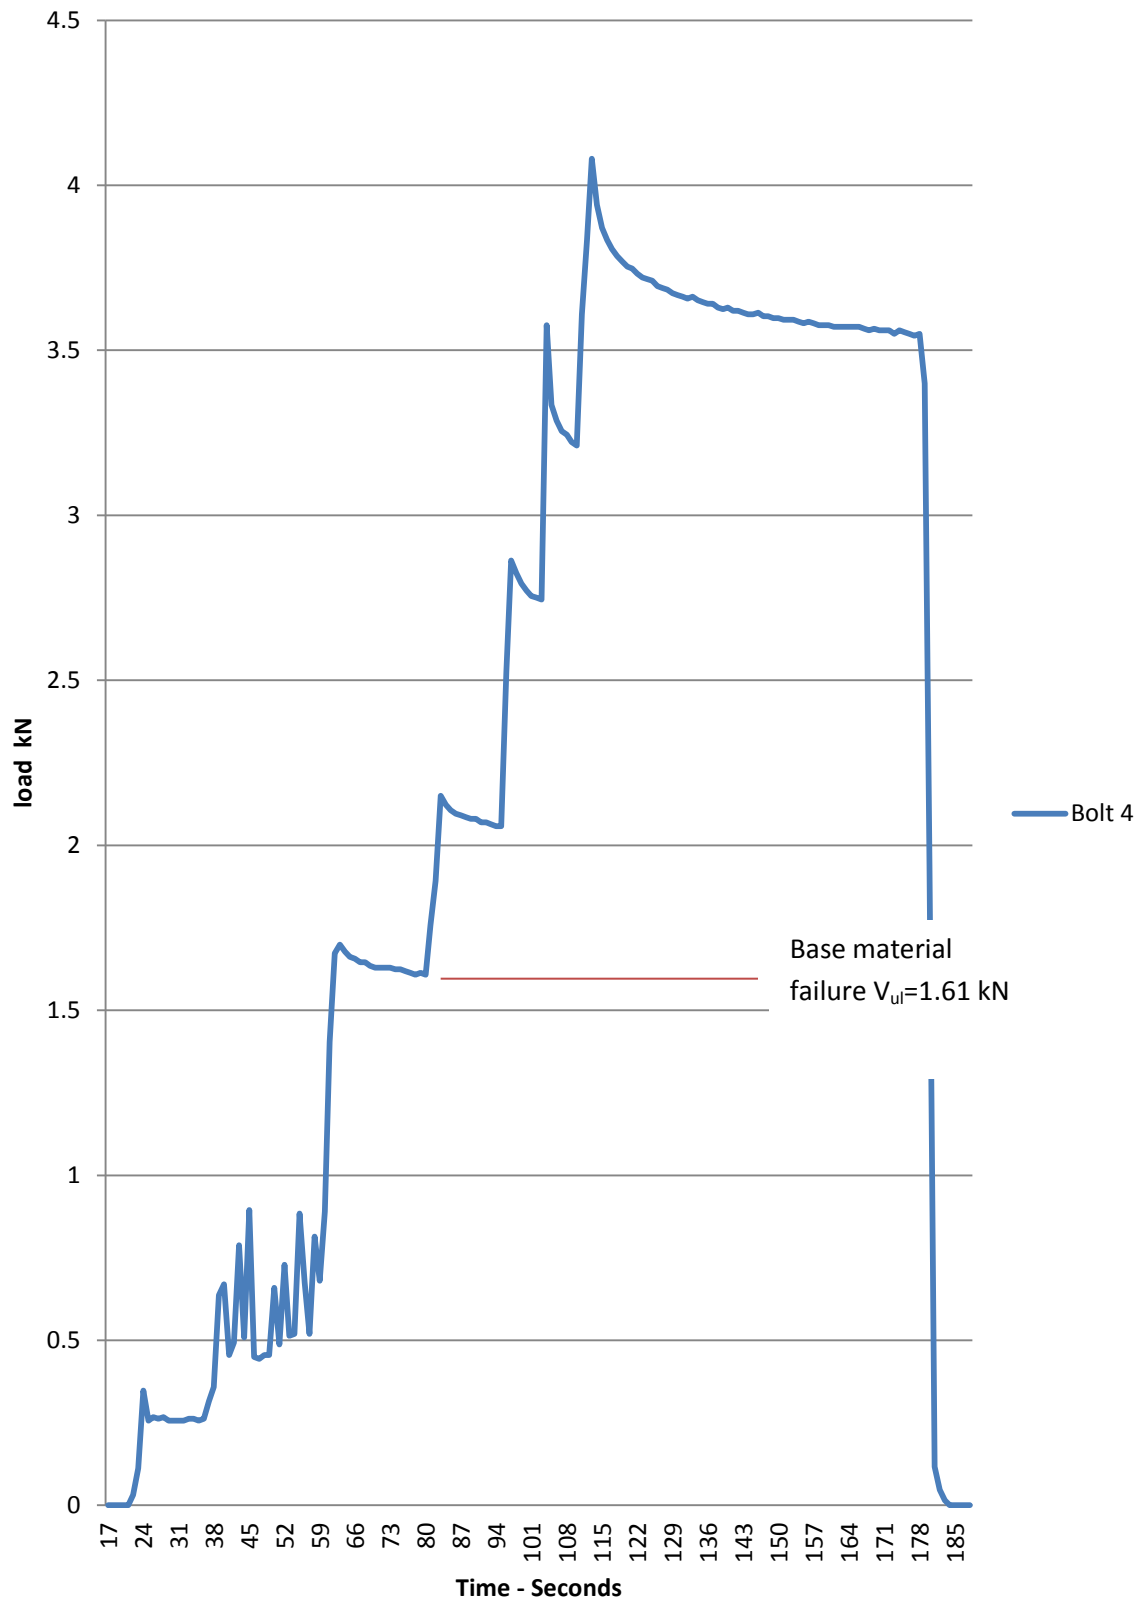
Bolt 4

BOLT #4 - Ground Floor		
LOAD APPLIED	GAUGE READING	DISPLACEMENT
kN	mm	mm
0	20.6	0
0.7	20.4	0.20
1.61	19.9	0.70
2.09	19.5	1.10
2.44	19.3	1.30

Base material Fail

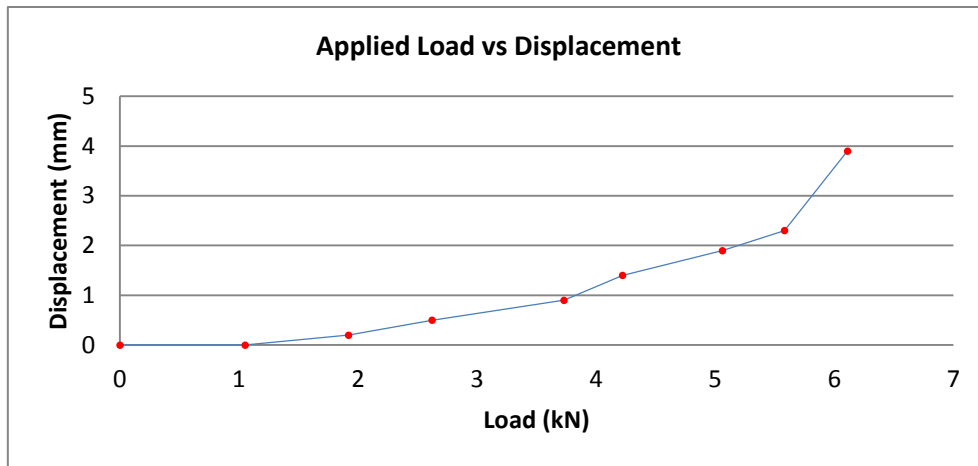
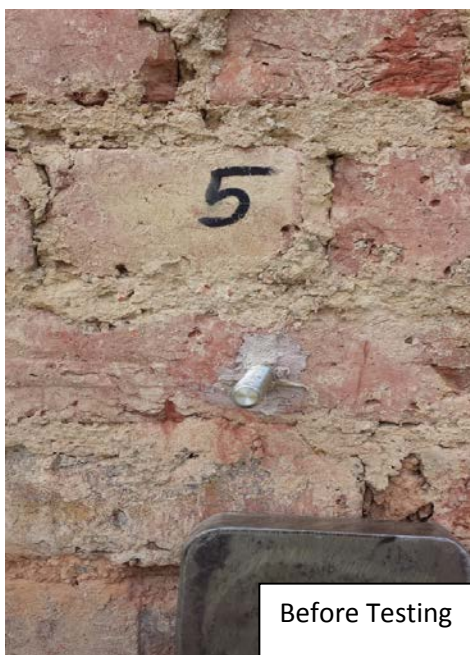
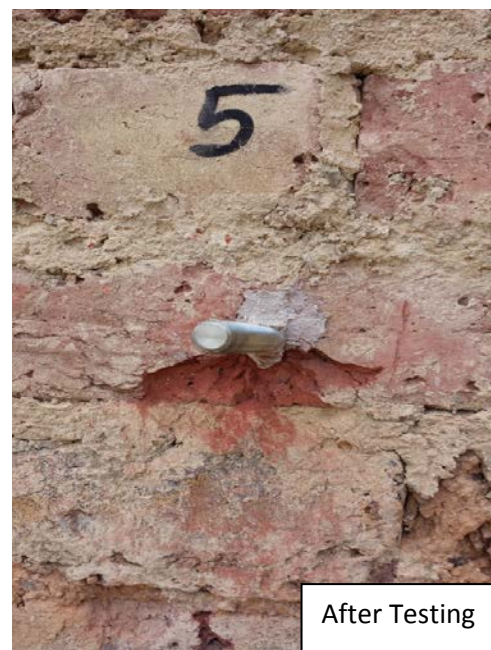
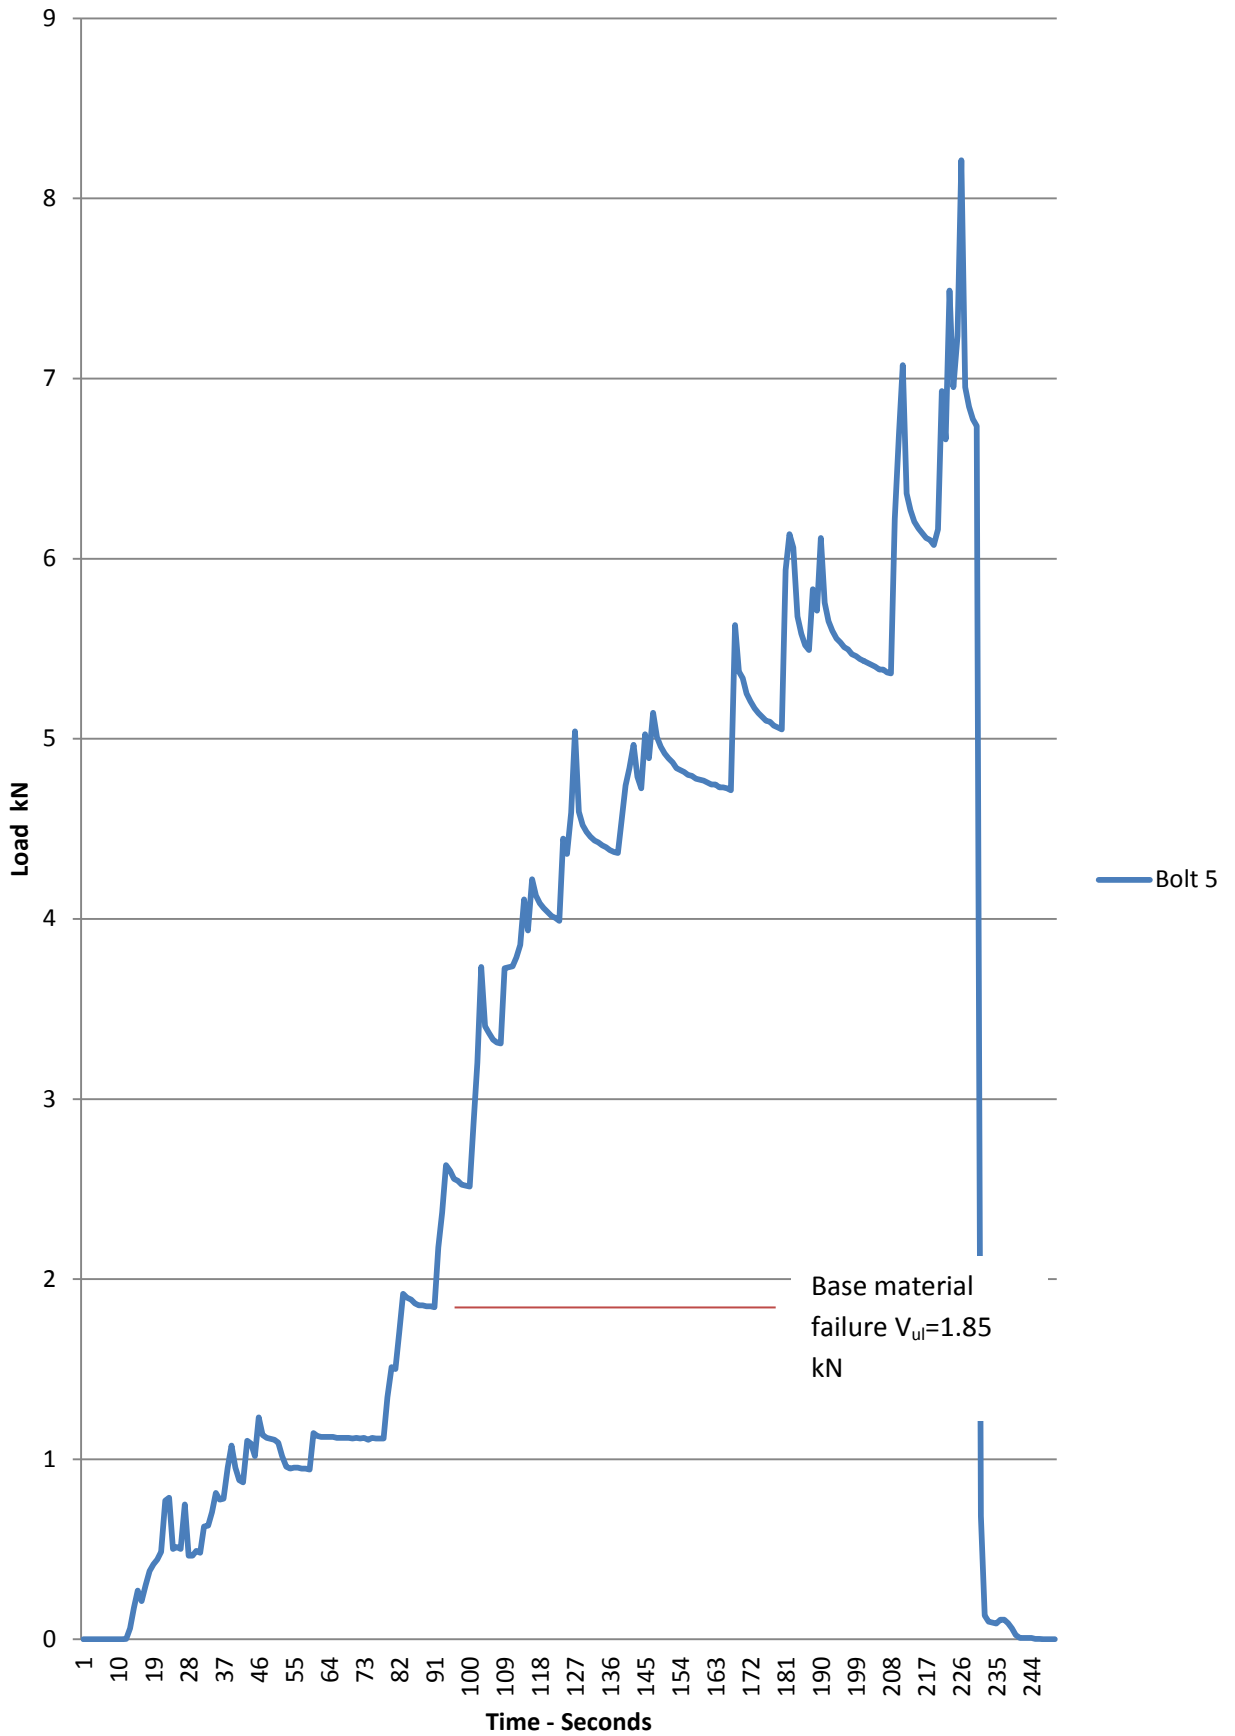
Bolt 5

BOLT #5 - Second Floor		
LOAD APPLIED	GAUGE READING	DISPLACEMENT
kN	mm	mm
0	20.9	0
1.05	20.9	0.00
1.85	20.7	0.20
2.62	20.4	0.50
3.73	20	0.90
4.22	19.5	1.40
5.06	19	1.90
5.58	18.6	2.30
6.11	17	3.90

Base material Fail

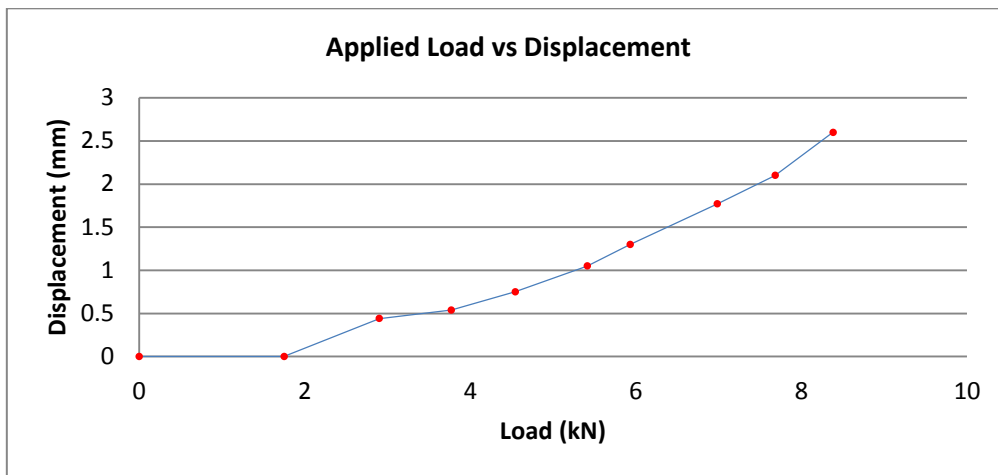
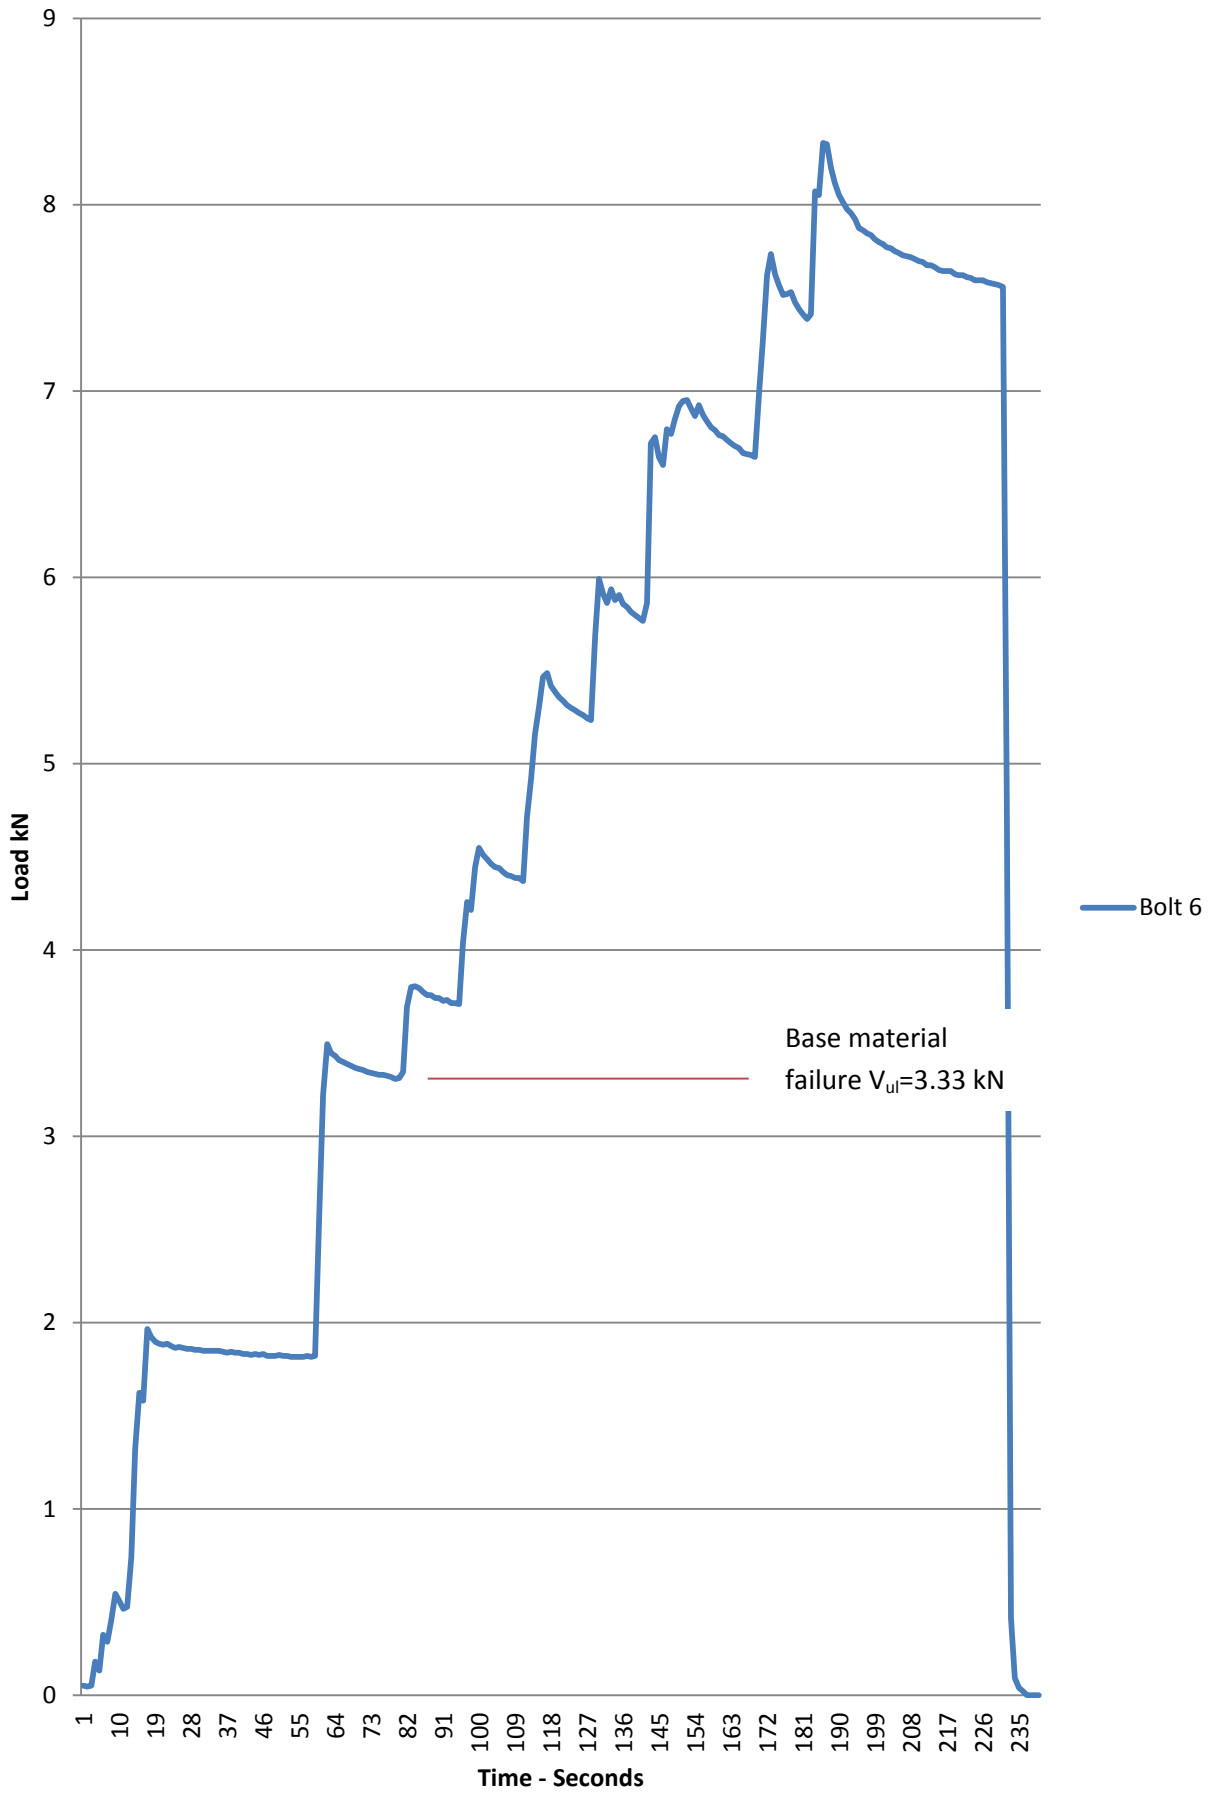
Bolt 6

BOLT #6 - Second Floor		
LOAD APPLIED	GAUGE READING	DISPLACEMENT
kN	mm	mm
0	14.9	0
1.75	14.9	0
2.9	15.34	0.44
3.33	15.44	0.54
4.54	15.65	0.75
5.41	15.95	1.05
5.93	16.2	1.3
6.98	16.67	1.77
7.68	17	2.1
8.38	17.5	2.6

Base material Fail

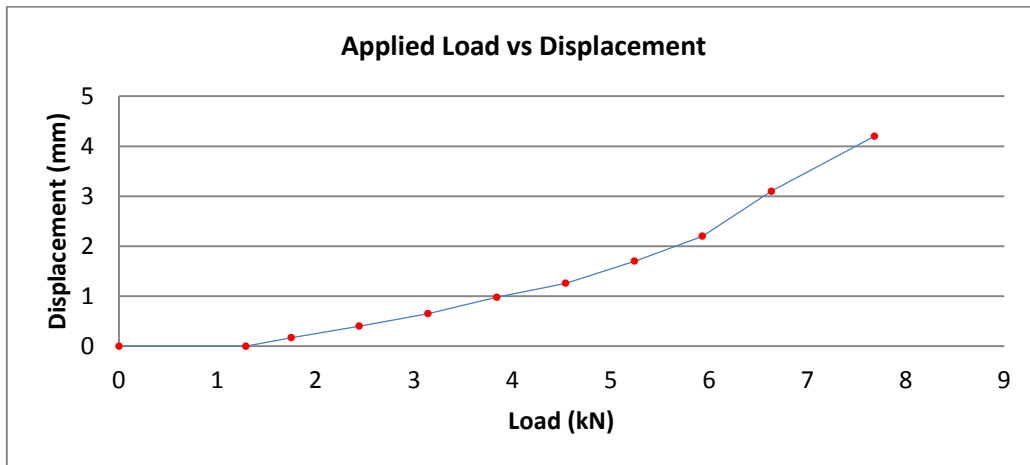
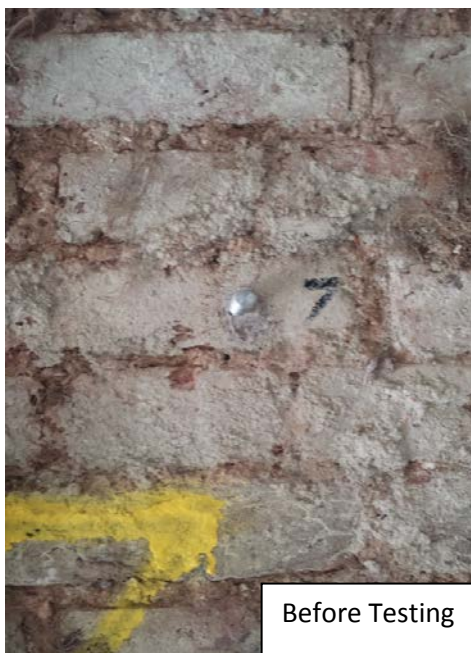
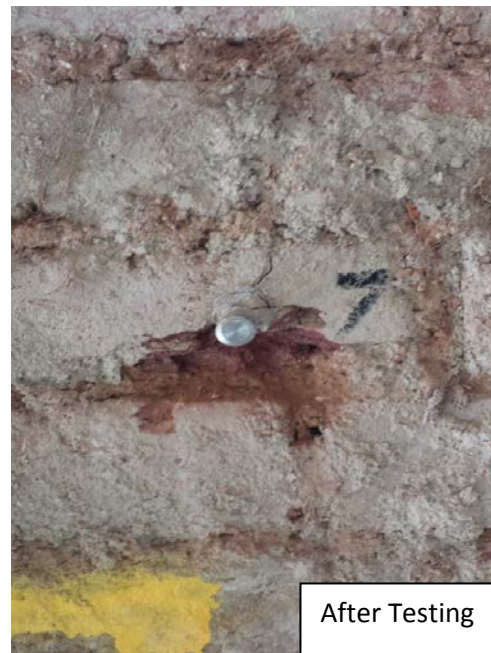
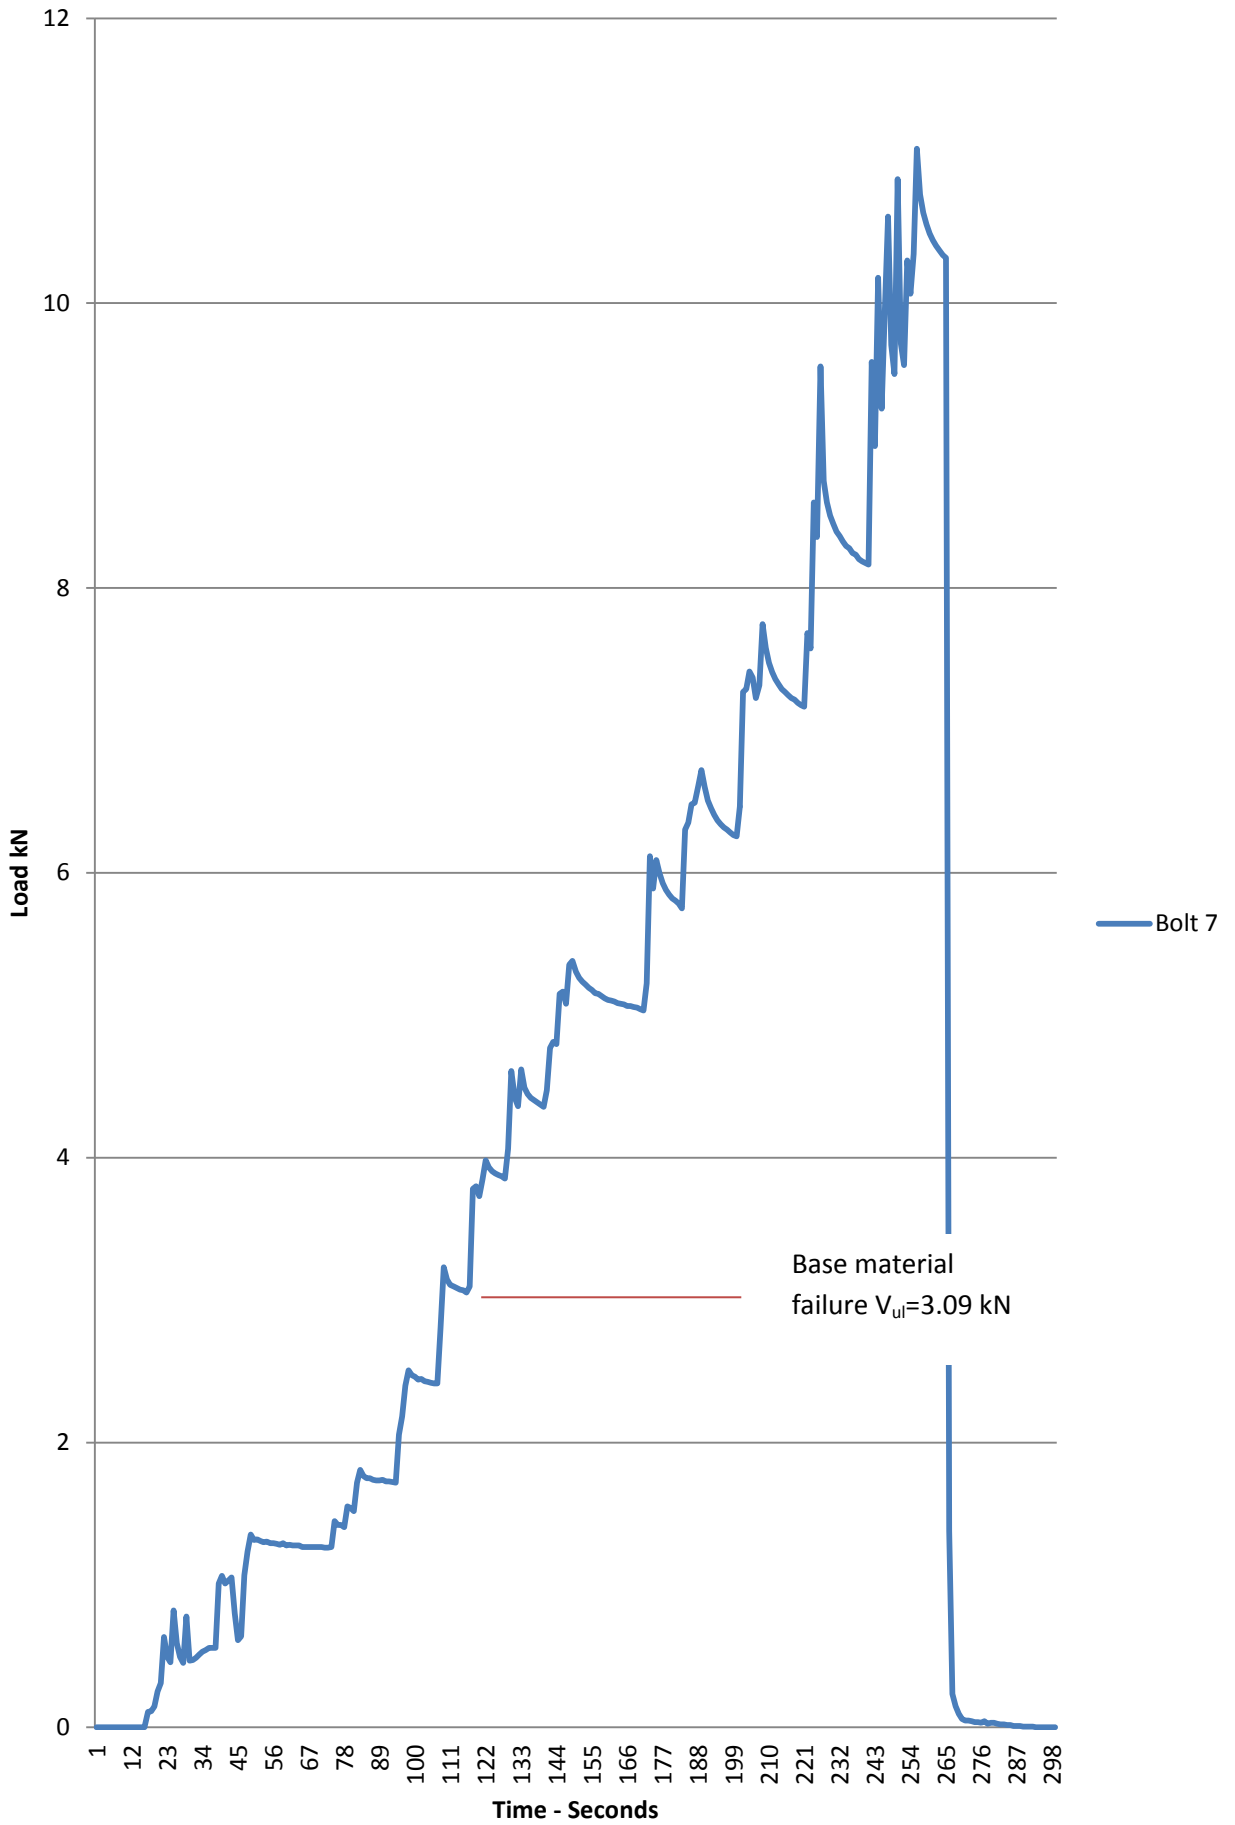
Bolt 7

BOLT #7 - First Floor		
LOAD APPLIED	GAUGE READING	DISPLACEMENT
kN	mm	mm
0	25.8	0
1.29	25.8	0
1.75	25.63	0.17
2.44	25.4	0.4
3.09	25.15	0.65
3.84	24.82	0.98
4.54	24.54	1.26
5.24	24.1	1.7
5.93	23.6	2.2
6.63	22.7	3.1
7.68	21.6	4.2

Base material Fail
