SHEAR TEST

CLIENT: CJ O'Shea

SITE ADDRESS: 42-45 Belsize
Park, London,
NW3 4EE

REPORT NUMBER: SC-550-ST-001

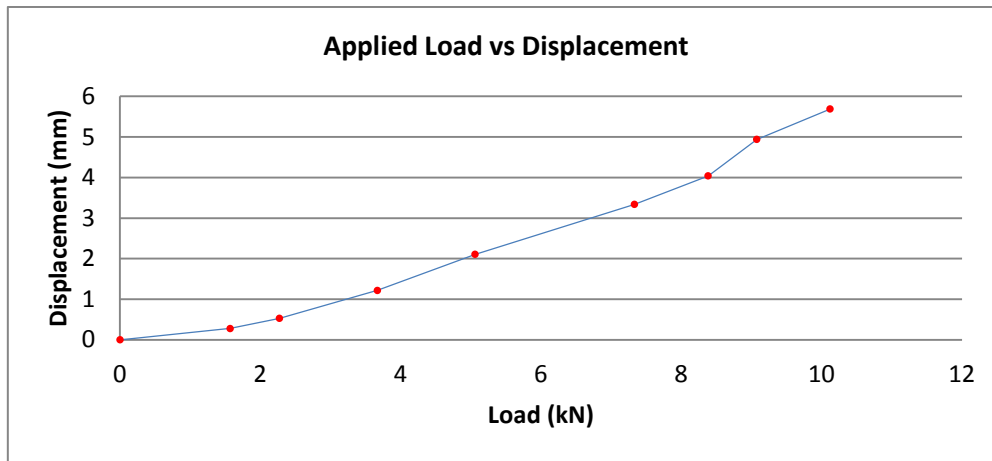
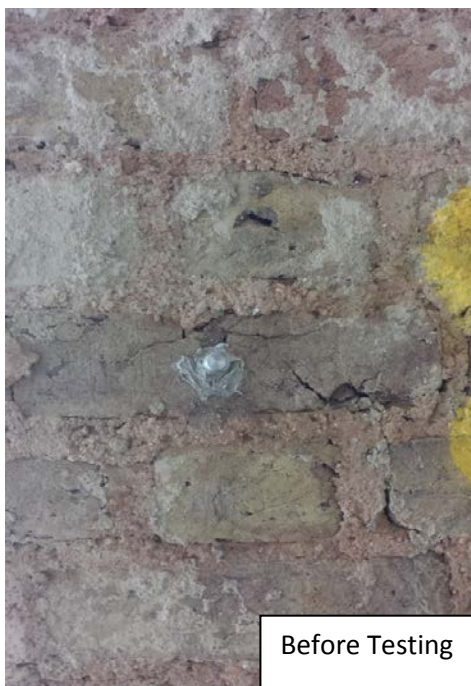
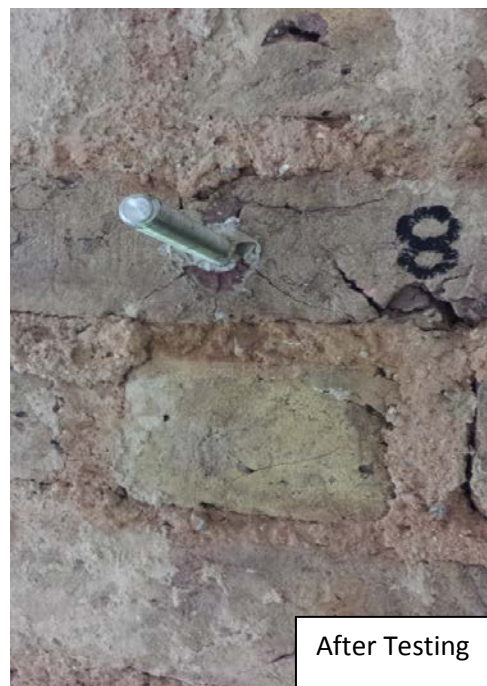
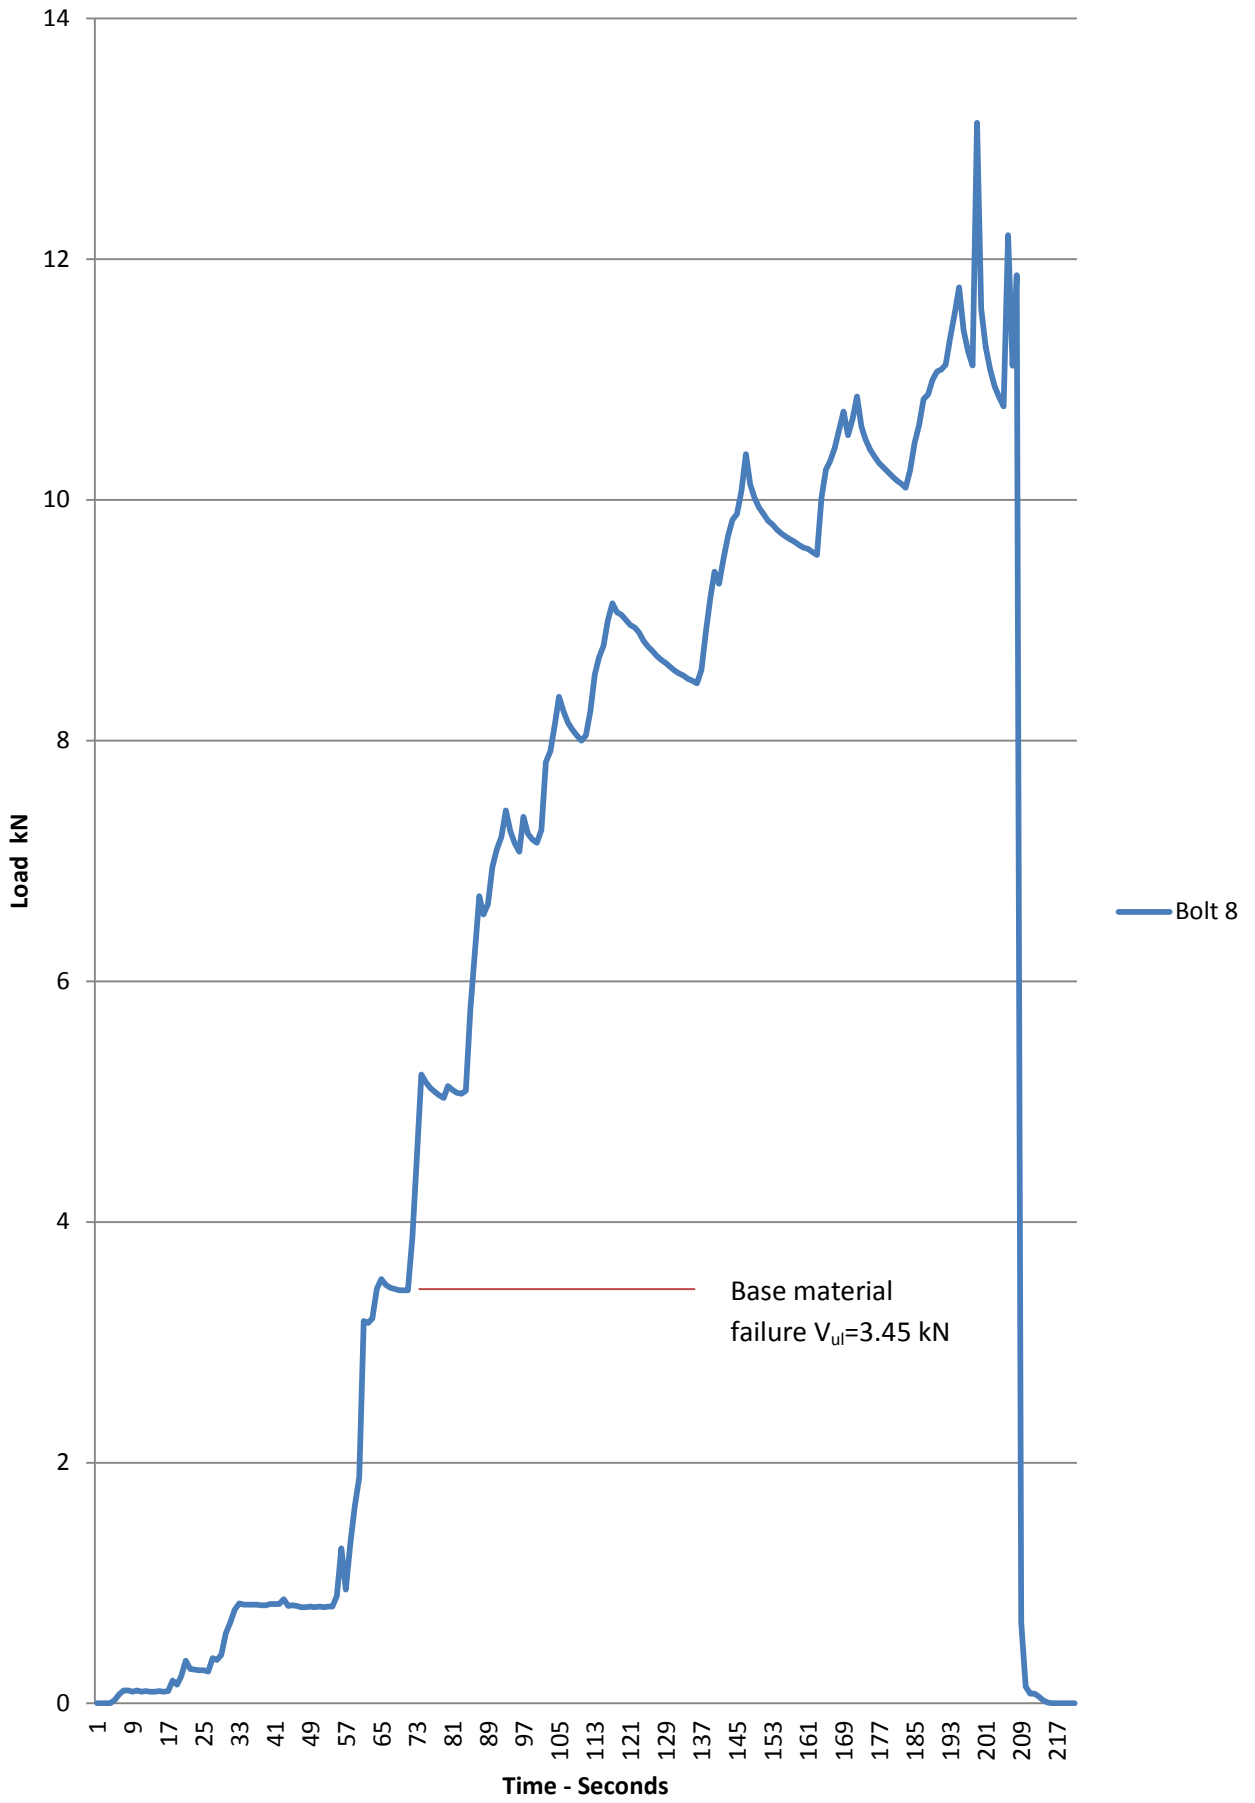
Bolt 8

BOLT #8 - First Floor		
LOAD APPLIED	GAUGE READING	DISPLACEMENT
kN	mm	mm
0	25.41	0
1.57	25.13	0.28
2.27	24.88	0.53
3.45	24.19	1.22
5.06	23.3	2.11
7.33	22.07	3.34
8.38	21.37	4.04
9.074	20.47	4.94
10.12	19.72	5.69

Base material Fail

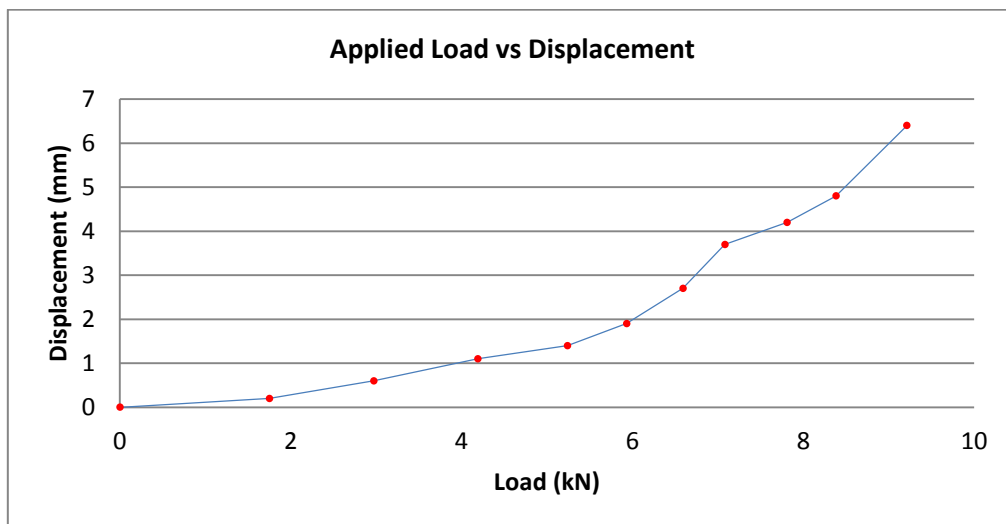
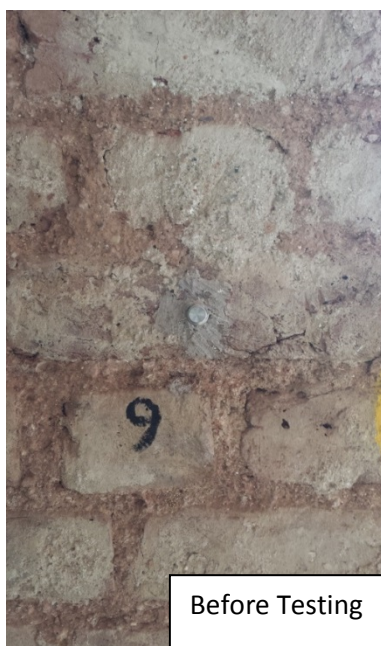
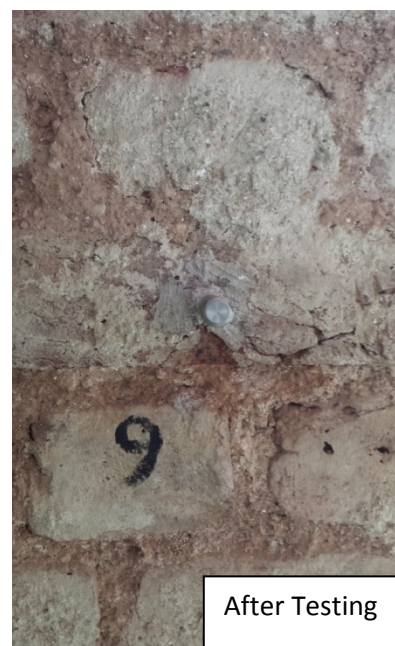
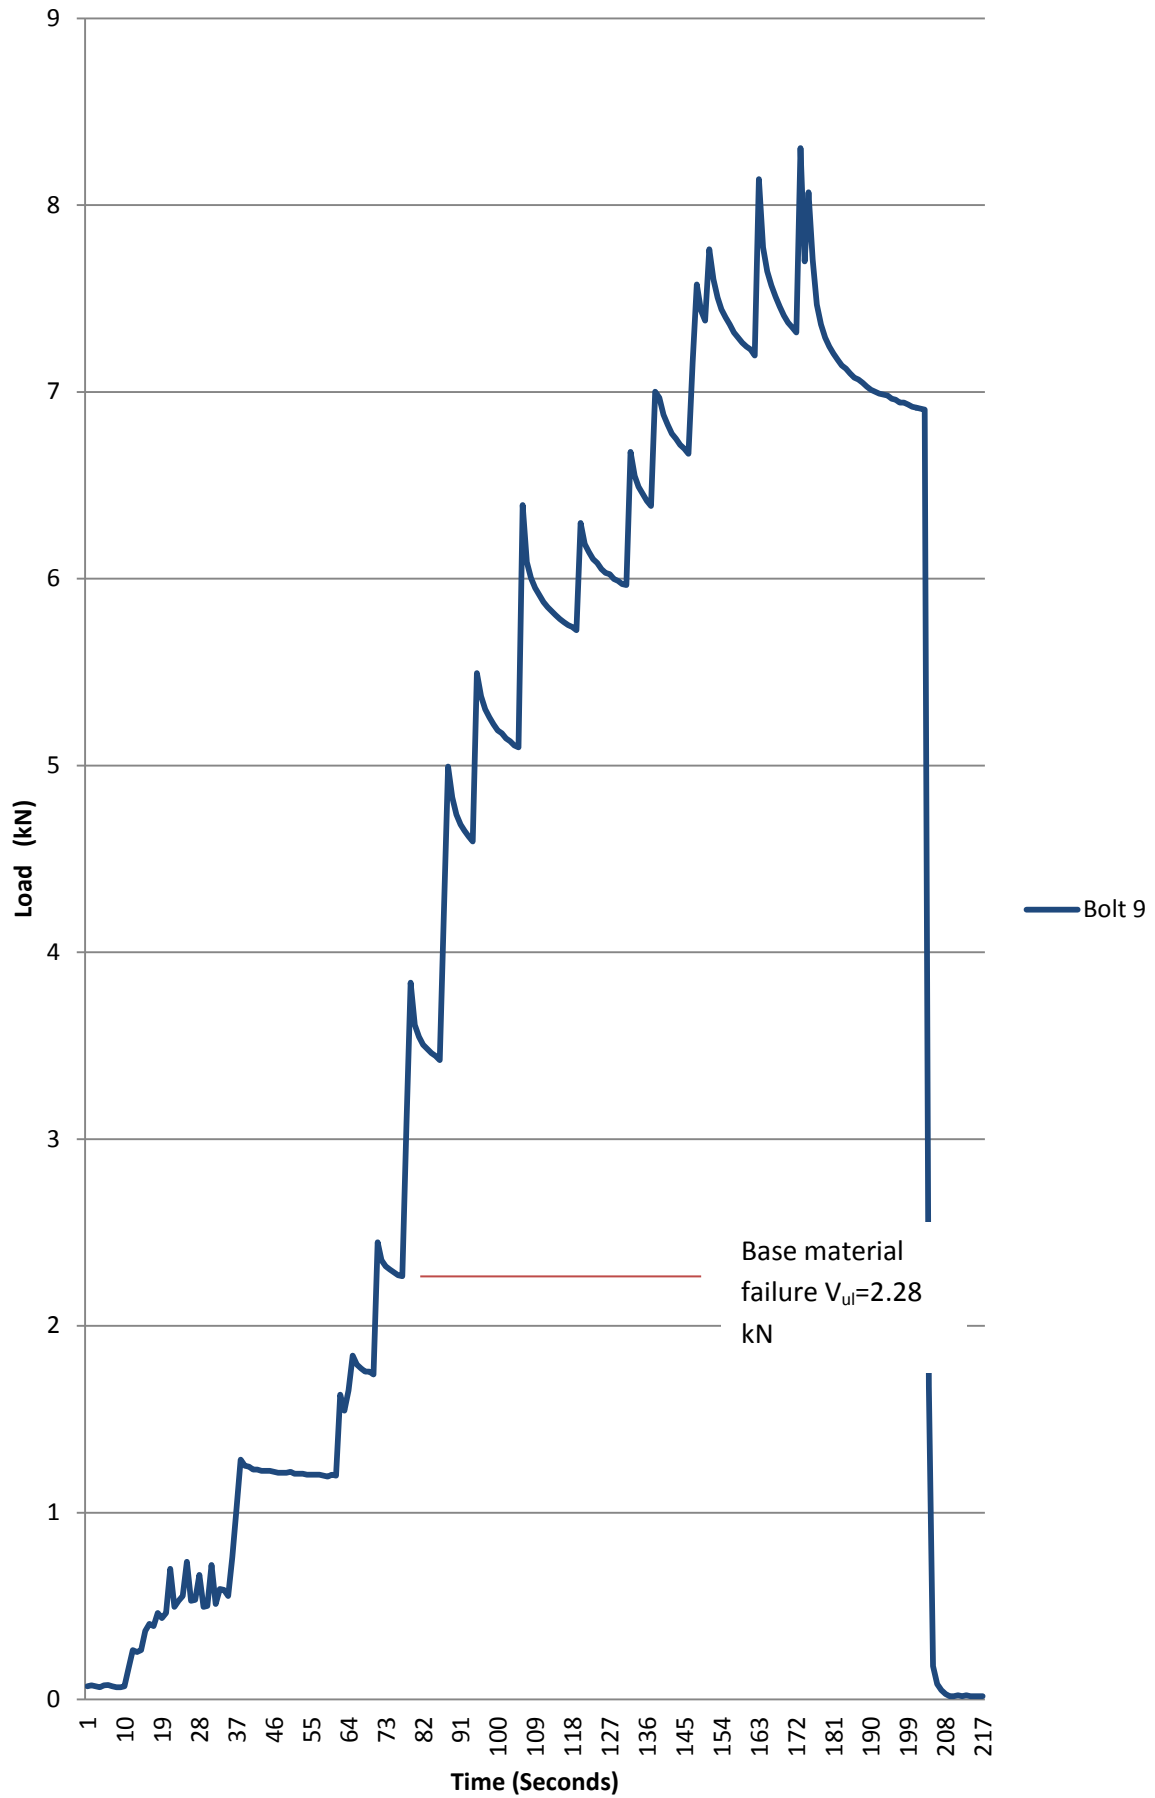
Bolt 9

BOLT #9 - First Floor		
LOAD APPLIED	GAUGE READING	DISPLACEMENT
kN	mm	mm
0	15.4	0
1.75	15.4	0.2
2.28	15.3	0.6
4.19	15.1	1.1
5.24	14.7	1.4
5.93	14.2	1.9
6.59	13.9	2.7
7.08	13.4	3.7
7.81	12.8	4.2
8.38	11	4.8
9.21	10	6.4

Base material Fail

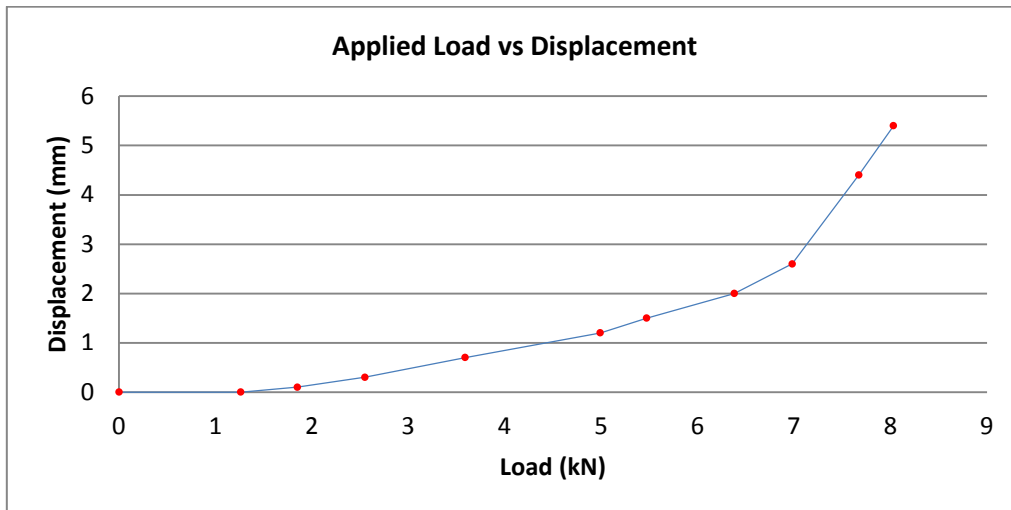
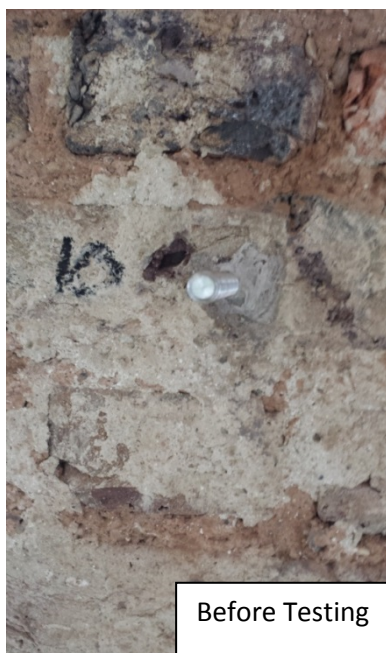
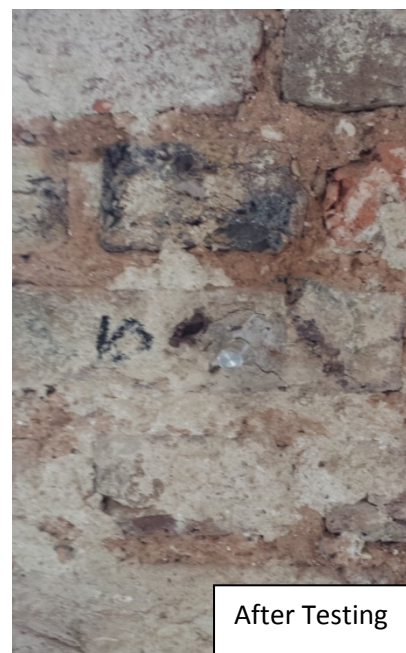
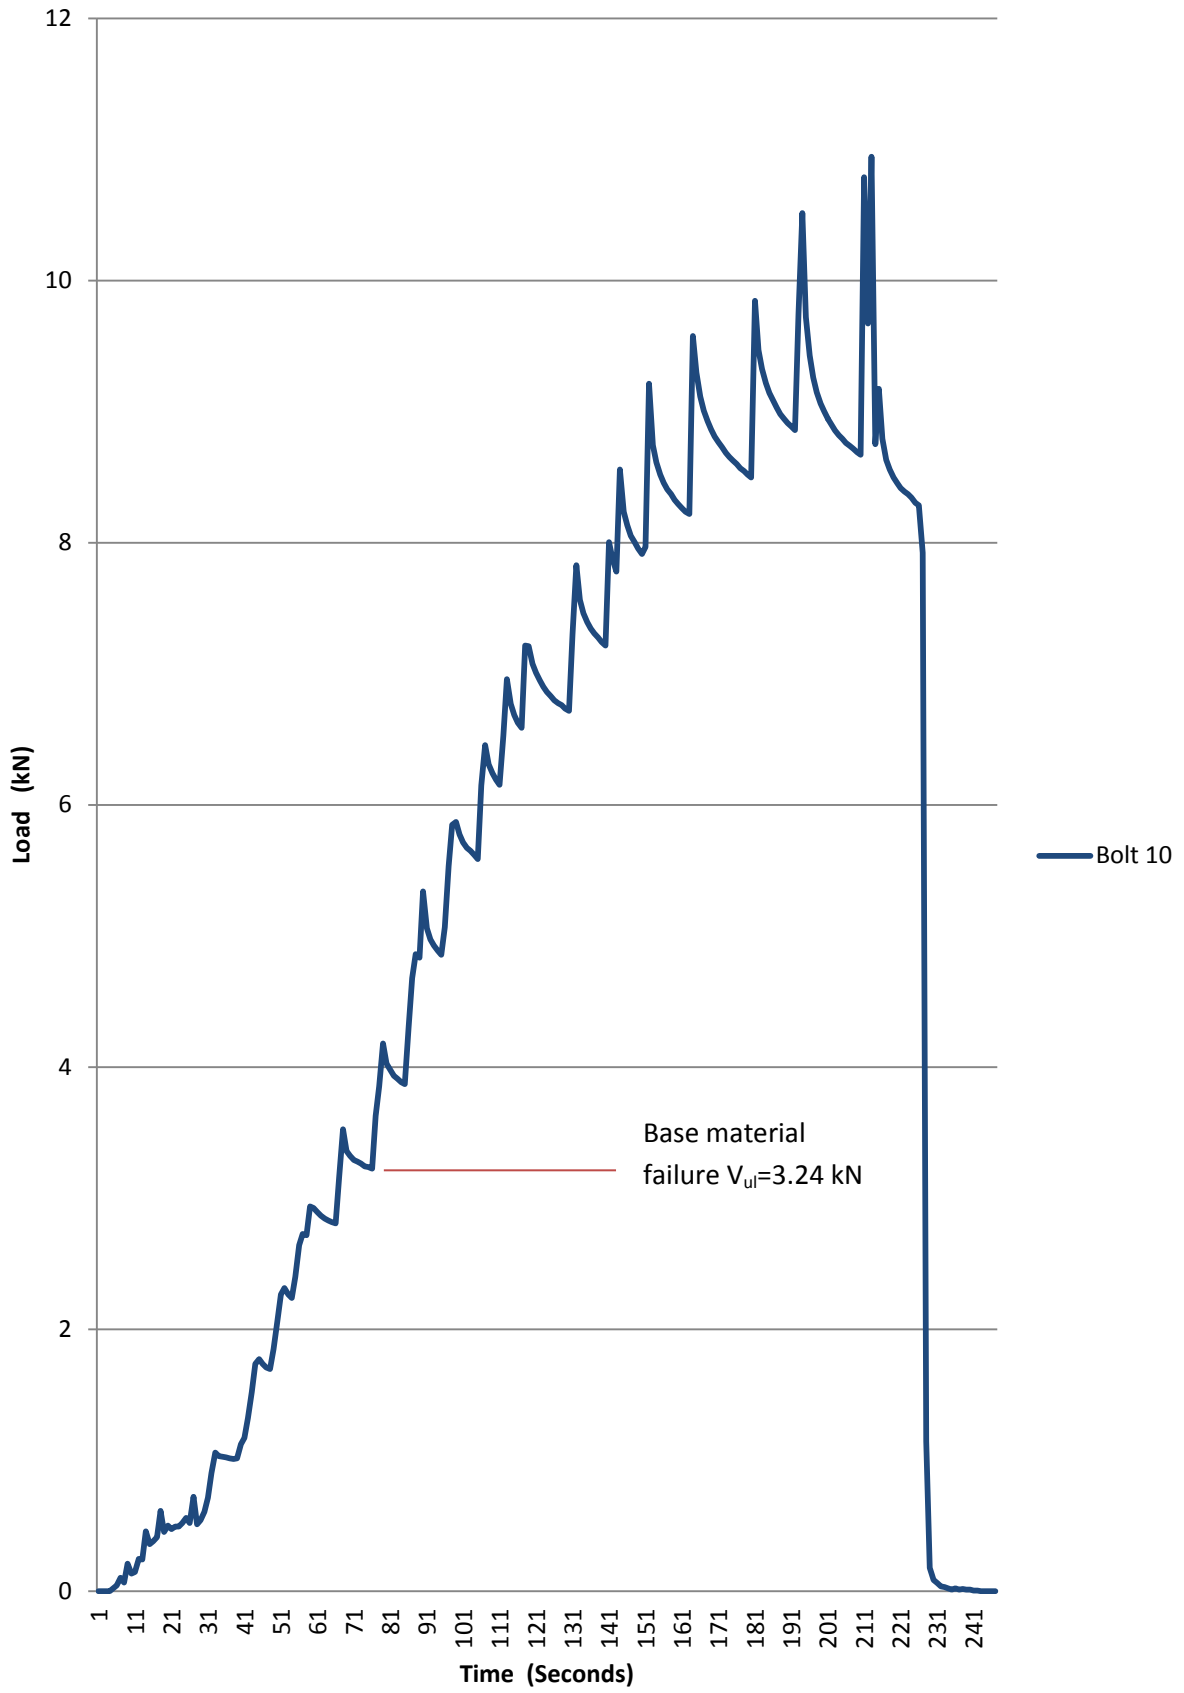
Bolt 10

BOLT #10 - First Floor		
LOAD APPLIED	GAUGE READING	DISPLACEMENT
kN	mm	mm
0	18.7	0
1.26	18.5	0
1.85	18.1	0.1
2.55	17.6	0.3
3.24	17.3	0.7
4.99	16.8	1.2
5.47	16	1.5
6.38	15	2
6.98	14.5	2.6
7.67	13.9	4.4
8.03	12.3	5.4

Base material Fail
