7.0 Retained Facade Elevation Reference Drawing with Site Notes

8.0 Embedded Timber Lintel Report. May 2013

44-45 Belsize Park, existing facade: Structural engineers site inspection to view embedded timber lintels

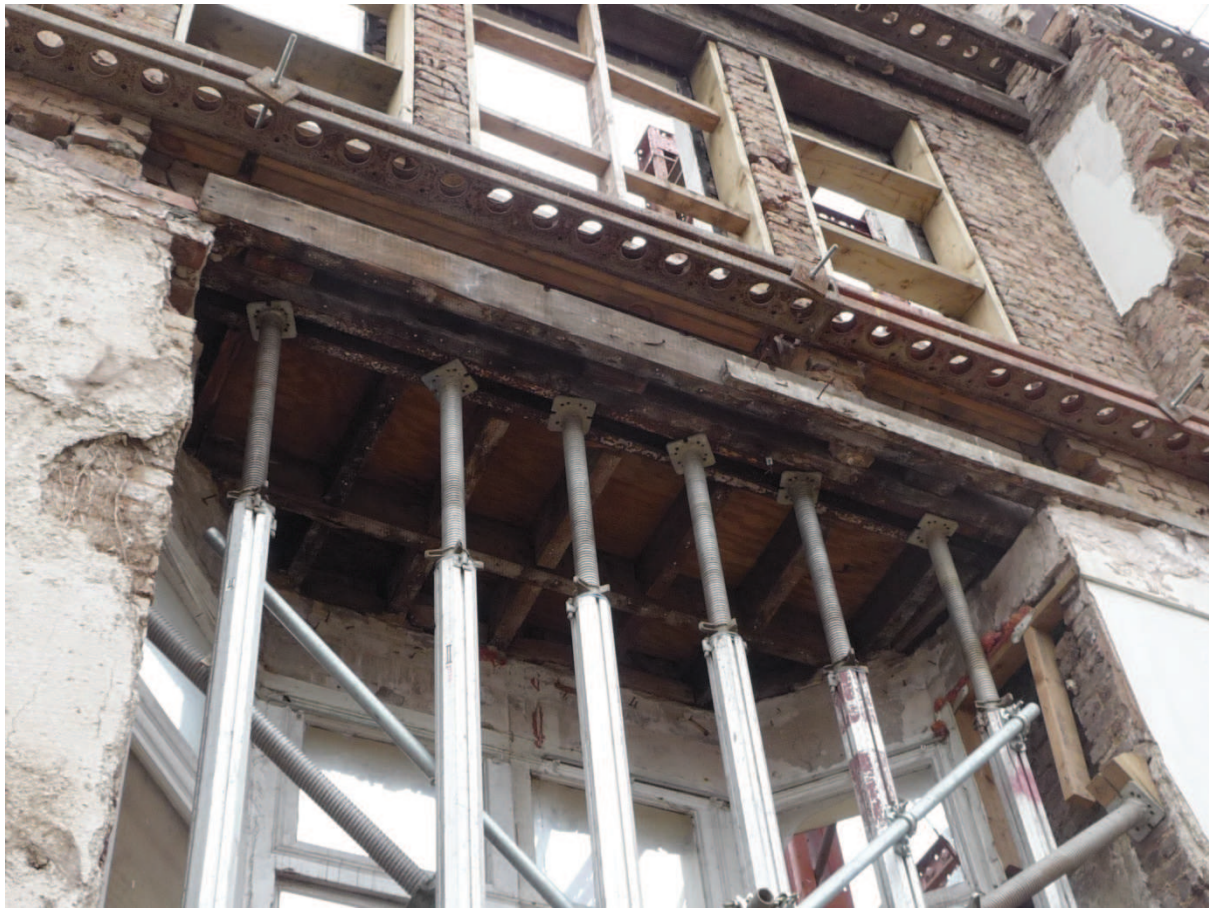
Photograph 12: Rear face of retained facade to No.44 showing RSJ's propped and timber bay window flat roof.

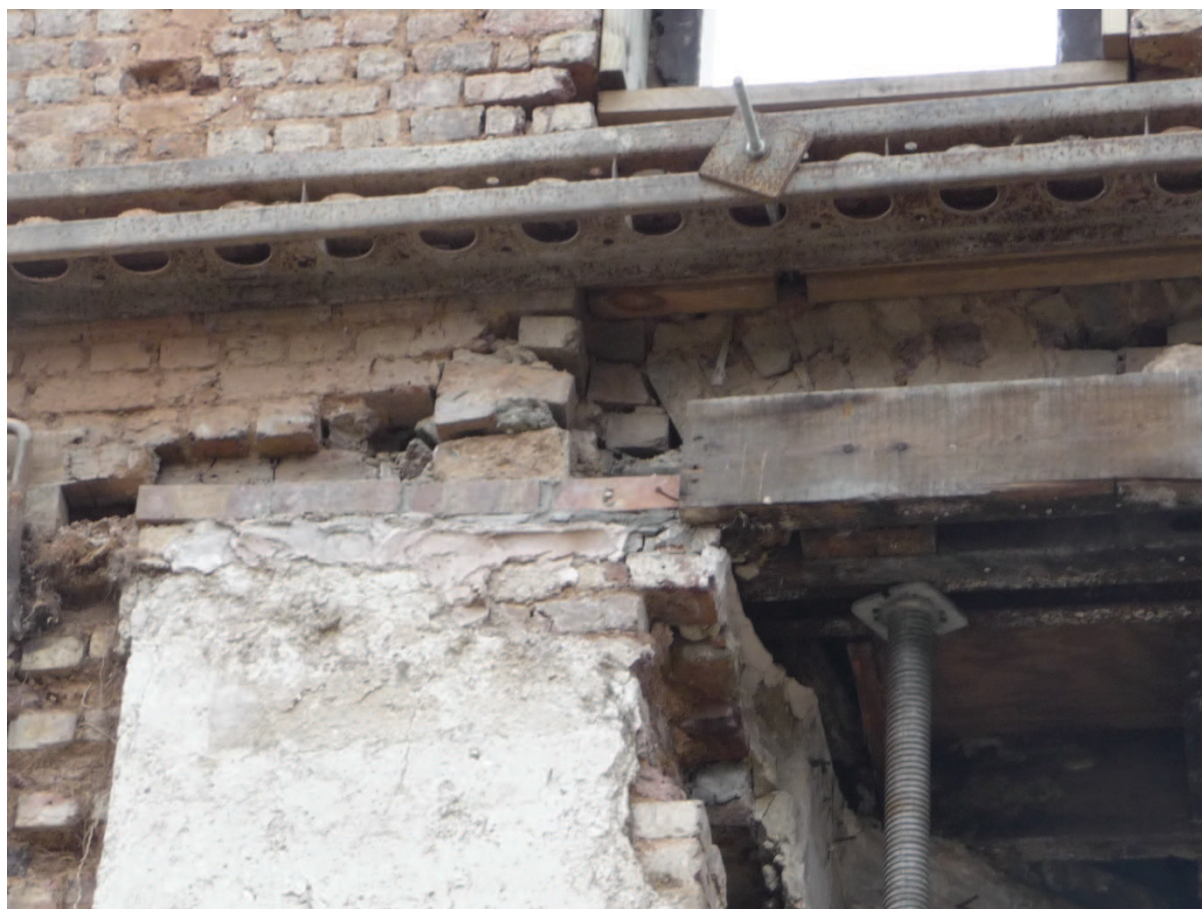
Photograph 13: Rear face of retained facade to No.44 showing loss of bearing for relieving arch and loose un-bonded masonry.

On this basis it is recommended that all embedded timber lintel sections and relieving arches are carefully removed in an agreed sequence and replaced as part of the new development with more durable concrete lintels onto repaired/re-bedded masonry at the bearings that will give the required load-bearing requirement.

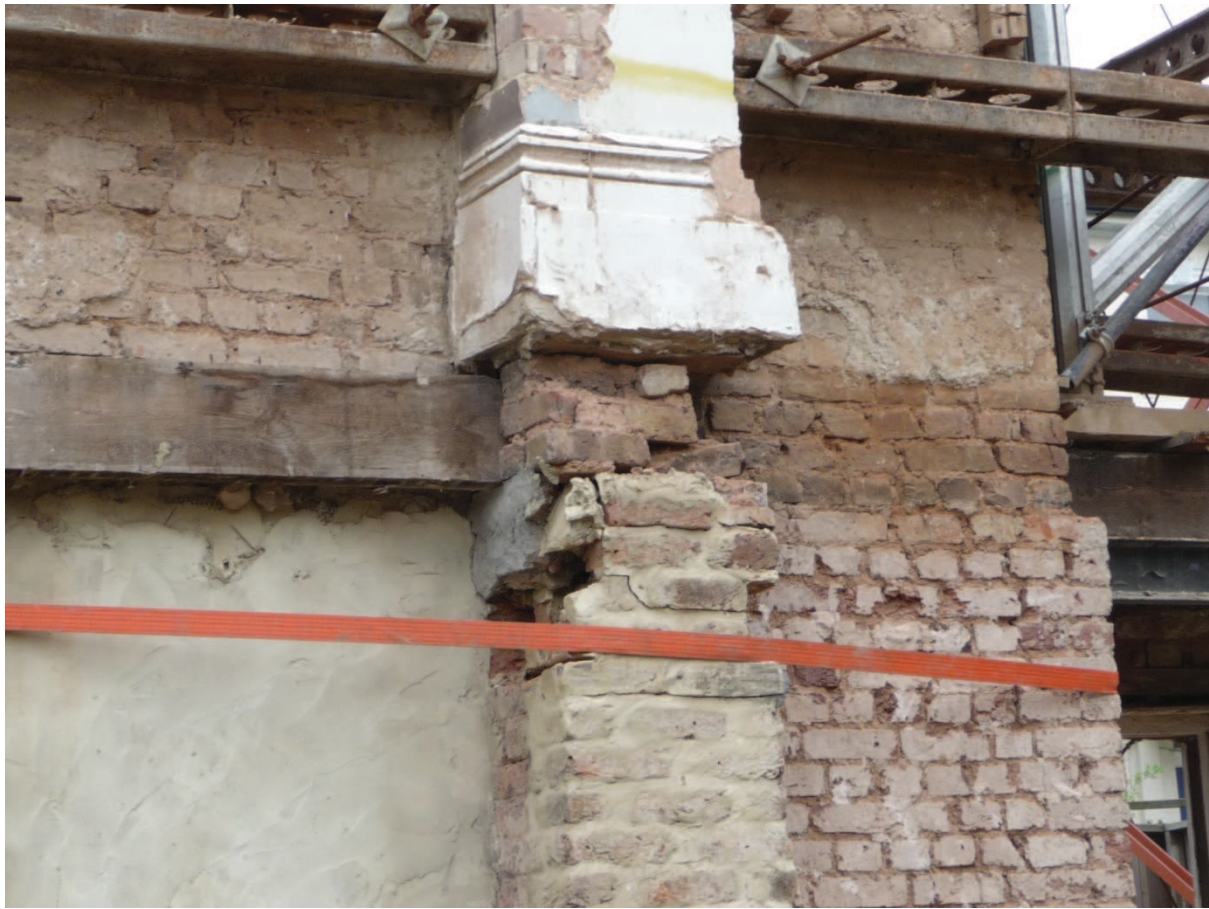
Photograph 14: Rear face of retained facade showing very poorly bonded masonry with embedded timbers and unstable pier remnant.

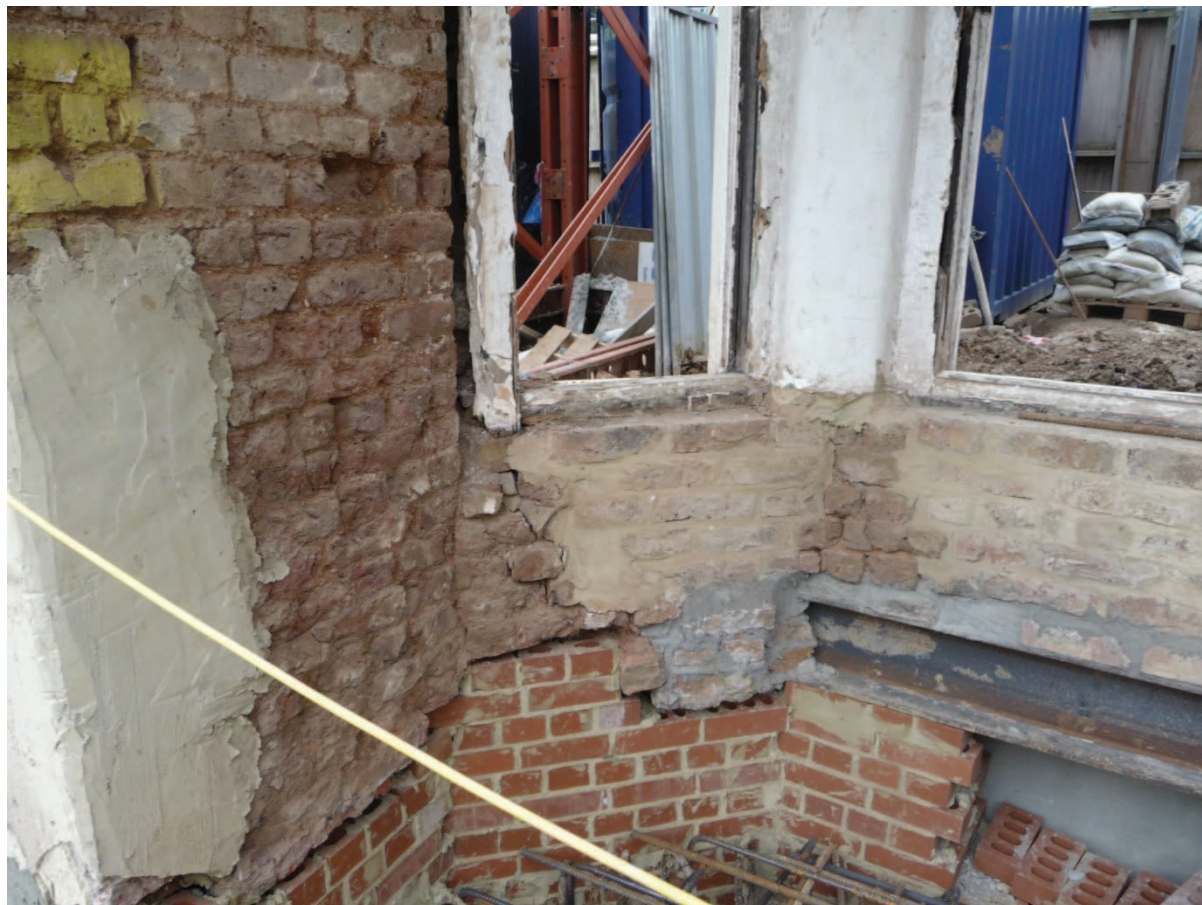
Photograph 15: Rear face of retained bay projection, showing poor quality masonry and minimal bonding.

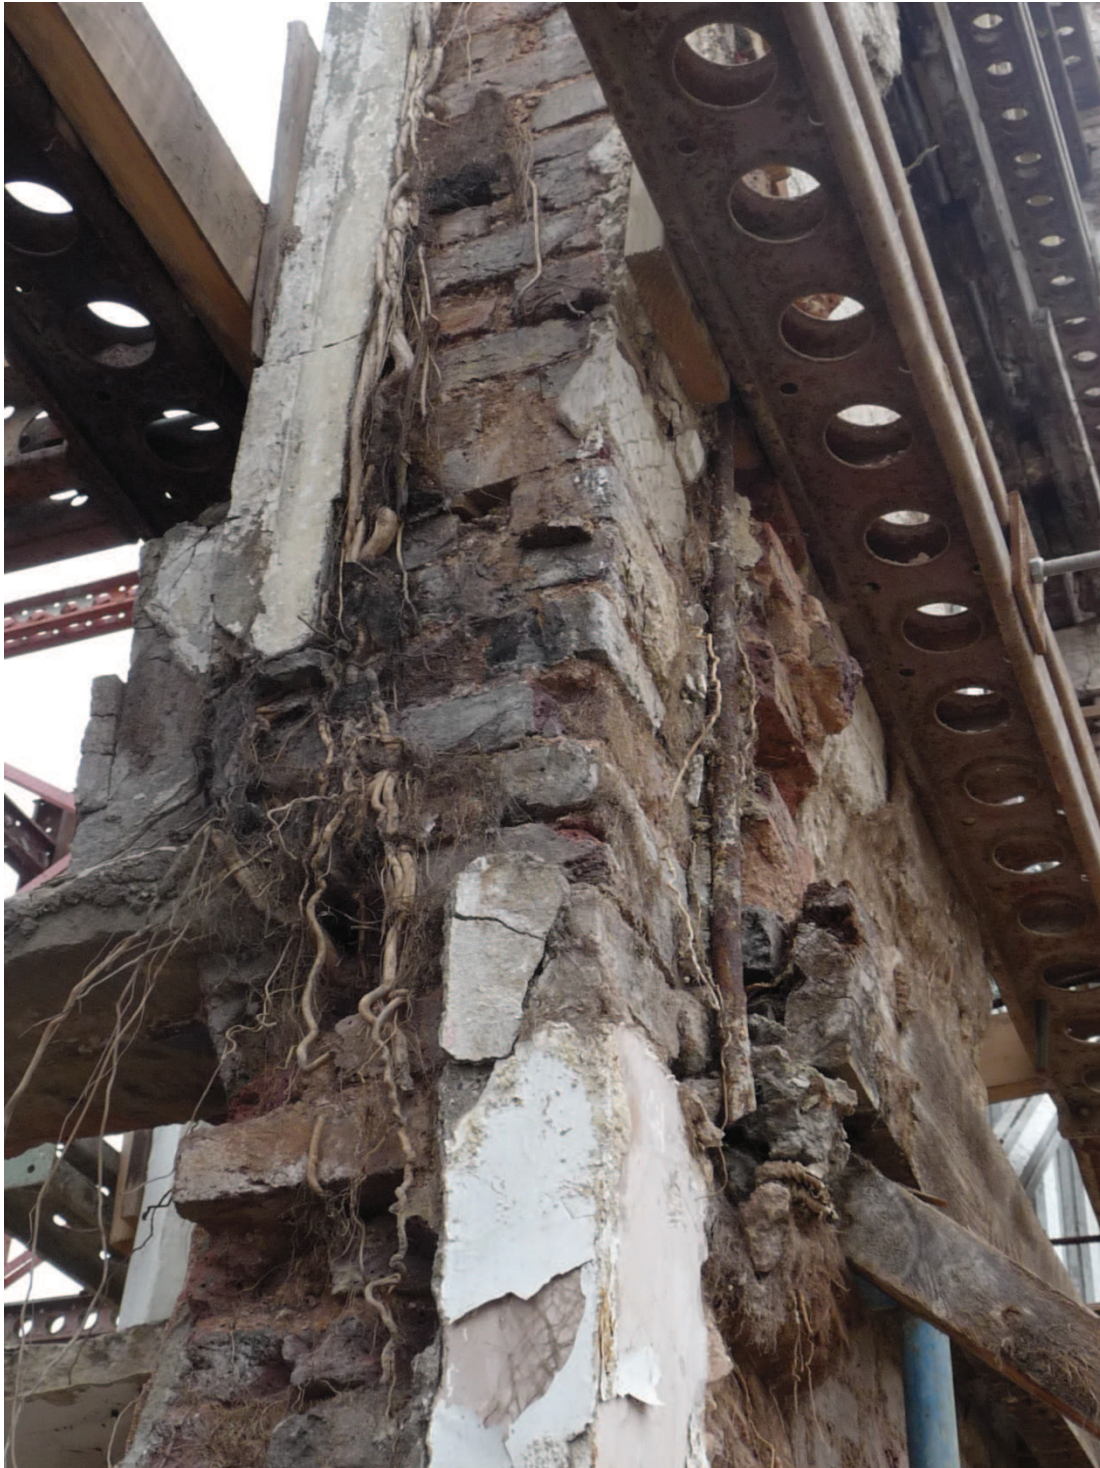
Photograph 16: End view of facade. Embedded roots and vegetation with very poor masonry

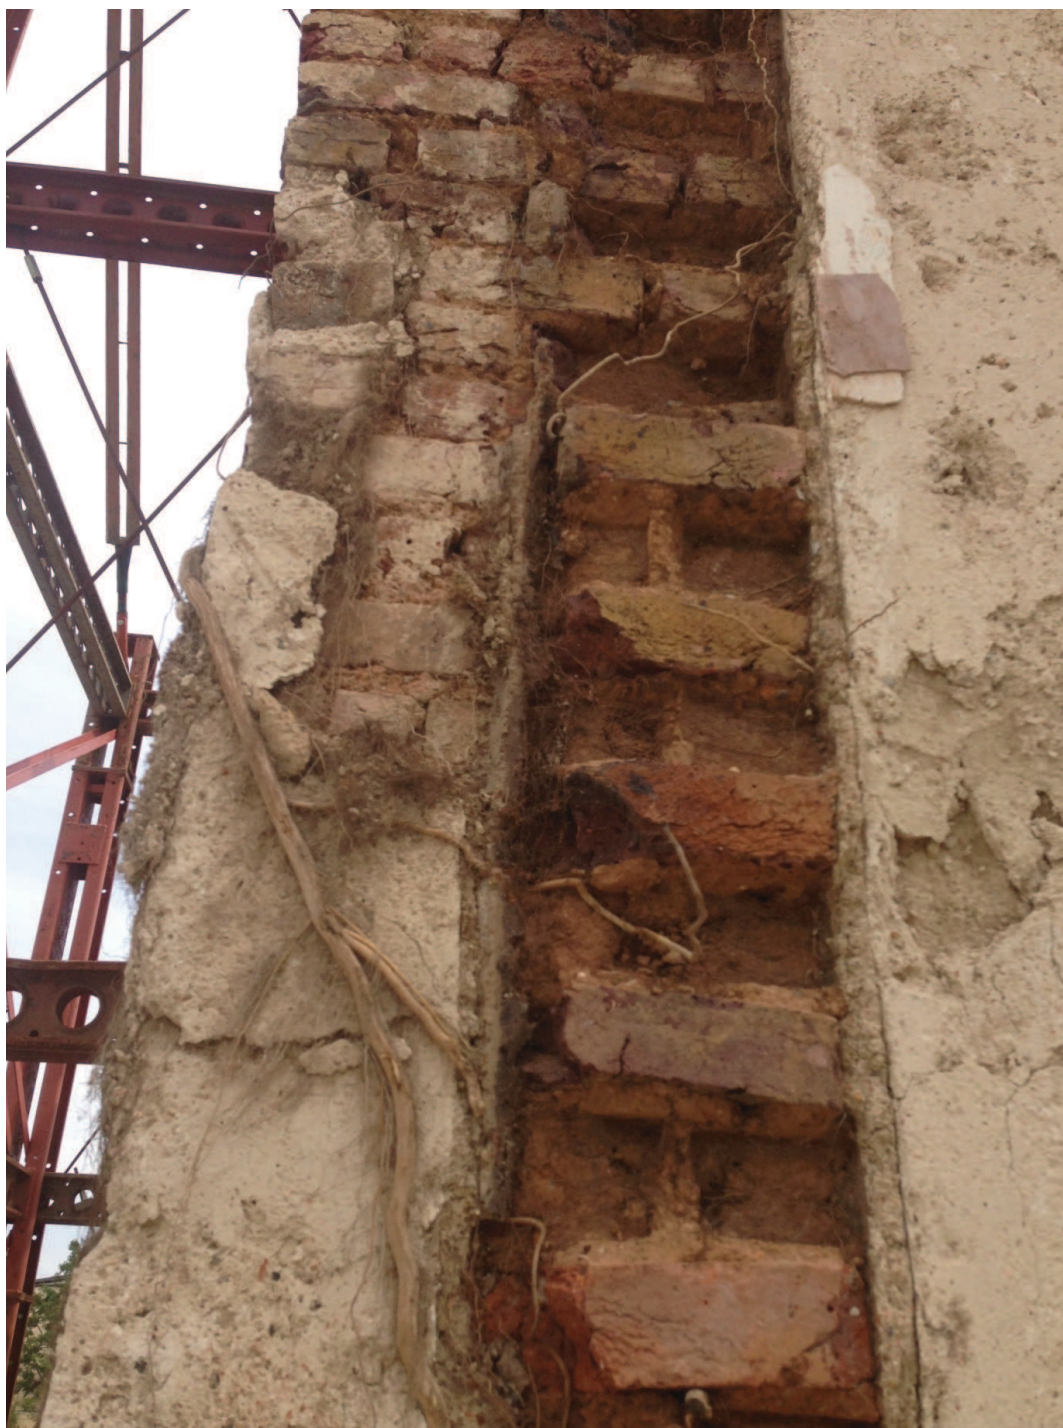
Photograph 17: Close up of embedded roots and vegetation with very fragile masonry.

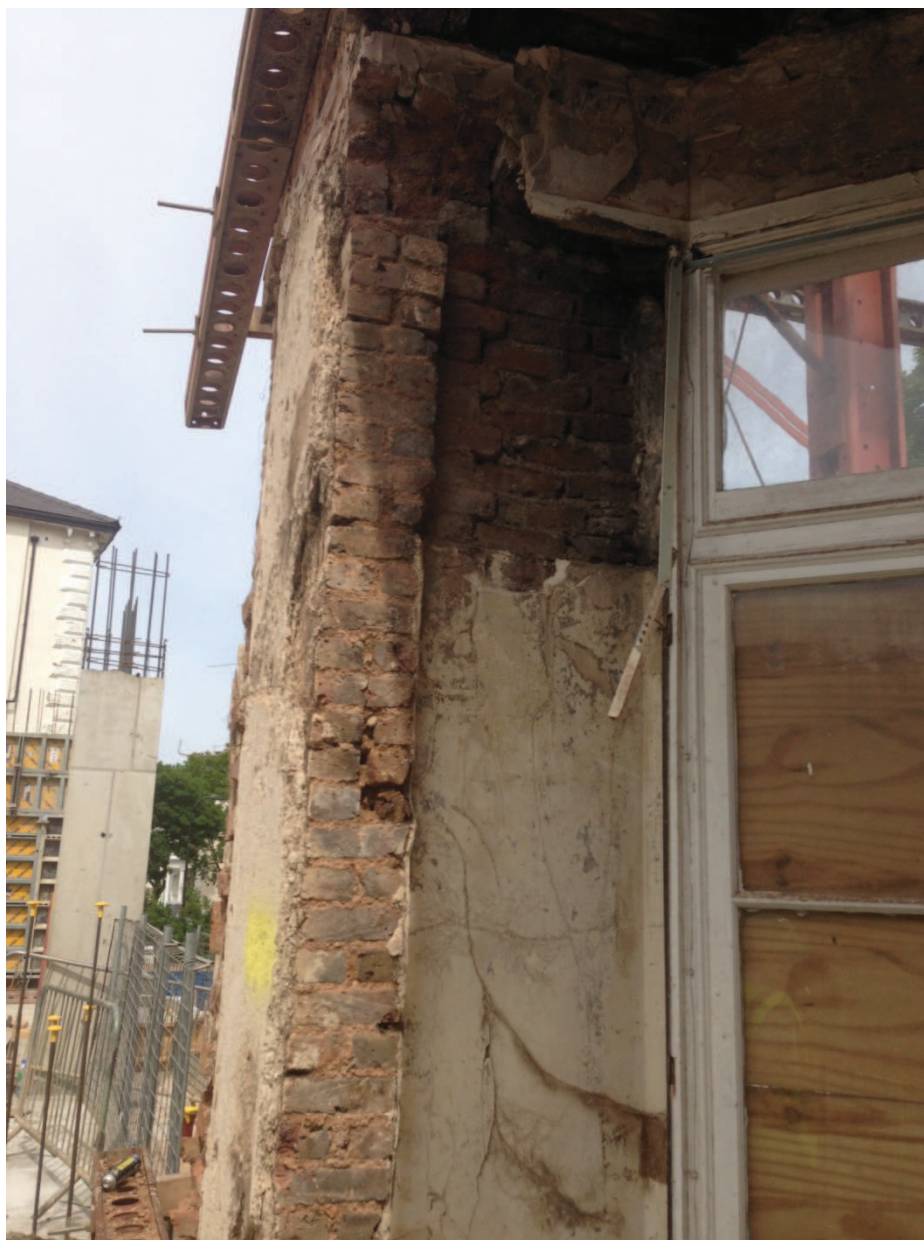
Photograph 18: A typical wing wall to the bay windows to be retained.

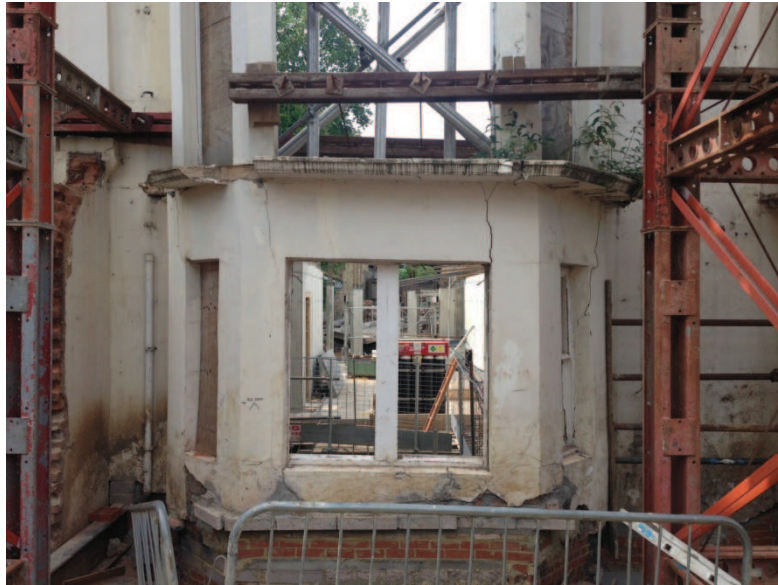
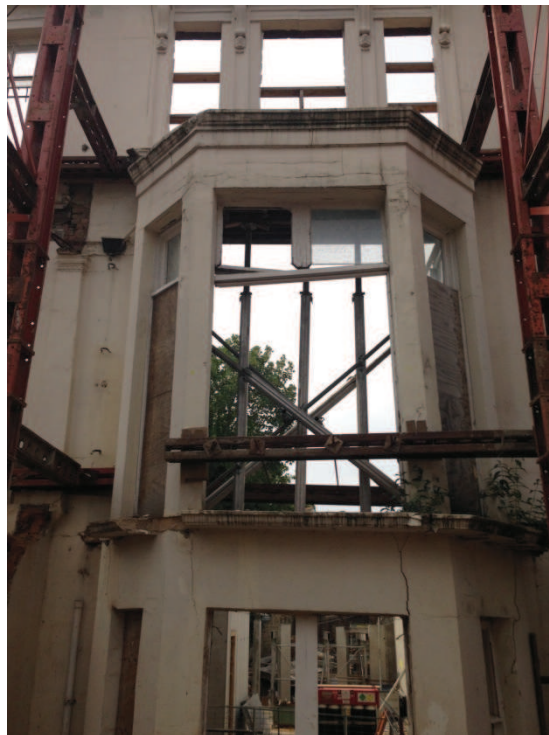
Photograph 19 Showing typical condition of No.45 bay windows, suffering distortion
