Arboricultural Appraisal Report

Subsidence Damage Investigation at:

32 Heath Hurst Road
London
NW3 2RX

CLIENT:	Crawford & Company
CLIENT REF:	SU1204069
POLICYHOLDER:	Mr Andre & Mrs Myra Polya
MWA REF:	NW070113.01DW-REV1
MWA CONSULTANT:	David Williams (N.D.Arb MArborA)
REPORT DATE:	02 September 2013

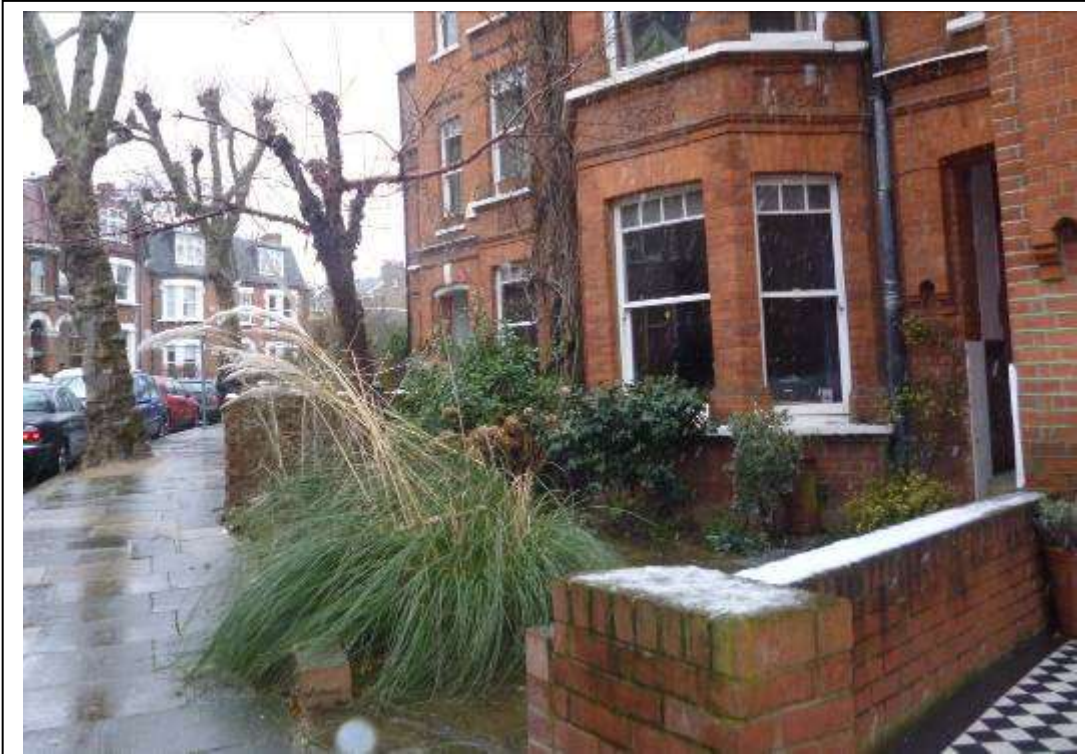
View of front elevation and garden
