THE MORTON PARTNERSHIP LTD.

## CONDITION STATEMENT OF CORAM CAMPUS BOUNDARY WALL

**Date:** March 2010

**Ref:** PC/12493-cond – Rev C

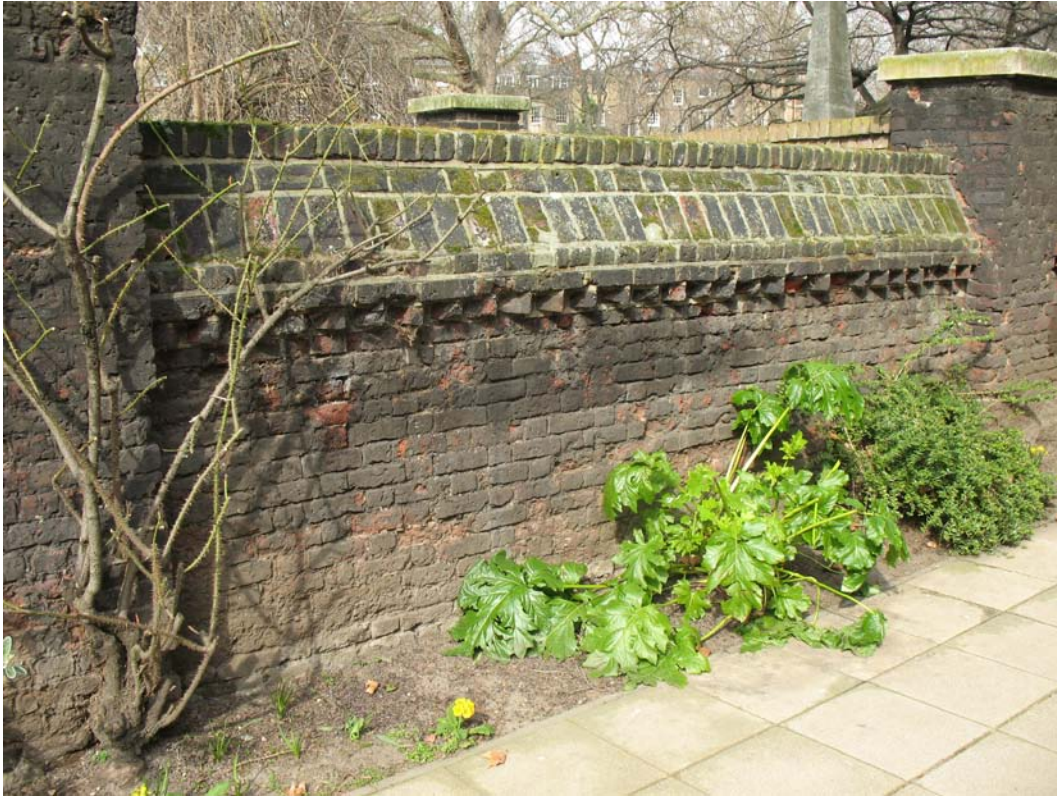
**Photograph 1:** Typical elevation of south elevation showing piers and dog tooth course

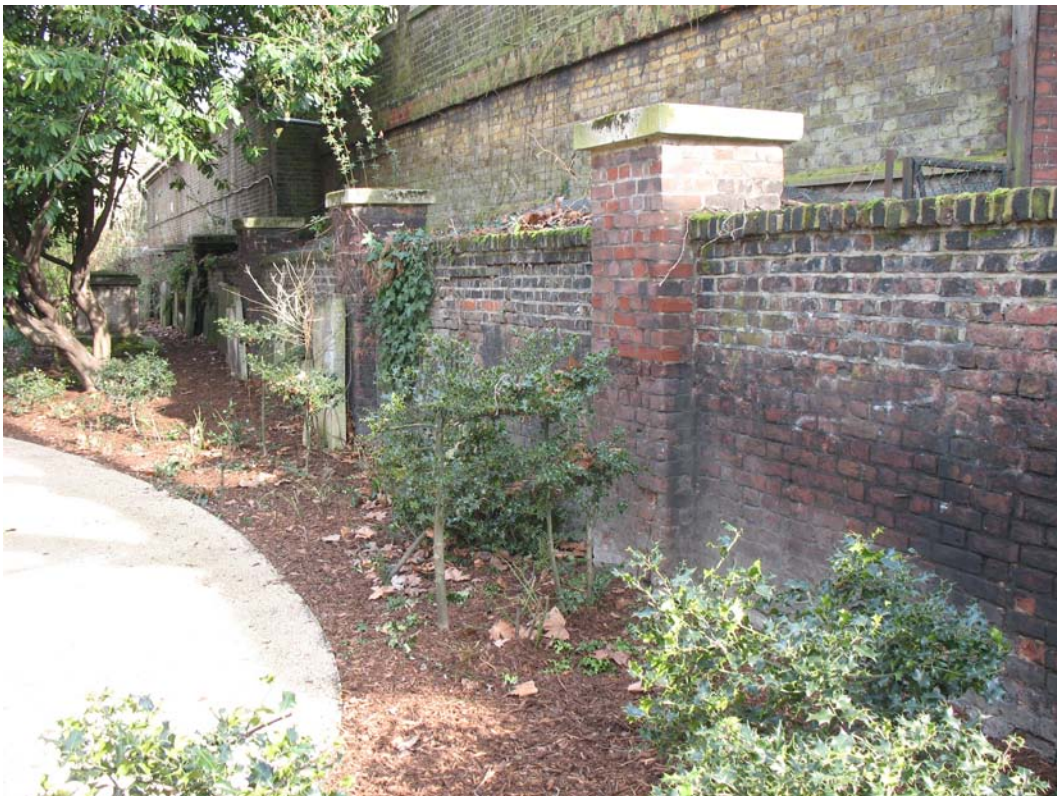
2.1.1 The wall is approximately 1.8m high along its length. Large brick piers are spaced at approximately 4.5m centres which are generally 660mm x 660mm and have a large stone coping. The wall is generally 330mm thick with a dogtooth course at shoulder level to the south facing elevation. Above the dogtooth course the wall reduces in thickness to a brick on edge capping (Photograph 1). The north facing elevation of the wall is generally flat with no change in elevation or thickness or decoration courses (Photograph 2).

**Photograph 2:** Typical elevation of north elevation

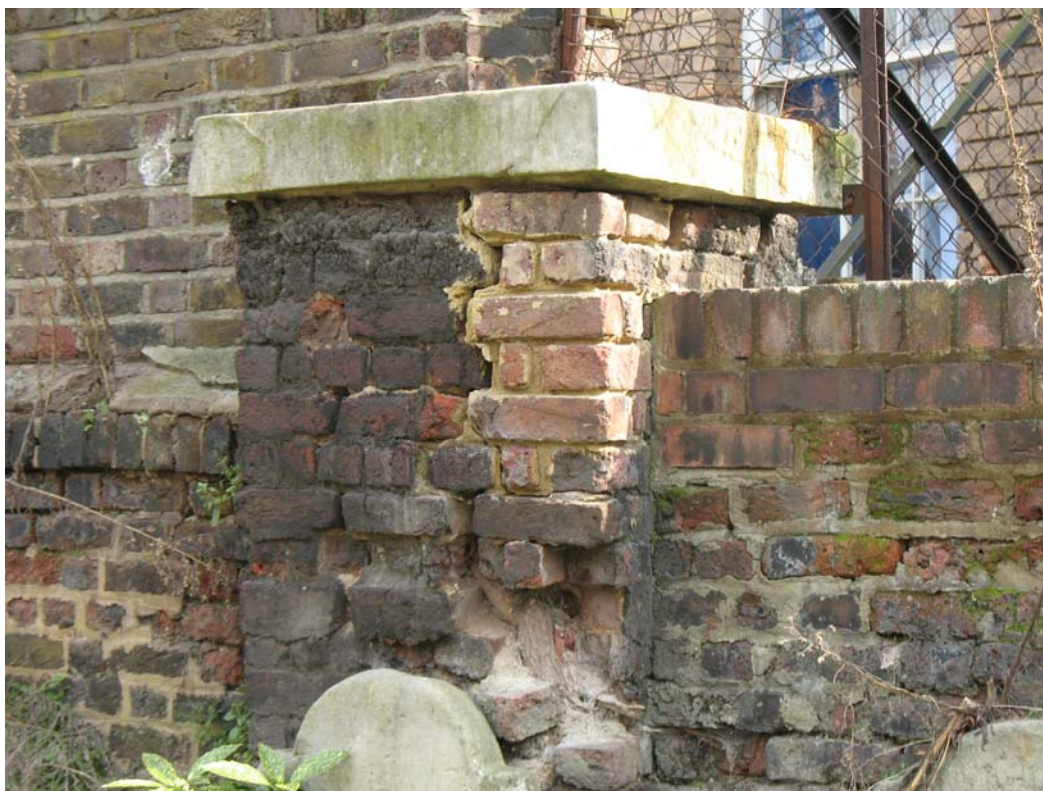
2.2.1 Pier A has moved considerably in the past and currently has missing bricks and a poorly reconstructed edge using different colour bricks (Photograph 3).

**Photograph 3:** Pier A showing poor quality local reconstruction and missing bricks

- 3.4 As a schedule of minimum requirements carried out to the wall prior to the development works commencing we would recommend the following. All areas of missing bricks should be carefully stitched in by competent bricklayers fully trained in conservation works. Replacement bricks should match existing in size and colour and the mortar is to match the existing where a good example exists. We would expect that the local authority will want to see a sample of this work prior to full scale works commencing. The bricklayers should also inspect the full length of the wall where accessible and check for loose bricks, particularly the brick on edge copings. All loose bricks are to be carefully removed and if possible, re-used in the reconstruction of the loose areas of brickwork. As with infilling of missing bricks, a sample should be provided to ensure that any new work matches the existing and that quality can be agreed. We would also recommend that the render is removed from the south elevation to panels 1 and 2 and also 29 and 30.

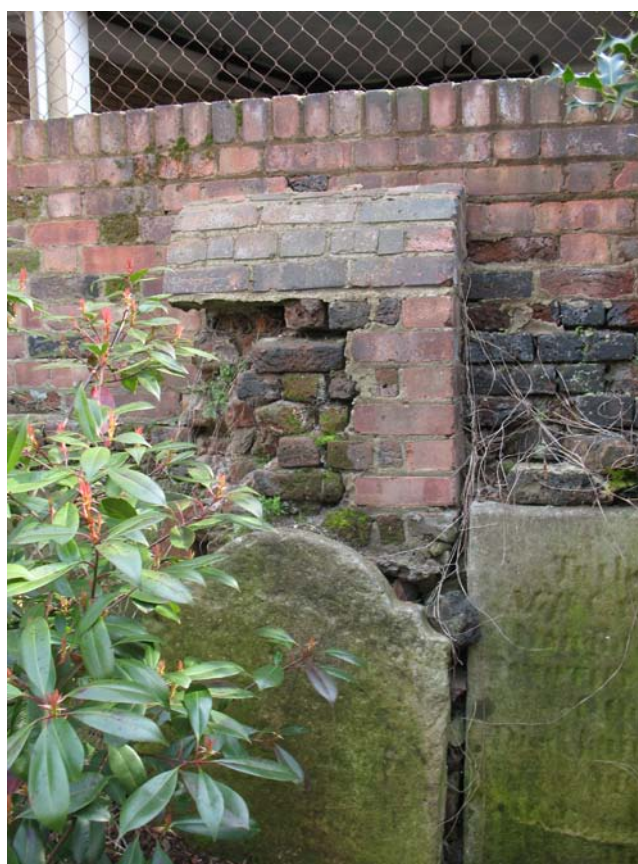
2.2.2 Pier B is not a typical full height square pier as per all of the other piers along the length of the wall. This pier is only found on the north side of the wall and the top of this pier is approximately 3 courses below the top of the wall. This pier has a number of missing bricks over its area (Photograph 4).

**Photograph 4:** Pier B not full height with missing bricks

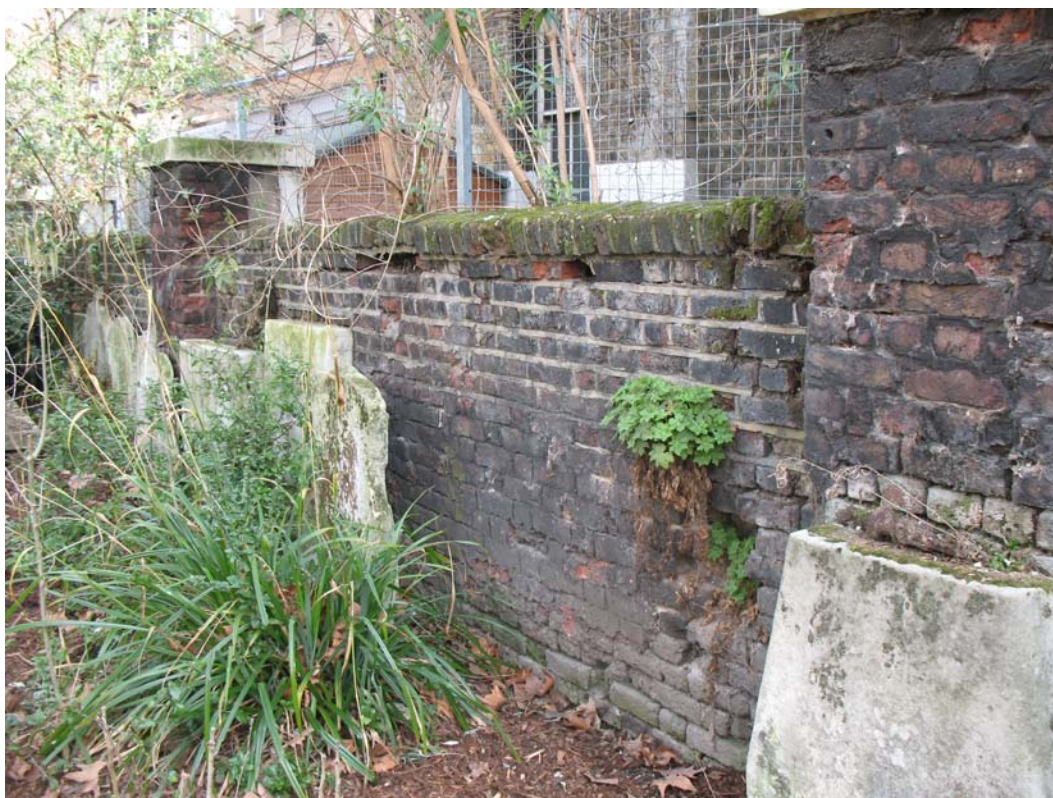
- 2.2.3 Wall panel 4 has an open horizontal joint in the course below the brick on edge course for the majority of the length of wall.
- 2.2.4 Wall panel 9 has a number of holes where bricks are missing. Vegetation is now growing in some of these holes causing further damage to the walls (Photograph 5).

**Photograph 5:** Wall panel 9 with missing bricks and vegetation growing in holes

- 3.5 We would also recommend that all vegetation is stripped from the walls to enable a full inspection of the wall as should the gravemarkers that are resting against the north side of the wall.

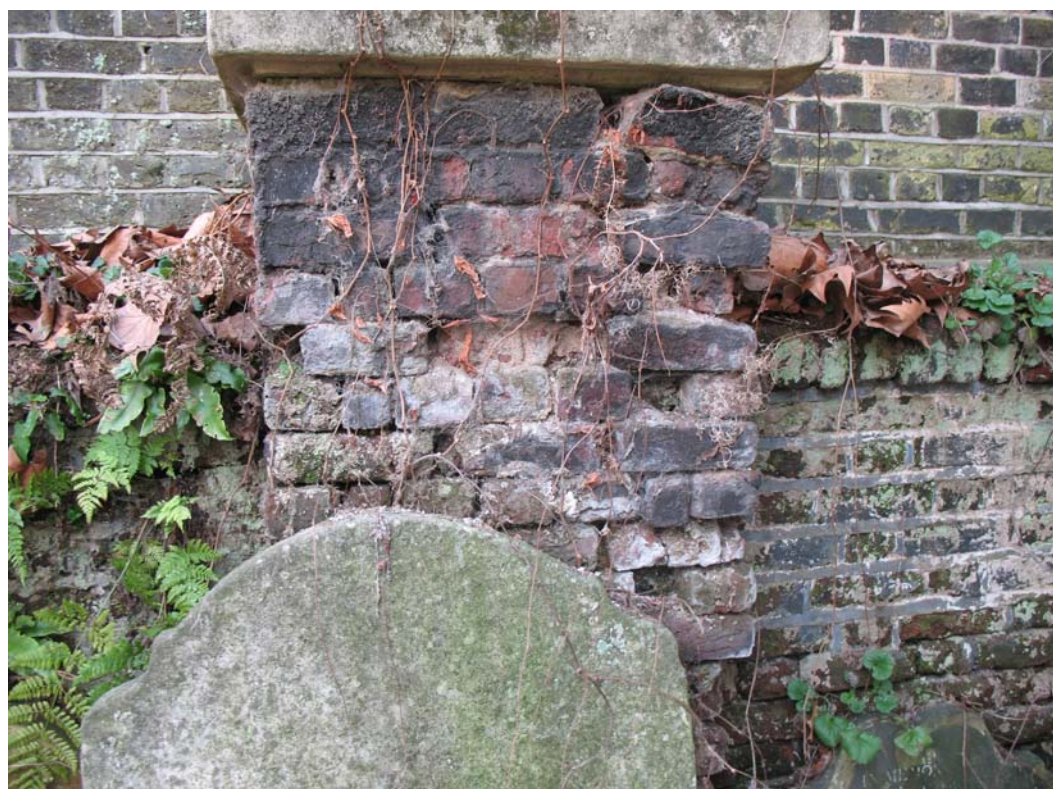
- 2.2.7 A number of bricks are loose and missing to pier N which was generally found to be in particularly poor condition (Photograph 6).
- 2.2.8 Wall panel 14 leans outward in the location of the return wall on the south side between the wall and the building. This has also caused some cracking locally to this wall (Photograph 7).

**Photograph 6:** Pier N in particularly poor condition

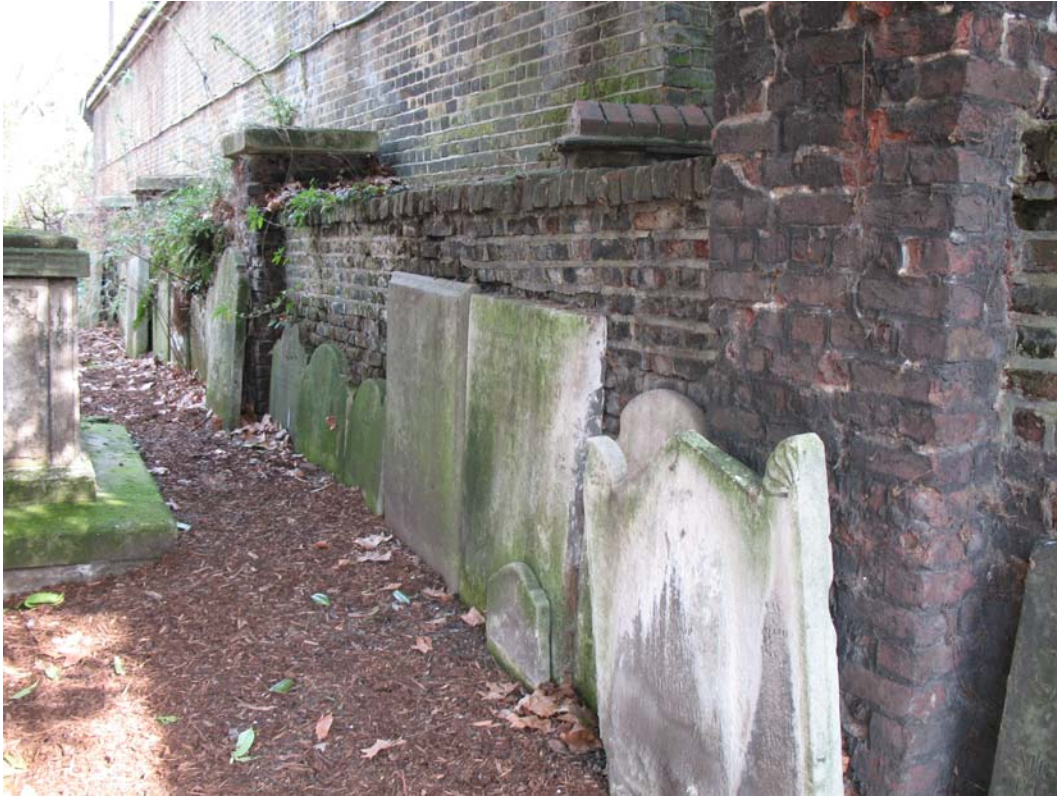
**Photograph 7:** Wall panel 14 leans toward garden in location of return wall on other side

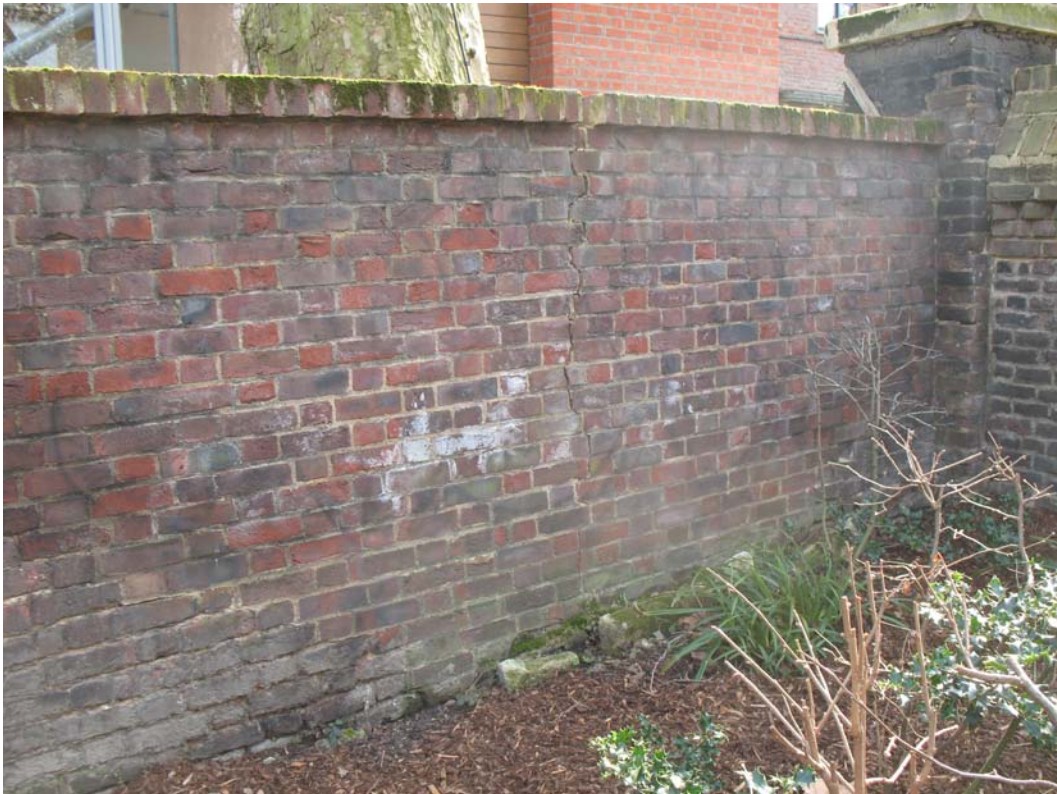
- 2.2.9 The top 2 or 3 courses of wall panel 16 lean inward and appear to be loose as opening up of the bed joint has occurred (Photograph 9).
- 2.2.10 A vertical crack in the brickwork to wall panel 18 has occurred in the location of the tree on the south side of the wall. This is a substantial tree and is in very close proximity (<1m) of the face of the wall. This wall panel has been reconstructed in the past and is not the original bricks but it has been constructed as a facsimile of the original wall (Photograph 8).

**Photograph 8:** Vertical crack in panel 18 in location of tree. Panel has been reconstructed

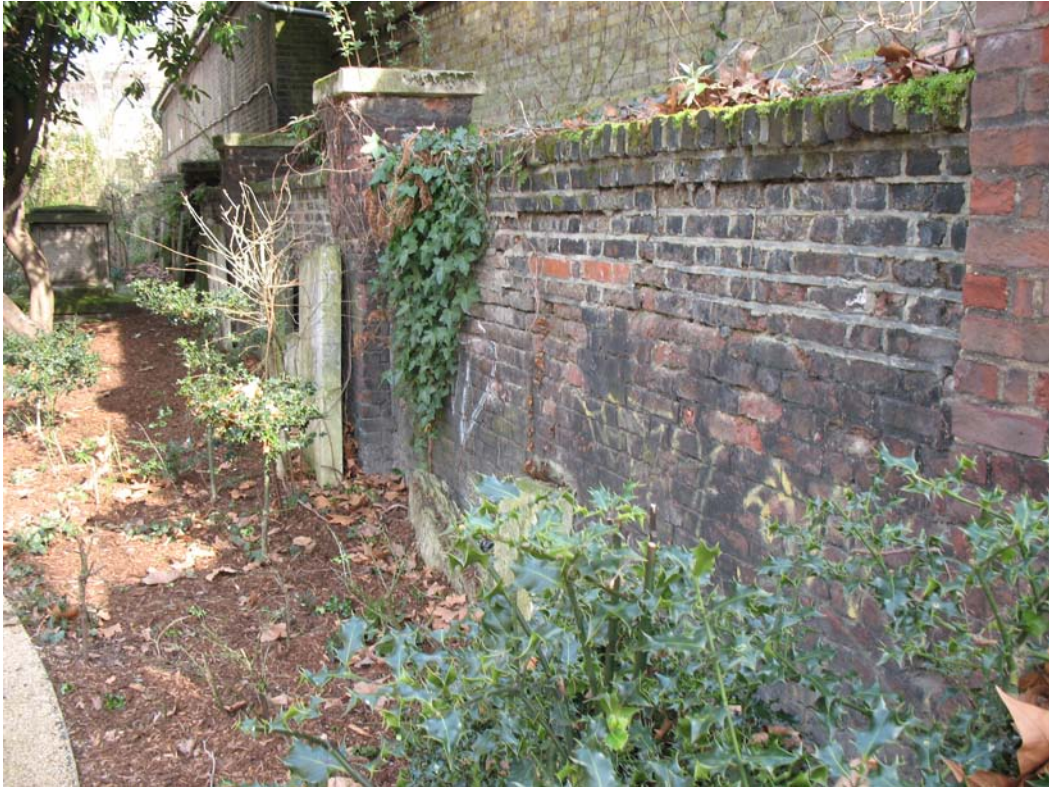
**Photograph 9:** Wall panel 16 showing horizontal movement in top courses

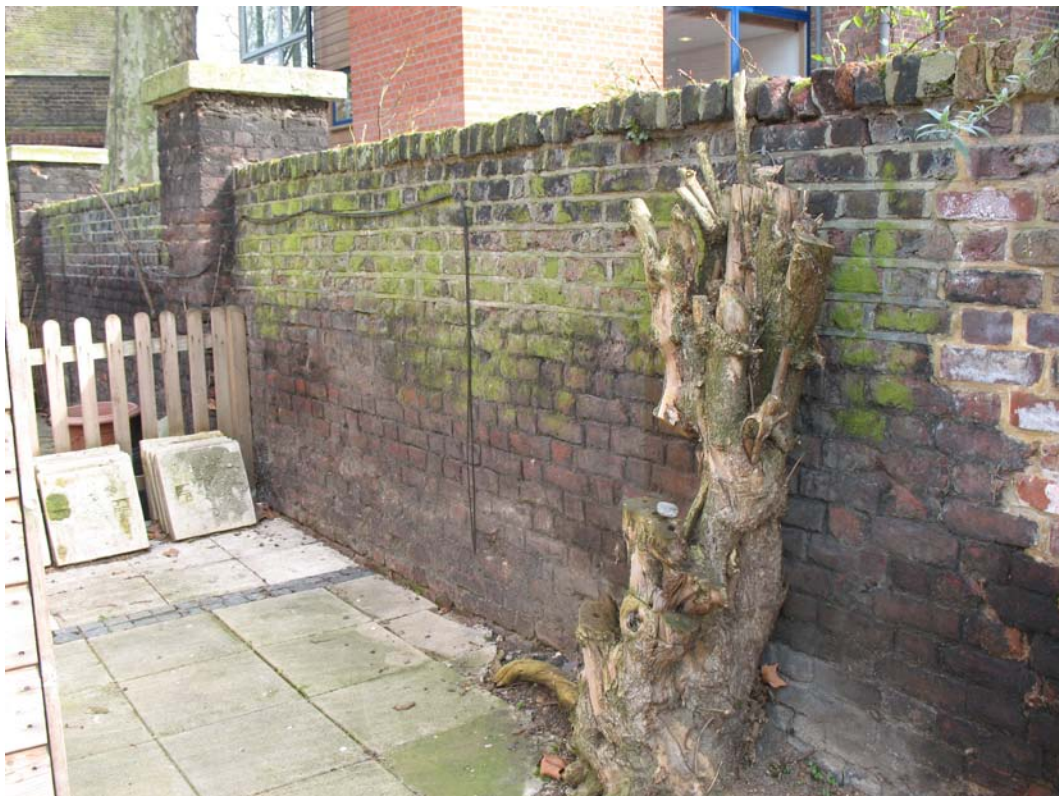
- 2.2.11 A number of bricks are missing to the left hand side of pier T.
- 2.2.12 A number of brick on edge cappings have become dislodged in wall reference 20. There is also a cut back tree stump very close to the wall (Photograph 10).

**Photograph 10:** Wall panel 20 with loose brick on edge course and close proximity of cut back tree.

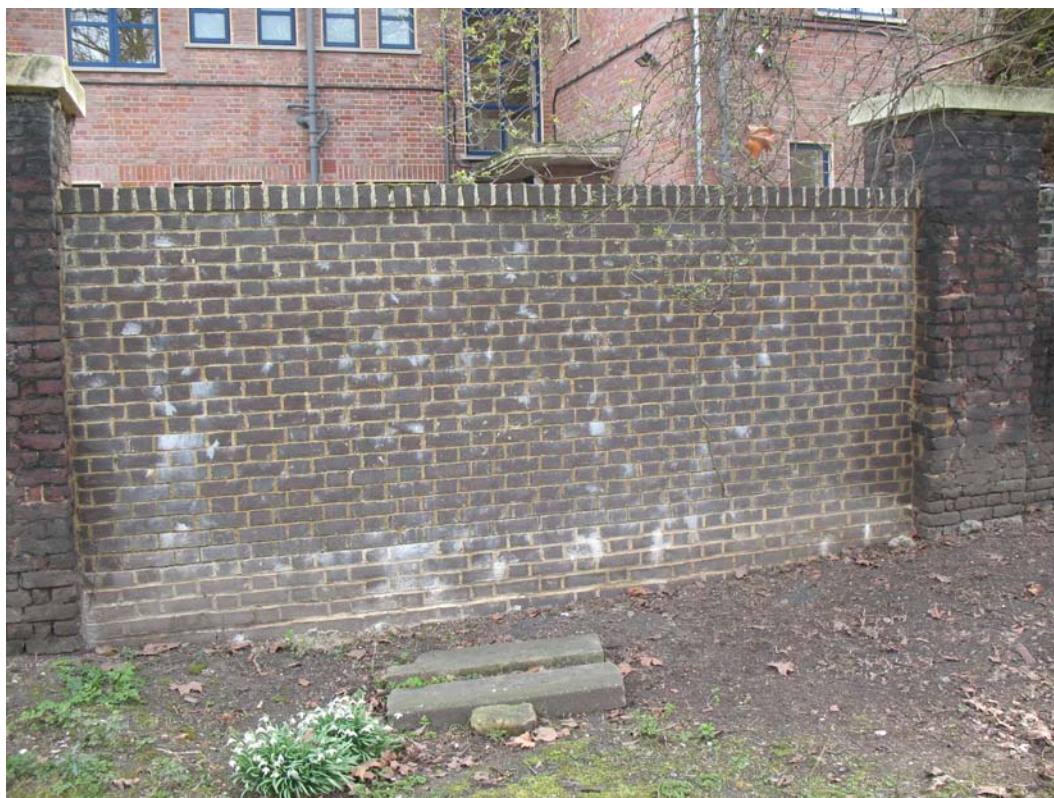
- 2.2.14 A number of brick on edge cappings have become dislodged in wall reference 23. There is also a vertical crack in this wall.
- 2.2.15 Wall panel 24 has been reconstructed and is in reasonable condition (Photograph 11). The bricks used are similar to panel 21 and would assume that this panel was constructed at the same time and therefore we would make the same assumption regarding the bonding between the pier and wall panel.

**Photograph 11:** Reconstructed wall panel 24

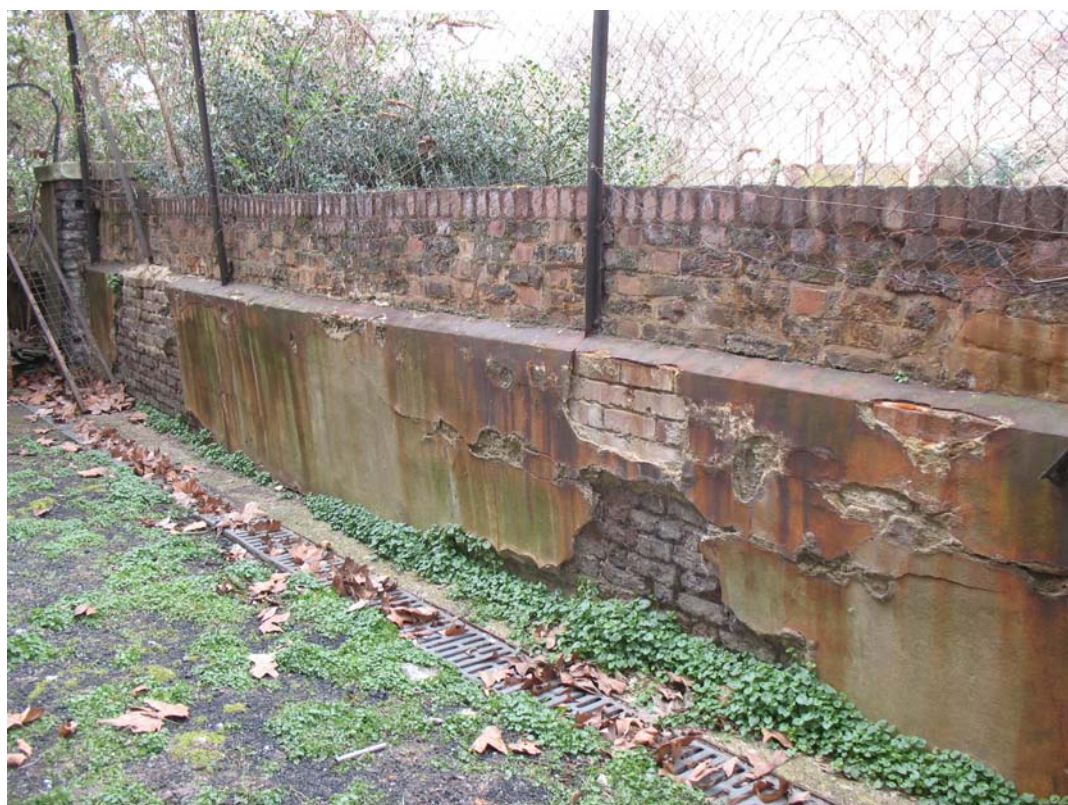
**Photograph 12:** South elevation of wall panel 1 & 2 showing failing render

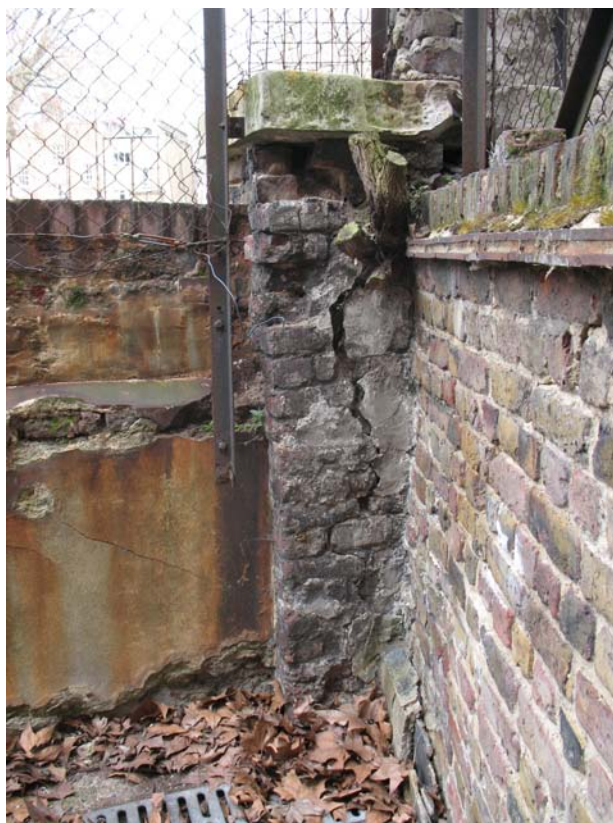
**Photograph 13:** Pier A showing cracking and cut back stump embedded in wall

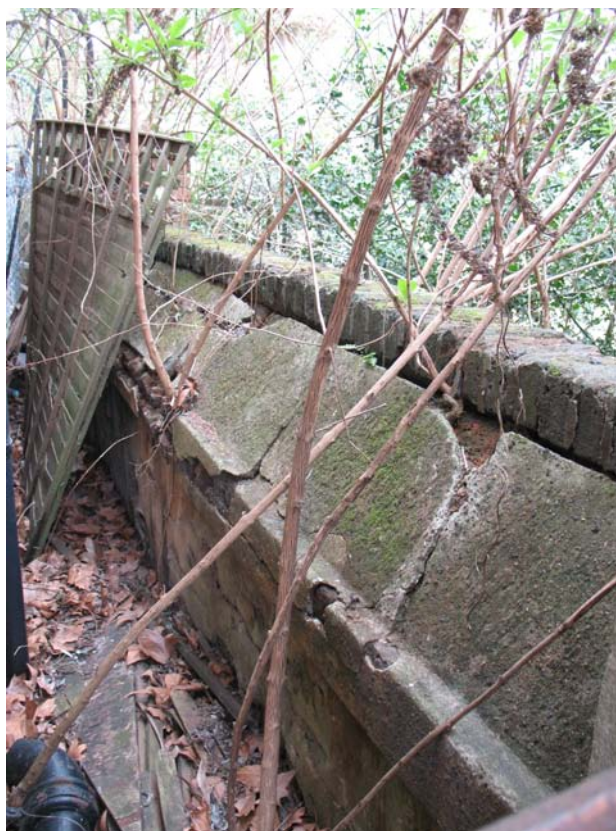
- 2.3.1 Wall panels 1 and 2 are rendered to the south side of the wall for the lower thicker section of wall. The render has fallen away in many areas and is live and has suffered significant cracking for much of the remaining areas. The top of this length of wall leans inward. The pier is not in evidence on this side of the wall but only occurs on the other side of the wall (Photograph 12).
- 2.3.2 Pier A has a stump from an old bush embedded with the brickwork which has caused the brickwork to crack and fall out (Photograph 13).
- 2.3.3 Access was limited to wall panel 3 but it could be seen that the render to the sloping flaunches was loose and appeared to be live (Photograph 14).

**Photograph 14:** Wall panel 3 showing failing render

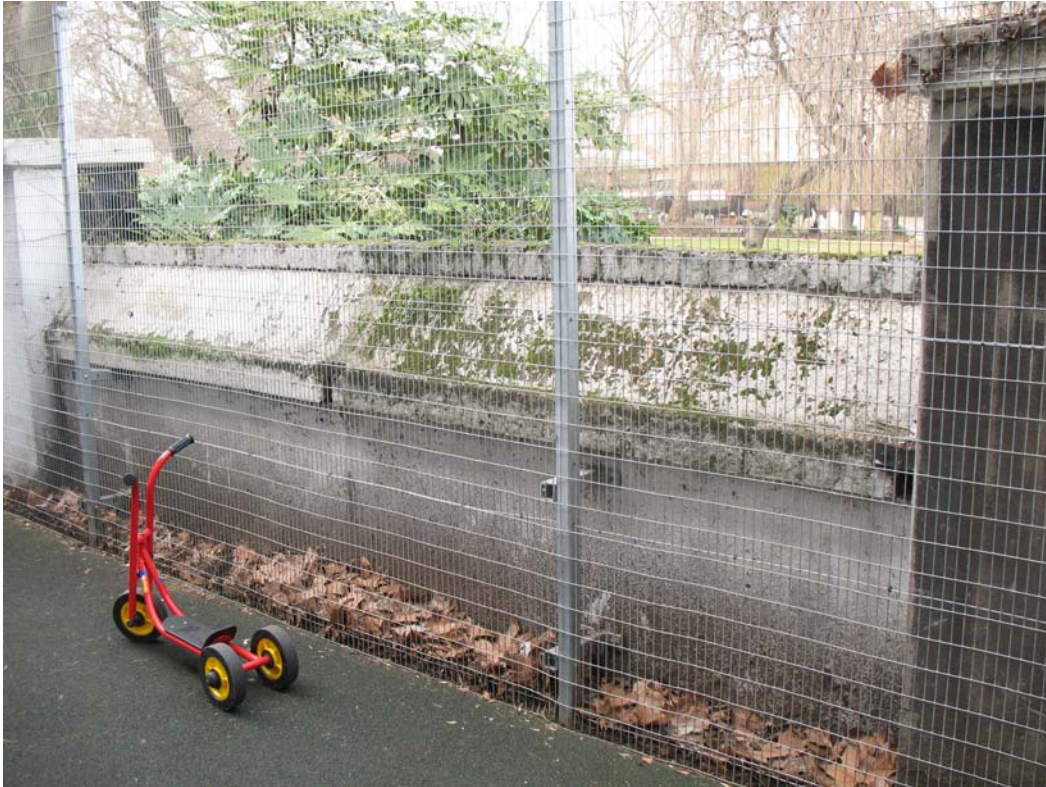
- 2.3.4 The wall to panels 5,6 and 7 was not fully accessible due to the wire mesh fence and frame enclosing the childrens playground. The frame has been fixed back to the wall via bolts/ anchors. A small vertical crack was recorded in panel 6 behind the wire mesh fence in the string course (Photograph 15).

**Photograph 15:** Panel 6 with wire fencing attached to wall

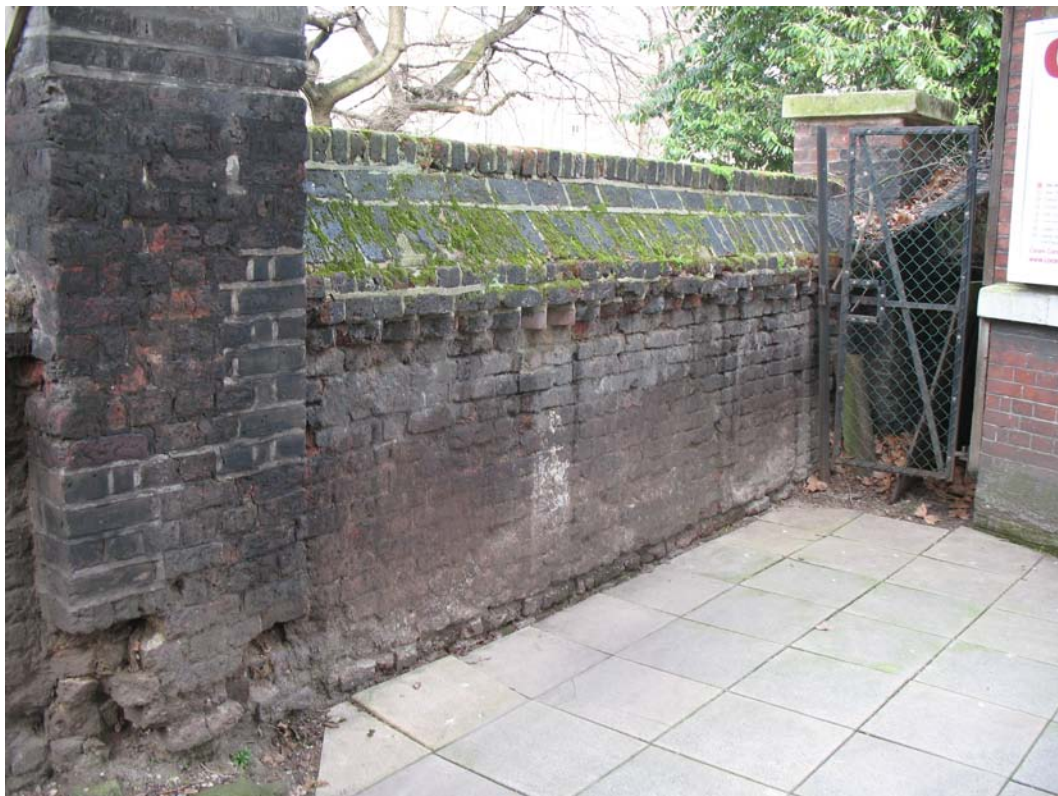
- 2.3.7 Pier reference P has a number of missing bricks to the base.
- 2.3.8 Wall panel 16 has a number of missing bricks to this elevation.
- 2.3.9 Pier R has a number of bricks missing to the pier base (Photograph 16).

**Photograph 16:** Missing bricks to base of Pier R and general condition of Wall 17

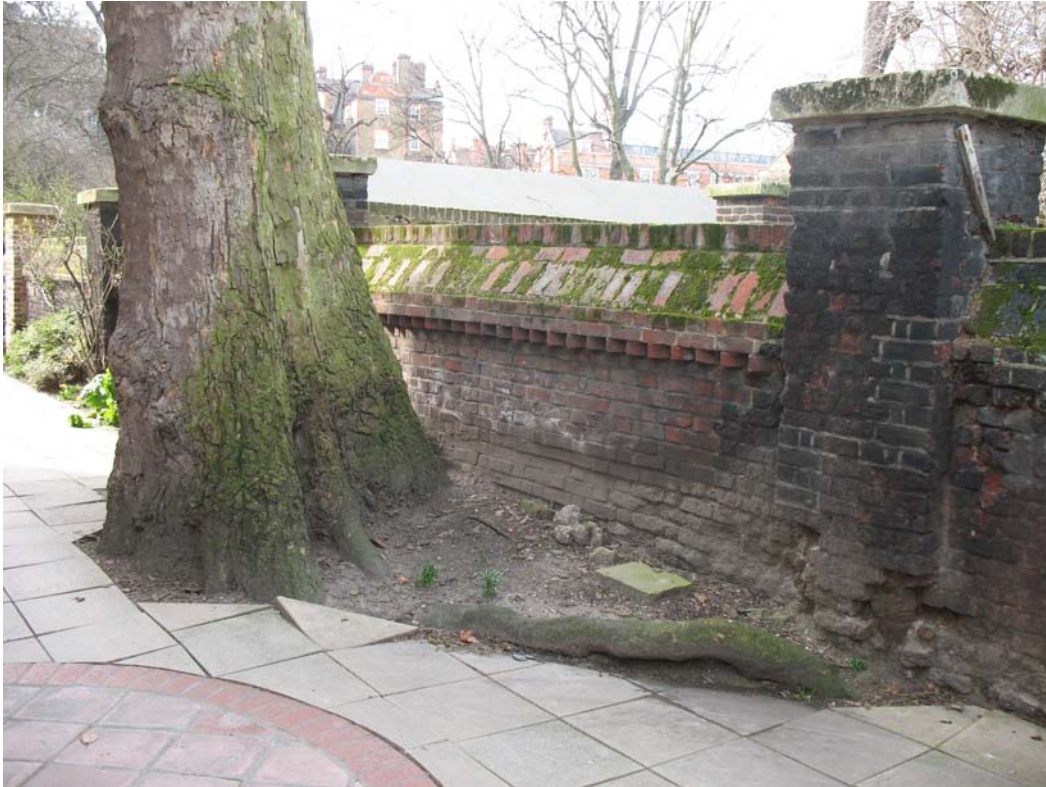
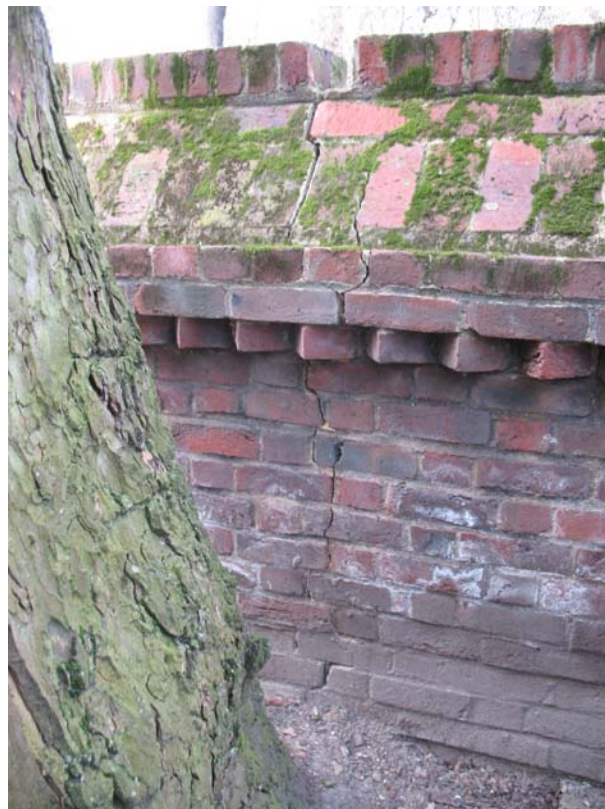
- 2.3.10 Panel 18 has a vertical crack that can be seen to both sides of the wall. There is a substantial tree less than a metre from the wall where the roots have caused the wall to move. This wall has been reconstructed but the tree has still caused movement in the wall (Photographs 17 & 18).

**Photograph 17:** Large tree in close proximity to Wall 18 which has a vertical crack. Missing bricks also in base of Pier R.

**Photograph 18:** Vertical crack in Wall 18 and missing coping brick on edge

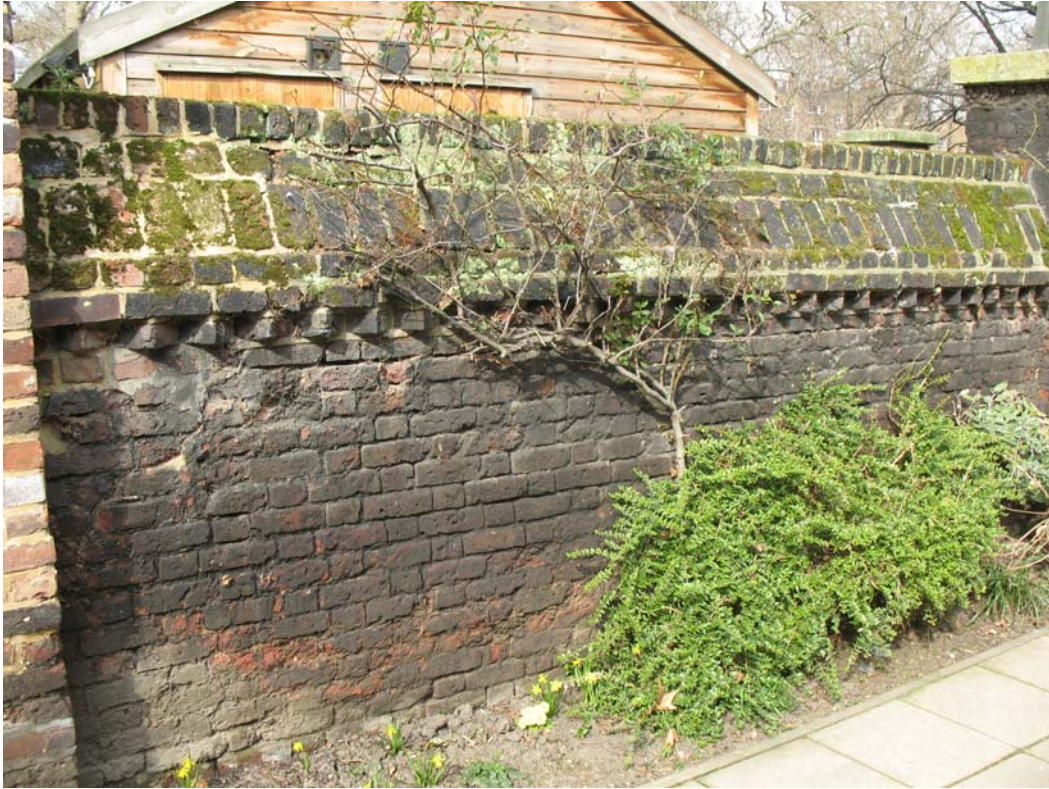
- 2.3.11 The dogtooth course in panel 20 has significantly eroded as has a reasonable amount of wall panel below the dogtooth course. There is also a diagonal crack in this panel adjacent to pier U however this could be a junction where the reconstructed panel 21 and Pier U is bonded into the original brickwork of panel 20 (Photograph 19).

**Photograph 19:** Wall panel 20 with eroded dog tooth course and diagonal crack adjacent to Pier U

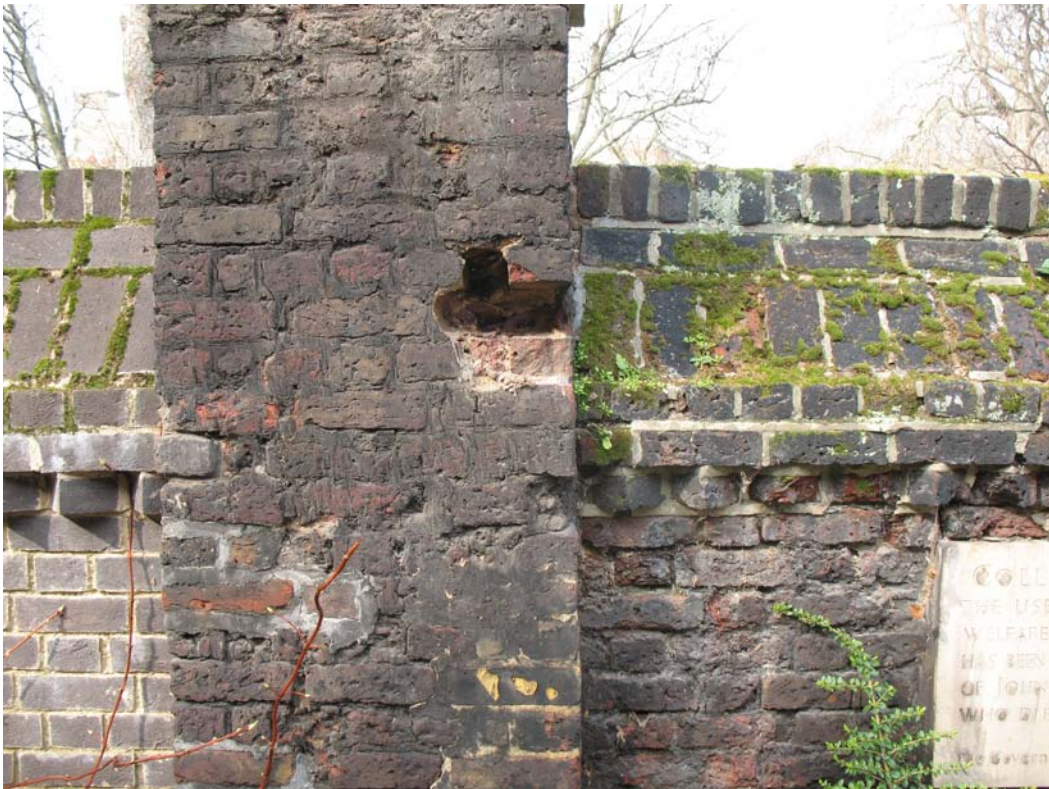
- 2.3.12 Pier X has a number of missing bricks adjacent to panel 23 (Photograph 20).
- 2.3.13 Panel 25 is in very close proximity to a large tree. This wall was considered to have suffered slightly worse than average erosion, particularly to the dog tooth course (Photograph 21). It was also noted that a number of bricks have been cut out and replaced, where erosion has been excessive.

**Photograph 20:** Missing bricks to Pier X

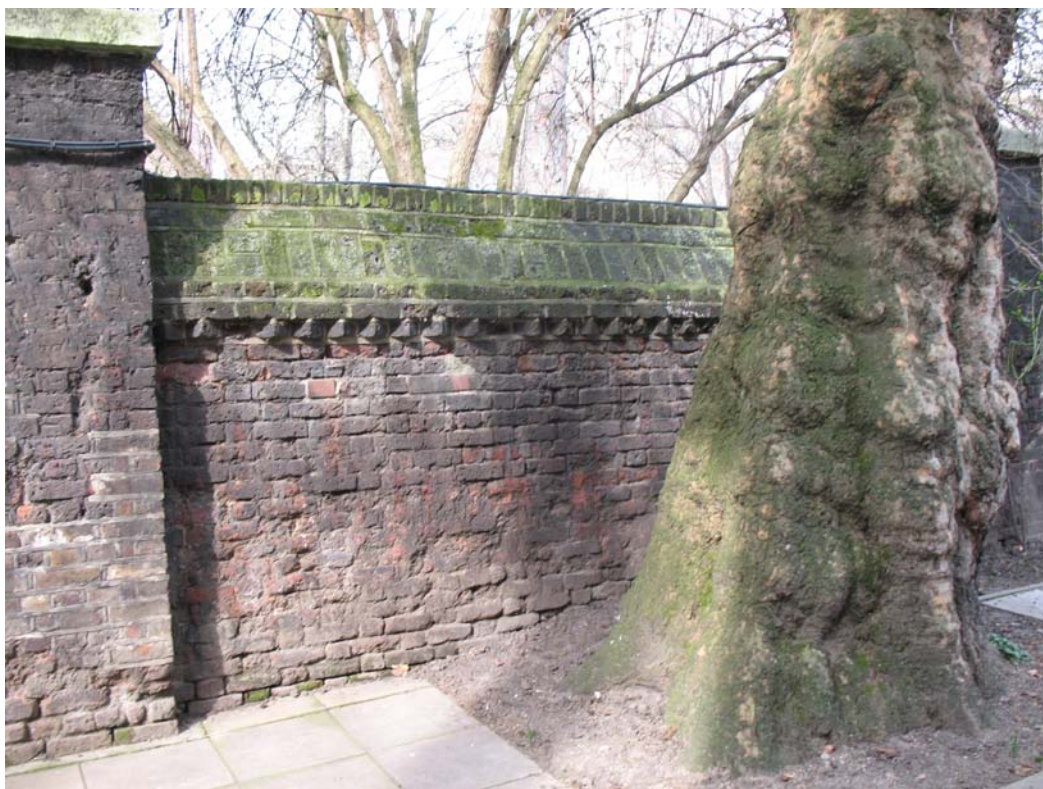
**Photograph 21:** Wall panel 25 general condition

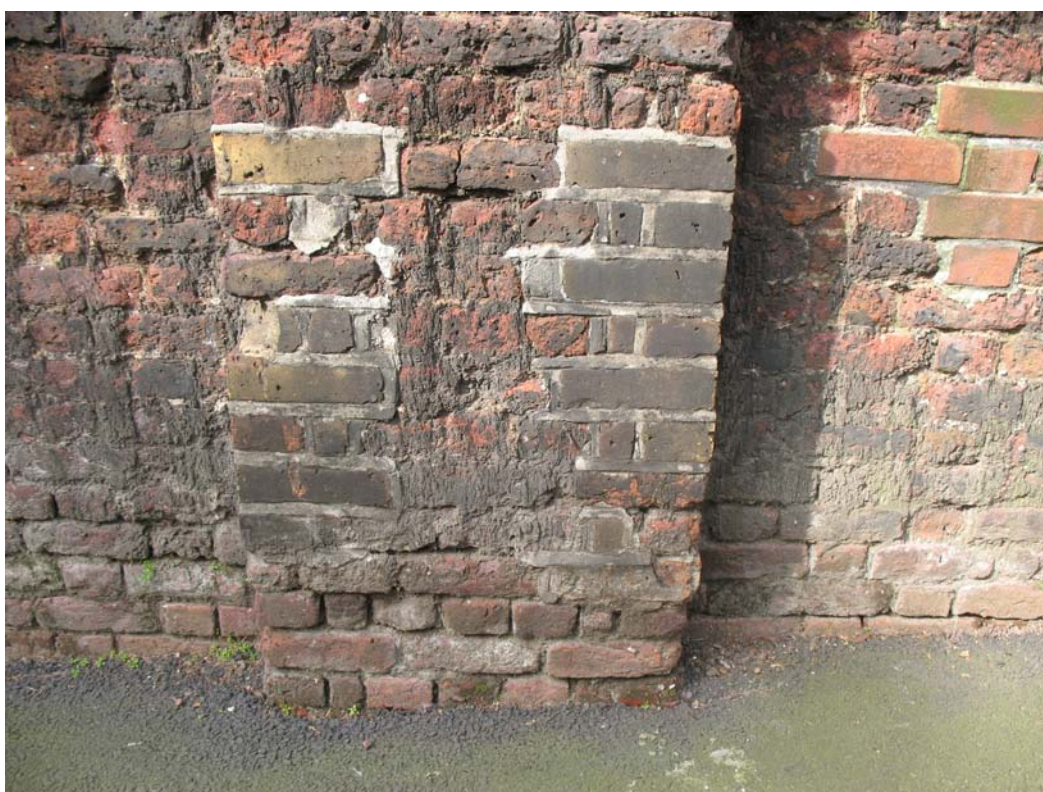
- 2.3.14 Pier Z has a number of missing bricks to the base of the pier on the left hand side.
- 2.3.15 Pier AA has had poor reconstruction work to the base on each side (Photograph 22).

**Photograph 22:** Pier AA with poorly stitched in brick repairs

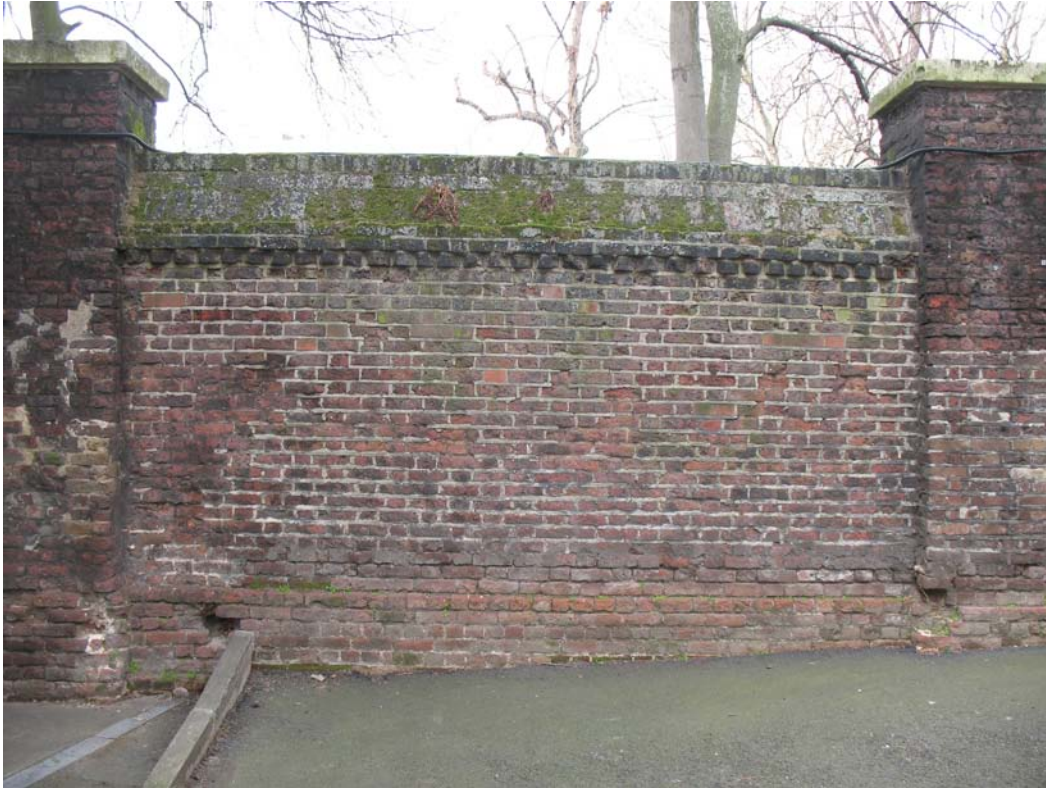
- 2.3.16 Pier AB has a number of bricks missing to the base of the pier on the left hand side.
- 2.3.17 There is a small hole where a number of bricks are missing in panel 28 just above ground level (Photograph 23).

**Photograph 23:** Wall panel 28 showing missing bricks in panel and adjacent Piers

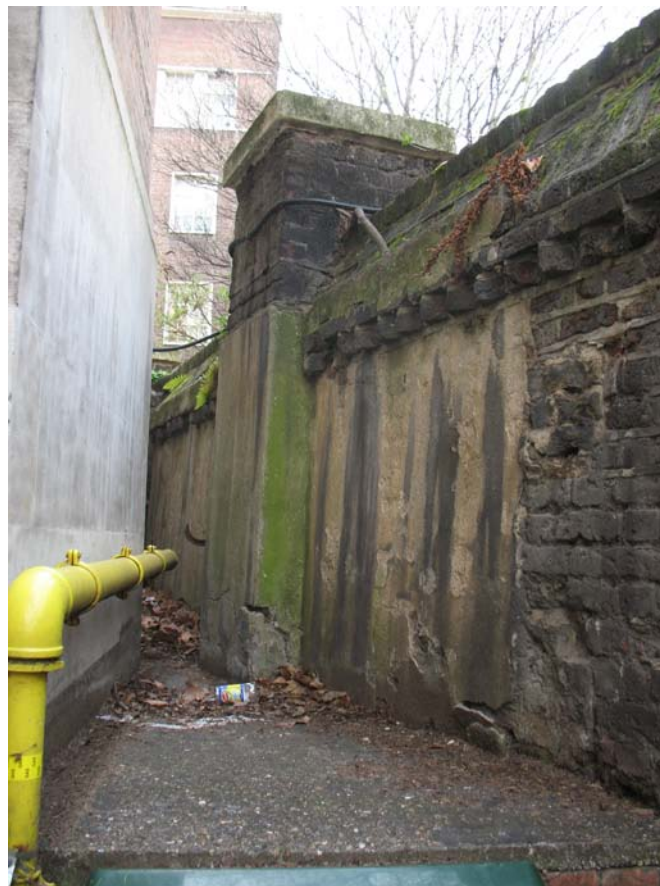
- 2.3.19 Panel 30 and part of panel 29 are rendered. The render has cracked in a number of areas and appears to be live in some areas (Photograph 24).

**Photograph 24:** Cracking render to Wall panels 29 and 30
