Arboricultural Assessment Report

Detailed Report on Trees

For:	Client:	Richard F Gill & Associates
	Insurer:	Aviva
Site:	Policyholder:	Mr & Mrs Anderson
	Risk Address:	52 Fellows Road, London NW3 3LJ
Refs:	OCA Ref:	54410
	Client Ref:	13211
	Insurer Ref:	8648681

Survey By:	James Sadler		
Title:	Arboricultural Technician	Date:	28 May 2013
Report By:	Andrew Graham		
Title:	Senior Consulting Arborist	Date:	30 May 2013

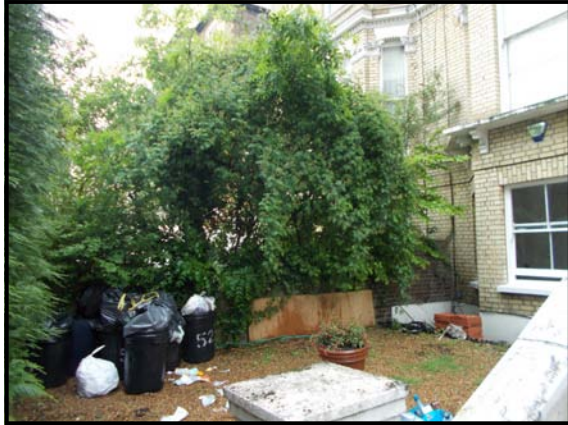
Therefore it is our opinion that sufficient information has been provided to demonstrate that, on the balance of probabilities, Butterfly Bush S1, Hornbeam T1, Ash T2, Raywood Ash T3 and Rose S2 are the material cause of the current subsidence damage

1. Butterfly Bush S1, Hornbeam T1, Ash T2

Given their proximity to the insured property we do not consider that undertaking pruning works to Butterfly Bush S1, Hornbeam T1, Ash T2, Raywood Ash T3 and Rose S2 will provide either an effective or sustainable means of controlling their water use. Therefore and in order to provide a long-term solution to the current subsidence damage we recommend this vegetation be removed.

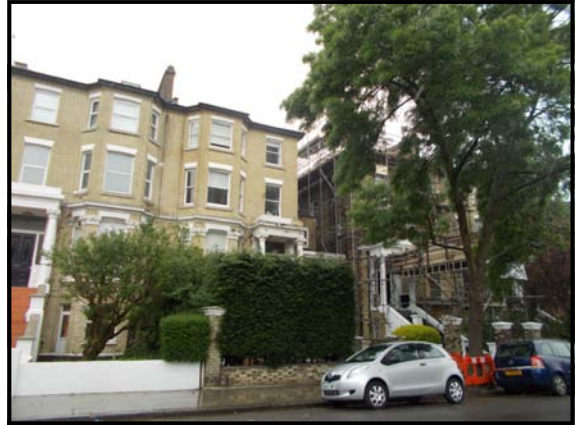
- 3.2** The insured property is a terraced three storey property constructed in the 1900's. The property has a small front and large rear garden with the only vegetation being a Lawson Cypress Hedge (G1) which appears to be maintained at its current dimensions.

2. Lawson Cypress G1

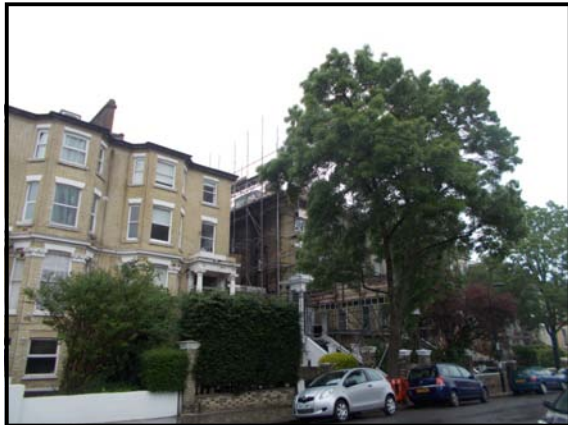
- 3.4** Street plantings on Fellows Road consist of early mature and mature Raywood Ash trees. The only significant street tree with regards to this claim is mature T3, which is located on the footpath directly to the front of the insured property.

3. Raywood Ash T3

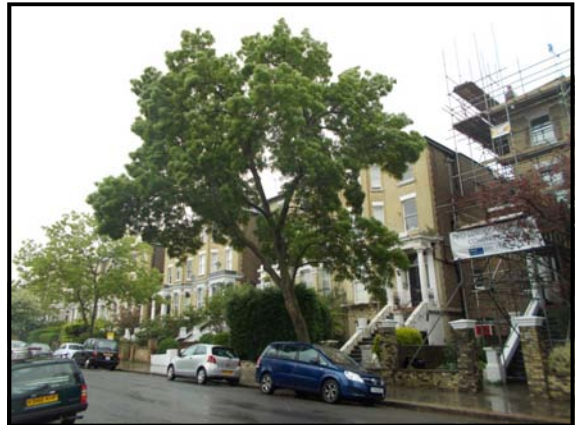
4. Raywood Ash T3

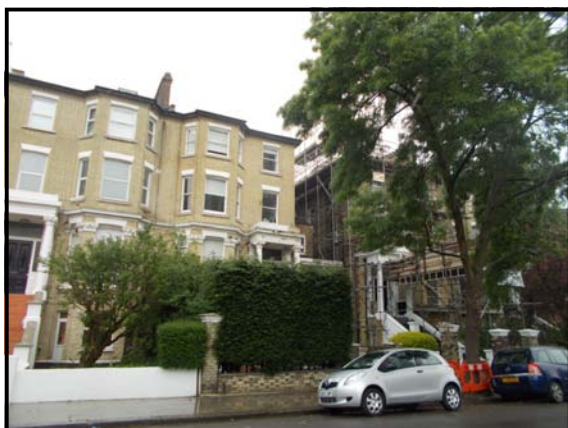
5. View of Butterfly Bush S3 left hand side of photograph
