# Arboricultural Consultancy for Lloyds TSB Insurance

<b>Insured</b>	Peters	<b>Address</b>	15 Pandora Road, London, NW6 1TS		
<b>Client</b>	Halifax General Insurance	<b>Contact</b>	Godfrey Sims	<b>Claim No.</b>	100996767
<b>MT Ref</b>	NL/1201121237/AC-REV1	<b>Consultant</b>	Thomas Peppiatt	<b>Contact No.</b>	08702 416 180
<b>Report Date</b>	02/05/2012

**This is a revision of our original report dated 09/02/2012, due to the addition of further site investigations.**

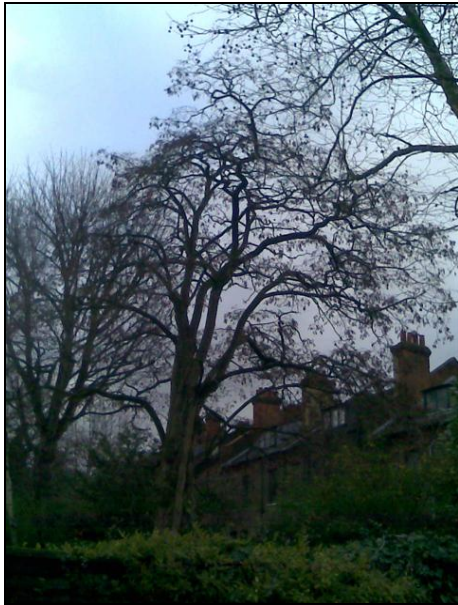
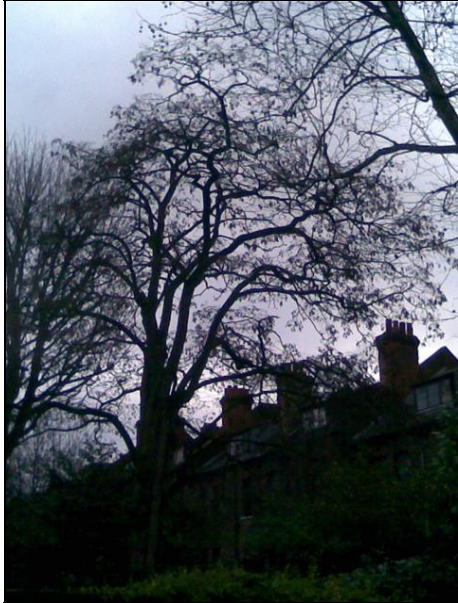
T2 (False Acacia), is also likely to be influencing soil volumes in proximity to the insured property, albeit in a secondary capacity when compared to T1 (Plane (London)).

The influence of the above is confirmed by the recovery of roots from TH1 which have been formally identified as *Platanus spp* and *Leguminosae spp*.

Such circumstances confirm the potential for T1 (Plane (London)) and T2 (False Acacia) to influence soil volumes below confirmed foundation depths and thereby contribute to the damage observed.

T2 - False Acacia

Tree No.	Species	Age Cat	Approx. Height (m)	Distance to Building (m)	Ownership	Action	Requirement
T1	Plane (London)	3	16	8.5	D - Unknown	Remove	Remove and treat stump to inhibit regrowth subject to heave assessment.
T2	False Acacia	3	14	14*	D - Unknown	Remove	Remove and treat stump to inhibit regrowth subject to heave assessment.
<b>Age Cat:</b> 1 = Younger than property; 2 = Similar age to the property; 3 = Significantly older than property

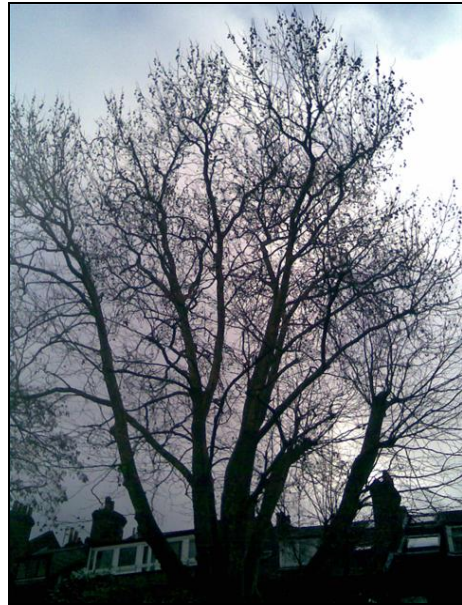
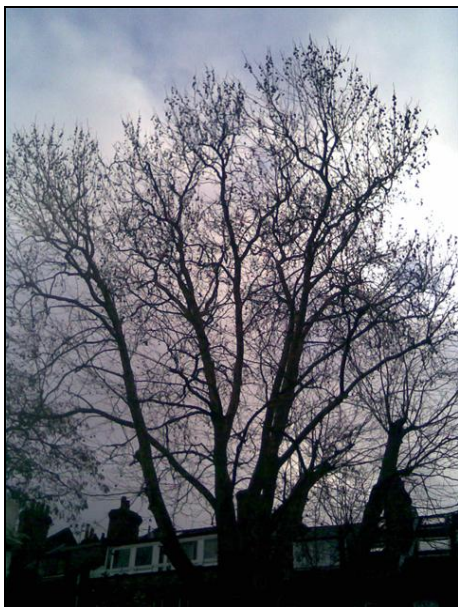
Based on our observations on site and with reference to supporting technical information, it is our opinion that T1 (Plane (London)) will be exerting the principal vegetative influence in respect of the current damage.

T1 - Plane (London)

Known practice and established research (Hortlink 212) suggests that pruning is an ineffective means of controlling water uptake. For these reasons removal is recommended.

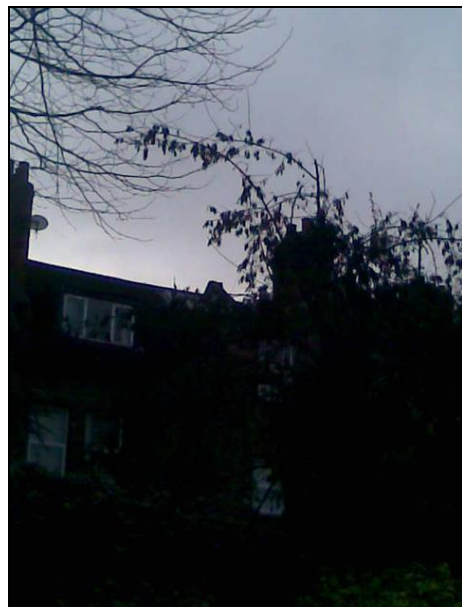
T3 - False Acacia

Tree No.	Species	Age Cat	Approx. Height (m)	Distance to Building (m)	Ownership	Action	Requirement
T3	False Acacia	1	6	10*	D - Unknown	Action to avoid future risk	Do not allow to exceed 7m height.
<b>Age Cat:</b> 1 = Younger than property; 2 = Similar age to the property; 3 = Significantly older than property
