Approved Installer Reference:		Helifix Project Reference:
		WC 207045
(1) PROJECT DATA SHEET	Warranties will not be is	ssued unless all information in the grey boxes is complete

(2) DEFECTS & DIAGNOSIS SHEET

(3) DIAGNOSIS AND REPAIR DETAILS

Project Name	The Treasury Office, New Square, Lincoln's Inn, London, WC2A 3TL
Drawing Name	Building elevation - location of the bulge.

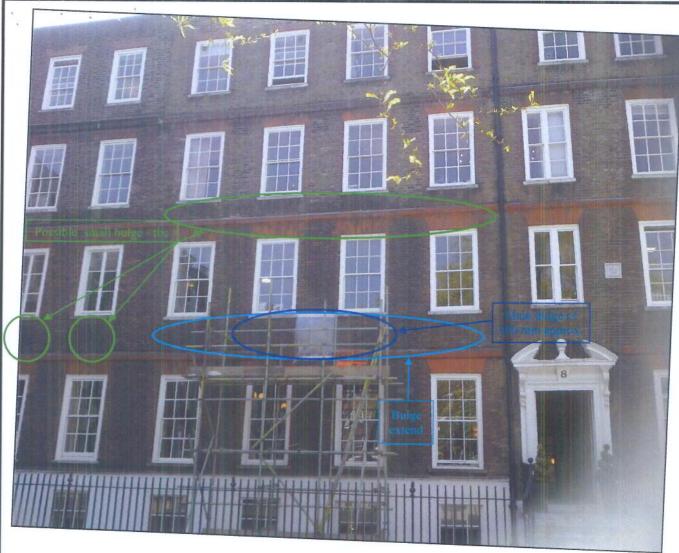
Approx. 100mm bulging of external leaf of the wall below the 2nd floor windows.

The main area of bulging is located below two windows and extends under two side windows (marked in attached photos).

Photo 1. Bulge location.

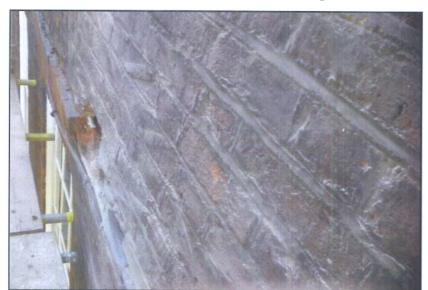
Unknown, however no wall ties were visible during inspection (lack of connection between the external and internal leaves).

Photo 2. Close-up of the bulge.

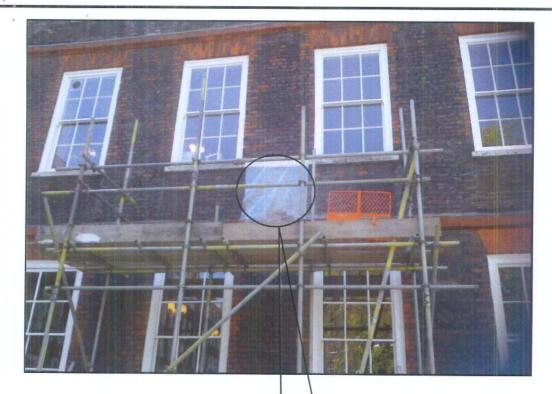
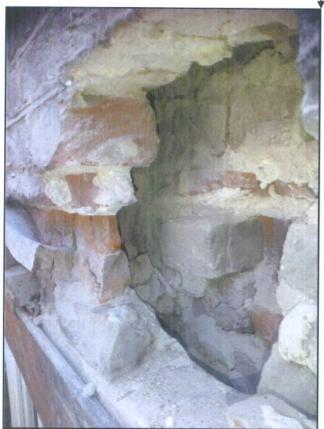
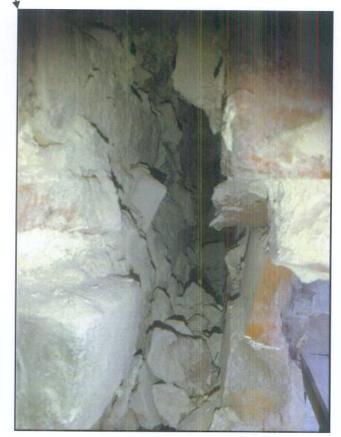
Photos 3-4. The gap created by separation of the external leaf.

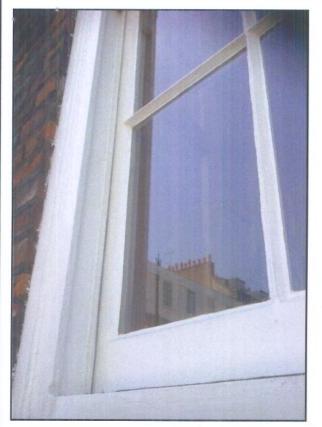
Photo 5. Internal wood cladding seen from outside.

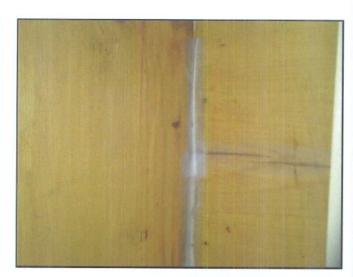
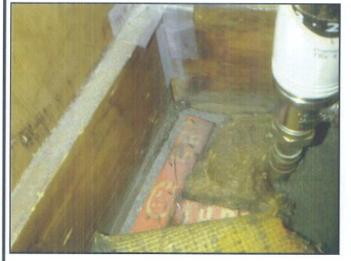
The interior of the affected room is clad with wood panels and there are cracks up to 5mm visible in the corners of the bay windows and between the wall cladding and the floor. It is unclear however whether these cracks have been caused by the movement of the wall or are by the natural shrinkage and movement of wood over time.

Photos 6-8. Cracks in the internal wood cladding (seal-taped due to draft and call air coming in through the cracks.)
