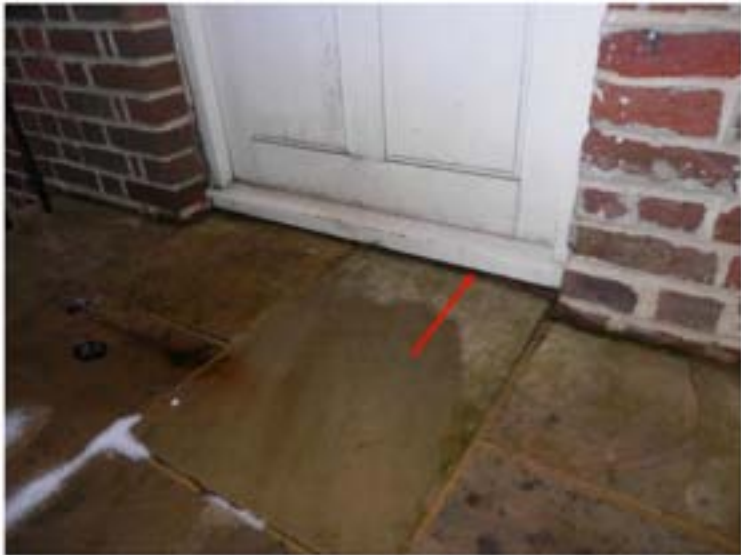
**PHOTOGRAPH 21:
NO WATERPROOF JOINT BETWEEN THE STEP AND THE WALL.**

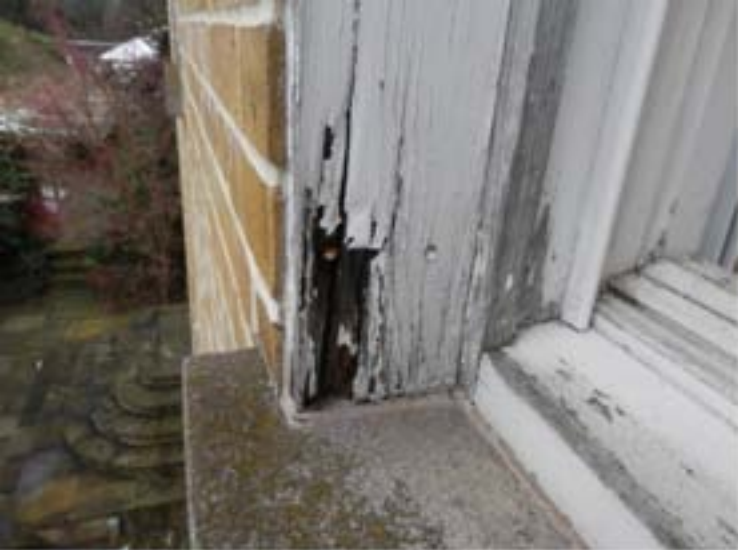
**PHOTOGRAPH 25:
ROT TO THE WINDOWS**
