FIRE RISK ASSESSMENT

Darband Restaurant

4th April 2013

Darband Restaurant
Fire Risk Assessment

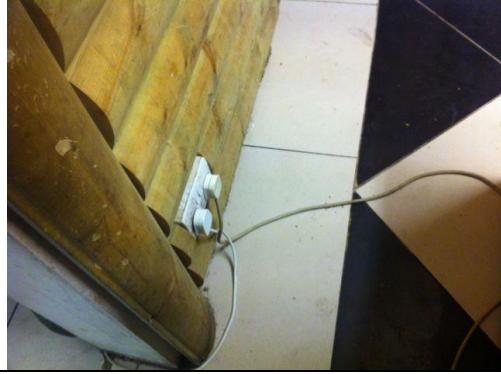
Photo 1 – Notes:

| | | Y | N |
|---|---|---|---|
| 1.4 | Comments and Hazards observed: <ul style="list-style-type: none"> • At the time of the assessment there was no evidence of Portable appliance testing (PAT). We recommend that the equipment in a commercial kitchen is PAT tested every 12 months. This is based on the IEE code of practise. • Records were not available to show when the last mains electric test was carried out. The fixed electrical supplies to the building should be tested in accordance with BS 7671 fixed wiring test, usually carried out every 5 years unless indicated otherwise by the engineers report. • Trailing leads were evident in the entrance to the kitchen area. Extension leads are meant for temporary use only. It is recommended that a qualified electrician install extra power sockets throughout the building and the practice of using trailing leads is stopped. | | |

Trailing leads were evident in the entrance to the kitchen area.

| | | PRIORITY |
|---|--|---|
| 1.4 | Trailing leads were evident in the entrance to the kitchen area. Extension leads are meant for temporary use only. It is recommended that a qualified electrician install extra power sockets throughout the building and the practice of using trailing leads is stopped. | 2 |

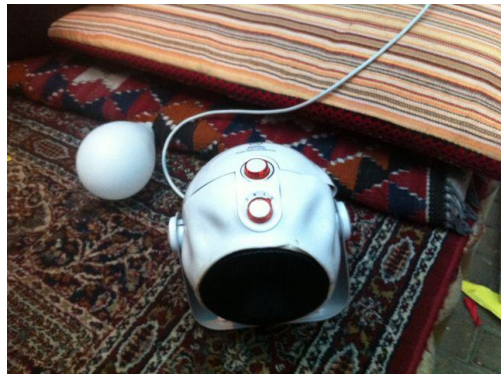
Photo 2– Notes:

| | | Y | N |
|---|--|---|---|
| 3.4 | Comments and Hazards observed: <ul style="list-style-type: none">• Portable heaters are used in the rear seating area. The convector type heaters appear to be faulty, one of them has a melted casing and it is recommended that they are not used.• The high-level radiator heaters are positioned too close to the straw matting that covers the ceiling. It is recommended that radiant heaters be replaced with fixed convector heaters or a central heating system.• At the rear of the seating area there were LPG type heaters. It is recommended that they are removed. | | |

Portable heaters are used in the rear seating area. The convector type heaters appear to be faulty, one of them has a melted casing and it is recommended that they are not used.

| | | PRIORITY |
|---|--|---|
| 3.2 | Portable heaters are used in the rear seating area. The convector type heaters appear to be faulty, one of them has a melted casing and it is recommended that they are not used. | 1 |

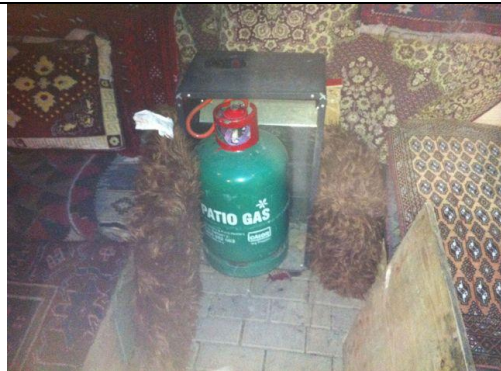
Photo 3– Notes:

At the rear of the seating area there were LPG type heaters. It is recommended that they are removed.

| | | PRIORITY |
|---|--|---|
| 3.2 | At the rear of the seating area there were LPG type heaters. It is recommended that they are removed. | 1 |

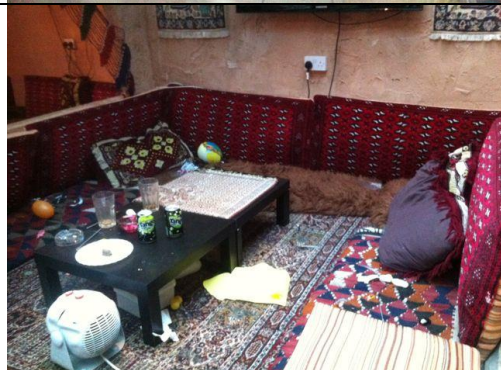
Photo 4– Notes:

The furnishings must conform to the Furniture & Furnishings (fire safety) Regulations. In the rear seating area curtains and draperies used as window coverings, having an aggregate surface area exceeding 50% of the surface area of the walls of the room should be inherently non-flammable or durably flame proofed and conform to BS 5867: Part 2.

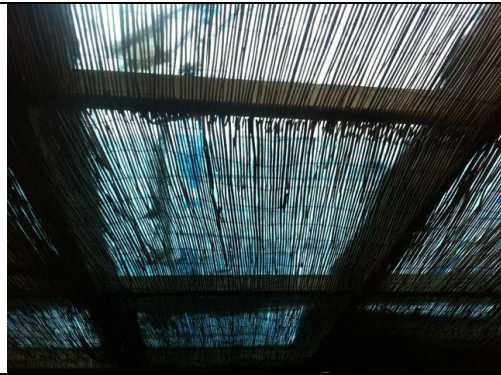
Photo 5– Notes:

The straw ceiling covering in the rear seating area should be flame proofed and conform to BS 5867: Part 2 or removed.

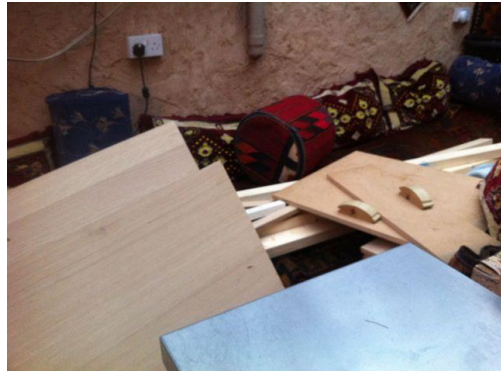
Photo 6– Notes:

| | | Y | N |
|---|---|---|---|
| 6.3 | Comments and Hazards observed: <ul style="list-style-type: none">• At the time of the assessment timber and other combustible items were being stored in the rear area. The owner informed that the items would be removed when the restaurant is in use. | | |

At the time of the assessment timber and other combustible items were being stored in the rear area. The owner informed that the items would be removed when the restaurant is in use.

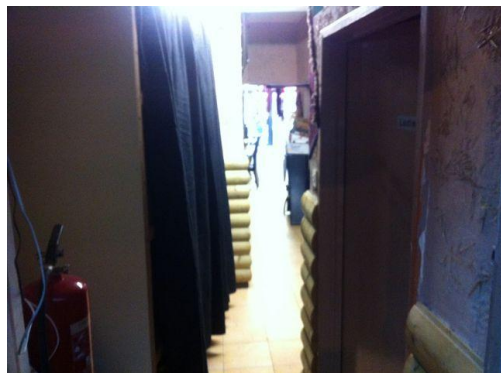
Photo 7– Notes:

| | | Y | N |
|---|---|---|---|
| 8.7 | <p>Comments:</p> <p>It is recommended that the escape route past the kitchen area be made a protected route with materials that provide at least a 30-minute standard of fire resistance. Doors to the kitchen and storeroom should be replaced with FD30s standard self-closing fire doors.</p> <p>The stored items in this area to be housed in cupboards constructed of, or, lined with 30-minute fire resisting materials. The access doors to be 30 minute fire resisting standard and kept locked shut when not in use.</p> | | |

It is recommended that the escape route past the kitchen area be made a protected route with materials that provide at least a 30-minute standard of fire resistance. Doors to the kitchen and storeroom should be replaced with FD30s standard self-closing fire doors.

| 8.7 | It is recommended that the escape route past the kitchen area be made a protected route with materials that provide at least a 30-minute standard of fire resistance. Doors to the kitchen and storeroom should be replaced with FD30s standard self-closing fire doors. The stored items in this area to be housed in cupboards constructed of, or, lined with 30-minute fire resisting materials. The access doors to be 30 minute standard and kept locked shut when not in use. | 1 |

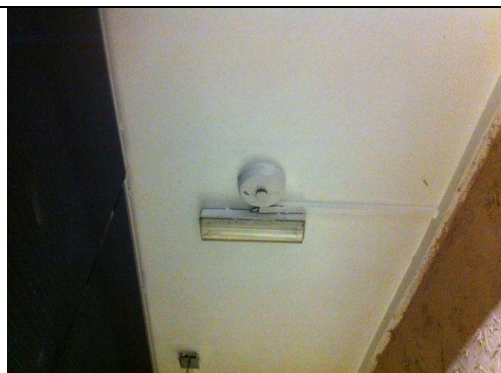
Photo 8– Notes:

Front area contains some smoke detectors but it could not be confirmed if they are working. At the time of the assessment one of the detectors was emitting a low battery or fault sound.

| 13.12 | <p>It is recommended that a BS5839 category L2 Fire Alarm System be fitted to this premises.</p> <p>L2 Fire Alarm Systems are designed to offer automatic detection on all escape routes within a building, with the addition of all rooms adjoining to the escape route. A heat detector is recommended for the kitchen area.</p> <p>L2 Fire Alarm designs should also incorporate audible sounders throughout the building, which operate when the fire alarm system is activated. An L2 Fire Alarm should also include manual call points on all exits to open air.</p> <p>The system must be fitted by a suitably qualified person and when installed tested in accordance with BS5839 Pt 1.</p> | 1 |
