## **PICUS SONIC TOMOGRAMS**

### **For two London Plane trees in Bedford Square Gardens, London WC1B**

**Prepared for:** Dr Martin Dobson of Martin Dobson Associates Ltd acting for Bedford Estates

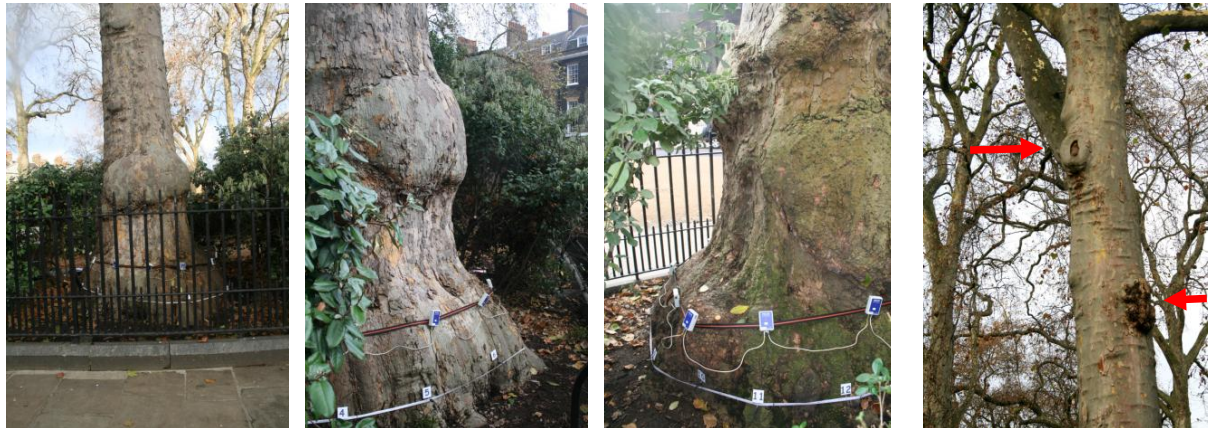
**Trunk base and trunk:** The southern half of the trunk base was swollen to an unusual degree, from ground level to approximately 0.8m, like the base of giant a chess piece. Whereas the swelling on the *northern* half of the trunk was from 1.6m to 1.7m, and also substantial. Several of the other 20 or so plane trees in the gardens had similar swellings, though less pronounced..

Above 1.7m the trunk rose straight to a height of 7m where branch division began. There was one old, semi-occluded wound at 7m and a further wound with some burry growth 1.5m below that.

Views of the swellings on trunk and trunk base

Old wounds

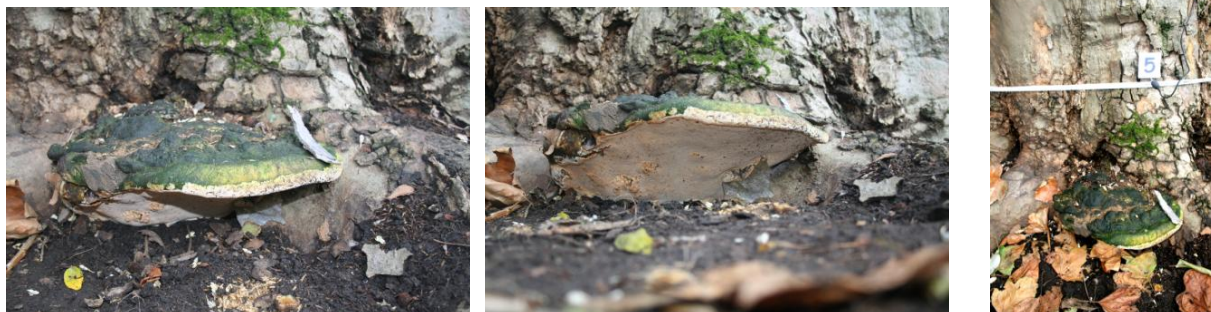
Near ground level on the west side there was a fungal fruiting body (bracket fungus) of the species *Ganoderma applanatum*. At 300mm wide and 200mm deep, it had several years' growth on it but the under surface showed that it was still active. On the north side there were the old, woody remains of a very small bracket at 400mm above ground level.

*Ganoderma* bracket on west from above and below

and its location

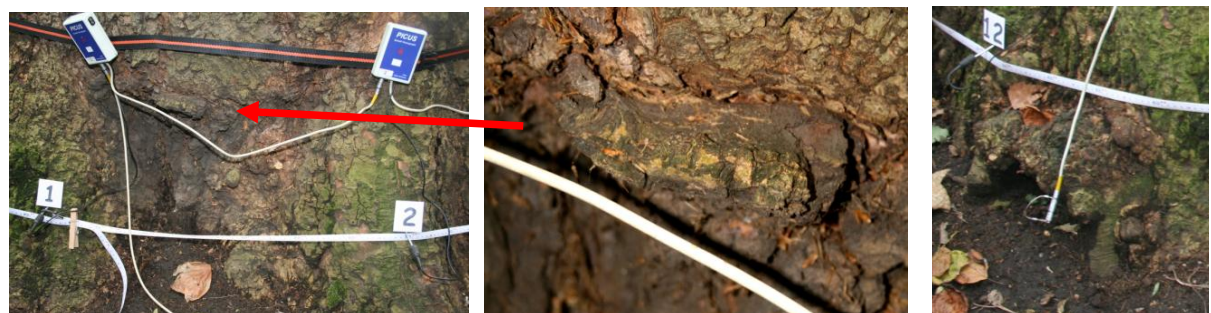
Location of very old bracket on north

Dead epicormic

Dead epicormic shoots on the north may indicate minor root death.

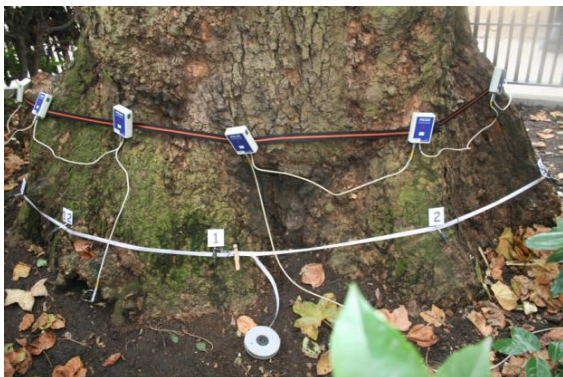
Sensors 11 - 3 showing depression between 1 & 2

The green patch between sensors 1 & 2 is related to a depression between these two sensors and does not indicate decay. The green near sensor 8 is less clear, but undulations in the trunk profile at this point are the most probable explanation of this green patch, rather than decay.

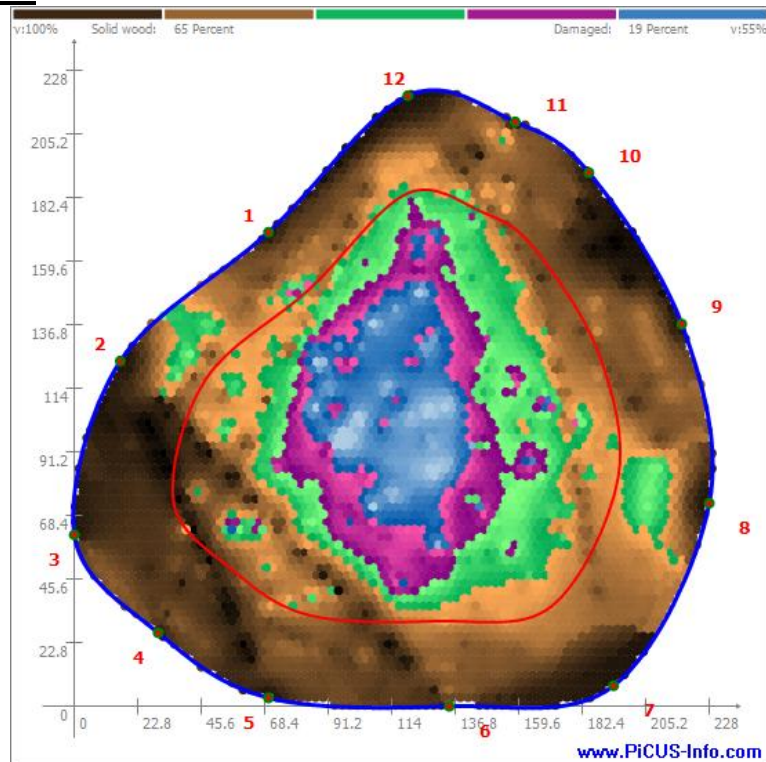
The tomogram shows 65% solid wood (brown), and 19% decay or cavity (blue and purple), with a further 16% wood affected to some extent (green) at this level. The red line represents 30% of the radius, and decay extending beyond this might indicate a tree at risk of failure. In the case of Plane trees a narrower residual wall of wood is widely regarded as tolerable.

*Ganoderma applanatum* degrades lignin rather than cellulose so that the tree is stimulated to lay down extra wood in response to greater flexure of the stem. This would cause swelling at the base of the trunk. Typically the area of decay would taper upwards from the roots into the trunk. The tomogram was taken low down so that decay further up the stem is likely to be less extensive. Decay penetrating into the roots is probable, but serious root death would show as die-back in the crown. The dead epicormic growth and associated dead bark near ground level below sensor 12 may indicate a minor amount of root death.

My conclusion therefore is that the tree is not at immediate risk of failure. However I would recommend re-examination in three years' time. Meanwhile as the tree is a tall specimen, leverage exerted by the wind could be considerably lessened by reducing the height.

- **Reduce the height by approximately 3m back to previous pruning points and by a further 2m or so if considered practicable. (See indication in picture below) The spread would also be reduced slightly to maintain a good form.**
- **Re-examine for spread of decay in three years' time**

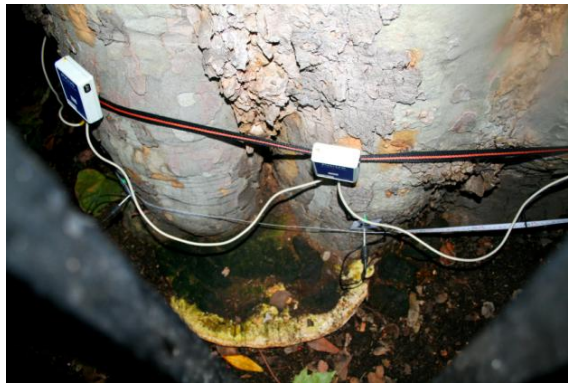
**Trunk base:** The trunk base was fluted and buttressed all round. One flute between two buttresses on the west side could be probed to a depth of 300mm, indicating some decay at ground level. Another small cavity on the south was 200mm deep but when probed, the wood was sound. On the south side a mature fruiting body of the fungus *Ganoderma applanatum* was growing at ground level.

The *Ganoderma* bracket between sensors 7 & 8

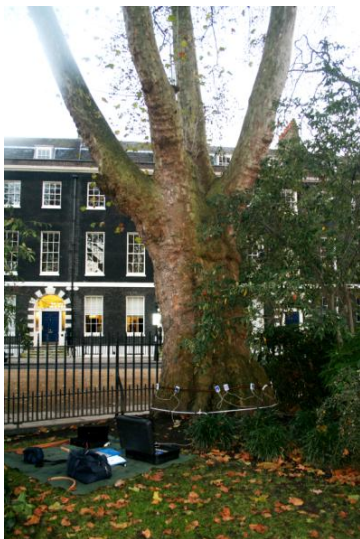
**Trunk, main limbs and branches:** The stem was clear of branches to a height of 3m, where it divided into four main limbs. The branch attachment appeared good with no signs of imminent breakage. The remains of a fifth limb, previously broken or cut, were still present.

Four main limbs from 3m . . . . .

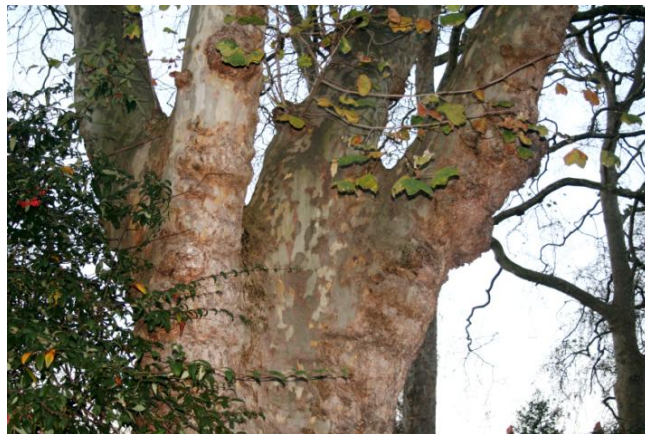
. . . . . well attached

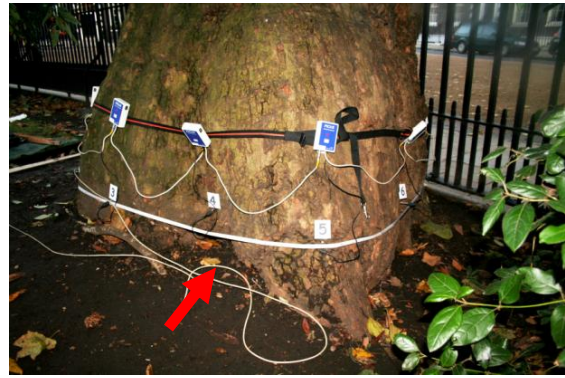
Sensors 3 – 6, with decay probed below 4

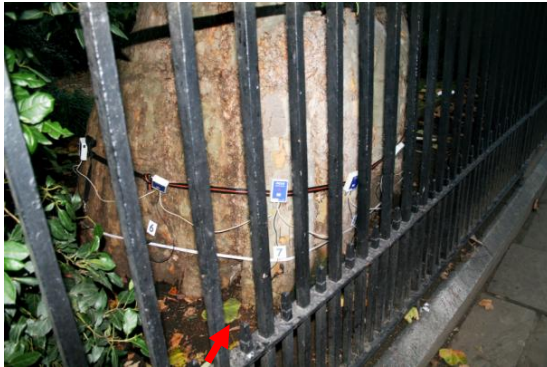
Sensors 6 – 8, with small cavity between 6 & 7

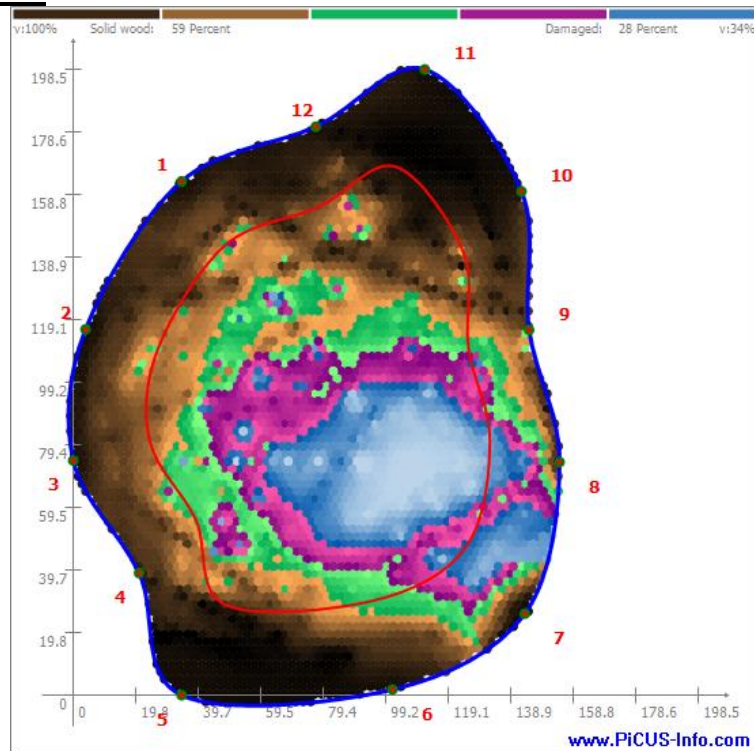
The tomogram shows 59% solid wood (brown), and 28% decay or cavity (blue and purple), with a further 13% wood affected to some extent (green) at this level. The small cavity was between 6 & 7, and the *Ganoderma* bracket was between 7 & 8. The tomogram

shows a considerable amount of decay, and importantly, the decay is not centralised but extends right to the edge of the cross section.

While a tree stem in the form of a hollow cylinder will retain most of its strength until the cylinder wall becomes thin, a weakness or cavity in the wall of that cylinder weakens it seriously.

The buttressing at 4 and 11 looks thick and strong, but decay was detected at 4 and the north-west side of the tree is not so strong. In my opinion, the position of this tree overhanging the street, and the weakened condition of the trunk lead me to conclude that this tree poses an unacceptable risk, and is likely to become more dangerous as time passes.

- Option one: Reduce the height and spread of the tree drastically, within six months, especially on the east side over the street. In the short term this would diminish the forces threatening to break the tree across the railings and into the street. Unfortunately removing a lot of wood would reduce the tree's energy reserves and the loss of foliage would reduce its photosynthetic capability. Both of these factors would be likely to favour the more rapid advance of the decay.
- Option two: Dismantle and remove the tree within six months. This is the safer option and moreover it would create a space for a replacement tree to grow in the light. This collection of trees will eventually reach a stage when they all have to go and the opportunity could be taken to start a programme of replacement planting.
- I favour option two.
