Arboricultural Assessment Report

Preliminary Report on Trees

For:	Client:	Oriel Services Limited
	Insurer:	Allianz Cornhill Broker Division
Site:	Policyholder:	Mr & Mrs. Abdelaziz
	Risk Address:	28 Montpelier Grove, London, NW5 2XD
Refs:	OCA Ref:	53840
	Client Ref:	7189695
	Insurer Ref:	5H/2/2510021

Survey By:	Paul Cook		
Title:	Senior Consulting Arborist	Date:	30 January 2013
Report By:	Paul Cook		
Title:	Senior Consulting Arborist	Date:	28 February 2013

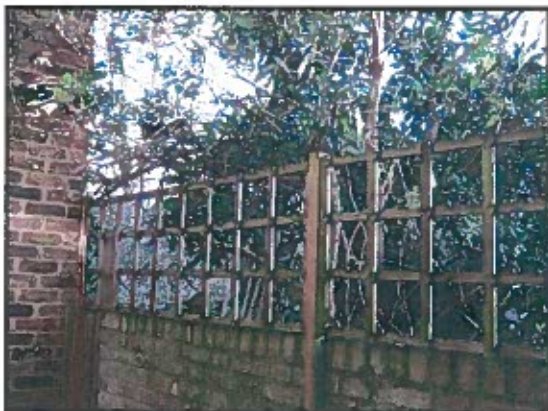
Given its size, species, and proximity to the location of TP/BH1 we consider that these roots have emanated from Sycamore T1.

No other roots were recovered during the site investigation. However, given its size, species and close proximity to the insured property it is likely that roots from Loquat S1 have also extended beneath the depth of foundations of the damaged extension.

Therefore it is our opinion that sufficient information has been provided to demonstrate that, on the balance of probabilities, Sycamore T1 is the material cause of the current subsidence damage and Loquat S1 is a contributory factor.

1. View towards Loquat S1 and Sycamore T1.

We do not consider that pruning works will offer either an effective or sustainable means of controlling water use of Sycamore T1 or Loquat S1. Therefore and in order to provide a long-term solution to the current subsidence damage we recommend that this vegetation be removed.

Tree No:	Species	Works Required
T1	Sycamore	Fell as close to ground level as practicable and treat the stump with an appropriate herbicide to prevent future growth
S1	Loquat	Fell as close to ground level as practicable and treat the stumps with an appropriate herbicide to prevent future growth

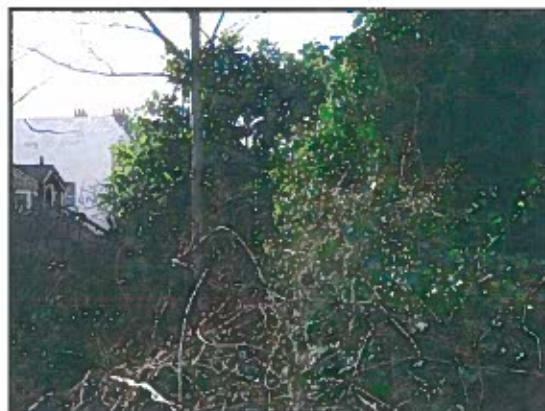
2. View towards Sycamore T1 (centre) and Loquat S1 (rear).

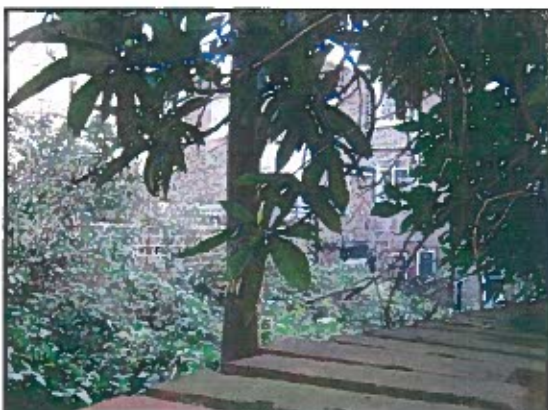
3. Lower stem of Sycamore T1 and part of Loquat S1.

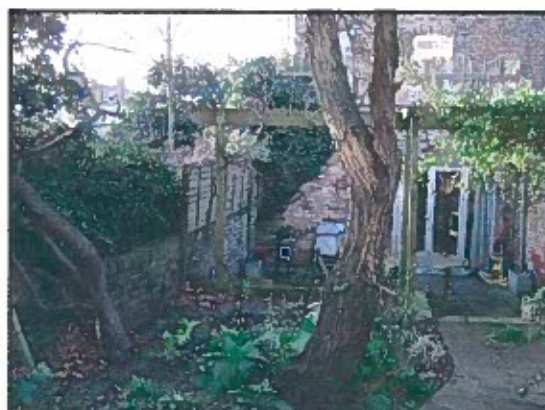
With reference to Laburnum T2, Butterfly Bush S2, Sycamore T3, Goat Willow T4 and the group of Sycamore and London Plane G1, given their size, species and distance to the insured property we do not consider this vegetation to be a factor of the current movement. However, Laburnum T2 and Butterfly Bush S2 present a significant risk of causing subsidence damage in the future.

4. Lower stem of Goat Willow T4 in relation to the rear of the insured property.

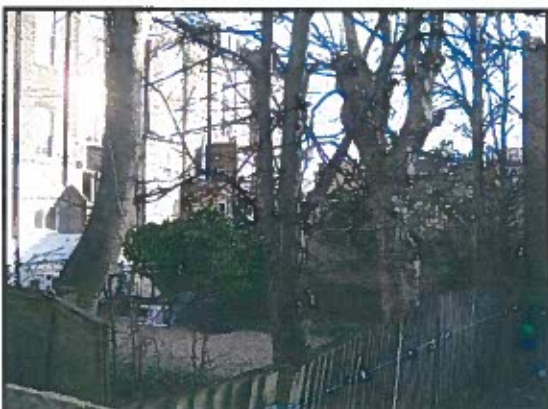
5. Sycamore and London Plane G1.

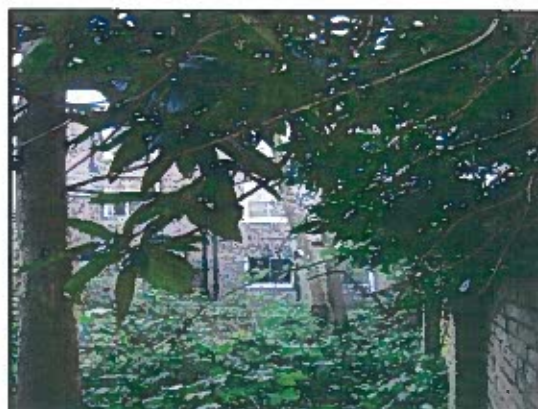
6. View towards the lower stem of Sycamore T1 and Sycamore T3.
