**STRUCTURAL APPRAISAL OF THE EXISTING  
BUILDING IN RESPECT OF THE  
PROPOSED DEVELOPMENT**

**43 BELSIZE LANE, LONDON, NW3 5AU**

Name of Client: PKS Architects

**Tel: 01892 521841**  
**Fax: 01892 533149**  
**E-mail: [tw@vkhp.co.uk](mailto:tw@vkhp.co.uk)**  
**Date: 8 February 2013**

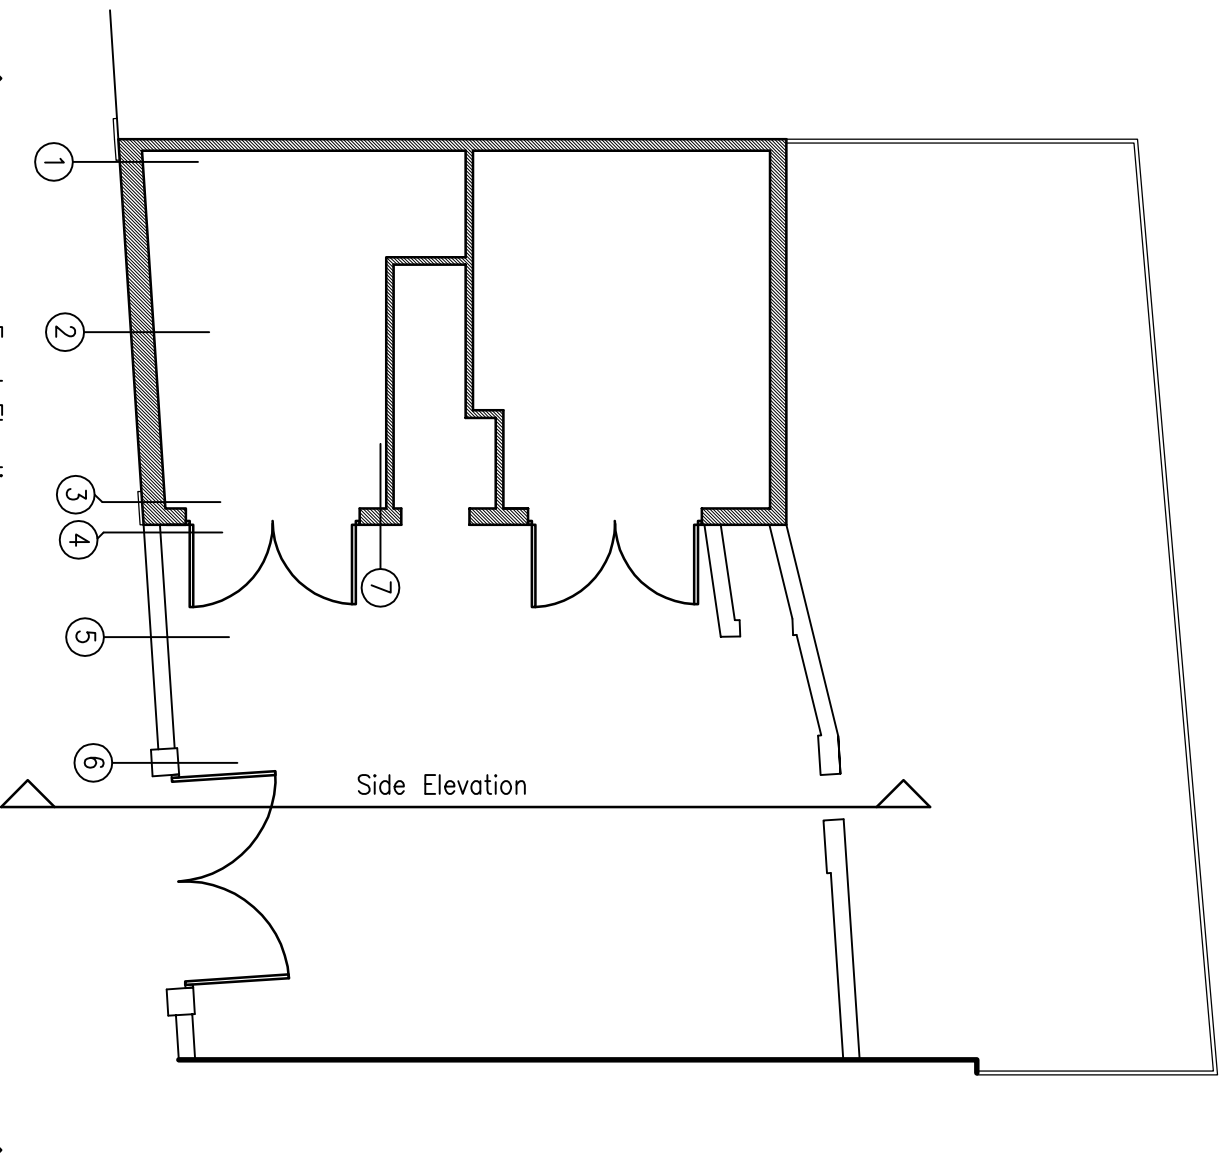
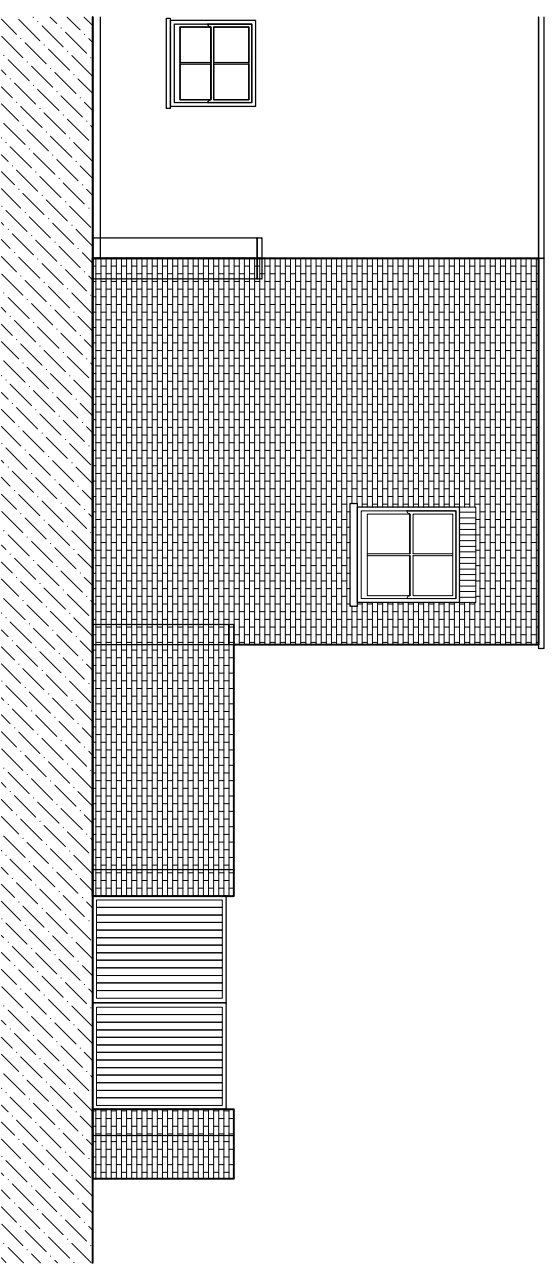
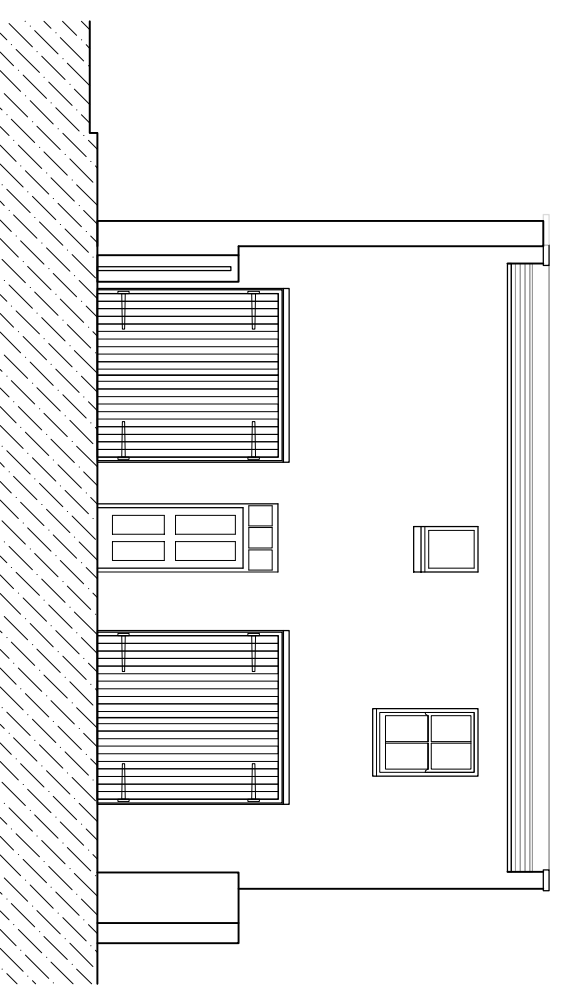
**Plumb Survey - Location Plan**

The upper portions of the wall contains one first floor window and an upstand masonry parapet was seen to lean to varying degrees. This wall was checked for verticality and the results appear on 870612/001 and 002 in Appendix A of this report.

This wall was seen to be concave with the middle section having bulged towards the south east. This wall was checked for verticality and the results appear on 870612/001 and 002 in Appendix A.

- 4.5 From the plumb survey results, it is evident that the existing walls lean to varying degrees.

The degree of lean is such that without some form of supplementary support, some sections of wall could be expected to fall over. The centre of gravity is in many places outside the middle third, thus generating tension which, in lime mortar brickwork such as this, cannot be developed.

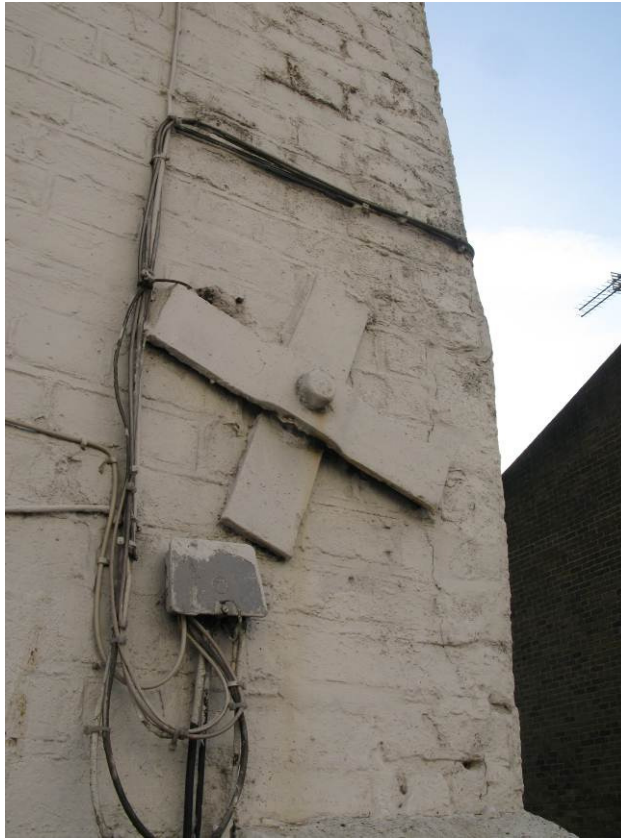
A historic tie bar end was located at the south west end of this elevation at first floor level. This bar was seen to be located immediately below the first floor and extended right through the property to a similar metal plate on the south east elevation. (See Photographs 1 and 2)

**PHOTOGRAPH 1**  
Tie bar end, North West end

- 5.5 The temporary works would also need to take into account existing loads from existing tie bars and ensure that sufficient temporary structure is introduced to replicate any loads prior to partial demolition of the existing structure.

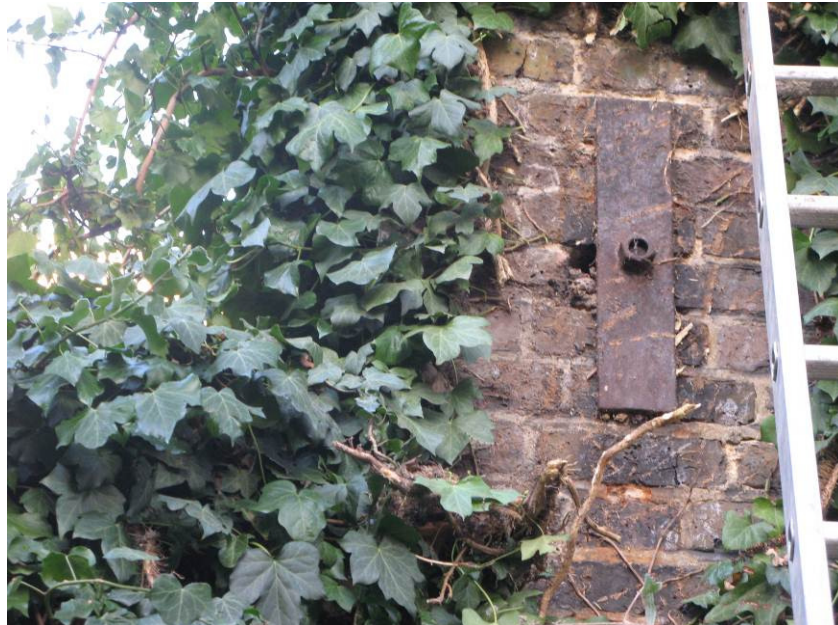
**PHOTOGRAPH 2**  
Tie bar end, South East end

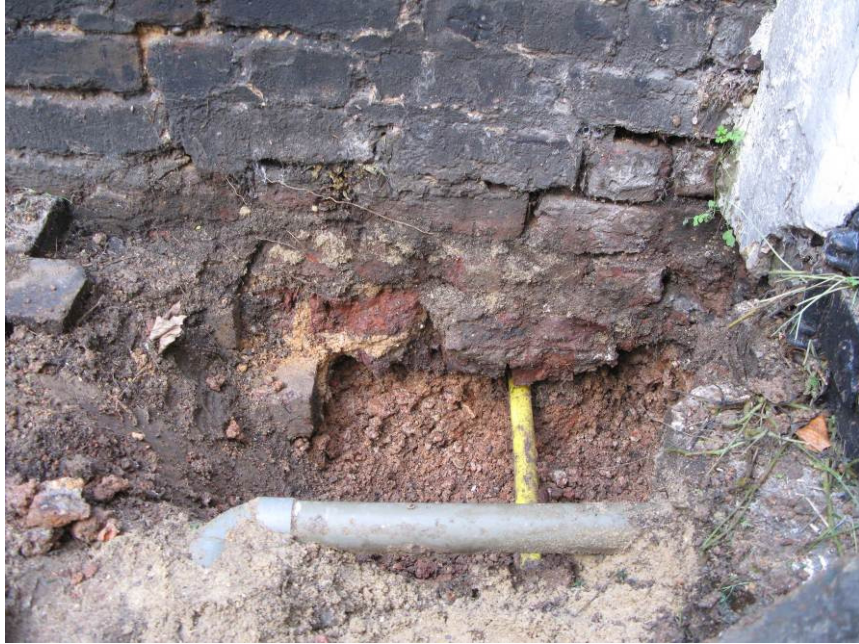
The whole wall shows clear evidence of decay and deterioration of, not only the bricks but also the mortar. (See Photograph 3.)

**PHOTOGRAPH 3**  
**Dilapidated brickwork**

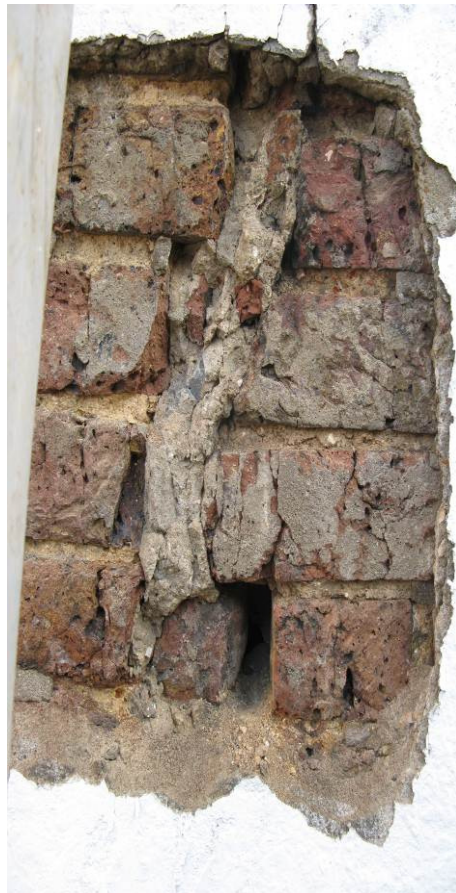
A section of render was removed midway up this crack line. This revealed extensive cracking in the brickwork, measured as circa 50mm horizontal movement and circa 12mm differential vertical movement. (See Photograph 4).

- 4.7 Examination on site revealed cracking 50mm wide with numerous repairs. The integrity of the wall in these areas is significantly reduced and, at worst, non-existent.

**PHOTOGRAPH 4**  
**Masonry fracturing**

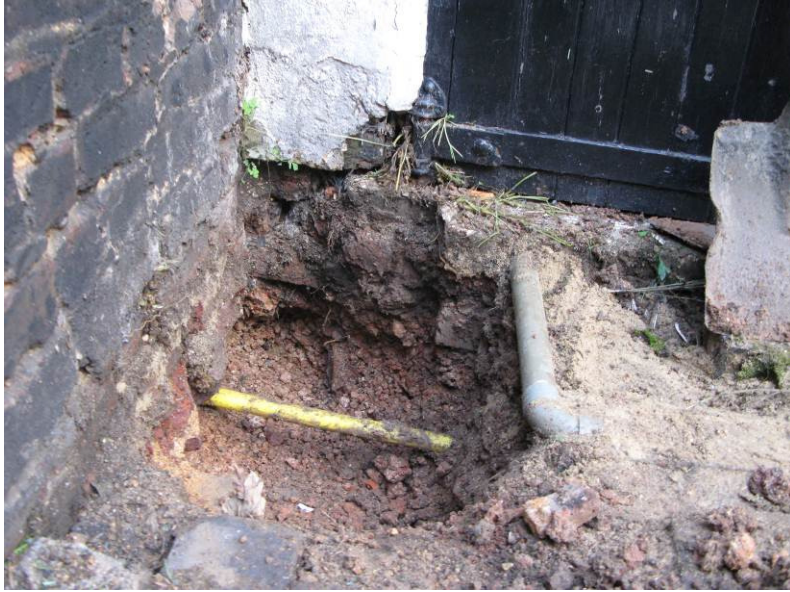
This trial pit revealed brickwork extending no more than 250mm below finished ground level, bearing on to a matrix of broken brick and lime mortar with no clearly identifiable interface to virgin ground. The below ground brickwork was significantly displaced in places. (See Photograph 3)

- 4.2 Exploration of the existing building, of which some areas have been scheduled for retention and integration into the redevelopment, revealed a building in urgent need of extensive structural restoration. Trial pit evidence revealed wholly inadequate and dilapidated foundations, the failure of which has been manifest in distorted and fractured superstructure.

**PHOTOGRAPH 5**  
**Displaced dilapidated brickwork**
