## 41/42 CHESTER TERRACE, LONDON, W1 APPENDIX A PHOTOGRAPHS

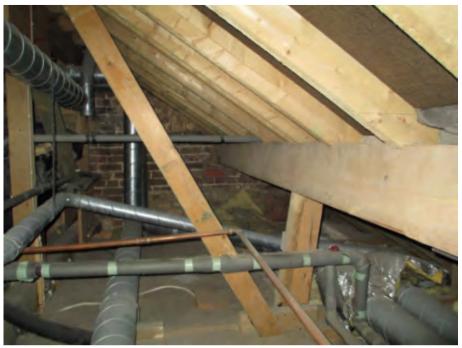
Photo 15 – Timber roof rafters and purlin, party wall behind

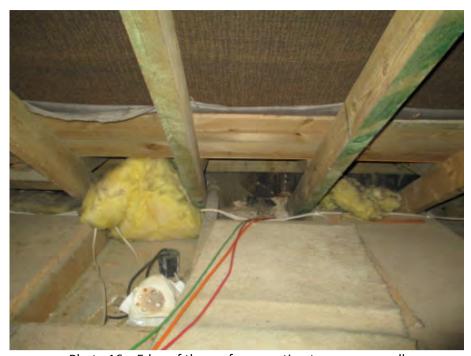
Photo 16 – Edge of the roof, connection to masonry wall

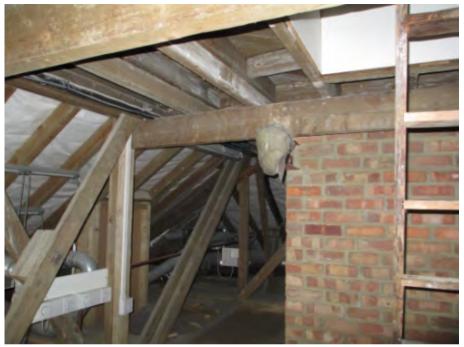
Photo 23 – No. 41 Lift enclosure with old truss trimmed around the walls, secondary truss

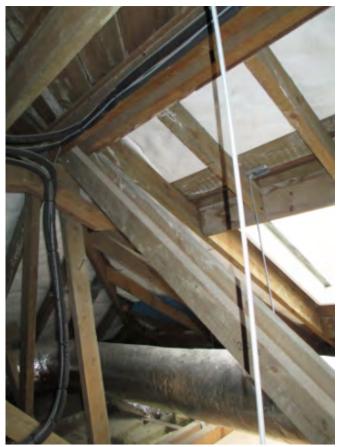
Photo 25 – No. 41 Secondary truss and roof rafters trimmed around rooflight

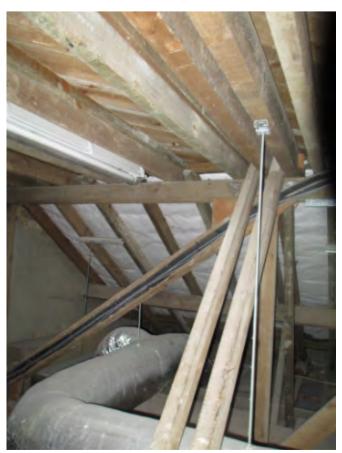
Photo 26 – No. 41 Timber joists supported on primary truss

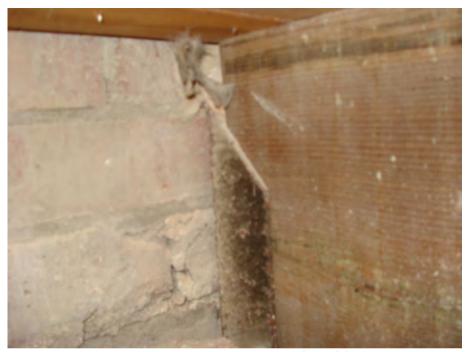
Photo 27 – Metal joist hanger (1960's)

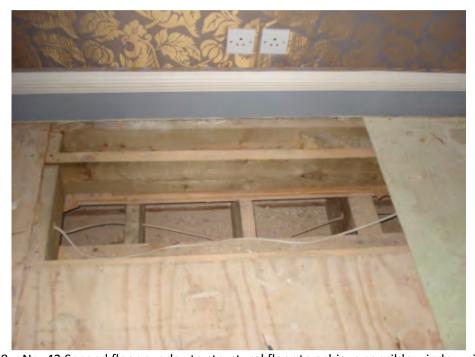
Photo 28 – No. 42 Second floor overlay to structural floor to achieve sensible window cill height

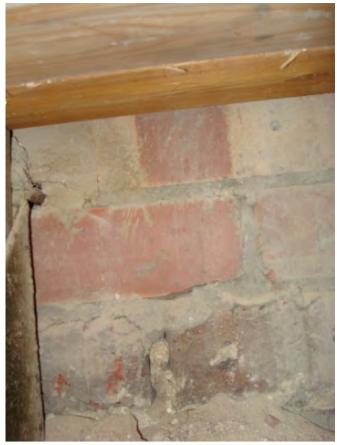
Photo 29 – Fletton brick repair (1960's)

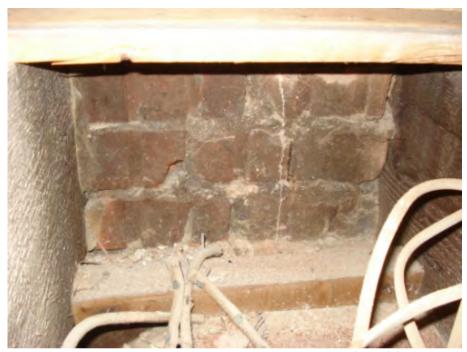
Photo 31 – Fletton brickwork to stair enclosure (1960's)

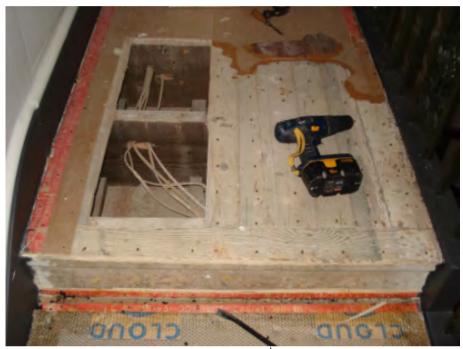
Photo 32 – Timber floor to stair 2<sup>nd</sup> floor landing (1960's)

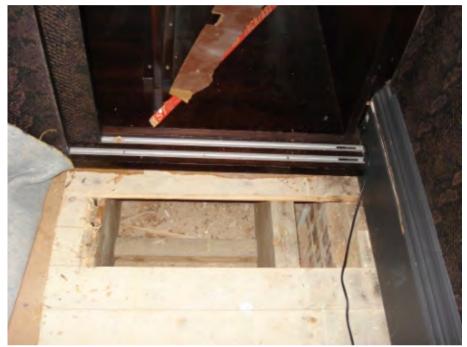
Photo 34 – Third floor timber floor – north fletton brickwork to external wall (1960's)

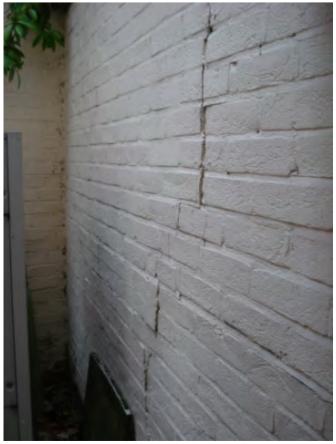
Photo 36 – Bulge and cracking of chiller compound wall
