# Arboricultural Consultancy for Ecclesiastical Insurance Group

<b>Insured</b>	27 Arkwright Road RTM Co Ltd	<b>Address</b>	27 Arkwright Road, London, NW3 6BJ		
<b>Client</b>	Infront Innovation	<b>Contact</b>	Oliver Deakin	<b>Claim No.</b>	IFS-EIG-SUB-12-0039018
<b>MT Ref</b>	NL/1401131331/TP	<b>Consultant</b>	Thomas Peppiatt	<b>Contact No.</b>	08702 416 180
<b>Report Date</b>	24/01/2013

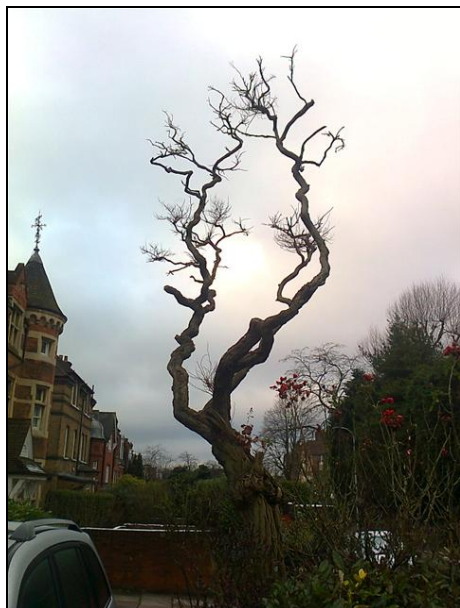
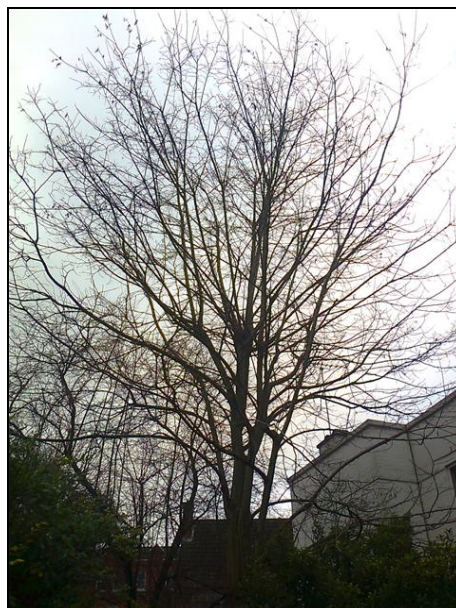
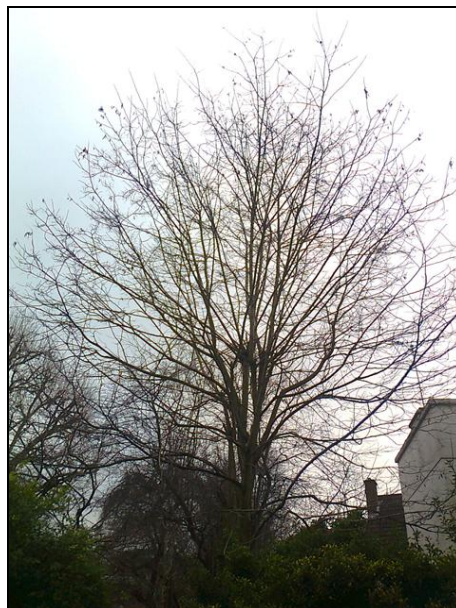
T2 - False Acacia

*Leguminosae* spp roots have been identified within TP/BH1 that confirm the influence of T2 (False Acacia) below foundation level.

Given the above and based on our site investigations, it is our opinion that T2 (False Acacia) will be exerting the principal vegetative influence.

Tree No.	Species	Age Cat	Approx. Height (m)	Distance to Building (m)	Ownership	Action	Requirement
H1	Euonymus	1	2.3	0.9	A - Third Party No 27B Arkwright Road. London. NW36BJ.	Remove	Remove and treat stump to inhibit regrowth.
T2	False Acacia	1	11	3.8	A - Third Party No 27B Arkwright Road. London. NW36BJ.	Remove	Remove and treat stump to inhibit regrowth.
T3	Prunus	1	6.8	5	A - Third Party No 27B Arkwright Road. London. NW36BJ.	Remove	Remove and treat stump to inhibit regrowth.
<b>Age Cat:</b> 1 = Younger than property; 2 = Similar age to the property; 3 = Significantly older than property

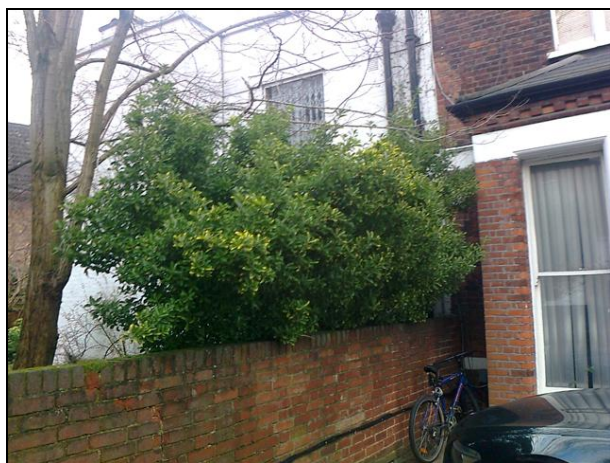
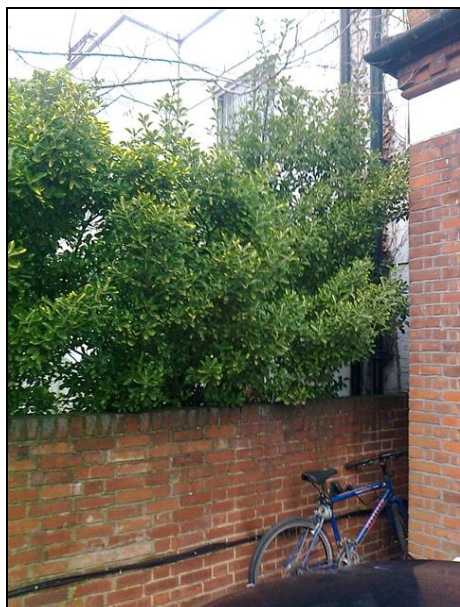
H1 - Euonymus

T3 (Prunus) and H1 (Euonymus) are also considered to be significant factors in the damage based on size and proximity.
