Engineer's Report

Our Reference	IFS-EIG-SUB-12-0039018
Claim Reference	000266699
Prepared for	Ecclesiastical

Report Date	21 September 2012
Policyholder	27 Arkwright Road RTM Co Ltd
Address	27 Arkwright Road, London, NW3 6BJ

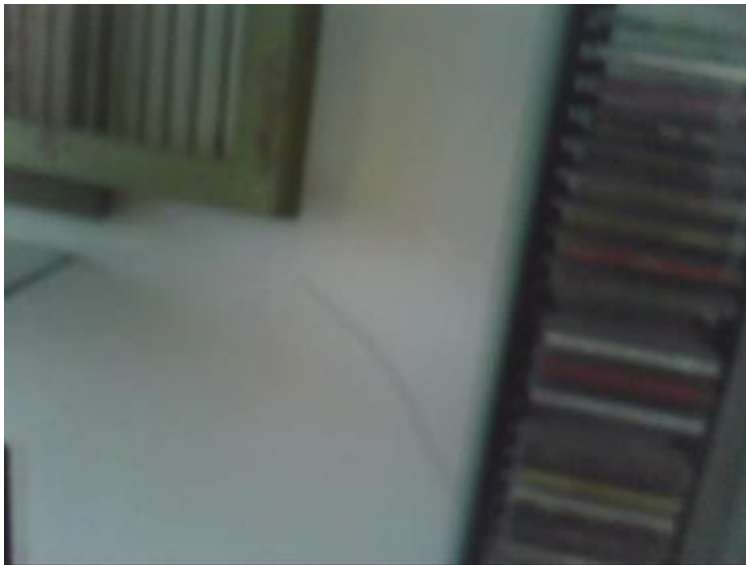
FIGURE 03 Flat 2

Within flat 2, the damage relates to minor cracking mainly along the left flank wall within the living room and also extending down the stairs. The stairs lead to a small basement over the middle/rear of the property.

Generally cracks 1mm wide or less will be filled (internal) or re-pointed (external). Internally, where the cracks are wider than 1mm, but less than 5mm the underlying brickwork or blockwork will be exposed and prior to making good the plaster finishes the cracking will be covered with expanded metal lathe. Where cracks are 5mm across or wider, some form of bed joint reinforcement should be introduced.

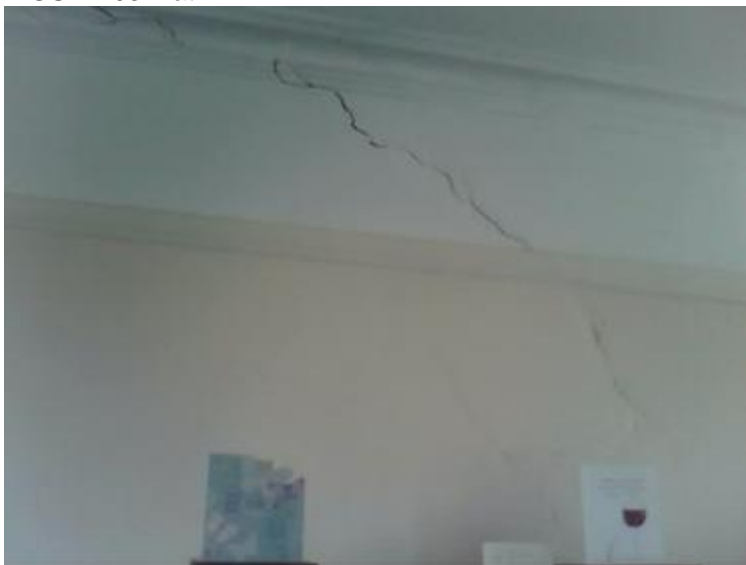
FIGURE 04 Flat 5

Within flat 5, the damage relates to moderate cracking also in the flank wall of both the front lounge and also rear kitchen areas. The diagonal cracks are much wider at this level consistent with foundation movement. There are also associated ceiling cracks and damage to skirting boards along the flank wall in the lounge. There is also some binding of the windows in the lounge.

Typically this will involve disc cutting a chase, 25 to 35mm deep into the bed joint across the crack. An epoxy resin mortar is then pressure grouted into the open joint, and a 6mm diameter stainless steel Helical steel bar set into place, the bar extending a minimum of 500mm either side of the crack. Bars should be installed every 4-6 brick courses.

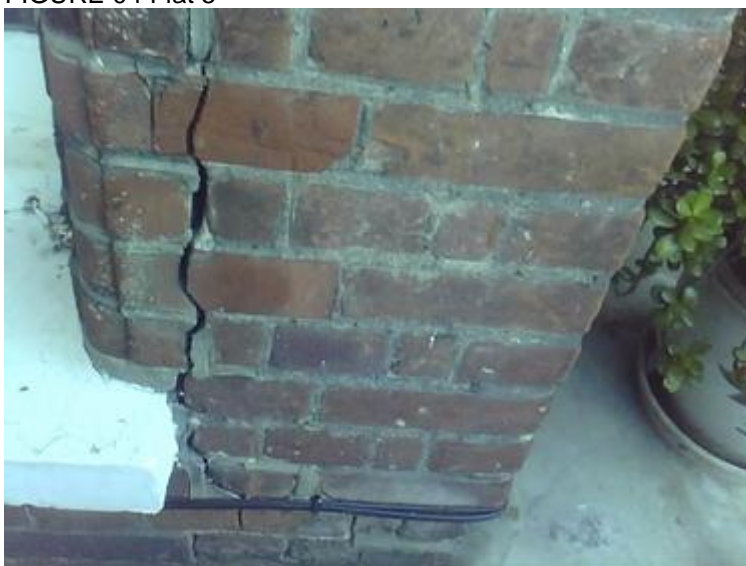
FIGURE 05 External left side bay

Crack damage to the left side of the front elevation comprises cracked bricks in locations under the ground floor bay window as well as above the window, where the lintel bears onto the left side brick pier. There is also some distortion to the entrance arch.
