# BS5837:2012 Tree Survey Report, incorporating Arboricultural Implications Assessment and Method Statement

**Camden Street, north of the junction with St Martin's Close,  
NW1**

Site Ref: 02/615507  
Status: FINAL  
Version: A  
Date: 14 February 2013

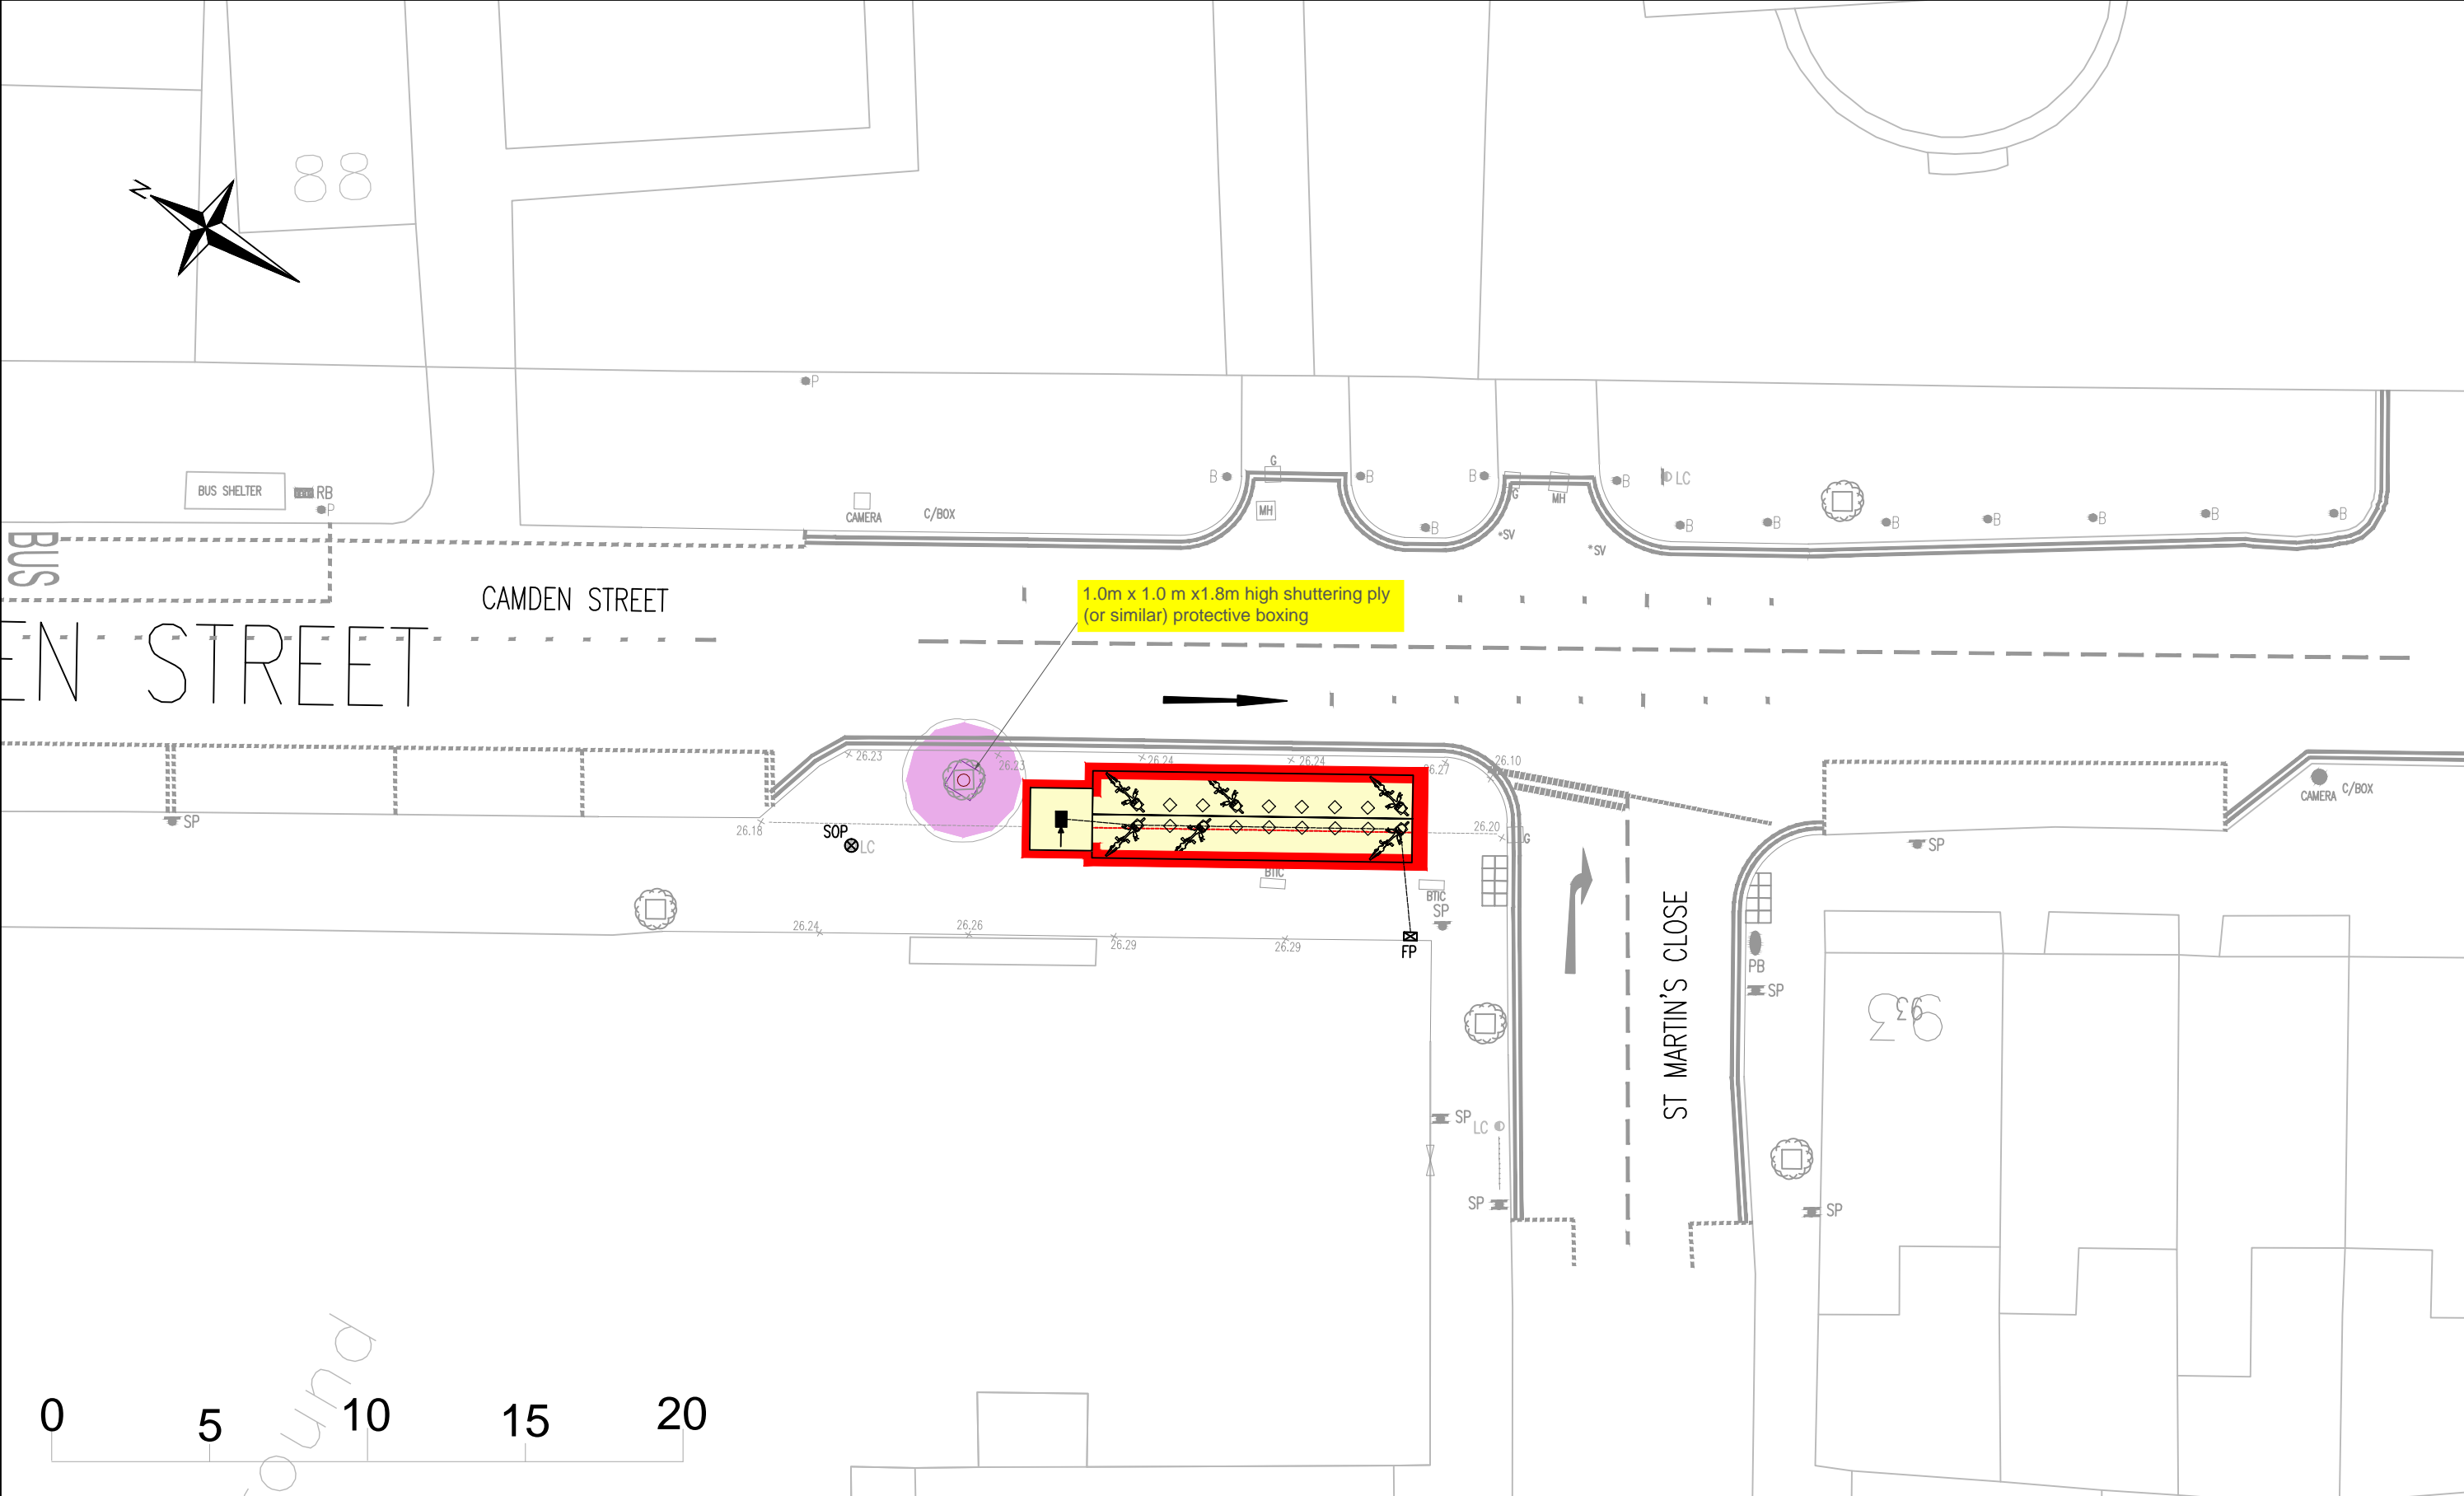
## Appendix 4: Tree Protection Plan

- One Italian Alder tree (T1) situated on the public footway adjacent to the site.

During the survey, minor surface distortion was noted within footway at the northern end of the proposed site footprint; indicating some minor roots may be located at required excavation depth within this area.

The stem and primary branches of T1 will be protected prior to commencement of any construction activity (including ground preparation) and throughout the construction process. The fencing will prevent damage to tree stems and buttress roots located in the immediate vicinity of the site by construction activity. Weldmesh panels or 18mm shuttering ply to a height of 1.8m will be positioned around the tree (a 1m x 1m tree protection fence has been specified in this case). The fencing will be robust enough to withstand occasional knocks from construction machinery and will be secured to the ground using brackets or ground pins. No excavation to secure fencing will occur.
