# Engineer's Report

| Our Reference | <b>IFS-RSA-SUB-12-0034571</b> |

| Address | <b>113 Chetwynd Road, London, NW5 1DA</b> |

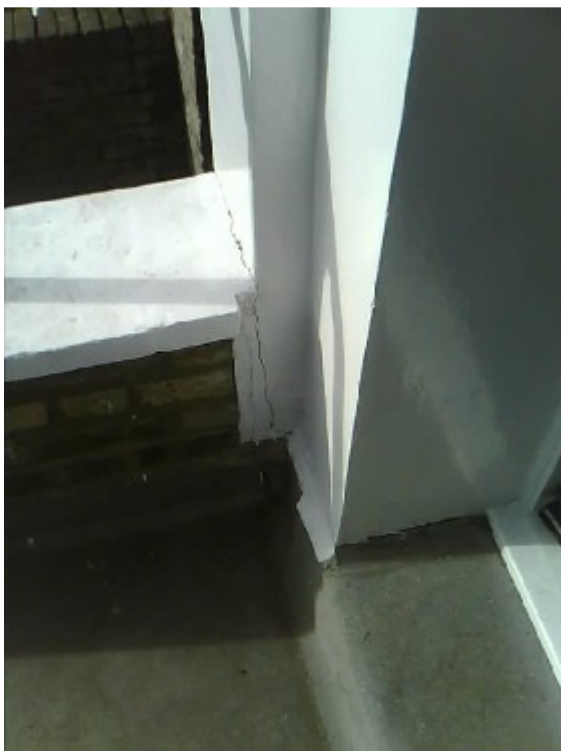
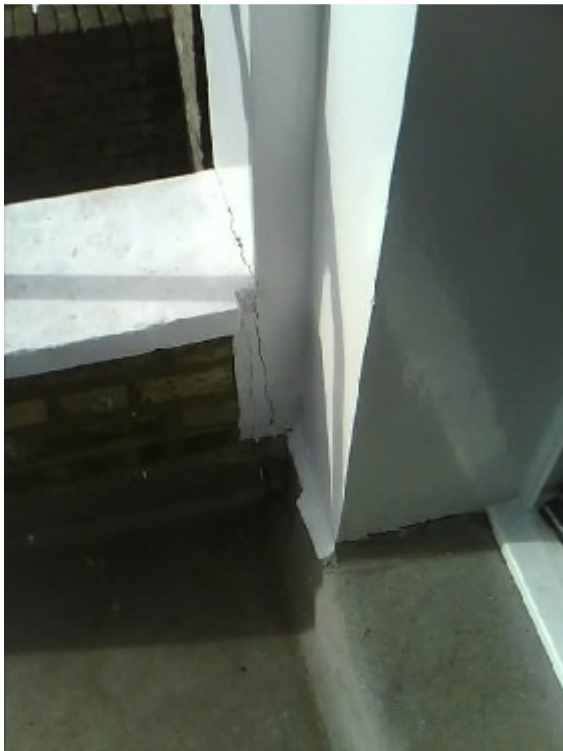
- Separation up to 30mm at the right hand junction of the lower levels of the entrance steps and the main dwelling. The majority of the separation appears historic with some evidence of recent movement.
- Cracking up to 4mm below the window opening to the right flank.
- Separation up to 5mm at the left hand junction of the lower levels of the entrance steps and the main dwelling.
- Separation up to 5mm at the left and right hand junctions of the parapets of the front entrance steps and front elevation of the main dwelling.

FIGURE 03 - Separation at the junction of the entrance steps and the main dwelling - High Level

The aspect and pattern of the cracking to the front entrance steps and front section of the central partition wall to the main dwelling is indicative of subsidence as a result of shrinkage of the clay subsoil due to the moisture extracting influence of the adjacent vegetation within the front garden of the risk address and neighbouring property.

In order to stabilise the property and prevent further damage occurring in the future, the cause of the movement needs to be addressed, with site investigations being required to confirm our initial diagnosis and to determine the extent of vegetation management works required. Following completion of mitigation works, the property will then be monitored to reaffirm stability.

Generally cracks 1mm wide or less will be filled (internal) or re-pointed (external). Internally, where the cracks are wider than 1mm, but less than 5mm the underlying brickwork or blockwork will be exposed and prior to making good the plaster finishes the cracking will be covered with expanded metal lathe. Where cracks are 5mm across or wider, some form of bed joint reinforcement will be introduced.

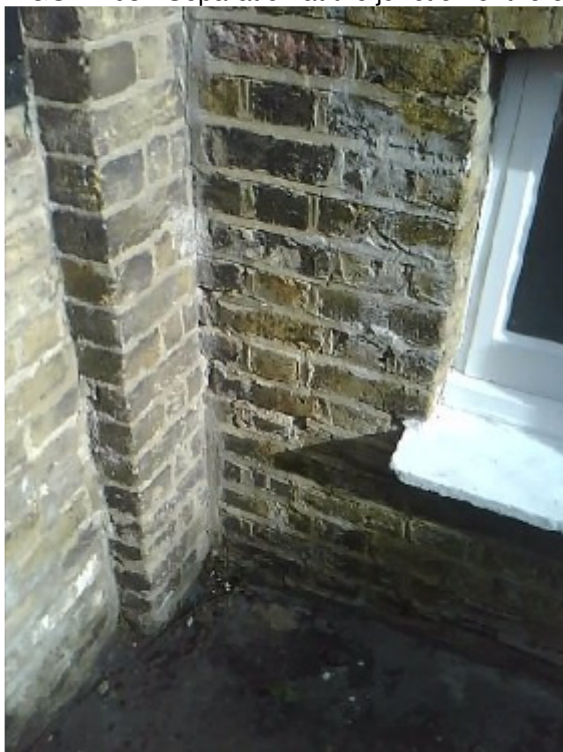
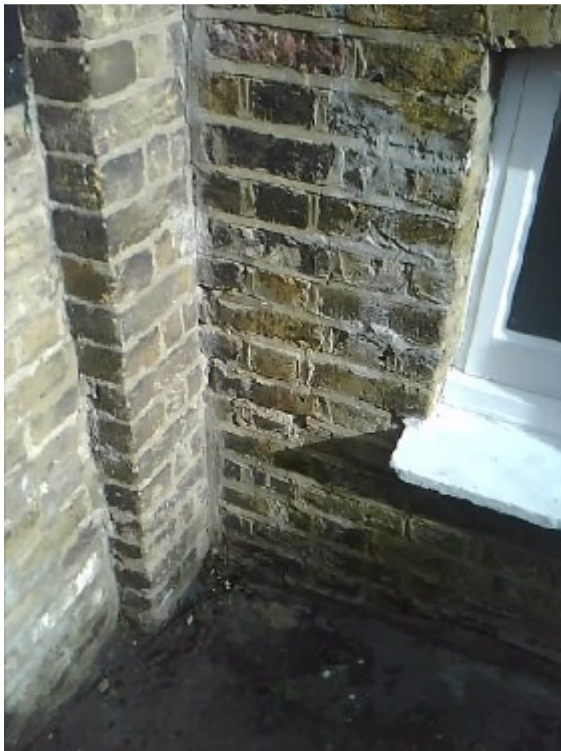
FIGURE 04 - Separation at the junction of the entrance steps and the main dwelling - Low Level
