SIMON JONES ASSOCIATES Ltd.

**TOWN & COUNTRY PLANNING ACT 1990, SECTION 211
TOWN & COUNTRY PLANNING (TREES) REGULATIONS 1999
TREES IN CONSERVATION AREAS
TREES AT No. 30 St.Mark's Crescent NW1 7TU**

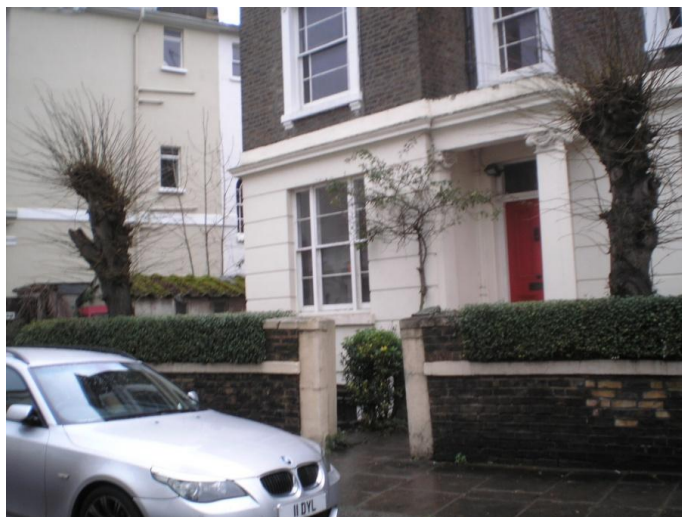
Photograph #1: Two Common Lime in the front garden of 30 St.Mark's Crescent.

The two trees are growing within a privet hedge, behind a low wall, adjacent to the footway of St. Mark's Crescent. Both are single stemmed, semi-mature specimens which have been pollarded at approximately 4m from ground level, have extensive epicormic growth and have small crowns extending to approximately 1.5m from the trunk. Lime tree no.1 has an open cavity on the west side of the trunk at a height of 2.5m where there is likely to be a cone of decay which may extend into the main stem. Lime tree no.2, has a stub with an uneven pruning cut/tear out wound at a height of 2.5m on the northwest side of the trunk with little wound wood response, areas of dead bark and evidence of decay. There is evidence of decay pockets around the pollard points on both trees.

Therefore due to the structural damage that both trees are causing, I write to inform you of my client's intention to fell the two Common lime trees at No. 30 St.Mark's Crescent, within the Primrose Hill Conservation Area.

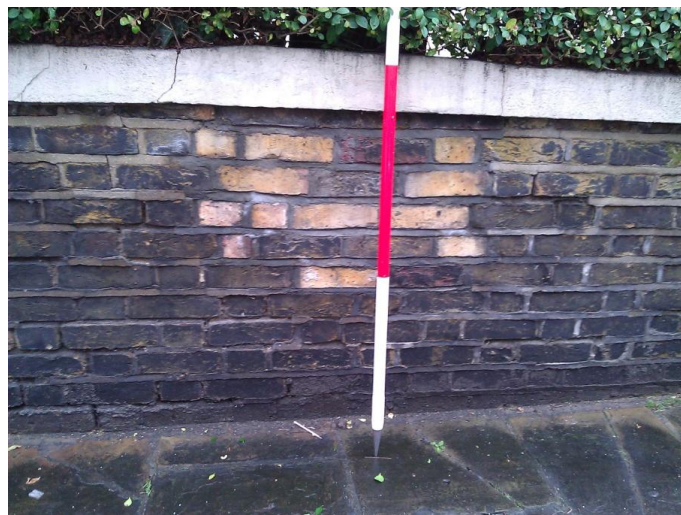
There is clear evidence that the trees (no.1 and no.2) are causing structural damage to the adjacent low level wall (see **Photograph #2** below). There is evidence of cracking and bowing adjacent to both trunks and it is clear that this wall has been patched in the past adjacent to both trees, showing that damage has been occurring for some time. Furthermore, the brickwork and the coping stone have been cut out adjacent to lime tree no.1 so that the wall is only one brick deep adjacent to the trunk. Despite this, the edge of the trunk is still only 85mm from the cut back coping stone. The trunk of the lime tree no.2 is 60mm from the non-cut out coping stone.

Photograph #2: Structural damage to low level wall adjacent to lime tree no.1.

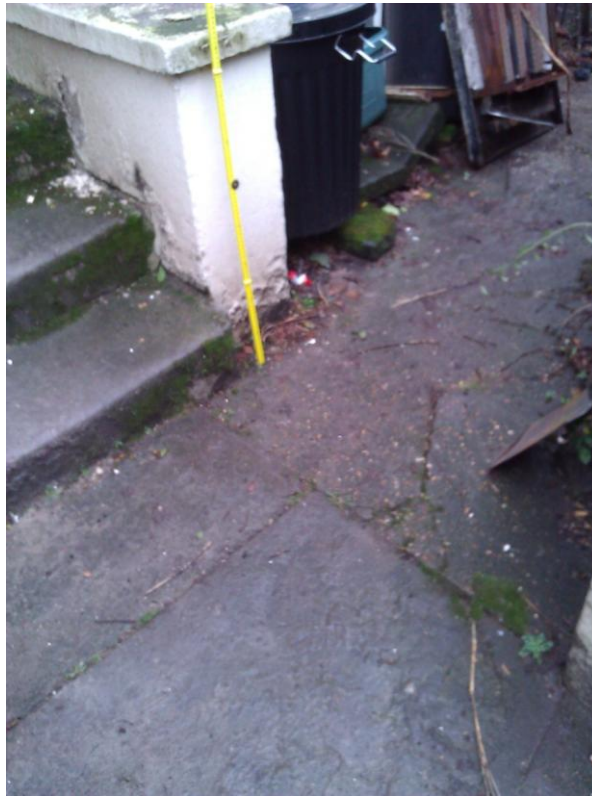
There is also clear evidence of cracking of the concrete slab adjacent to lime tree no.1 and evidence of lifting of the flag stones at the base of the steps to the front door (see **Photograph #3** below); this damage is all consistent with the action of tree roots.

Photograph #3: Cracking of concrete slab and lifting of flagstones.

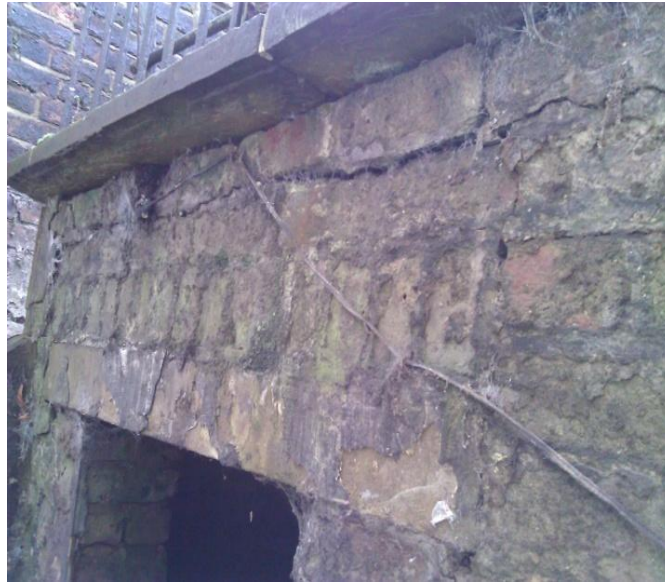
Furthermore, there is cracking of the brickwork and between the brickwork and the coping stones which support the railings on top of the vaults at the front of the house which are accessed by the steps (see **Photograph #4** below); this is also consistent with the damage that can be caused by the growth of roots.

There are two vaults extending by 2.7m towards the road and this is likely to be right up to the back of the footpath, and even possibly underneath the brick boundary wall; consequently, lime tree no.1 is growing directly above these vaults, possibly within only 500-550mm of soil (see **Photograph #4** below); this indicates that this a shallow rooted tree which is causing damage to the surfaces and brickwork of adjacent structures.

Photograph #4: Cracking of the brickwork under the coping stones which support the railings on top of the vaults. Also, shows the very limited depth available to the lime tree growing above the vaults.
